Exam Date: 10/3/2012

State of Idaho  
Department of Water Resources  
**Field Exam Map**  
57-7385

**System Diagram**  
Permit 57-7385

**IDAHO DEPARTMENT OF WATER RESOURCES  
--- DAM SAFETY RECORD OF INSPECTION ---**

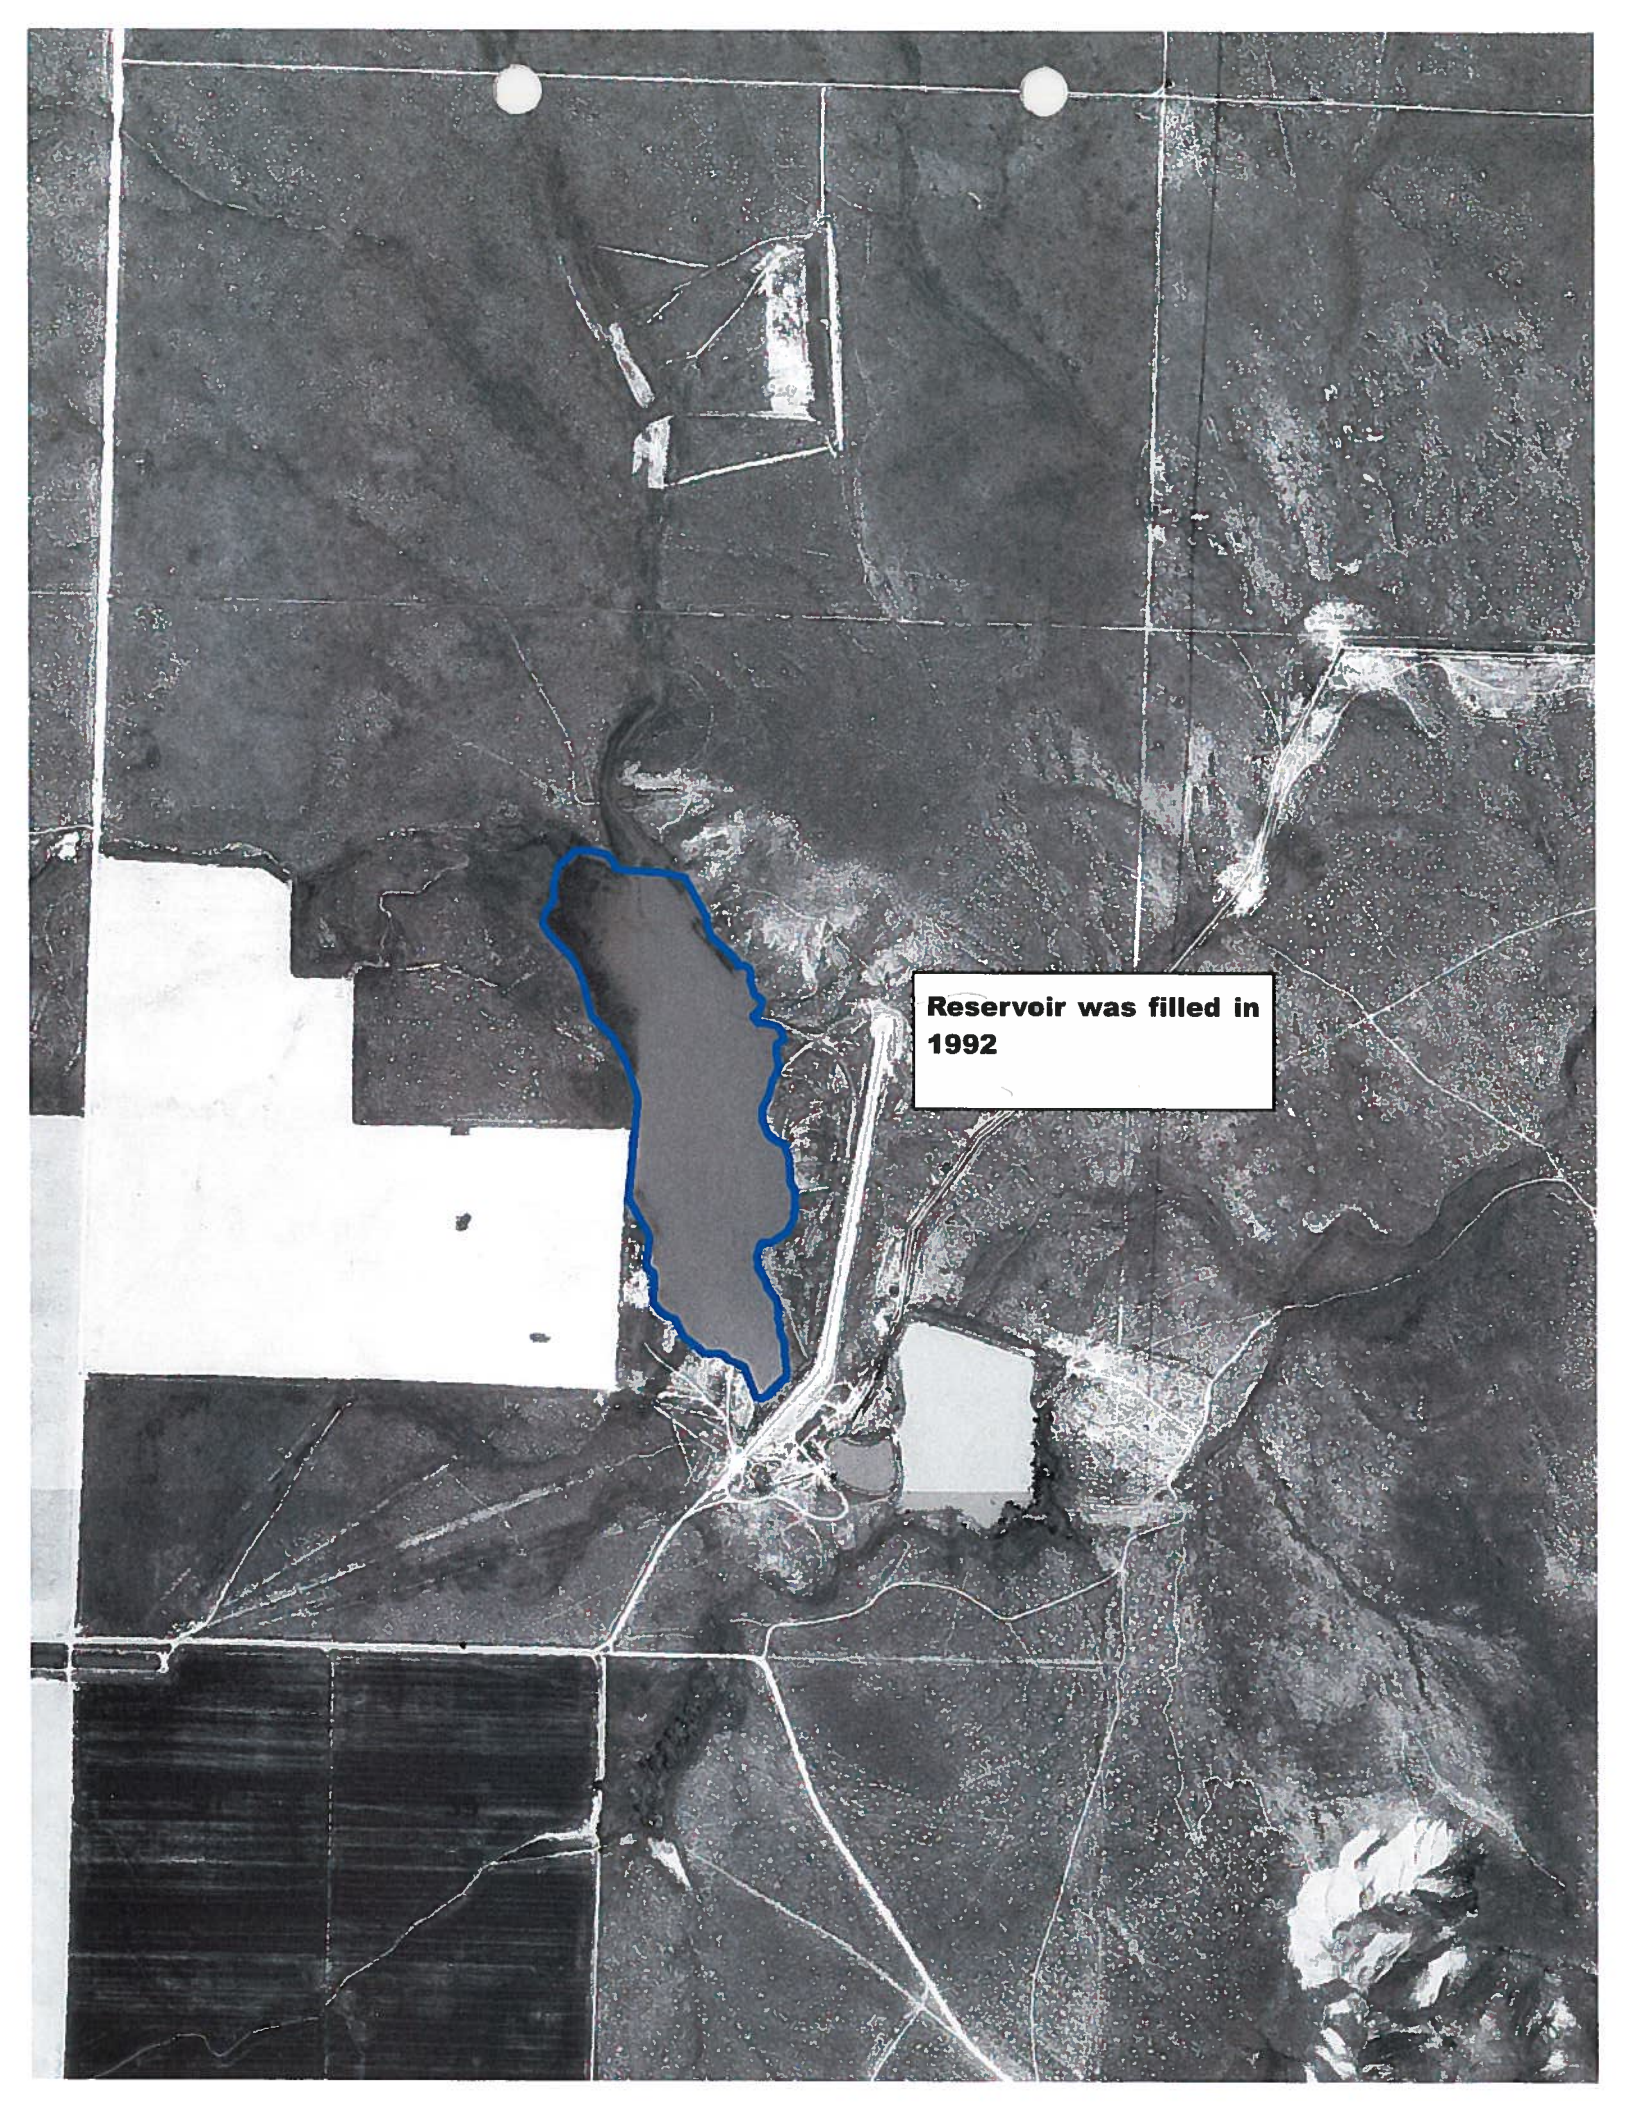
**Reservoir was filled in  
1992**

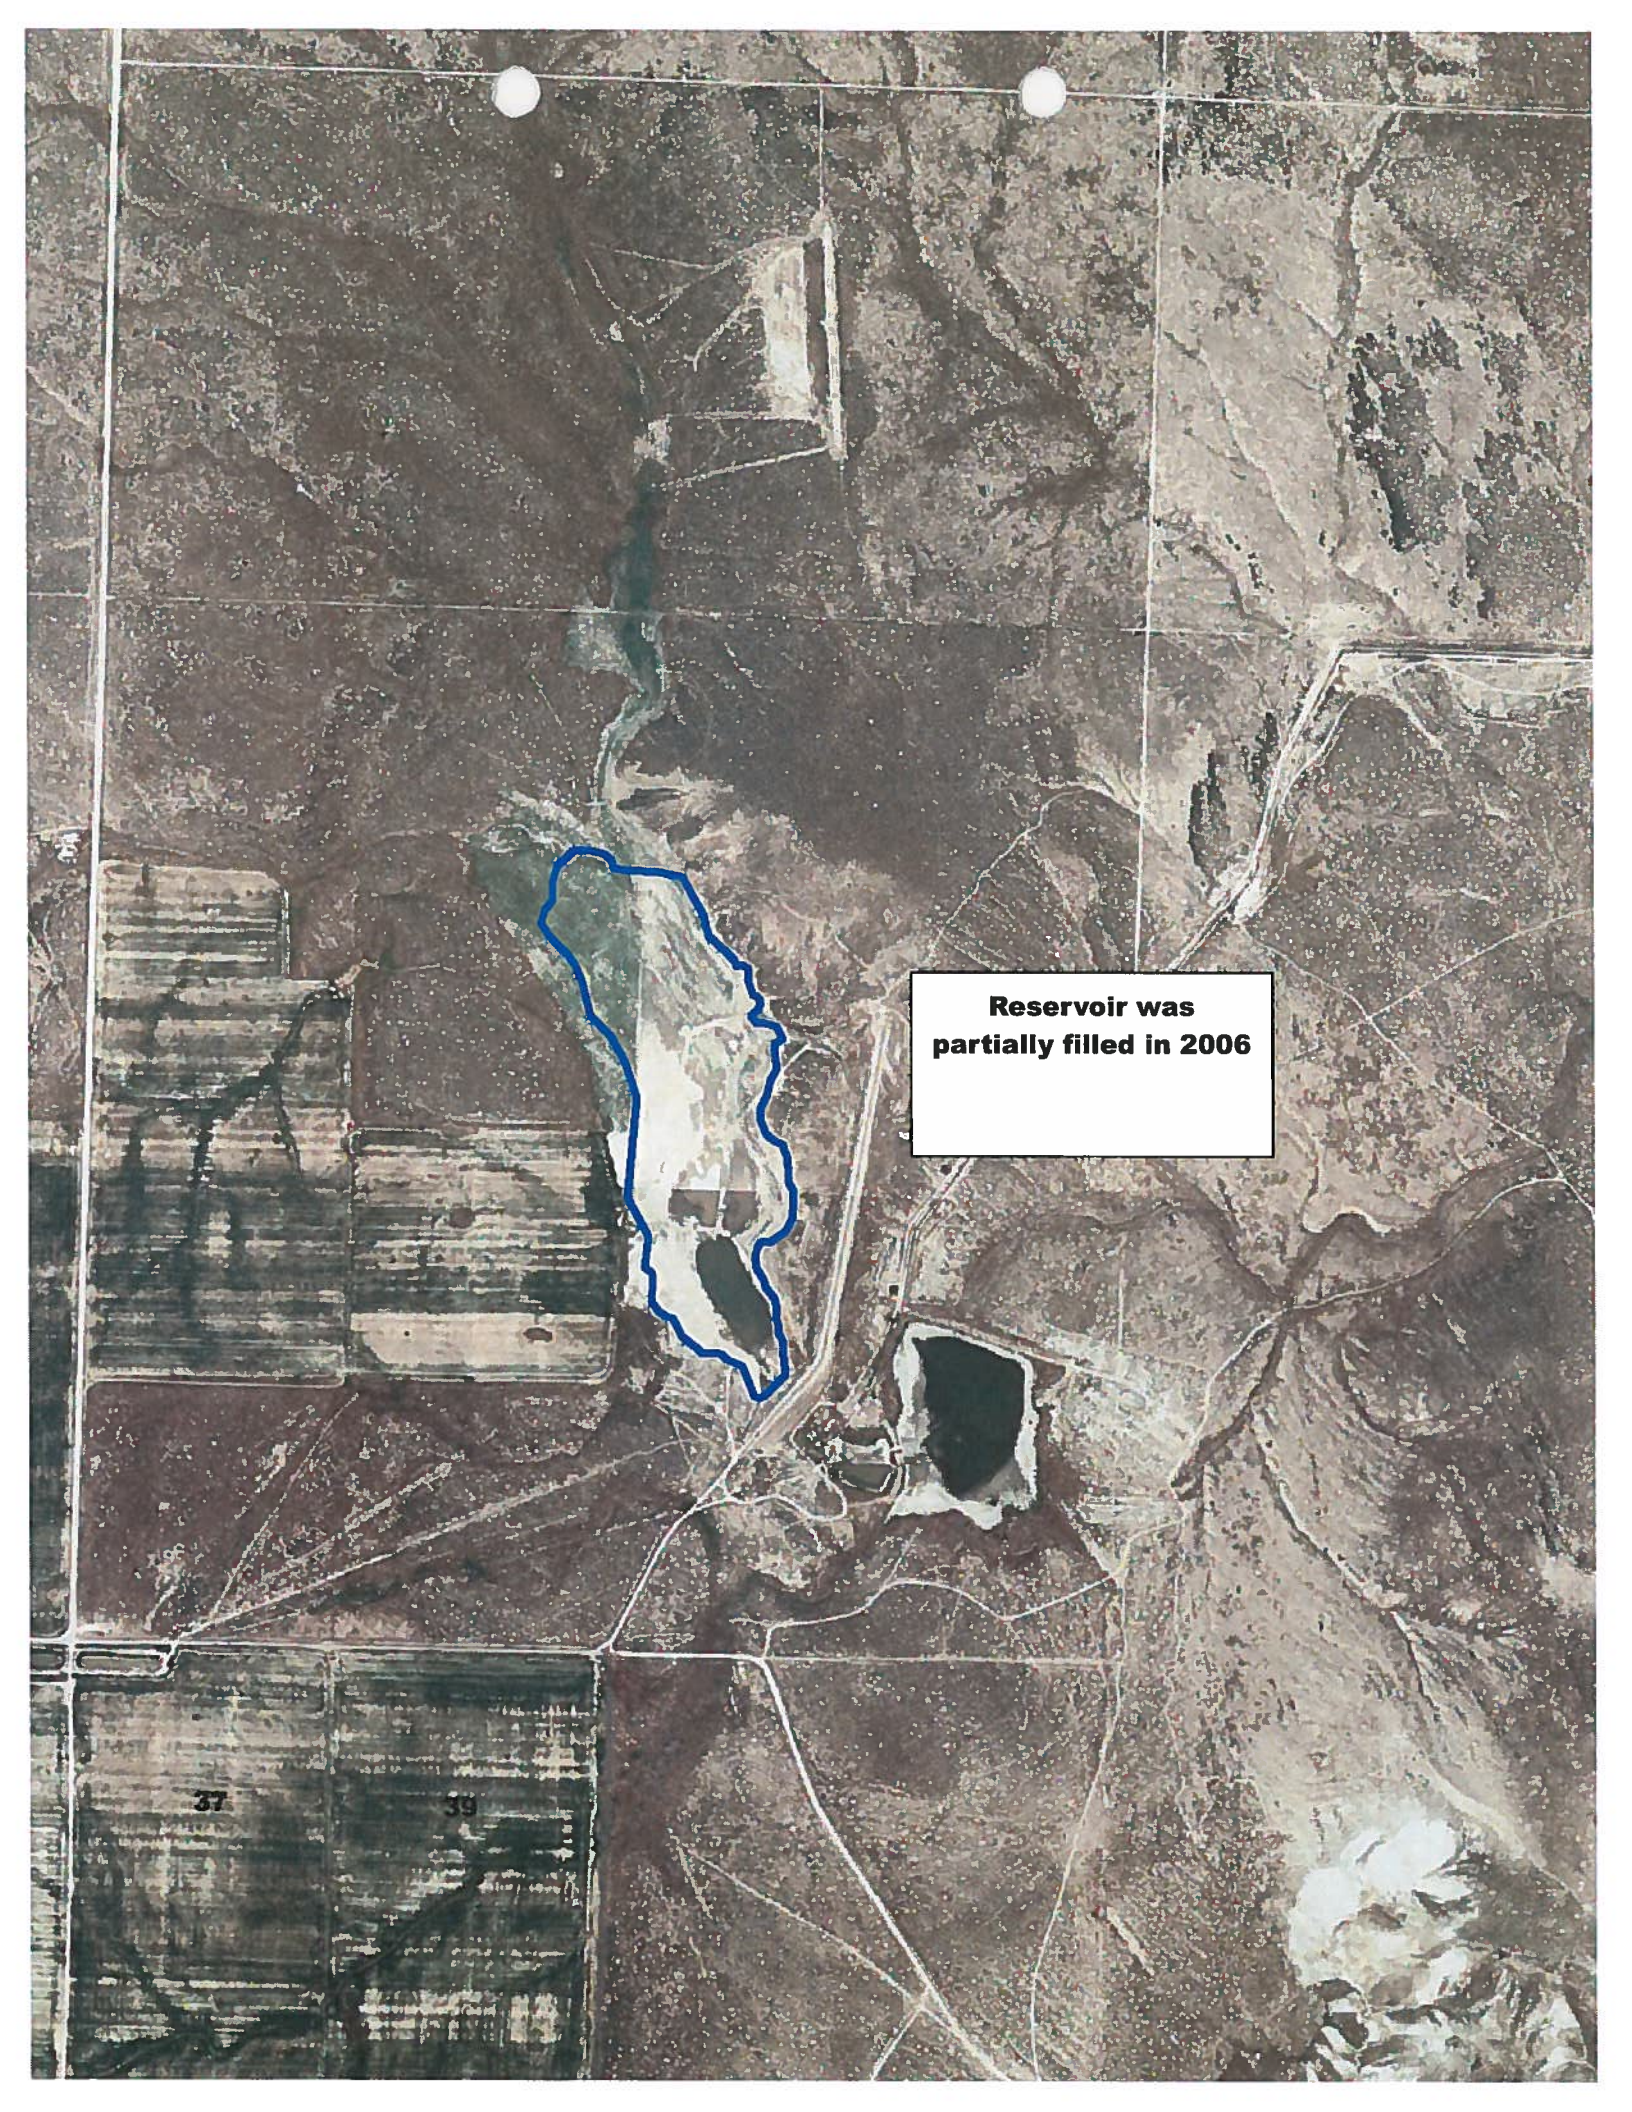
**Reservoir was  
partially filled in 2006**

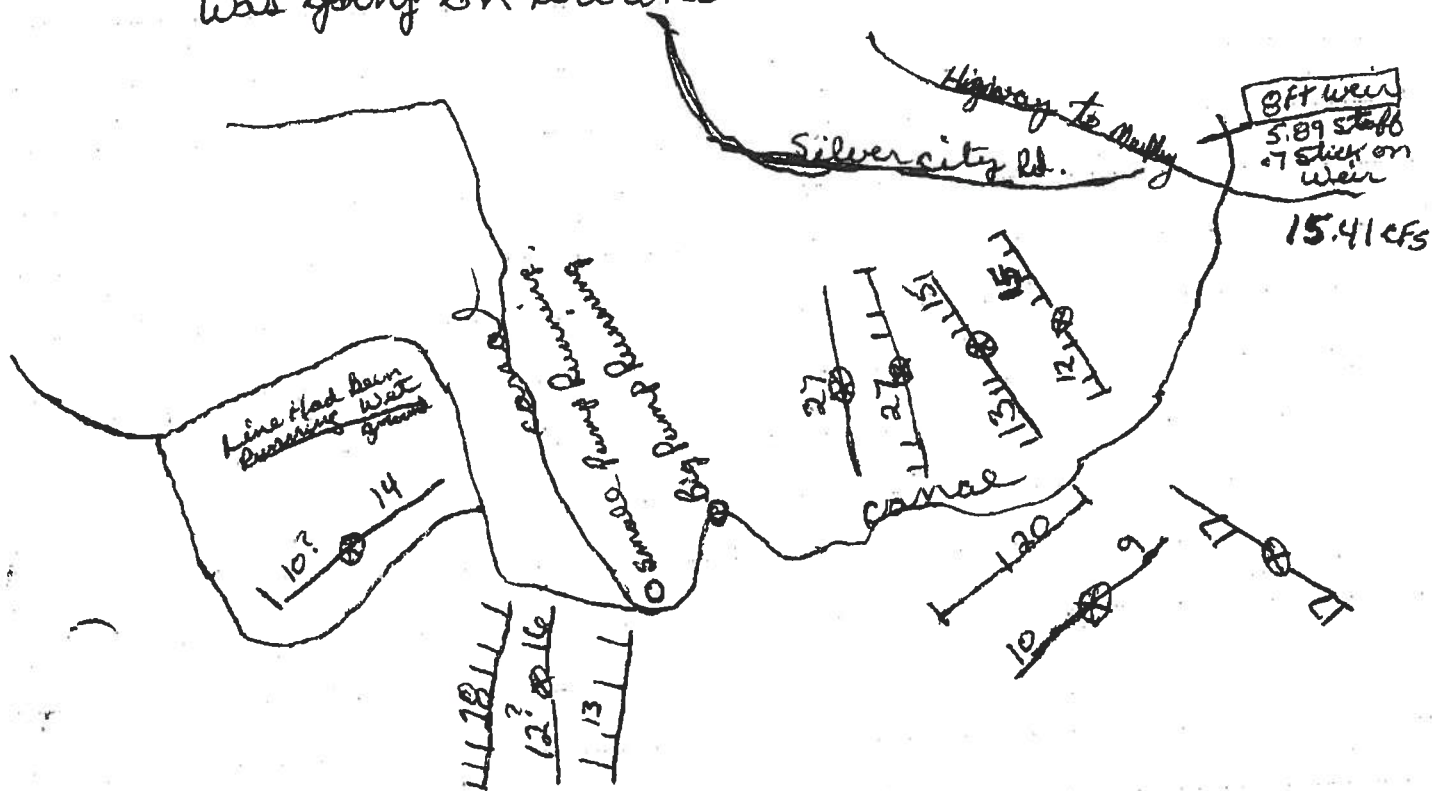
There were 265 sprinklers running.

Bench field running 1. CFS  
canal staff Read 5.36 For 56.07 CFS 10 FT weir.  
Stick on weir was .74 = 20.93 CFS (Weir Submerged).  
Paul Had Ground Water Pumping.  
Paul Had Refit to Canal on.

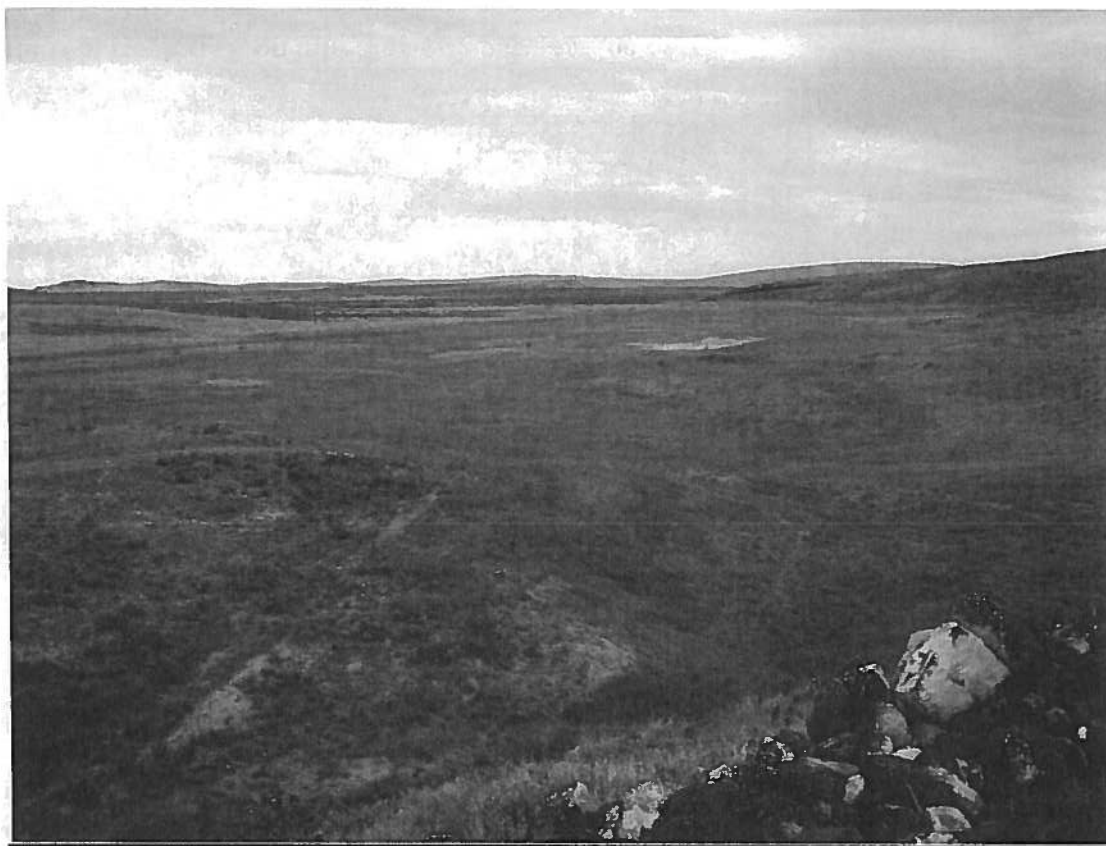
**Photo of impoundment as seen from right abutment.**

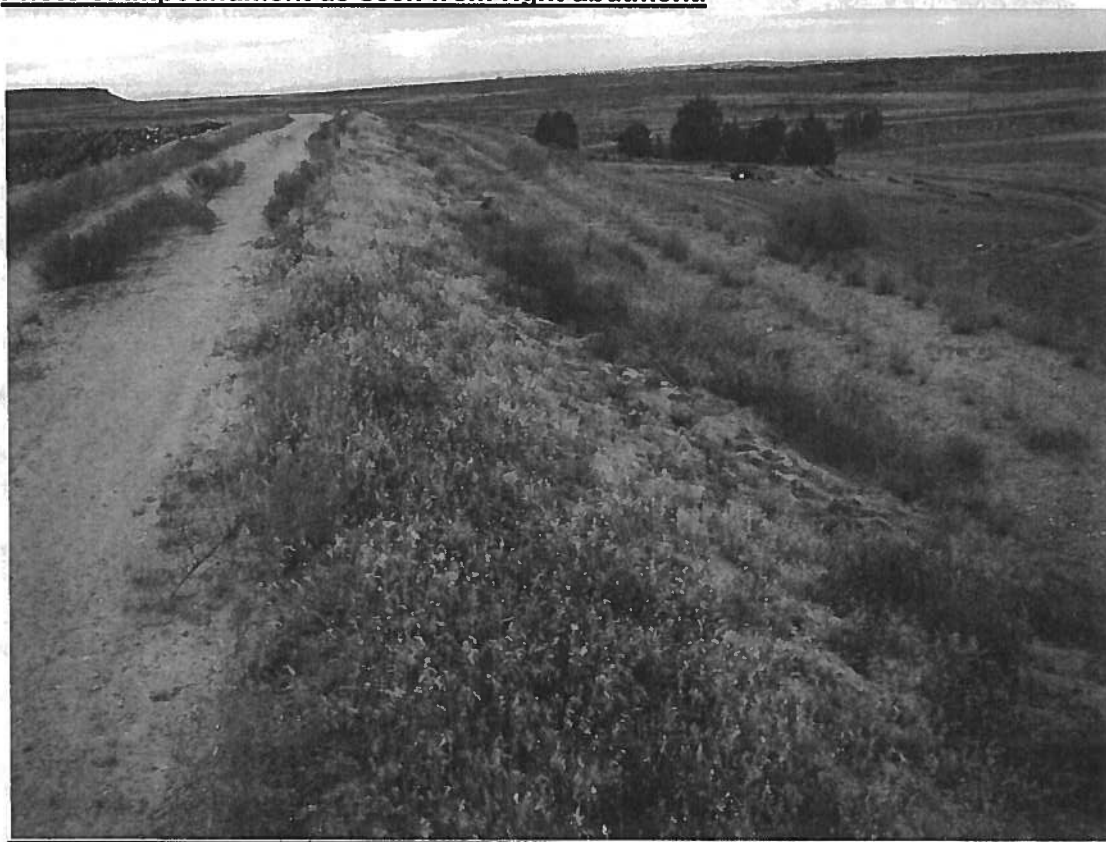
**Photo of crest and downstream face viewing growth on embankment faces.**

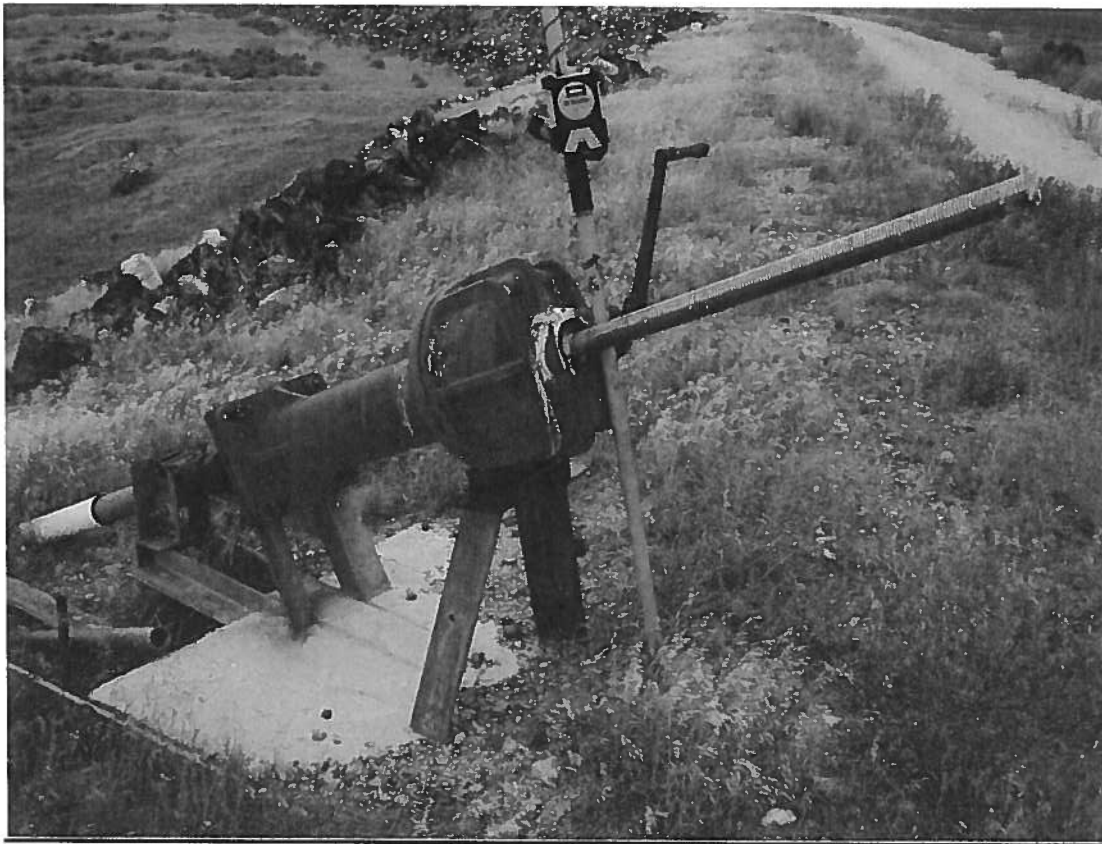
Outlet control works

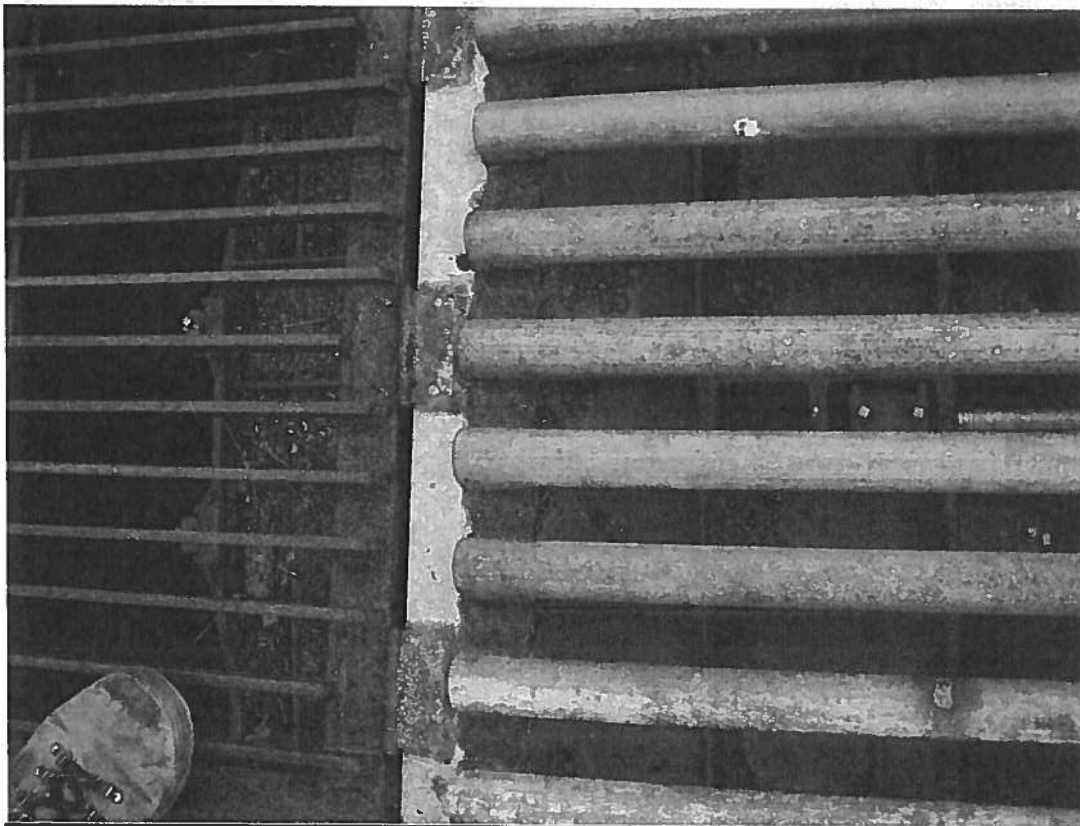
Photo of trash rack on inlet box on upstream toe of dam.

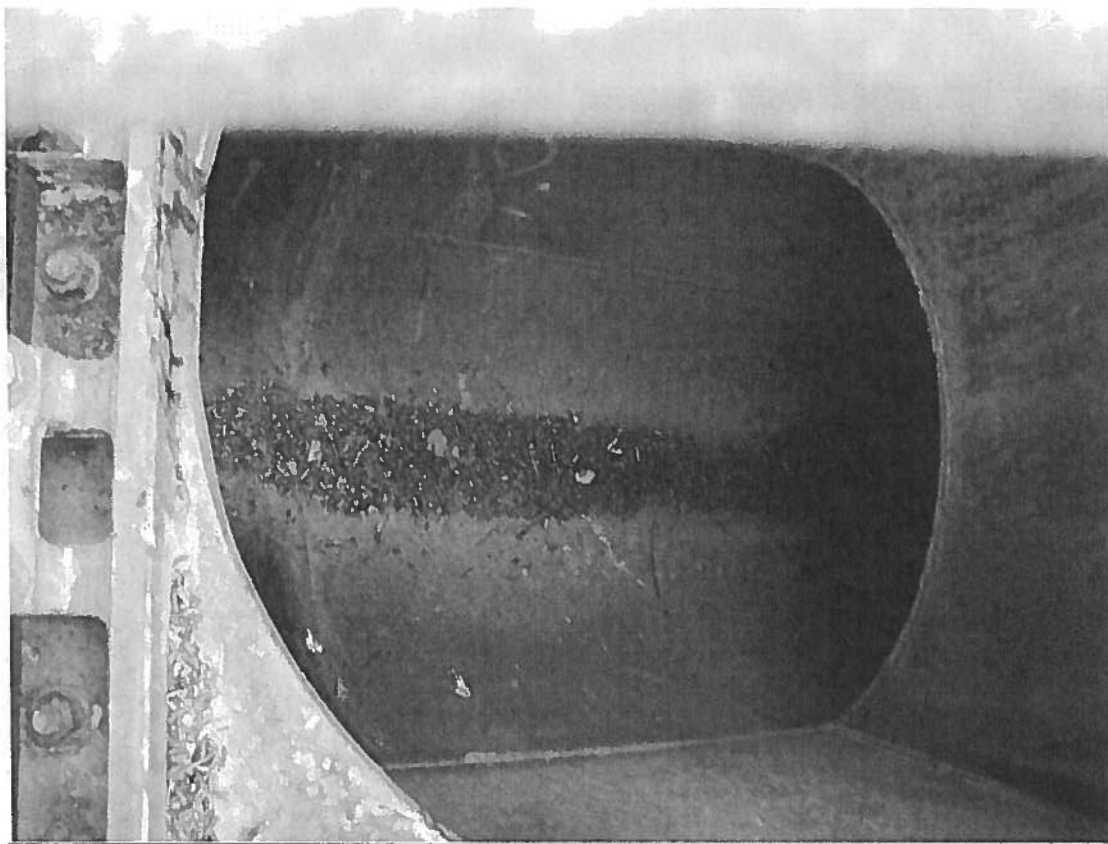
**Photo of drop inlet transition from gate to pipe.**

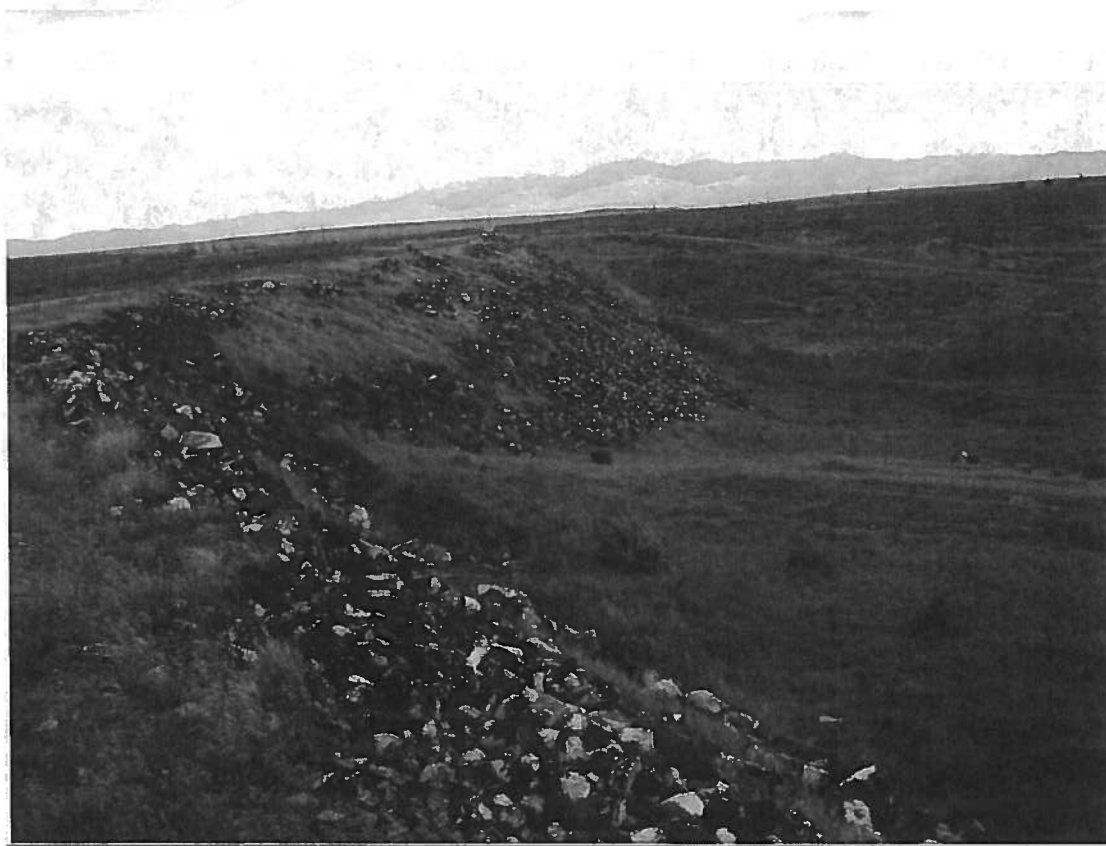
**Looking southerly at upstream face of dam viewing condition of riprap**

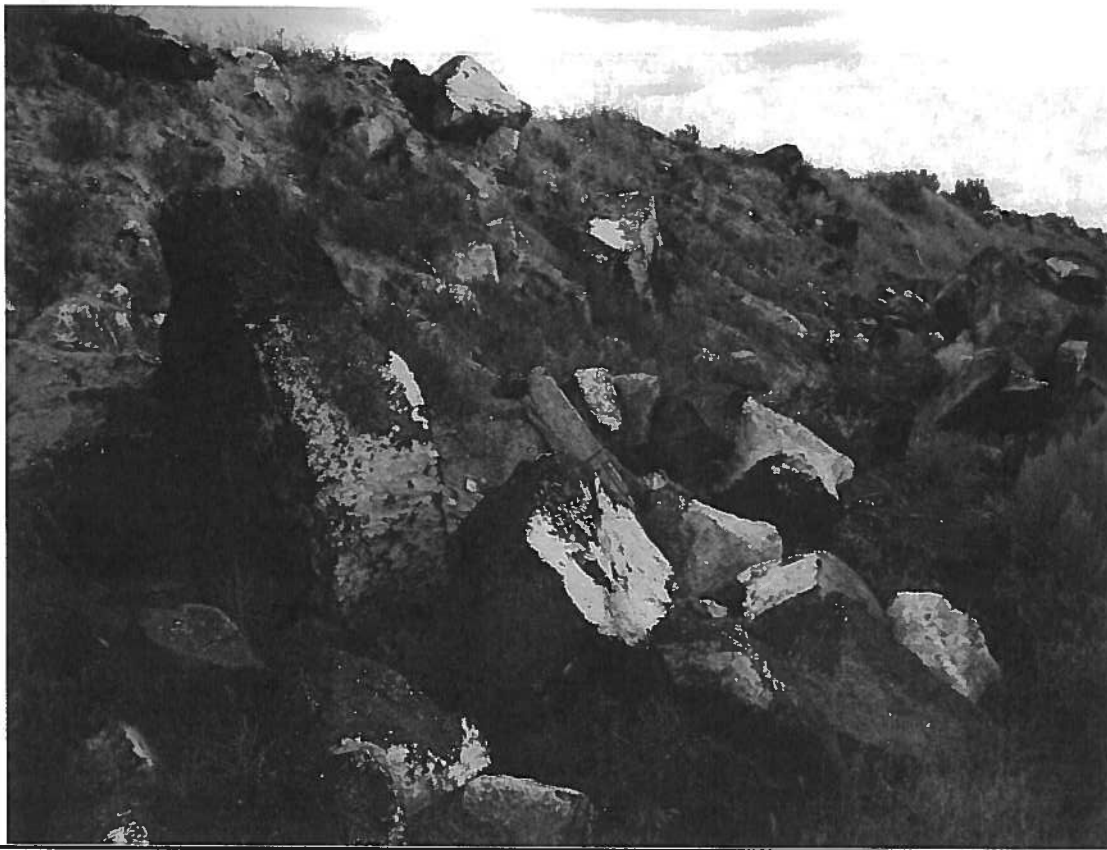
Photo of left section of embankment, riprap is gradually migrating down slope from dam crest.

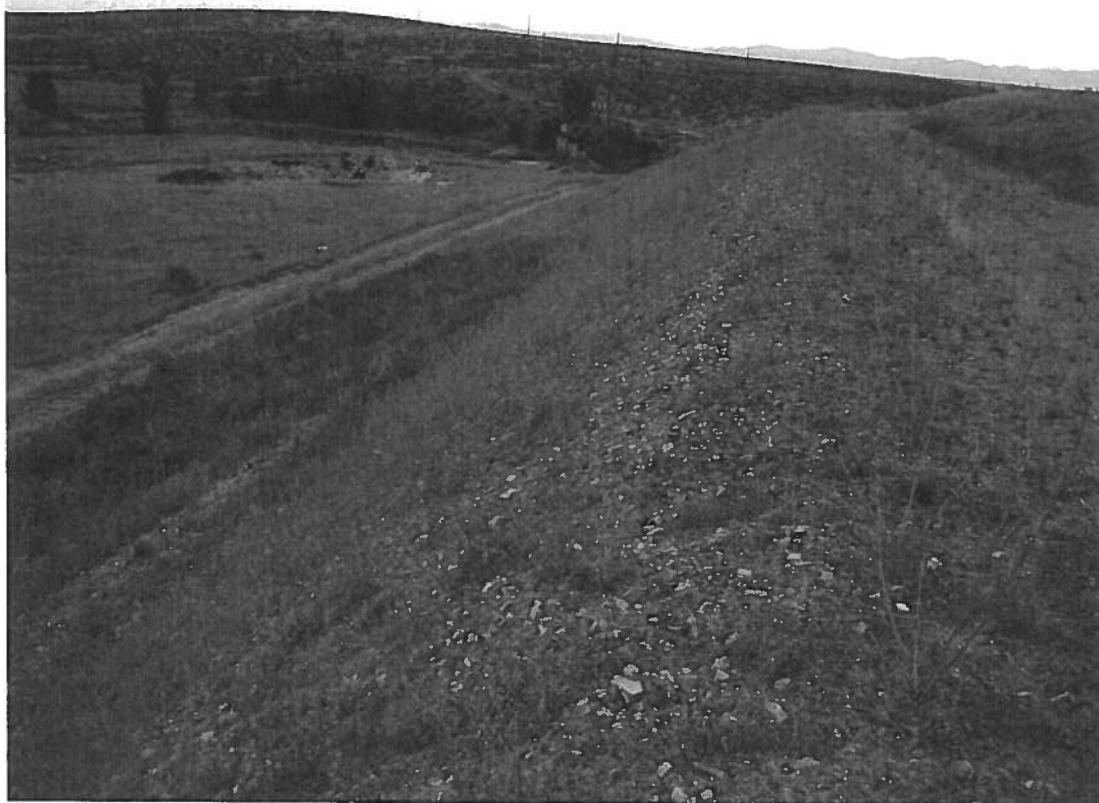
Photo viewing downstream face of dam as viewed from mid way point on dam looking towards right abutment.

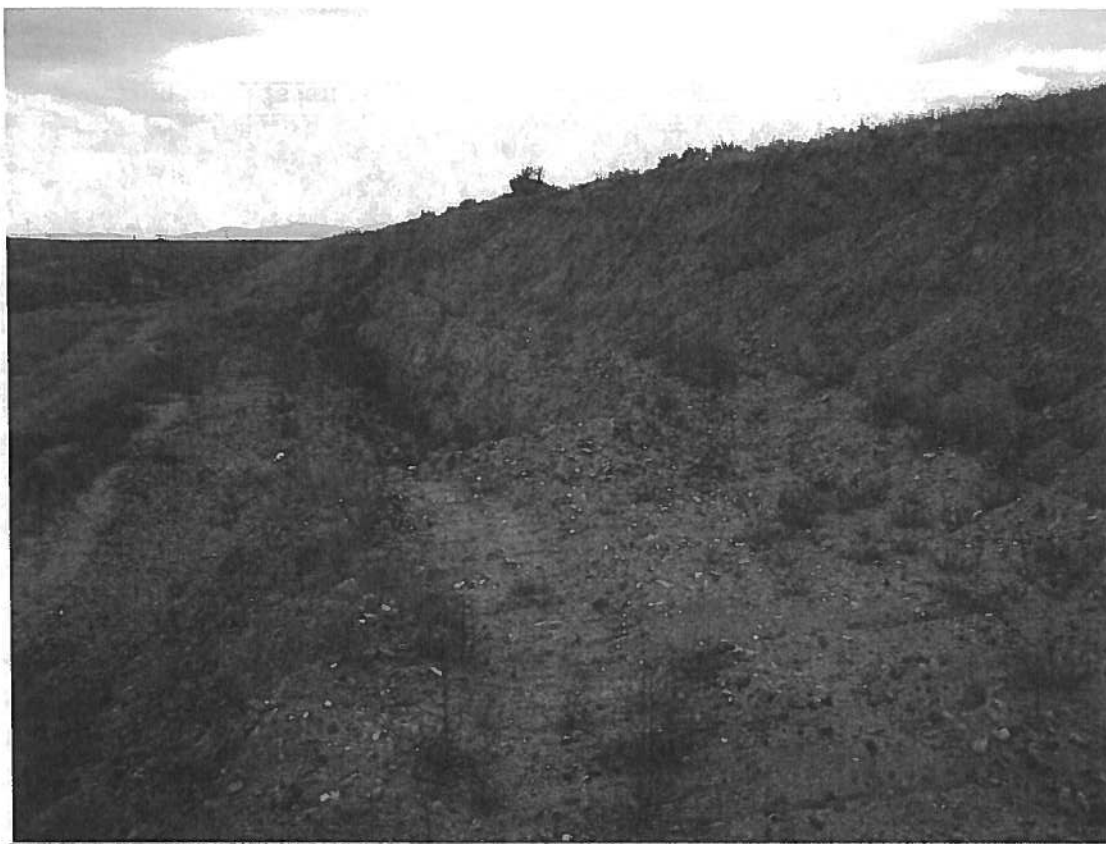
**Photo looking southerly towards right abutment at area where removal of embankment material has been excavated.**

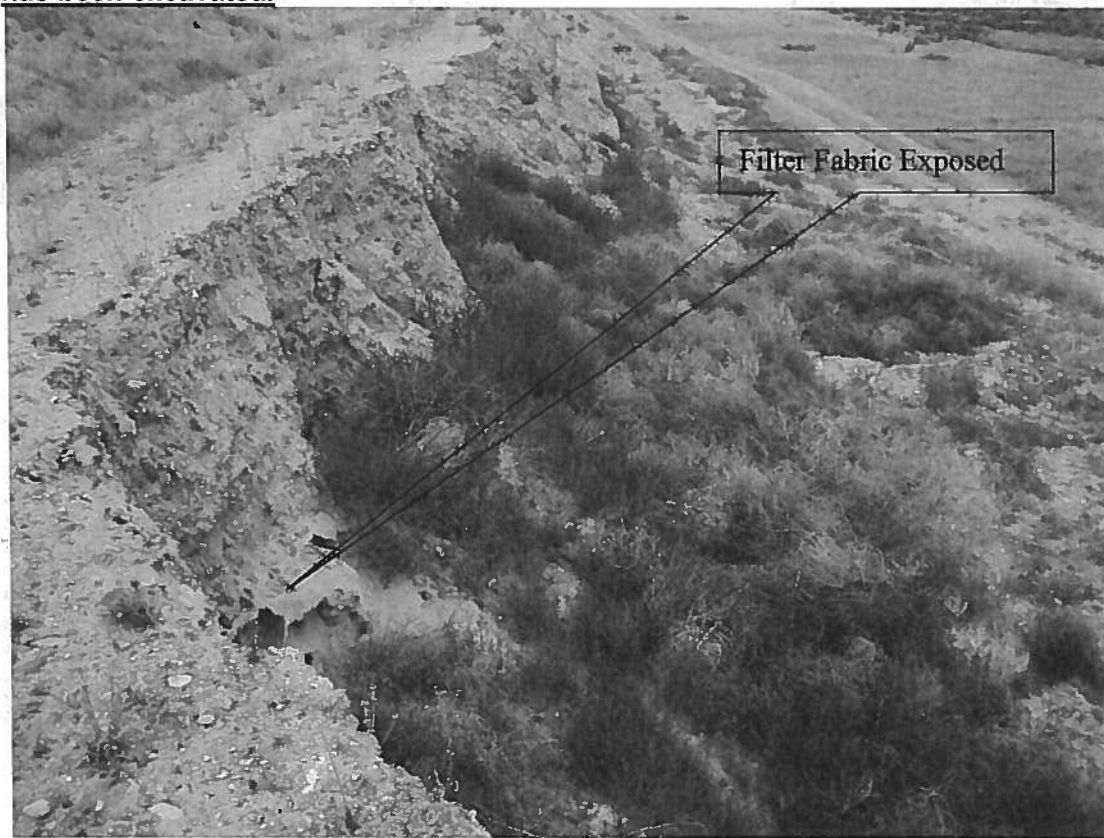
**Excavation is from roadway buttress down to toe of dam. See GPS map for location.**

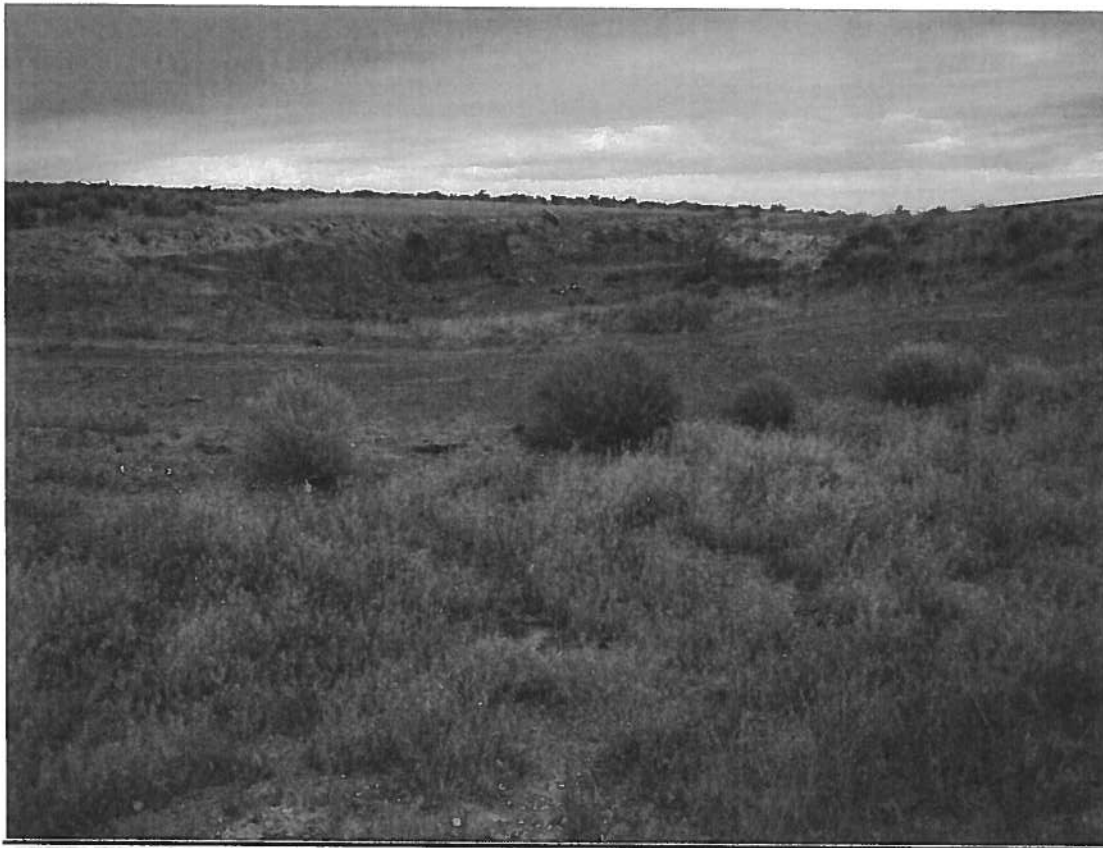
Photo of spillway inlet channel entrance.

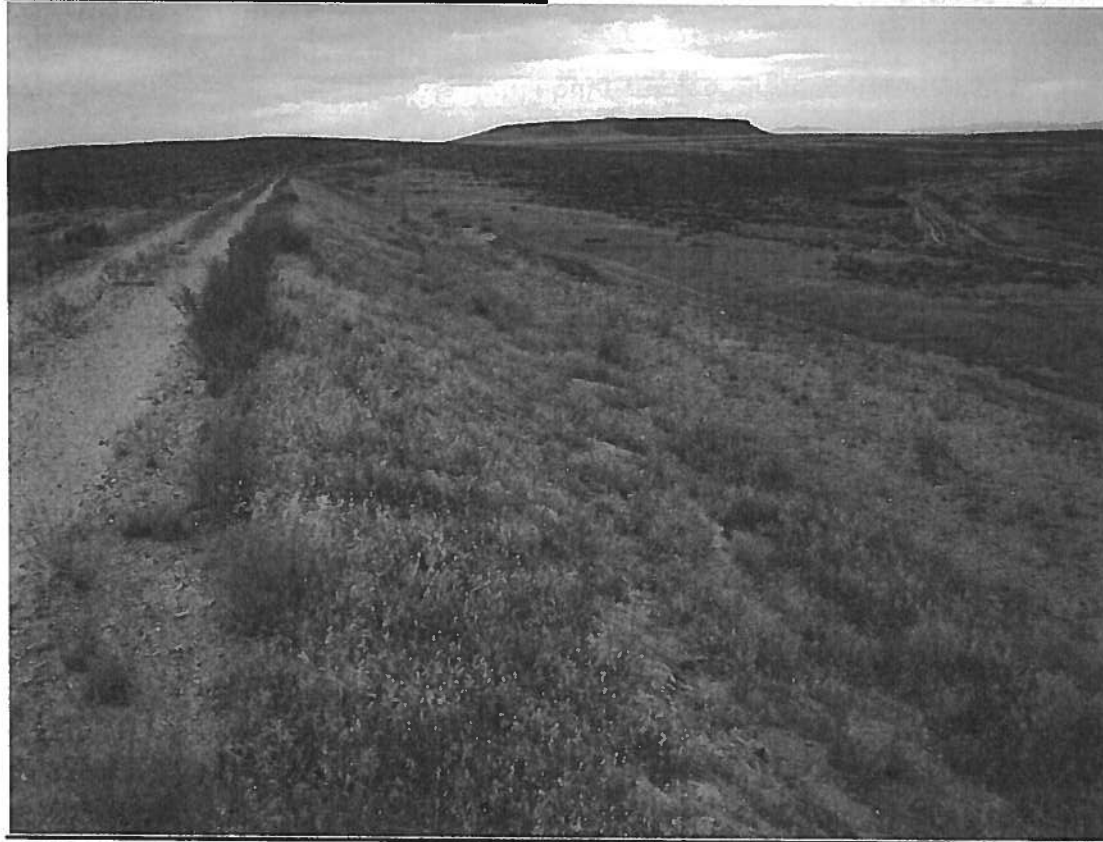
Photo looking towards left abutment downstream slope of embankment.

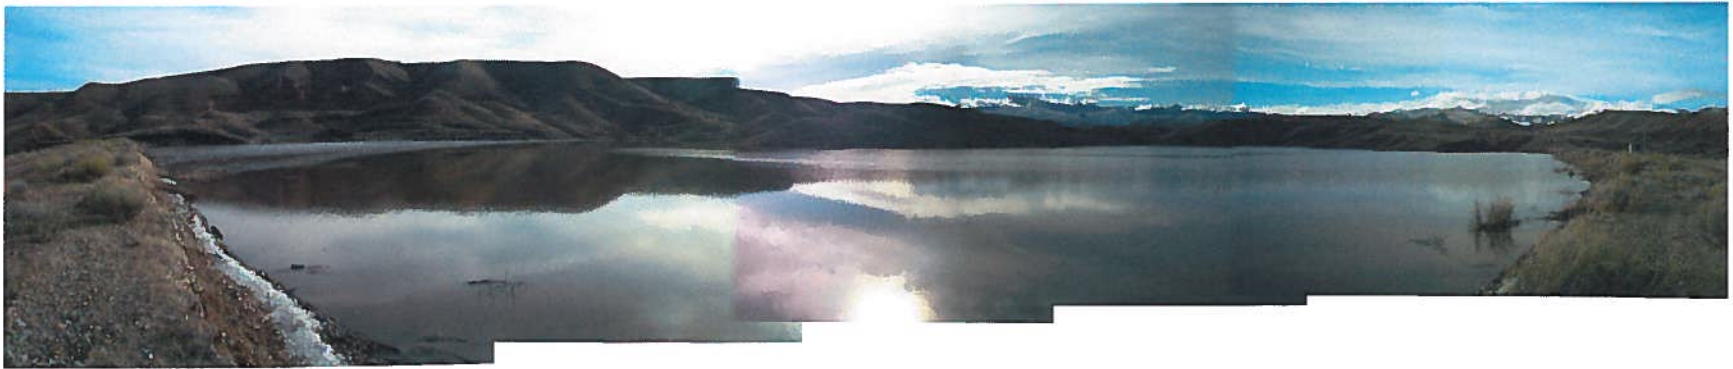
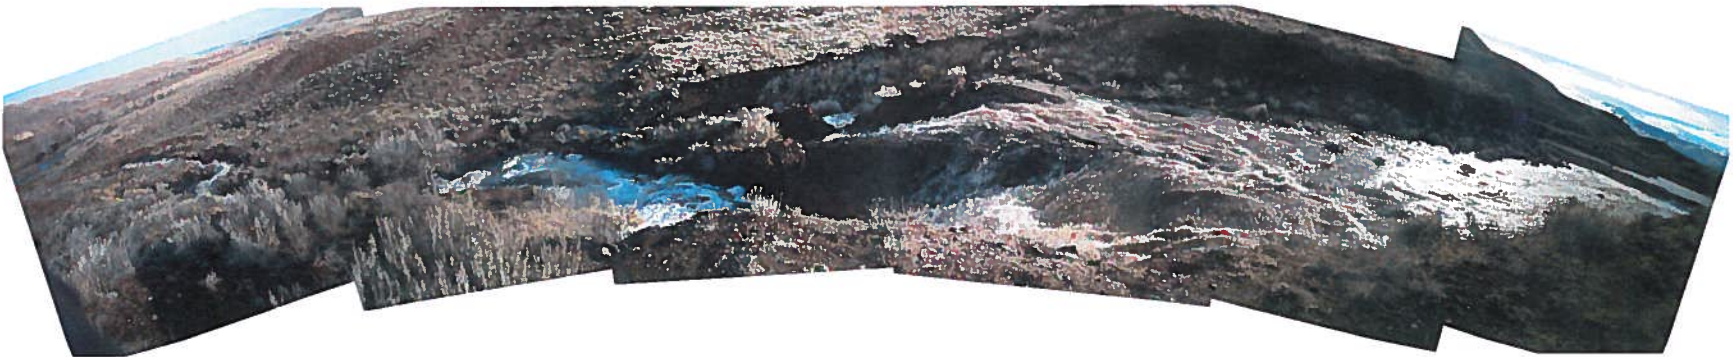
The photos above are of the Hulet Reservoir and spillway. The top photo is of the reservoir, and as you can see it is full. In the background you can see the Owyhee Mountains, which are still well covered in snow. The bottom picture is of the spillway. As you can see it is flowing at fairly heavy flows. I estimated the flows at well over 25 cfs, but couldn't determine the exact flow.

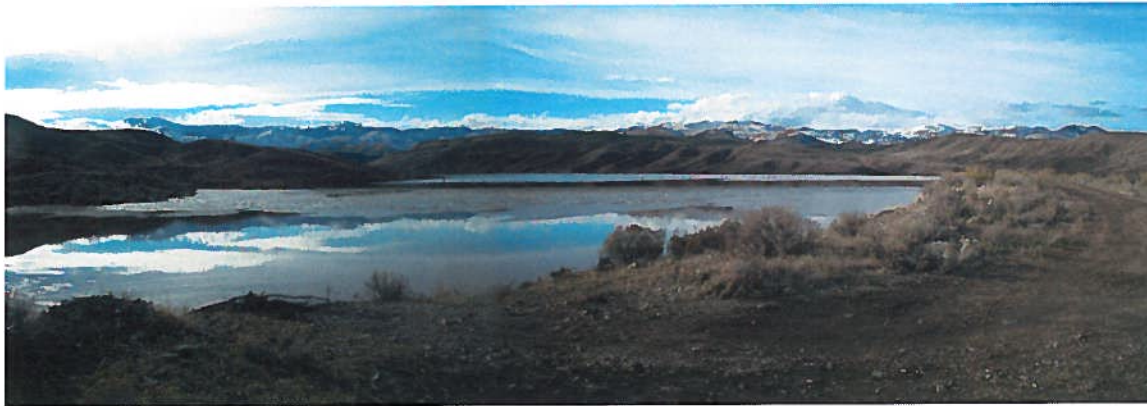
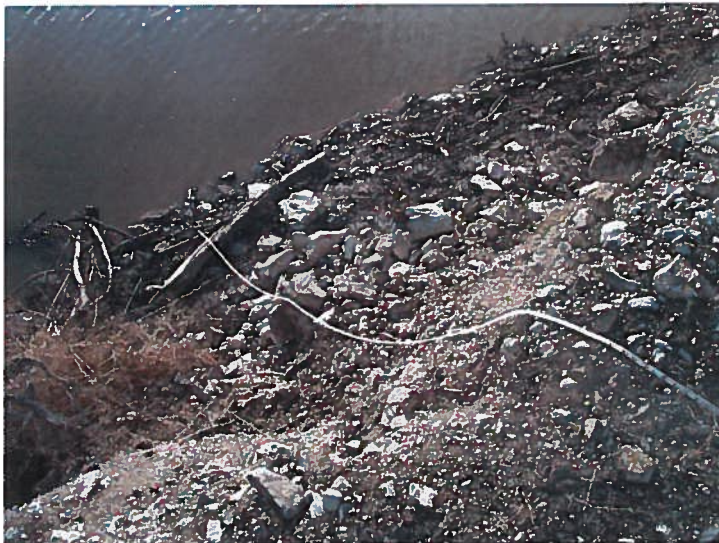
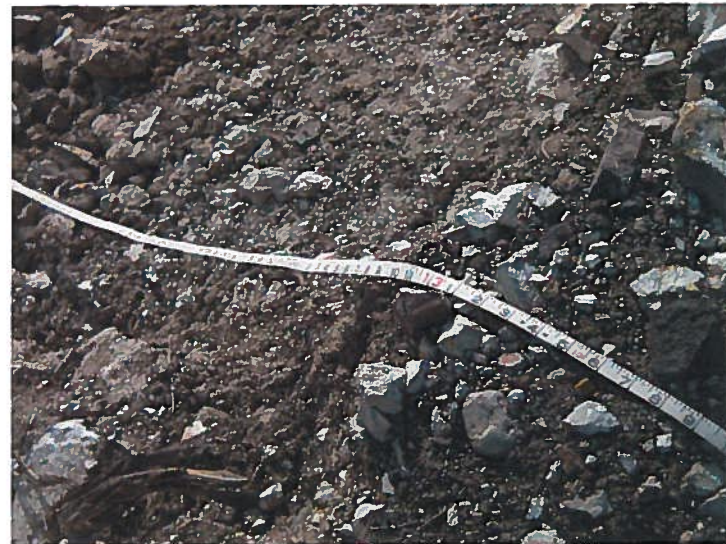
The top photo shows ice and debris building up by the spillway of the reservoir. This could become a more significant problem if the ice and debris clog the spillway. The bottom photo shows the measurement I made of the water to crest of the dam. The measurement was 13 feet.

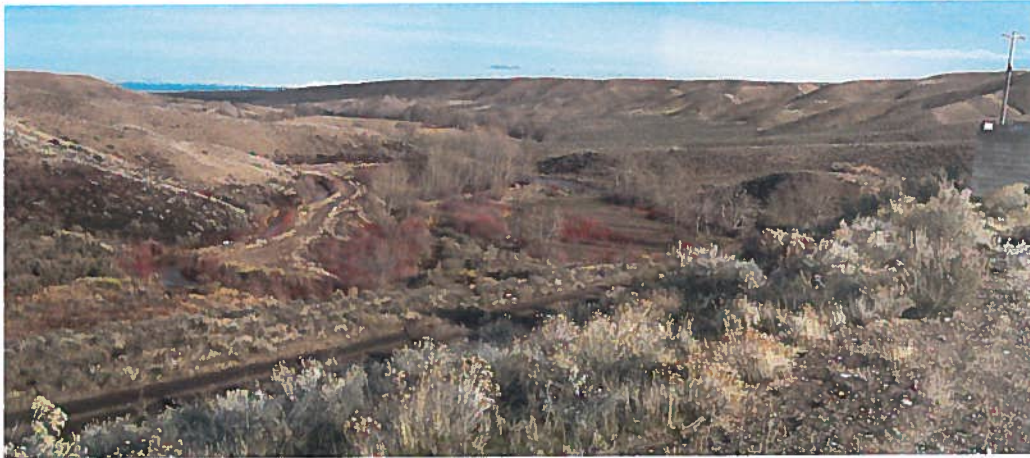
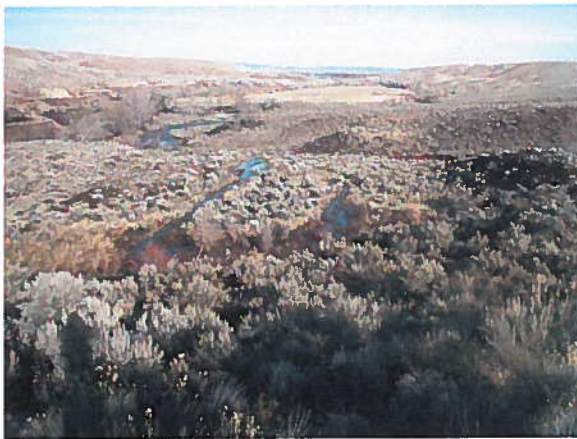
The top photo shows the valley below the reservoir. As you can see, the creek and the feeder canal are at full flows. The Hulet's are siphoning off some of the flows from the reservoir into the canal and sending it to storage ponds on their property. Although they are doing this for later irrigation benefits, it is actually a good idea to remove as much water from the creek channel as possible. Later pictures will show why.

The bottom picture shows a drain in the reservoir. It seems to be flowing normally when compared to previous information supplied in the dam safety file included in the 1998 report.
