Exam Date: 10/3/2012

State of Idaho  
Department of Water Resources  
**Field Exam Map**  
57-7385

**System Diagram**  
Permit 57-7385

**IDAHO DEPARTMENT OF WATER RESOURCES  
--- DAM SAFETY RECORD OF INSPECTION ---**

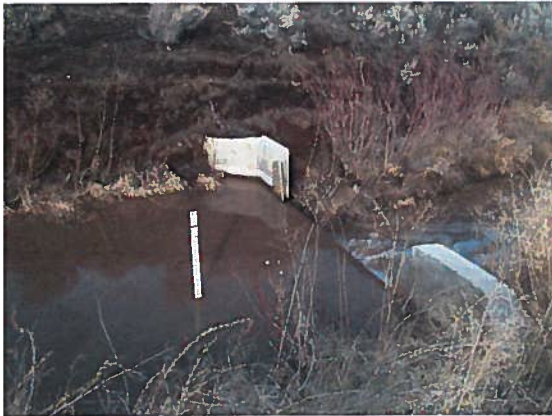
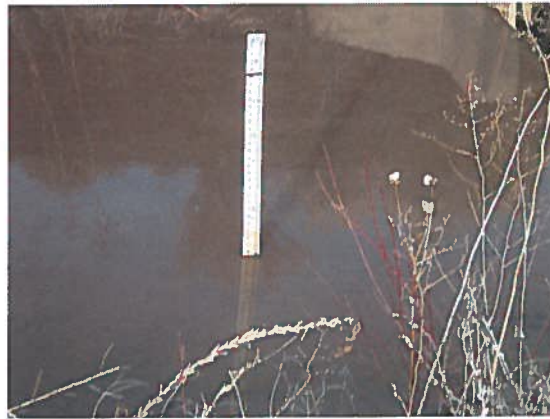
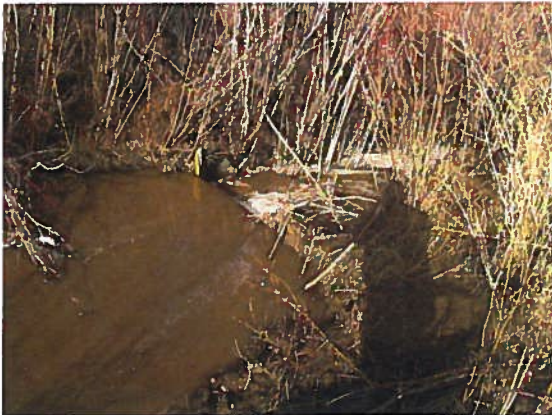
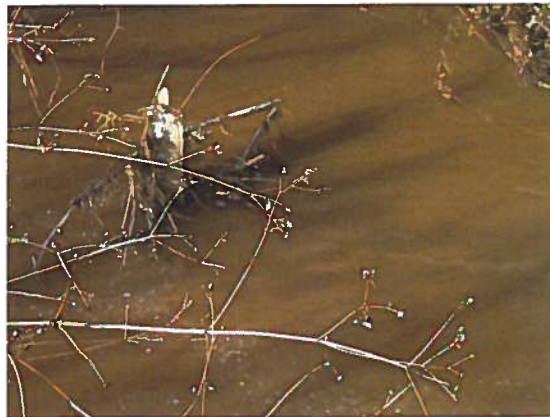
These photos show the flows being diverted out of the dam turnout. The pictures on the top show the water being diverted down the canal, and the pictures on the bottom show the water being diverted down Nettleton's ditches. They are attempting to relieve a little of the pressure on the spill way by running a portion of the water through these conveyances. I estimated the amount of flowing this direction to be approximately 25 cfs. I feel this is a very good idea, because the water in the canal is not going over Highway 78 through the creek channel. This will probably give more storage to canal users, but in the long run, I feel it is the best for all. This should help prevent any washouts down stream of the dam. There has been concern that the creek may wash out Highway 78. The water being diverted through Nettleton's ditches, is being spread over his fields. This will help his soil moisture, and possibly allow some of that water to be soaked into the ground instead of running down the creek channel. All of these techniques should help prevent further damage.

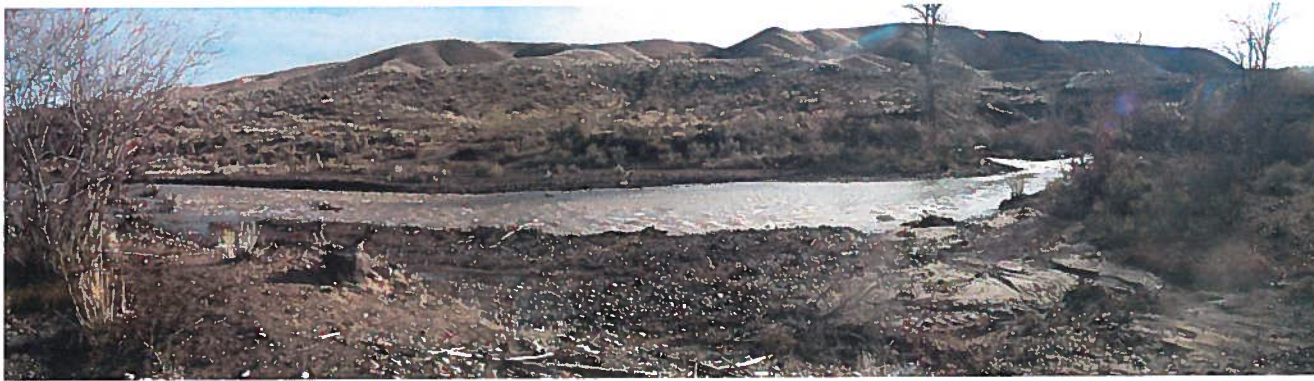
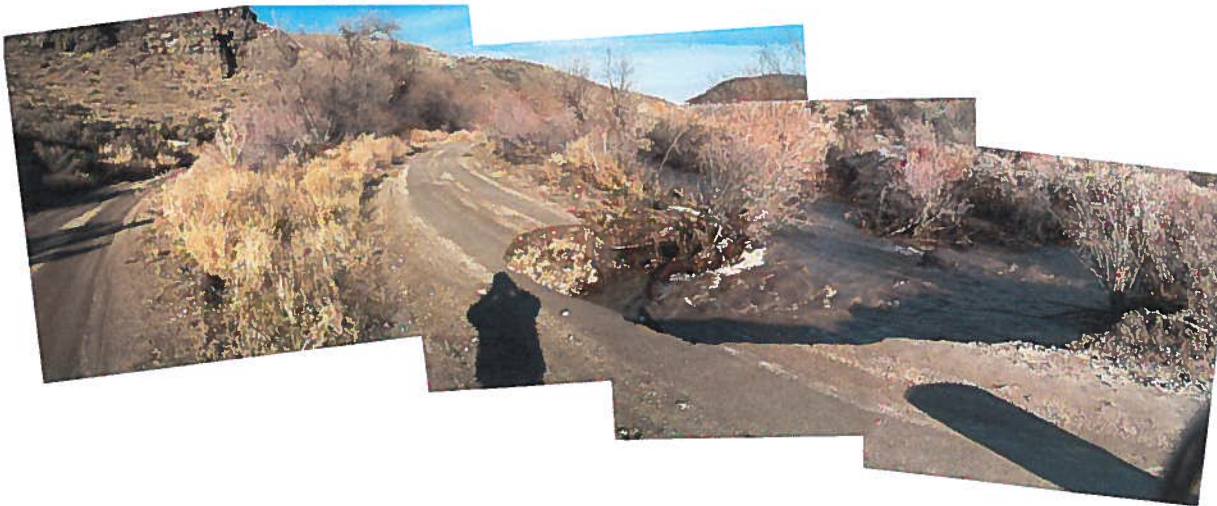
These photos are of Sinker Creek downstream of the dam. As you can see from the top photo, the stream has quite a flow of water going through the channel. The bottom photo shows where the stream has washed out a portion of the road to the Joyce Ranch.

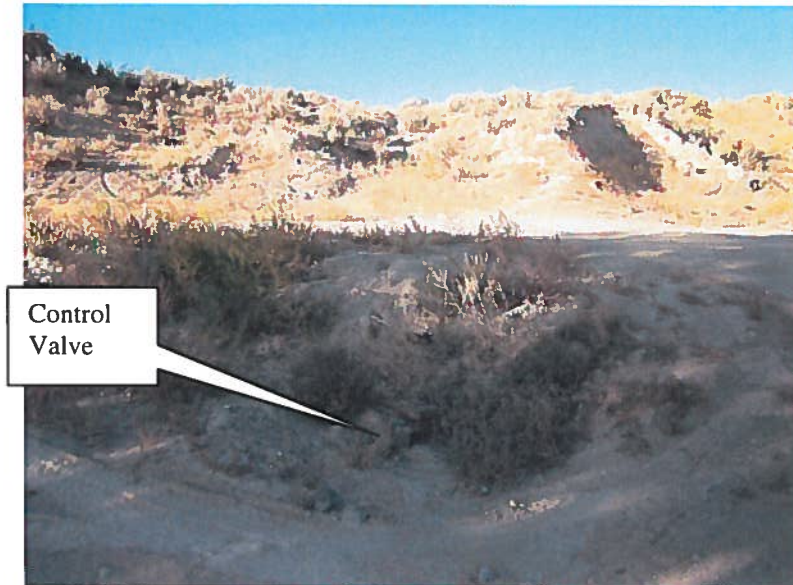
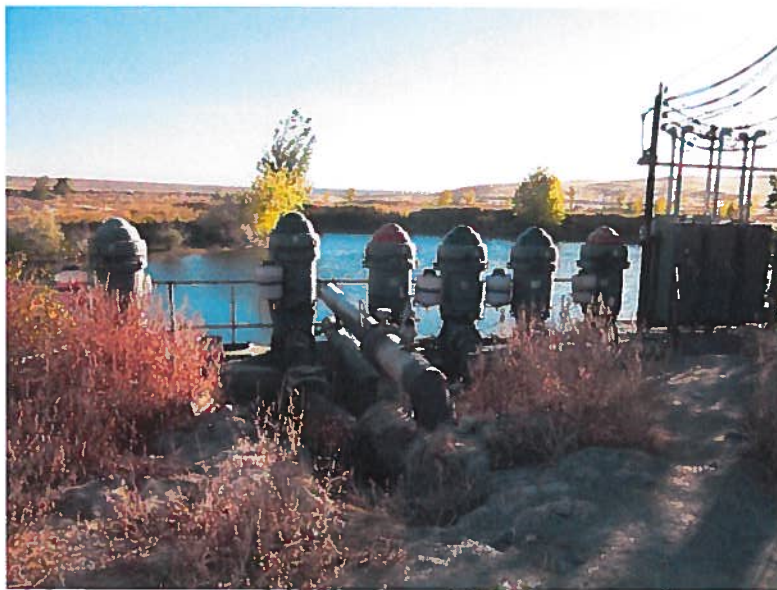
The photo above shows the control valve that diverts the water from the upper ponds into the Murphy Flat Reservoir #2. This Pipeline is the same line used to pump water from Regulation Pond #4 back up the hill to the irrigation system. The photo below shows the pumping station used to pump water from Regulation Pond #4 back up hill to the irrigation system. Regulation Pond #4 is in the background. Please note that one of the 7 pumps was out for maintenance.

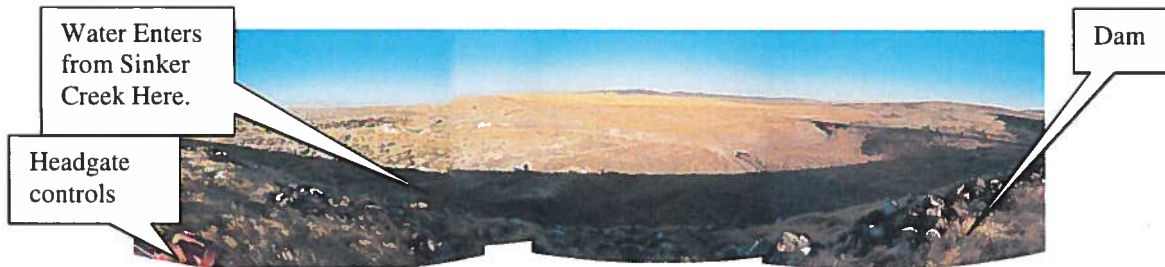
This is a photo of the Murphy Flat Reservoir #2 used under the storage component of this permit. The water comes in on west side of the reservoir, and it is diverted back into the Regulation Pond 4 shown below through a pipeline in the middle of the dam.

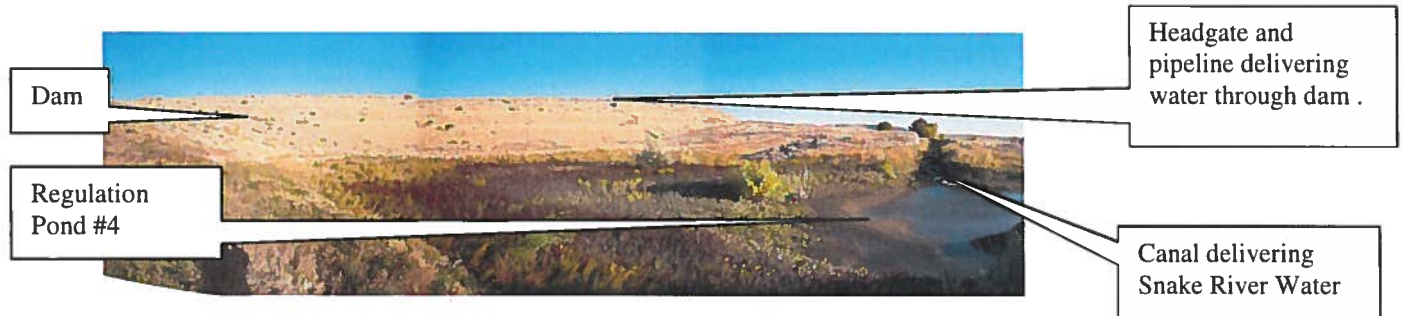
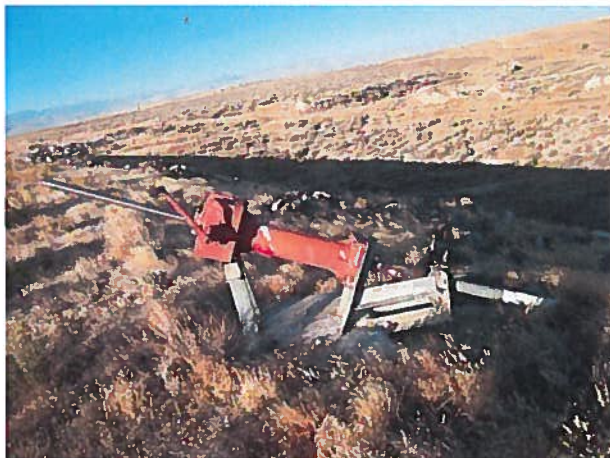
This photo shows the dam between the Murphy Flat Reservoir #2 and Regulation Pond #4. Regulation Pond #4 is shown in the foreground. Murphy Flat Reservoir #2 is on the other side of the berm. The water from Murphy Flat Reservoir #2 is diverted through a pipeline through the dam into Regulation Pond #4 and pumped back up to the irrigated fields. The canal coming in on the right side of the photo is the canal delivering Snake River water to the property. All of the Murphy Flat Reservoir #2 water and the Snake river water must go through regulation Pond # 2 to be pumped up to the irrigated fields. The headgate on the dam between the two reservoirs controlling the water being drained out of the Murphy Flat Reservoir #2 is shown below.

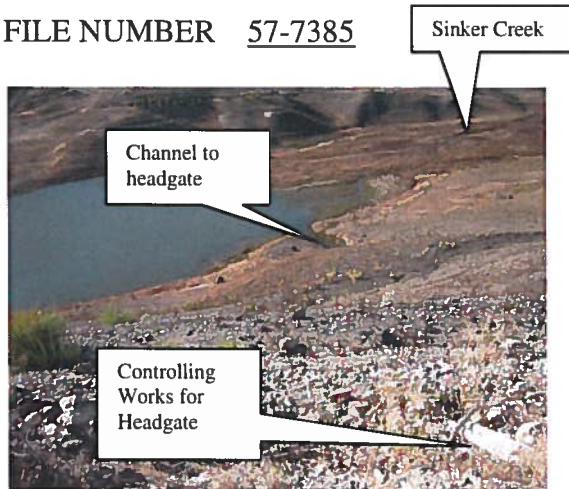
The photo to the left shows the main Murphy Flat Reservoir on Sinker Creek. This is also the point of diversion for this permit. The water diverted from the creek through the small channel shown at the bottom of the reservoir, and goes through a pipeline through the dam to the canal. The headgate control house is located on top of the dam, and you can see the controls traveling down the dam face to the diversion point. This is not the reservoir associated with this permit.

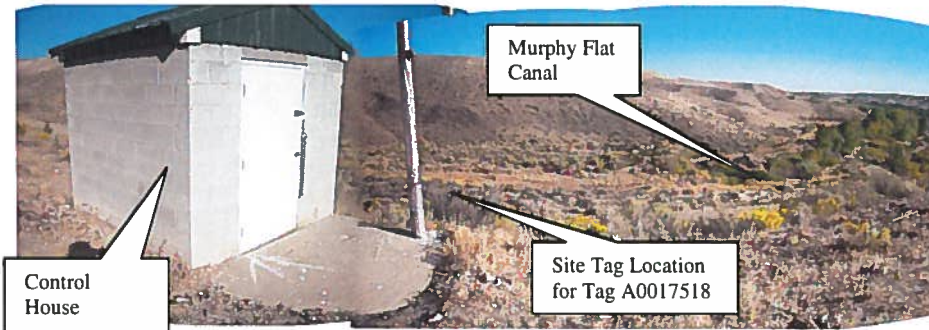
The above photo shows the control house and the canal. This photo was taken on top of the main Murphy Flat reservoir dam at the point of diversion.

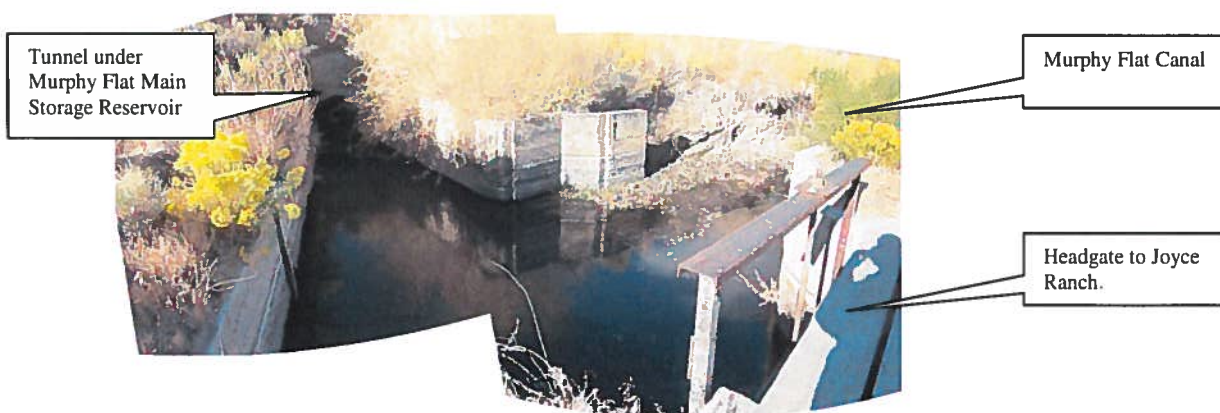
This photo shows the exit point of the dam the flows through the Main Murphy Flat Storage Reservoir at the point of diversion. This could be considered the point of diversion. The channel to the left is the starting point of the Murphy Flat Canal. The headgate in the foreground goes to Joyce Ranch, which is not associated with this permit.
