## MEMO

**TO:** Water Right File  
**FROM:** James Cefalo JRC  
**DATE:** December 10, 2012  
**RE:** Field Examination for Water Right 13-4203

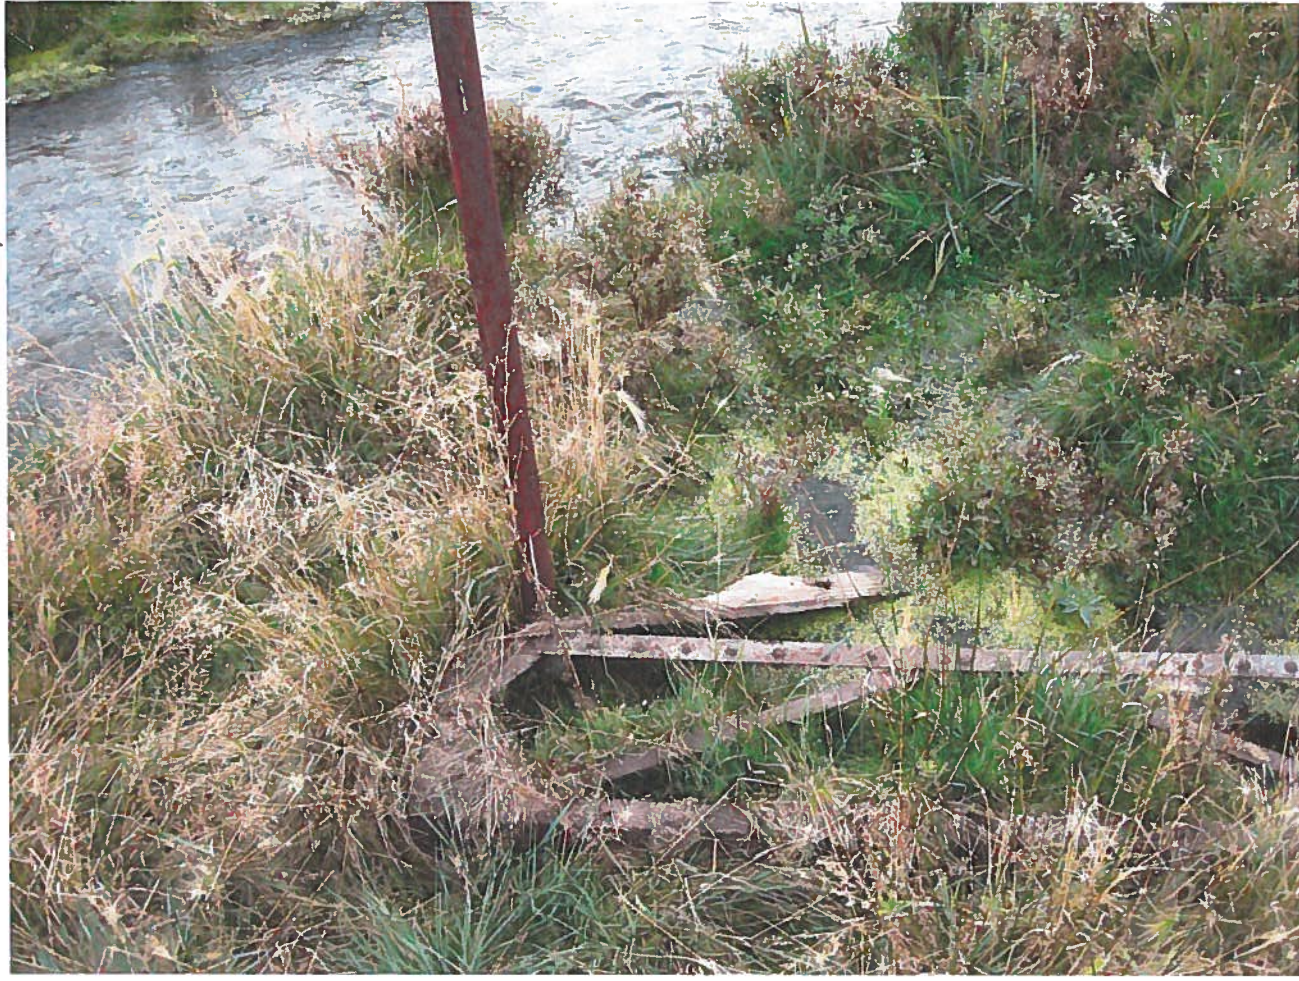
#2

I conducted a field exam for water right 13-4203 on Friday, September 28, 2012. I found very little evidence of irrigation. There is no existing functional diversion structure at the head of the ditch. I found the remnants of an old diversion dam (photos 1-3). However, the diversion dam is non-functional. The way the structure was positioned suggests that the stream channel used to flow through the area differently. I would guess that the stream channel was changed when the road culvert was last replaced. The diversion dam does not even sit in the natural channel anymore and is now useless for diverting water.

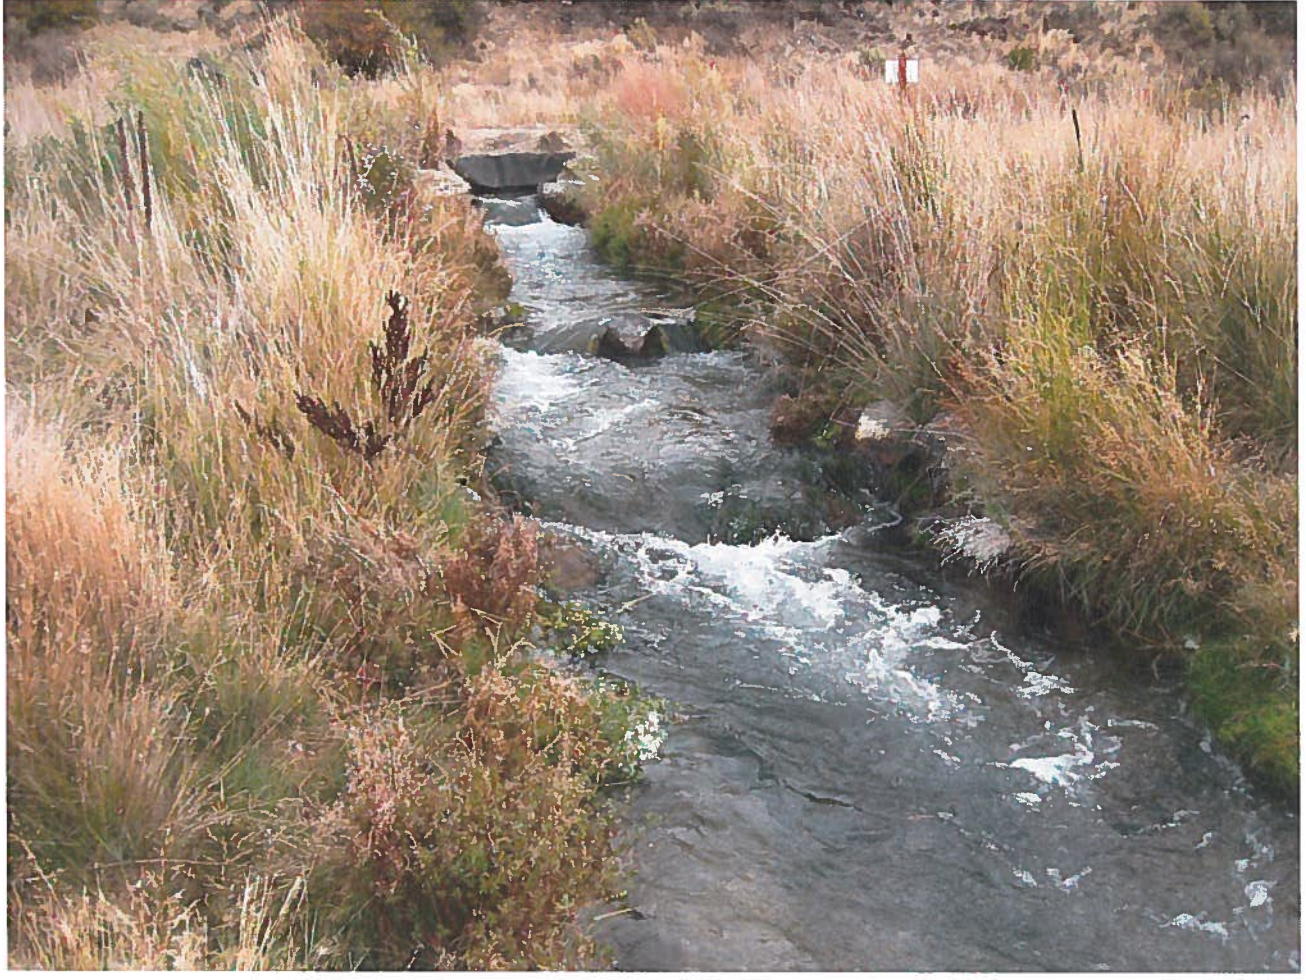
h#

Based on the ditches that were still visible, I created a shape of ground that could have been irrigated through the old ditch system. The area highlighted in red constitutes 5 acres. One indication that irrigation has not taken place for a long time is the size of the sagebrush plant growing in the middle of the 50-foot section of filled-in ditch. (photos 5 and 6) There are no sign of any pasture grasses. The area has been primarily vegetated by sagebrush and desert grasses. The spring flow is very good. It is flowing at much more than 0.3 cfs. (photo 4)

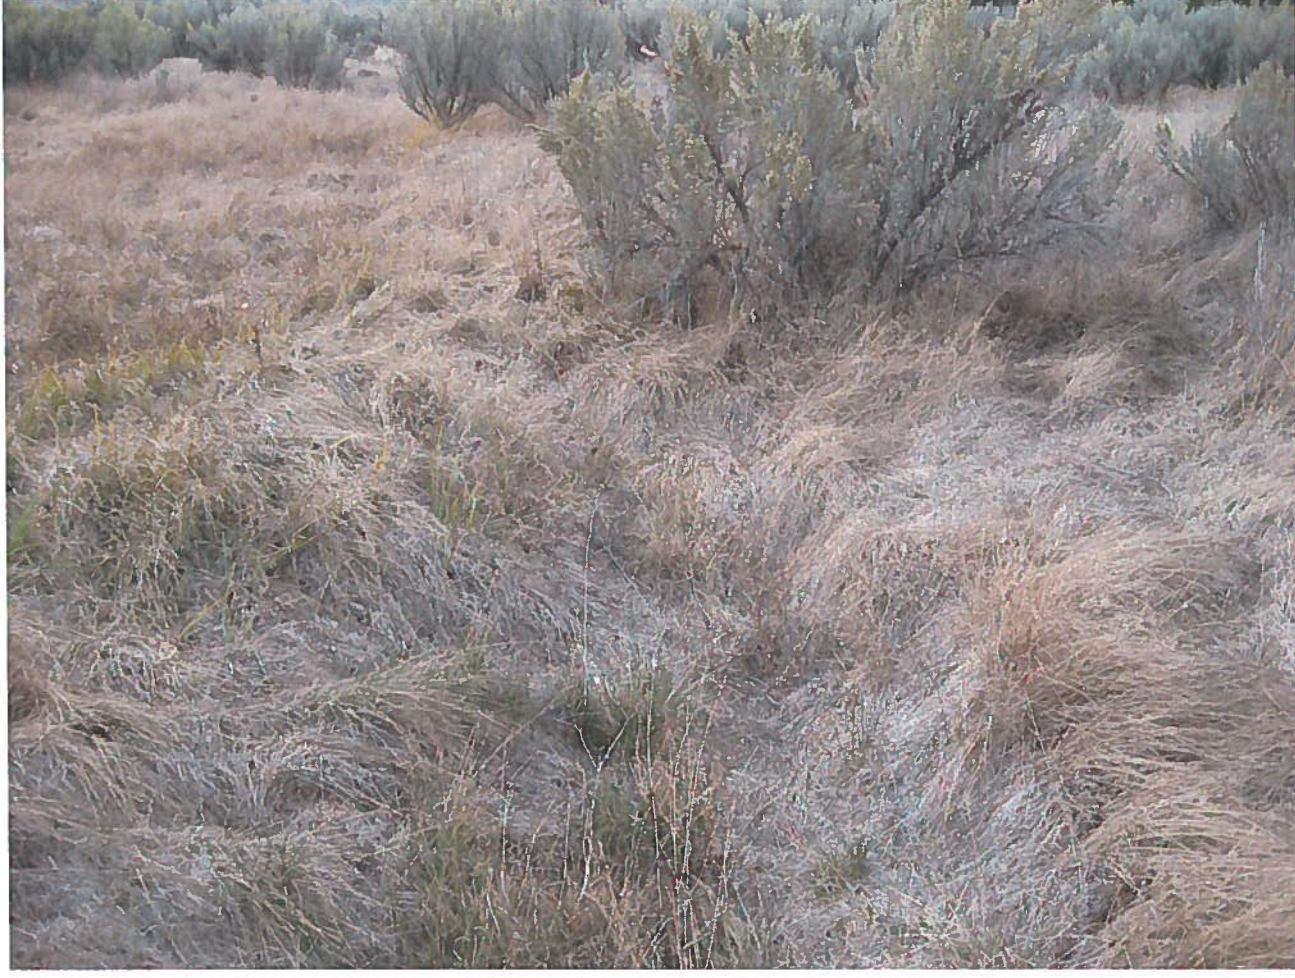
#6

The old ditches are still visible across some of the property. I took gps readings along the main ditch as far as it was visible. (photos 5-9) There was also a lateral ditch that split off to the west. (photos 10-12) The map attached to this email shows the extent that I could visually confirm the existence of ditches (shown in blue). Beyond the blue lines the ground is flat. The ditches are in poor condition. Many areas of the ditch are flattened out or filled in. Fifty feet down ditch from the old diversion structure, the ditch is completely filled in for a 50-foot stretch. Even if there were a functioning headgate/diversion structure, it would be impossible to irrigate the property without serious work to recondition (re-dig) the ditch.
