## MEMORANDUM

**Date:** June 29, 2012  
**To:** 65-22723  
**From:** Michele Edl  
**Re:** Dam Safety inspection

**IDAHO DEPARTMENT OF WATER RESOURCES**  
**--- DAM SAFETY RECORD OF INSPECTION ---**

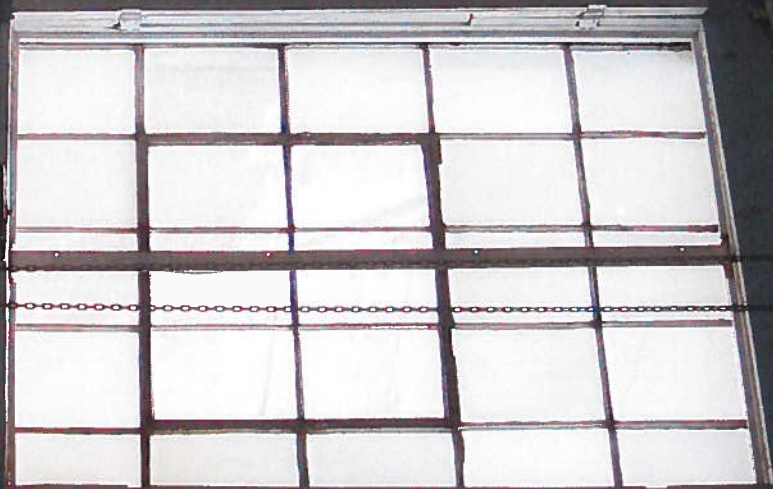
photo date 8/10/2010 Courtesy J. Falk

The photos confirm that the powerplant had been upgraded sometime before the August 2010 inspection.

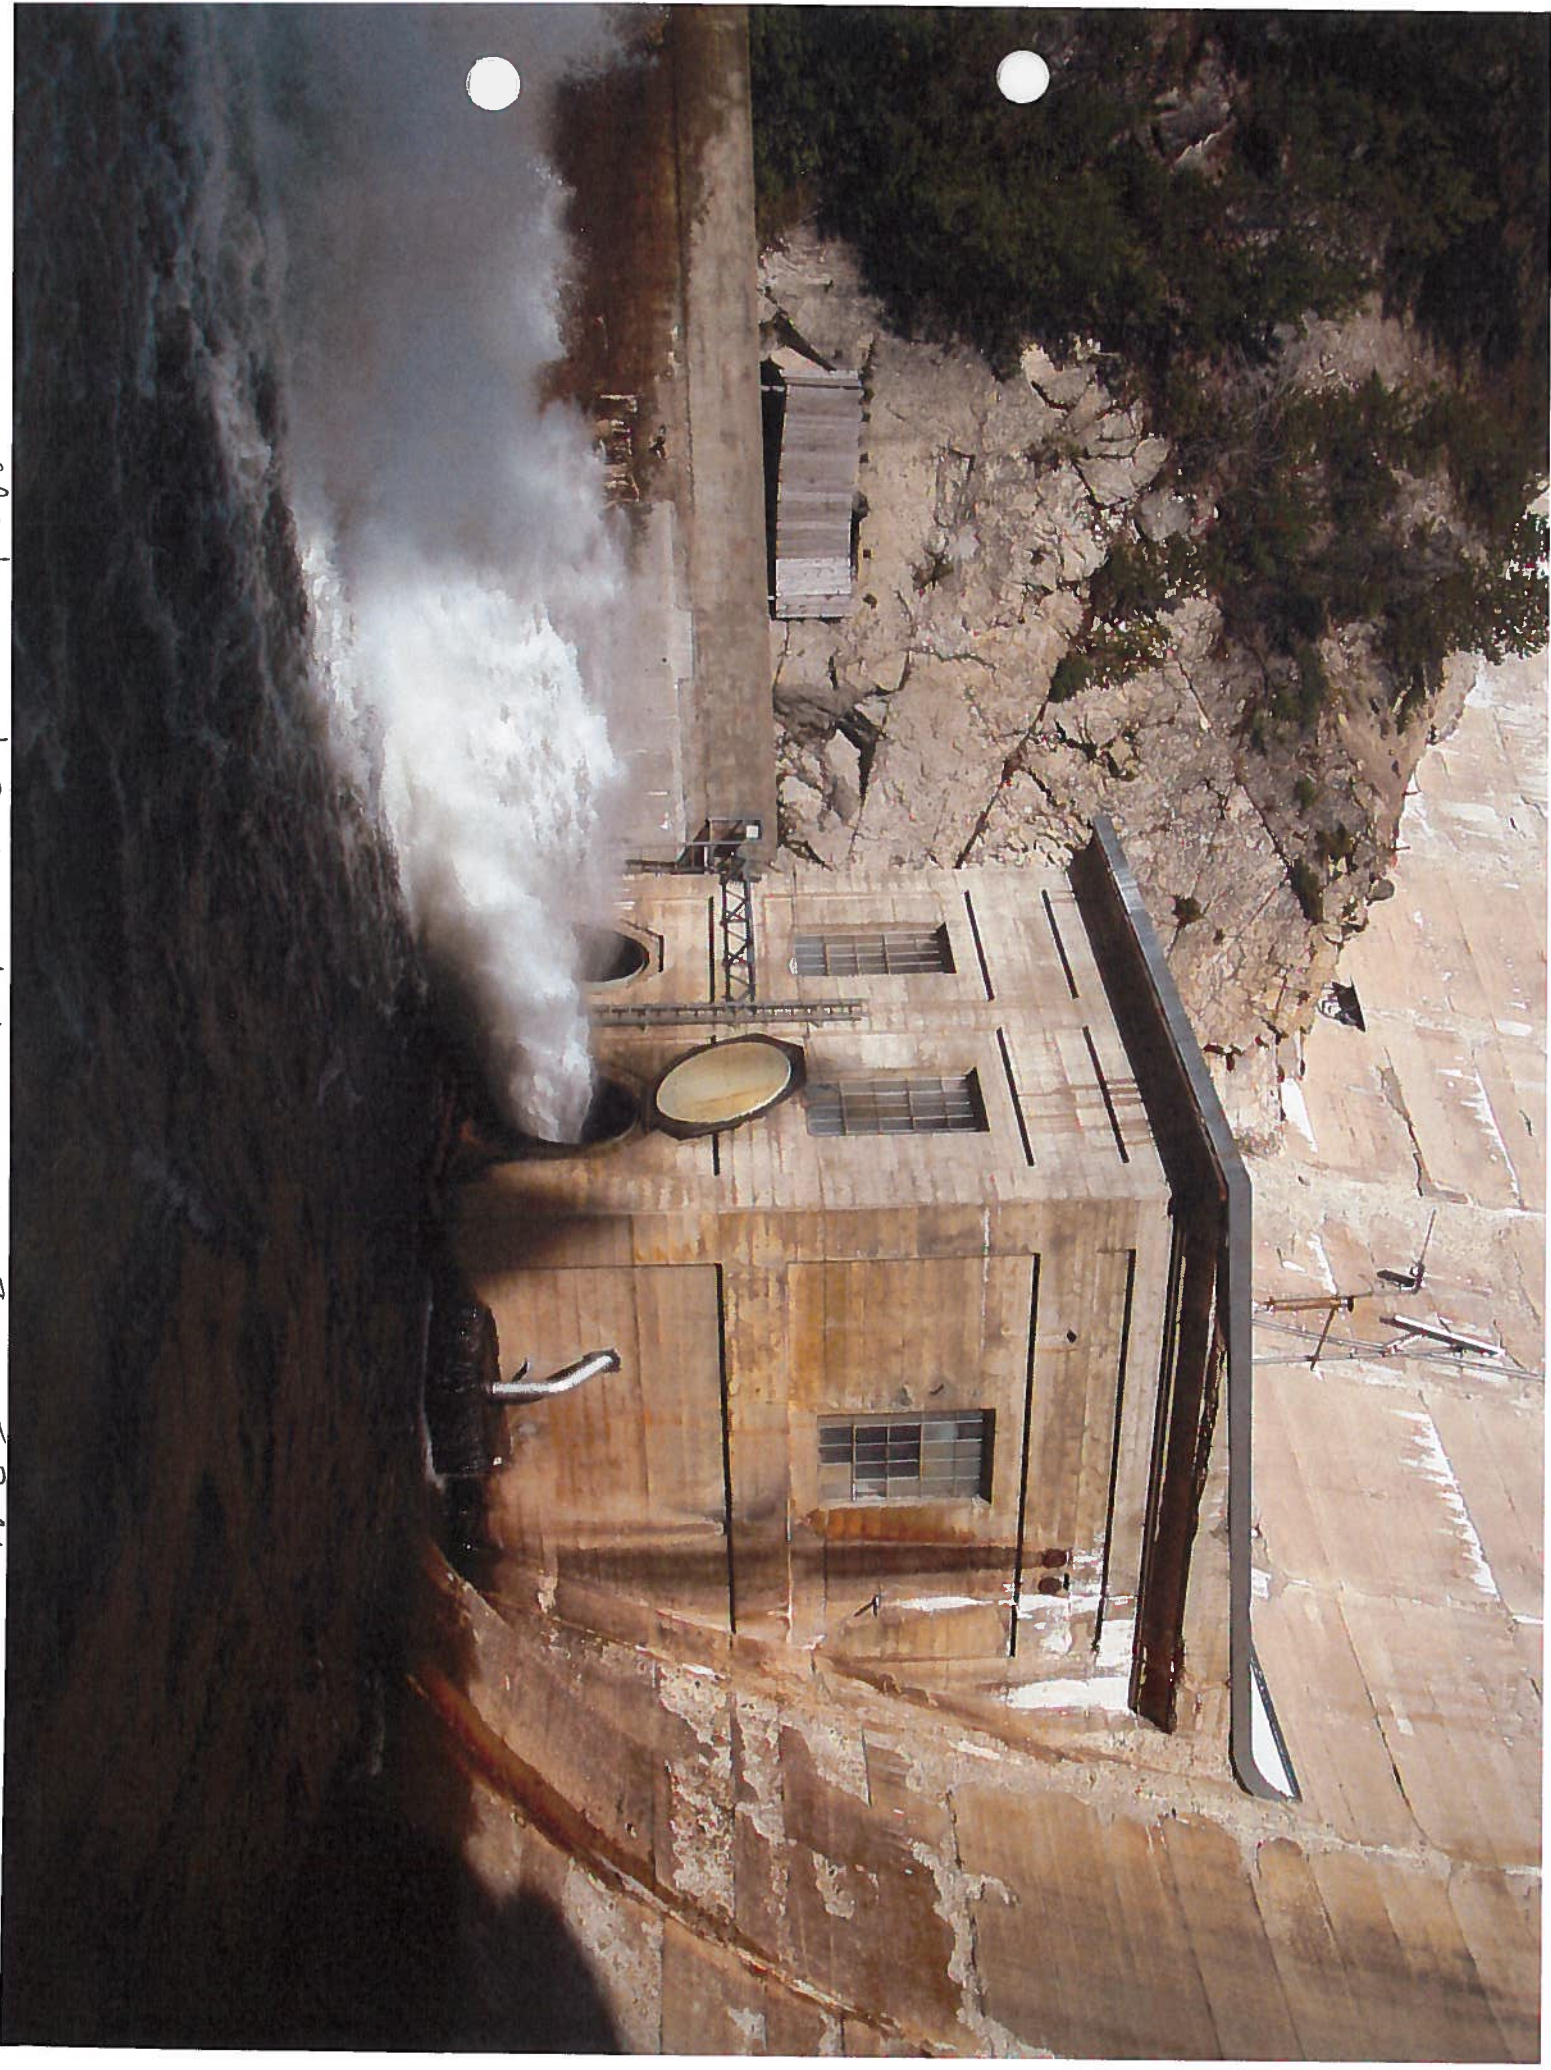
Water house exterior 9/10/2018 courtesy J. Park

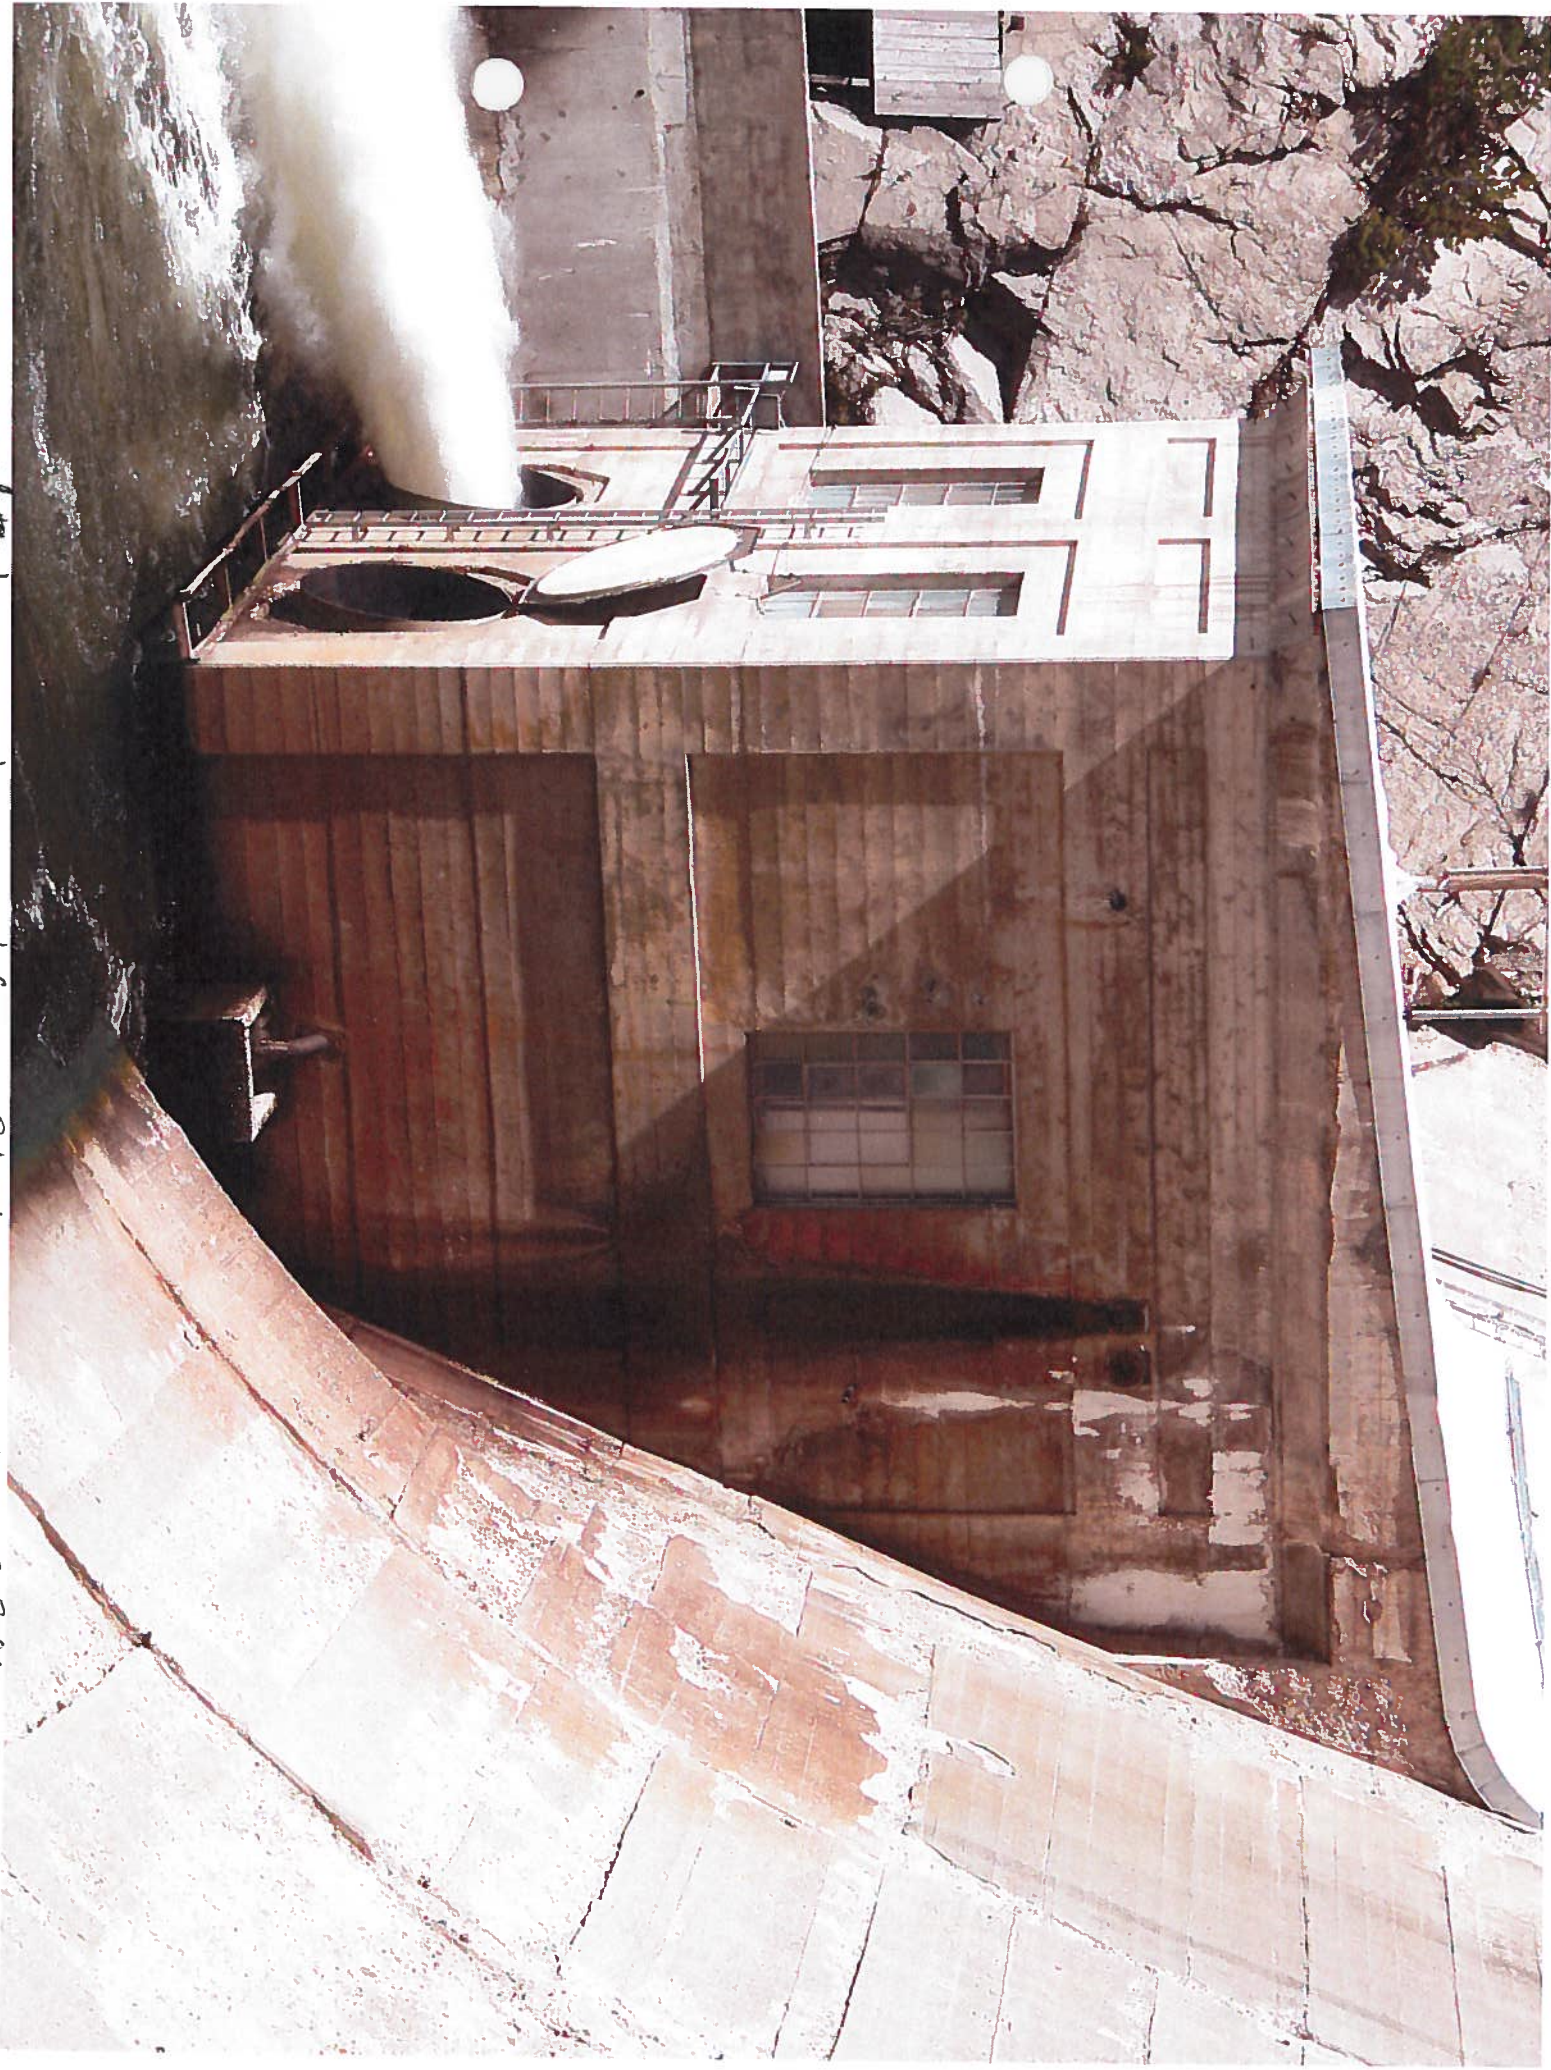
water house exterior before 8/10/2020 CSU/HO/S&I - T. Kelly
