**Year:** 2000  
**PWS:** 1090243  
**County:** Bonner  
**System:** Northern Lights Sagle Headquarters  
**Ownership:** Tim Cochran  
**Address:** PO Box 310, Sandpoint, ID 83864  
**Information obtained from:** Tim Cochran  
**Location:** Chevy Road at Monarch; T56N R2W Sec15  
**Inspector:** Mike Nelson  
**Population:** 3 building office/industrial complex

Subject: Enhanced Sanitary Survey conducted on *September 9, 2008*

## **Drinking Water Supply Report September 25, 2008**

**System:** Northern Lights                      **PWS#:** ID1090243  
**Date of Survey:** September 9, 2008      **County:** Bonner  
**System Representative Present at Survey:** Rod Babcock  
**Surveyed by:** Jamie Barton, PHD and Suzanne Scheidt, DEQ  
**Source:** Ground water well                      **Population/Connections:** 50/3  
**Water System Type:** Non-transient, Non-community

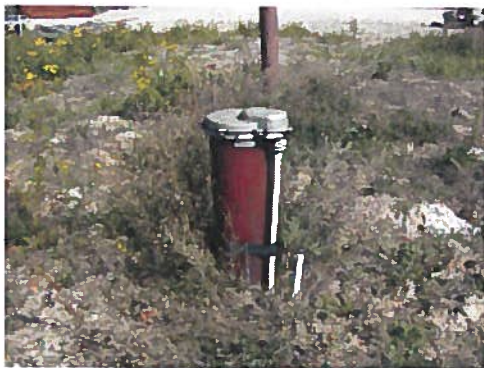
The Northern Lights water system is served by an eight-inch diameter well located on a well lot south of the storage yard. The well was drilled April 15, 1999 to a depth of 212 feet deep. The well casing extends 28 inches above the ground surface and is fitted with a watertight, vented well cap. The well is equipped with a 20 horsepower pump, which during the survey was measured to be producing 300 gallons per minute. The pump can be controlled by a pressure switch in the pump house. The water is pumped through a pitless adapter, 4-inch PVC and a 3-inch flow meter to the pump house and then out to the reservoir. At the time of the survey the meter reading was 44,453,300 gallons. The reservoir may be bypassed and the pump discharge direct to distribution. A raw water sample tap is not directly available at the well. Raw water samples are being drawn by isolating the reservoir and pressure tanks from the well.

**Water tight well cap with screened vent**

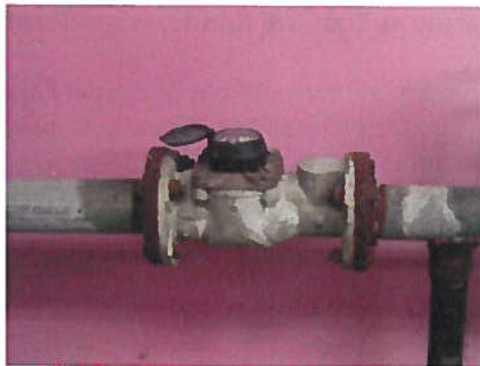
**Instantaneous and totalizing flow meter**

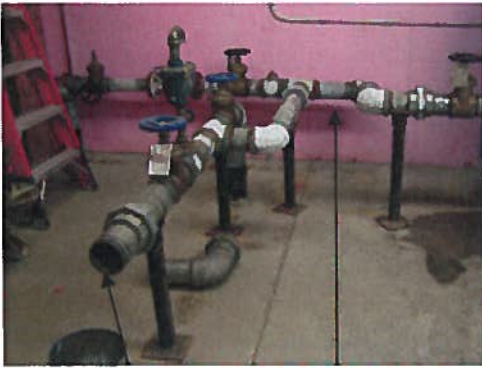
The pump house is located in the southwest corner of the vehicle storage building. The pump house contains the flow meter, pump controls, pump to waste, sample tap, and 12 Well-x-Trol, WX-350 pressure tanks that ride on the system. Each pressure tank has a 119 gallon capacity and can be isolated from the system. Most all non-sample taps in the pump house have been filed to remove the threads. If there are any threaded non-sample taps still existing, it is required the bibs be equipped with an atmospheric vacuum breaker prior to being connected to a hose.

**Pump to waste**

**Reservoir bypass**

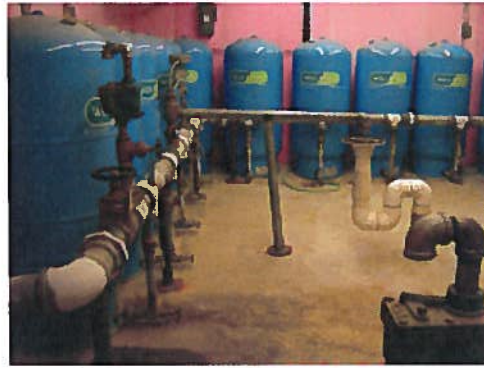
**Hydronumatic tanks**

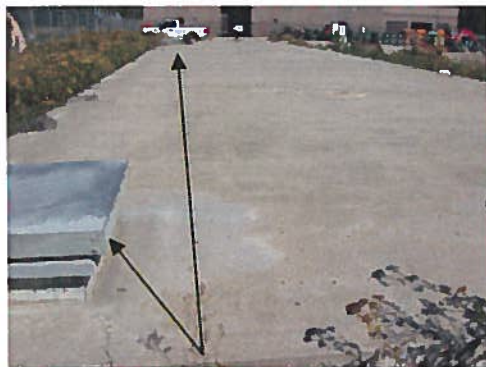
Storage is provided by a 150,000 gallon, below grade, concrete reservoir. The roof is approximately 2 feet above grade. Access risers are located in the southwest and northwest corners of the reservoir and are fitted with overlapping, locked, steel covers. There are two combination overflow/vents on the east side of the reservoir. During the survey, the northern most overflow pipe was identified as not having the required screen. This is a deficiency which must be corrected by the water system.

**Reservoir with access risers**

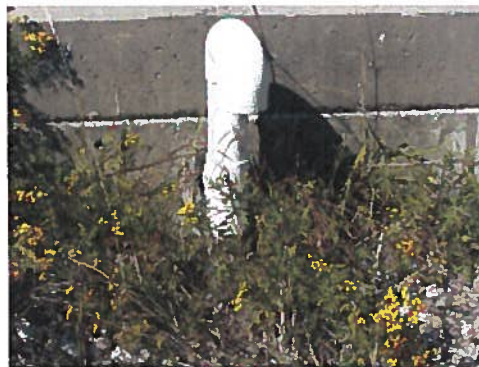
**Overflow / vent**

1. Storage: One of the overflows from the storage tank is not screen with non-corrodible 24 mesh screen as required by IDAPA 58.01.08.544.06.b.
2. Distribution: A cross connection may exist between the reservoir and the fire protection sprinkler system. A backflow prevention assembly is required between the reservoir and sprinkler system. Please provide information to clarify the backflow assembly installation for the fire protection system.
3. Pumping: Water pressure relief valves in the control room must be covered with a 24 mesh corrosion resistant screen.
4. Managerial: There is no total coliform rule (TCR) sample site plan, as required by IDAPA 58.01.08.100.01, which incorporates by reference 40 CFR 141.21.

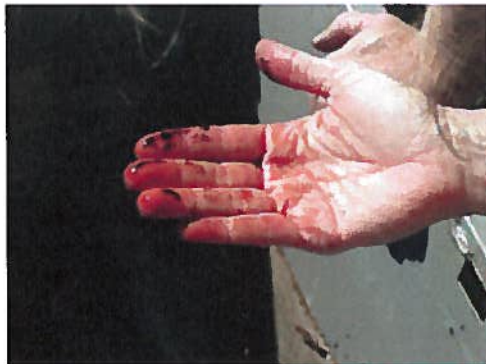
The reservoir has not been cleaned or inspected since the year 2000 when it went into service. At the time of the survey, a layer of film was evident on the walls of the reservoir and on the water, which provides an environment for bacterial growth. It is highly recommended to have the reservoir drained and cleaned at least every five years.

**Film from inside walls of reservoir**

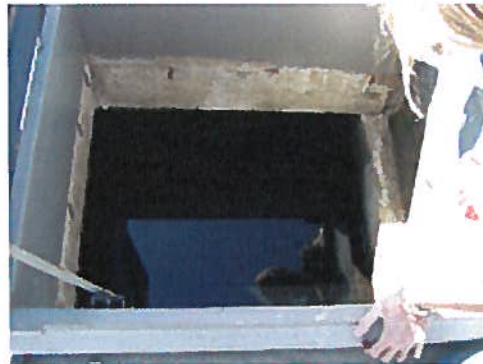
**Looking in reservoir through access riser**

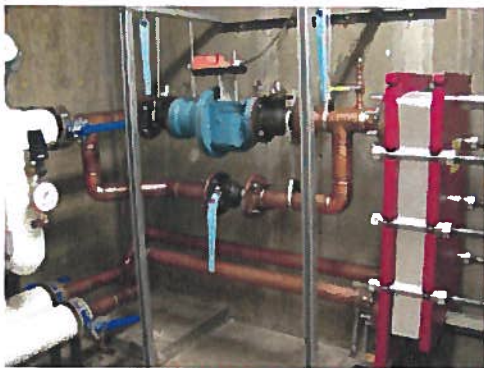
Also included in distribution are a heat exchange system and a fire protection sprinkler system. The original plans indicate all heat exchanger supply lines include a reduced pressure backflow preventer assembly and all fire protection sprinkler system supply lines include a double check valve backflow prevention assembly. It appeared on site, that a double check valve assembly was installed prior to the heat exchange system, however a double check valve assembly did not appear to be installed between the reservoir and sprinkler system. Please provide information to clarify the backflow assembly installation for the fire protection system.

Heat exchange system

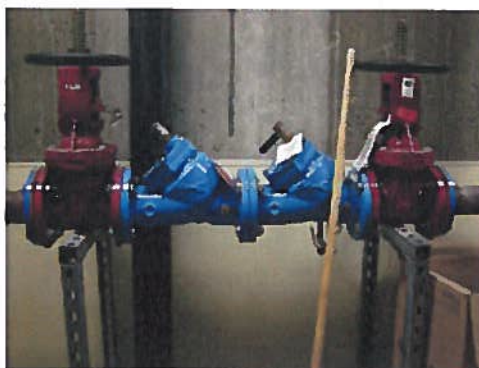
Double check valve assembly
