**From:** Weaver, Mathew  
**Sent:** Friday, November 04, 2011 8:37 AM  
**To:** Rex Barrie  
**Cc:** Edl, Michele; Miller, Nick; Don Anton  
**Subject:** Riverside Village Water Measurement Device

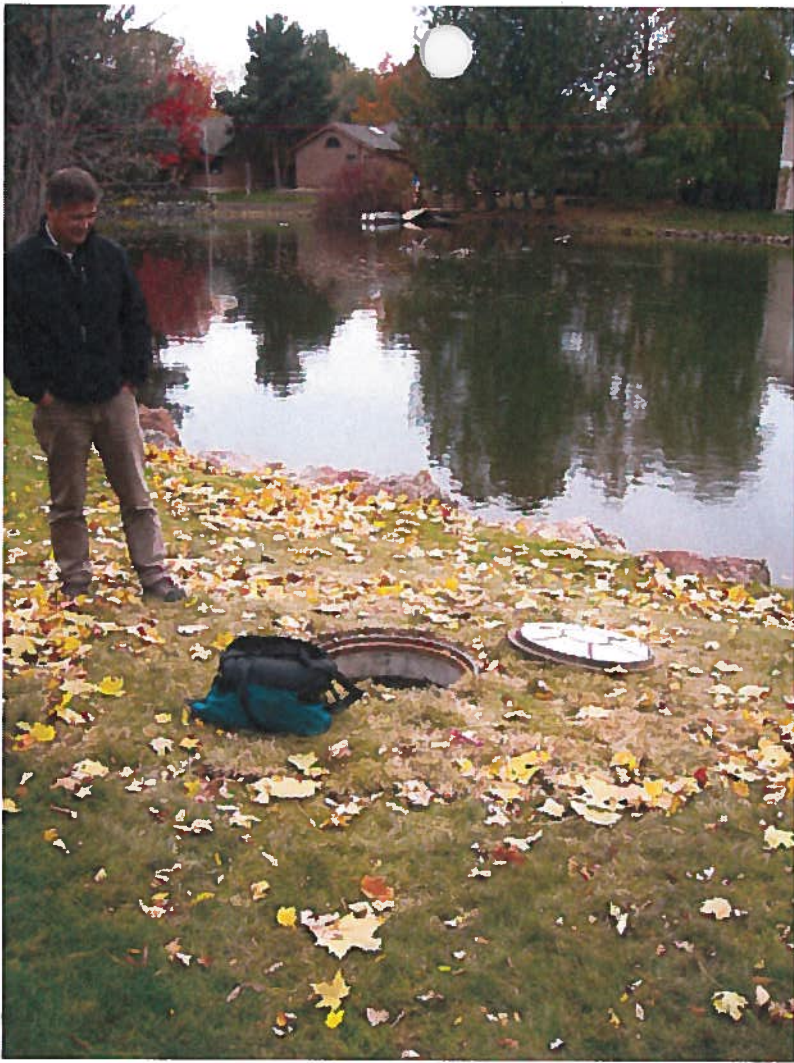
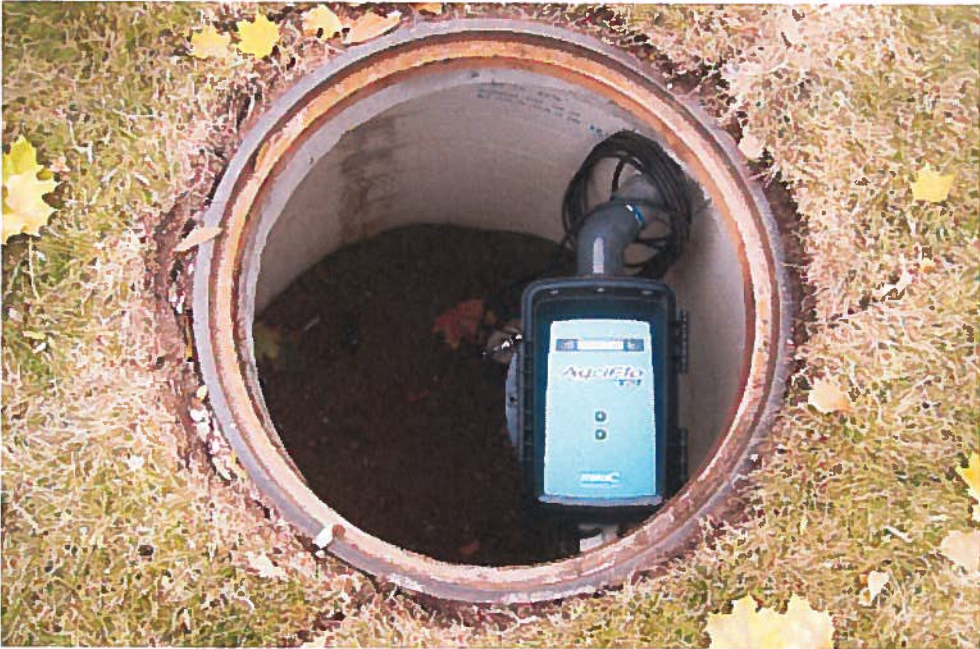
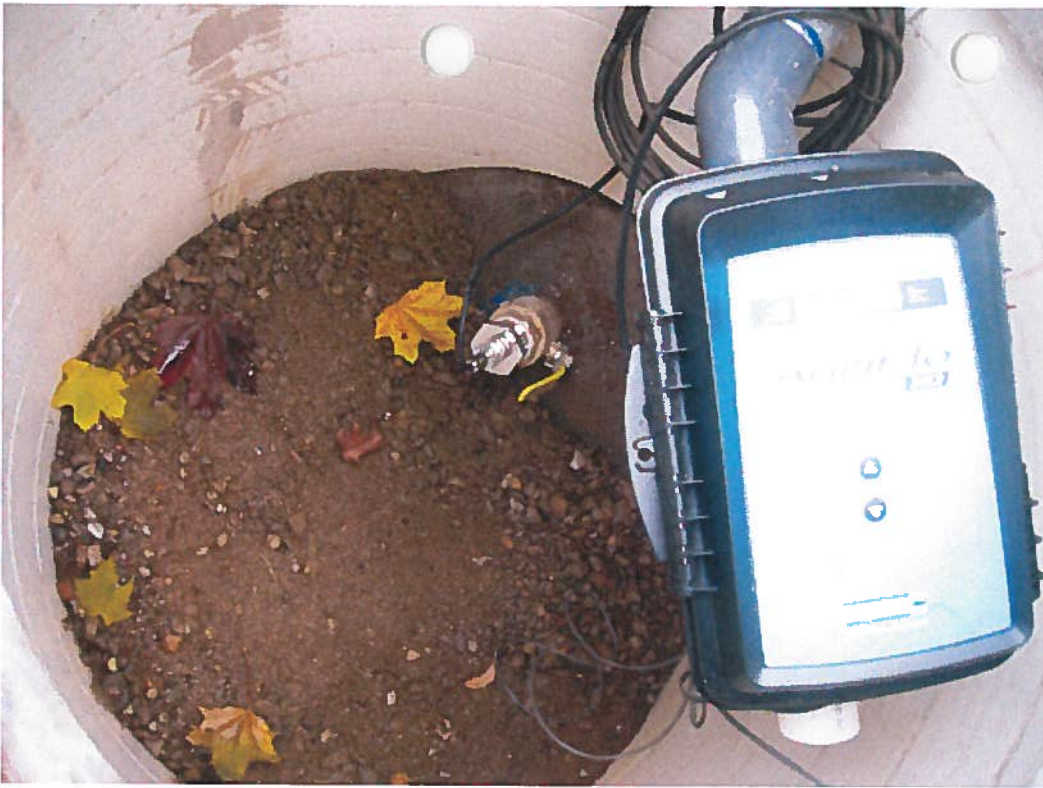
I met with Don Anton (president of the HOA) and the Engineer (Steve) to inspect the installed Doppler flow meter at the Riverside Village Subdivision (RVS). Refer to the attached pictures below. The insert-type Doppler flow meter (DFM) has been installed in a vault (36" diam. PVC pipe mounted vertically) with an insulated manhole type lid. The vault is located approximately 20 feet upstream of the outlet into the first RVS pond. The DFM was in good working order at the time of my site visit. I observed a flow rate of 2.18 cfs, velocity of 0.95 fps, system voltage of 12.6 volts, and a voltage output from the solar panel of 14.57 volts. The solar panel was located discreetly in a pine trip near the DFM.

The DFM has not been corroborated with a separate measurement yet. The engineer plans to provide a corroborating measurement at the start of irrigation diversions next year. The engineer indicated that he has already observed the pipe not flowing full (Saturday 10/29/2011). This is worth noting because insert-type DFM can only measure flow rate in a pipe full scenario. The flow rate in the Boise River at the Glenwood Gage (USGS 13206000) ranged from 240-320 cfs on Saturday. During my site visit, when the DFM was working and presumably the pipe was flowing full, the flow rate in the river was 295 cfs. Therefore, somewhere between 240-295 cfs, the pipe transitions into a non-full flow condition. This likely will not be a problem as we are concerned with flow rates during the irrigation season and one would expect that those would always be high enough to keep the diversion pipe full.
