STATE OF IDAHO  
DEPARTMENT OF WATER RESOURCES  
**BENEFICIAL USE FIELD REPORT**

**A. GENERAL INFORMATION**Permit No. 11-07390

Water Right Permit 11-7390  
BSA Camp Bartlett - Fern Canyon Dam

FERN CANYON DAM  
LAKE VOLUME CALCULATION

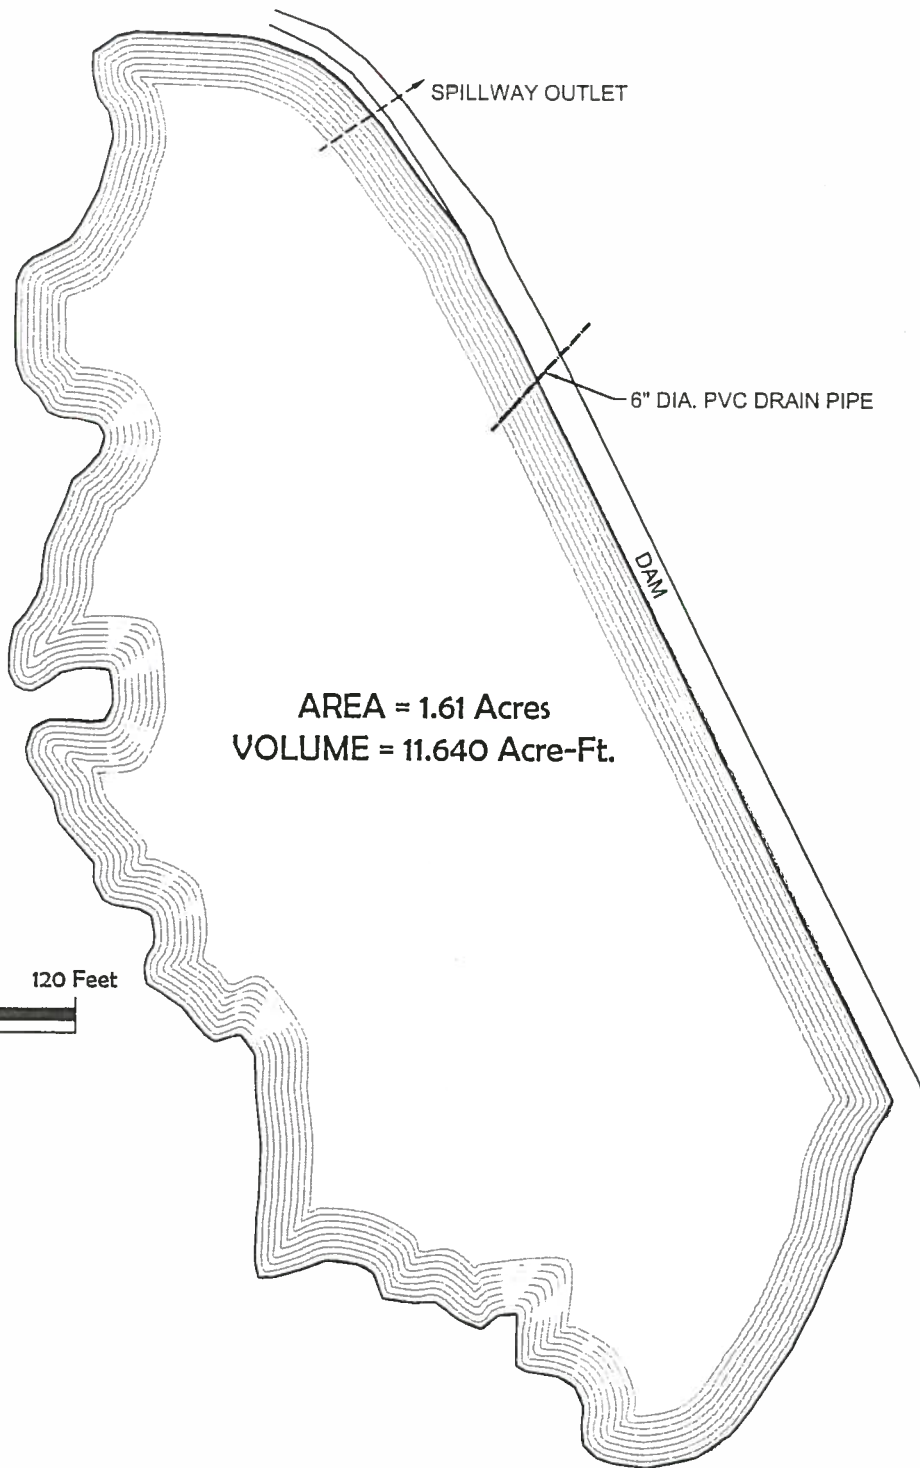
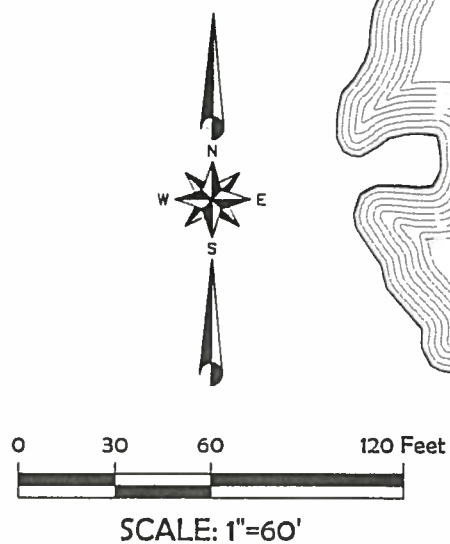
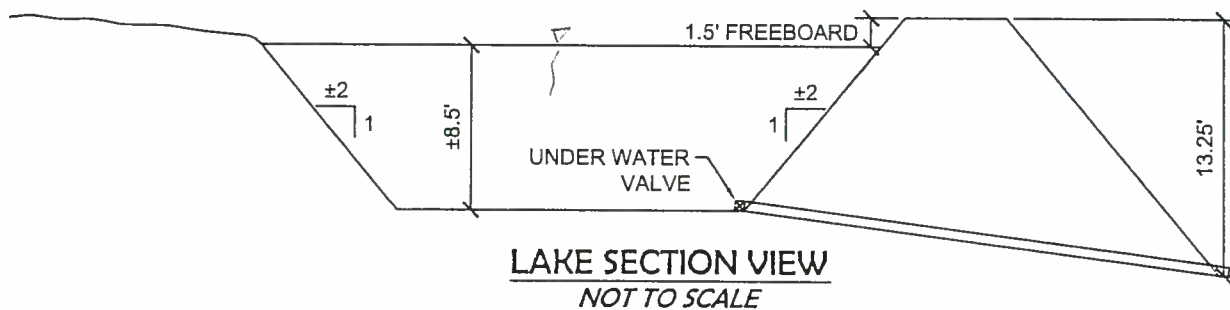
See attached CAD drawing and GIS maps that estimate the surface area and volume of the pond. The estimated volume is 11.64 AF. This estimate was arrived at assuming 2:1 (horizontal:vertical) berm slope and slope of the natural ground at reservoir edges, which should overestimate the actual volume of the reservoir. The permitted volume was 49.0 AF.

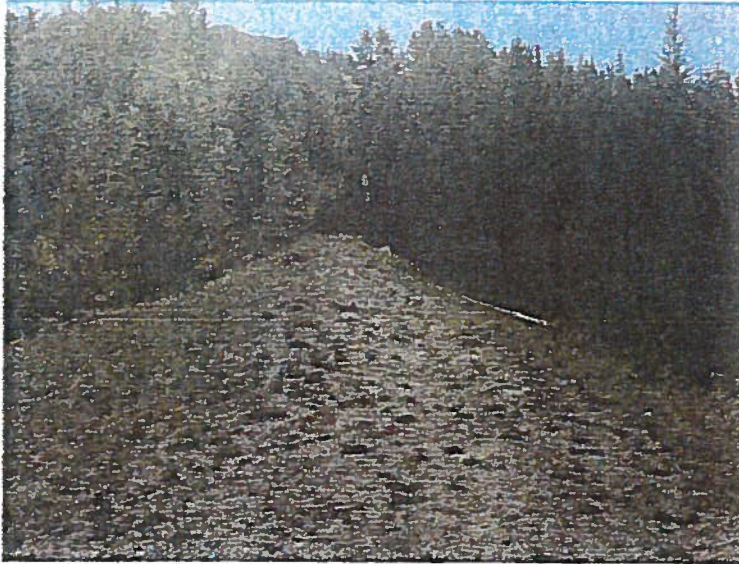
Dam crest standing on northeast end near spillway and looking southeast

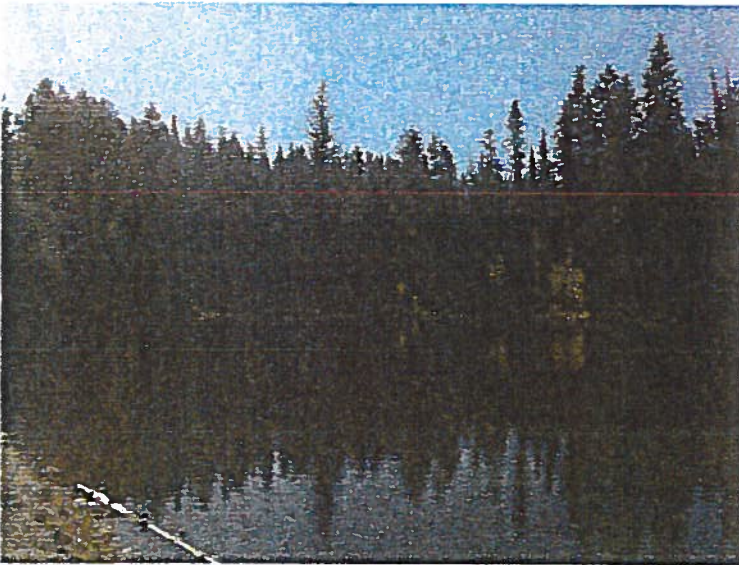
Reservoir looking straight south from northeast end of the dam

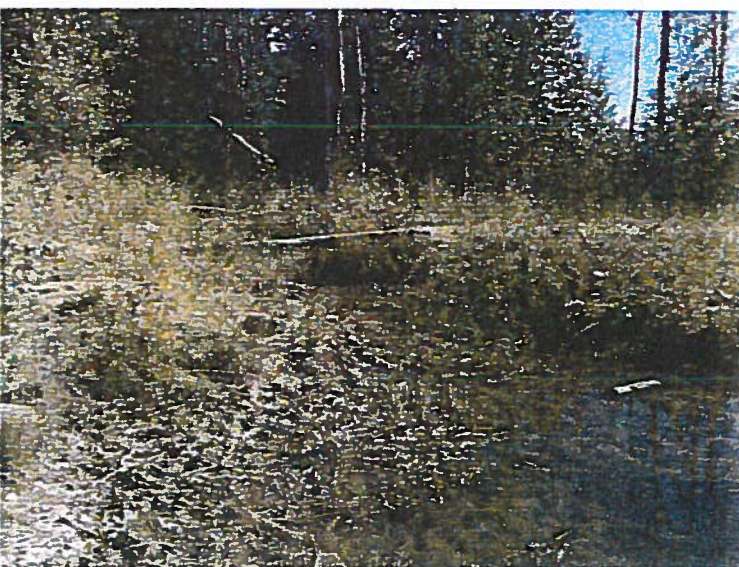
Dam spillway and continuation of Fern Creek. The walk bridge across spillway is in the center of the photo.

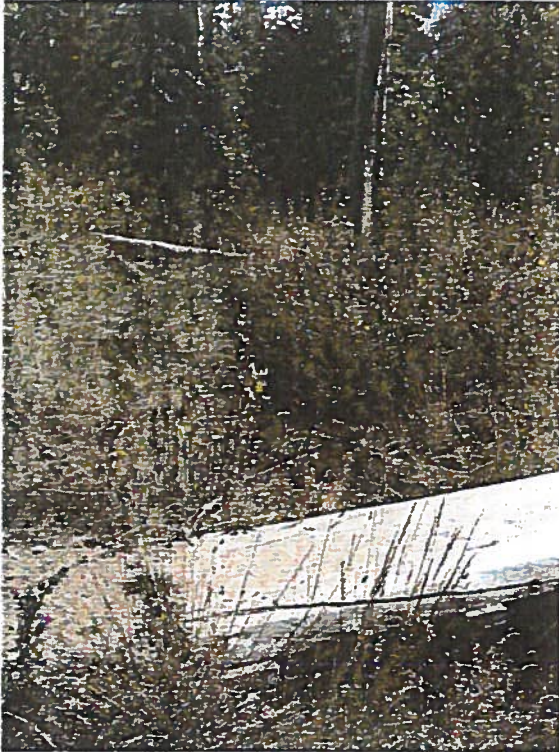
Another photo of spillway at walk bridge

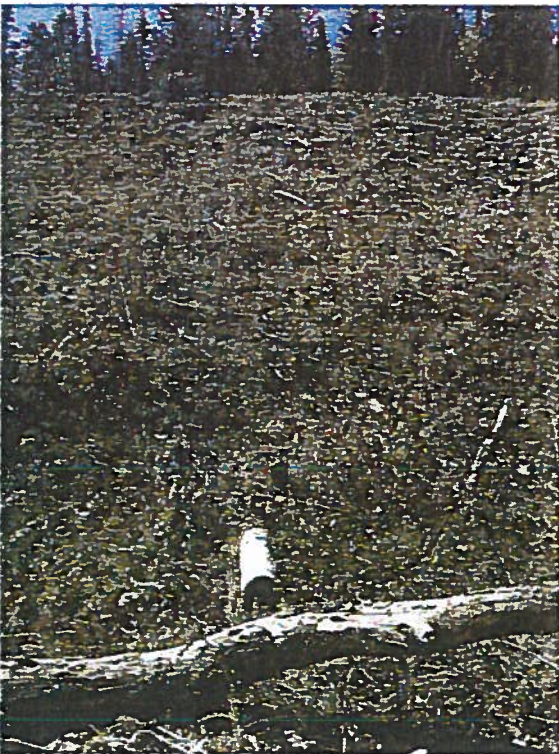
6" PVC drain at downstream toe of dam

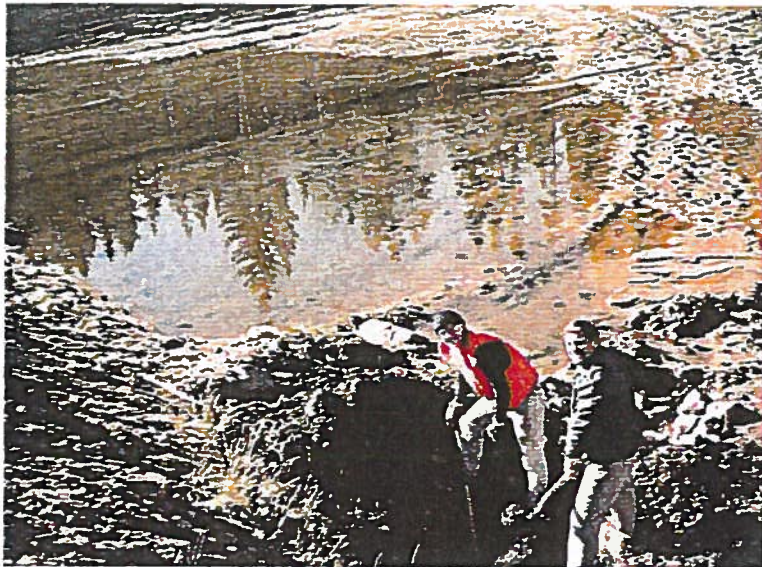
1994 construction photo of 6" PVC drain on the reservoir side of the dam prior to filling reservoir

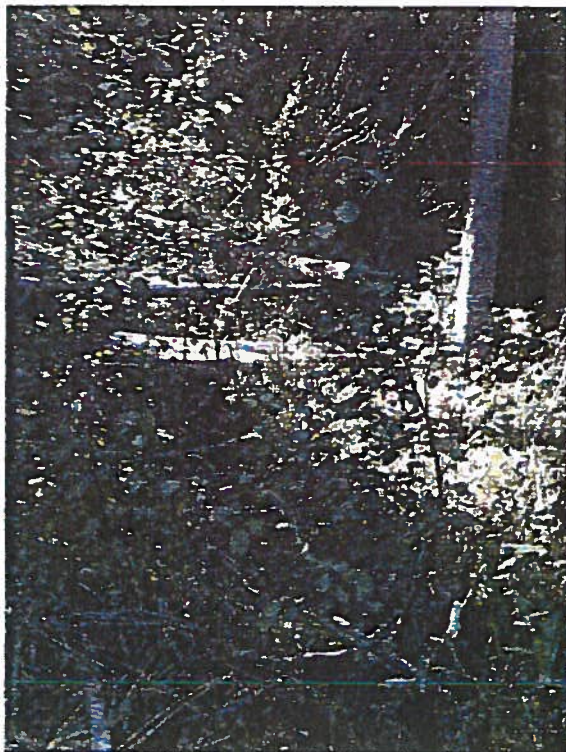
Fern Creek approximately 40 feet upstream of the reservoir. A walk bridge is visible in center of the photo

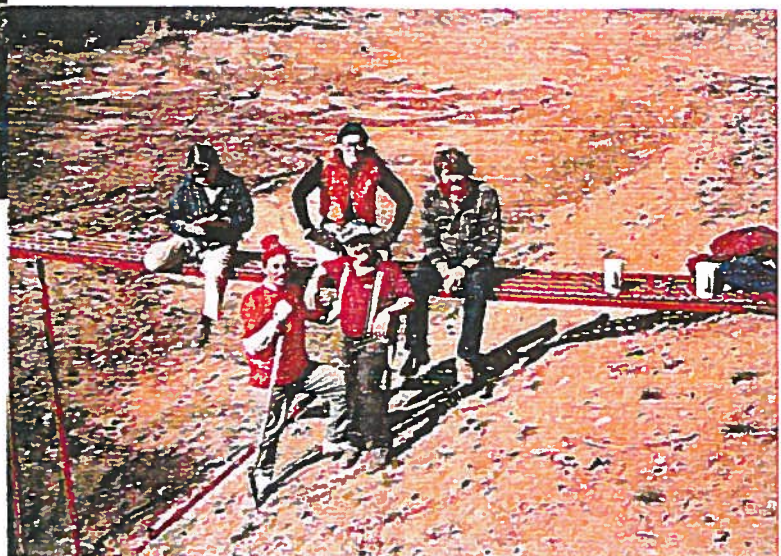
1994 construction photo showing relative height of the dam prior to filling reservoir
