## MEMORANDUM

**TO:** 72-16874 Application for Permit File

**SUBJECT:** Field Visit

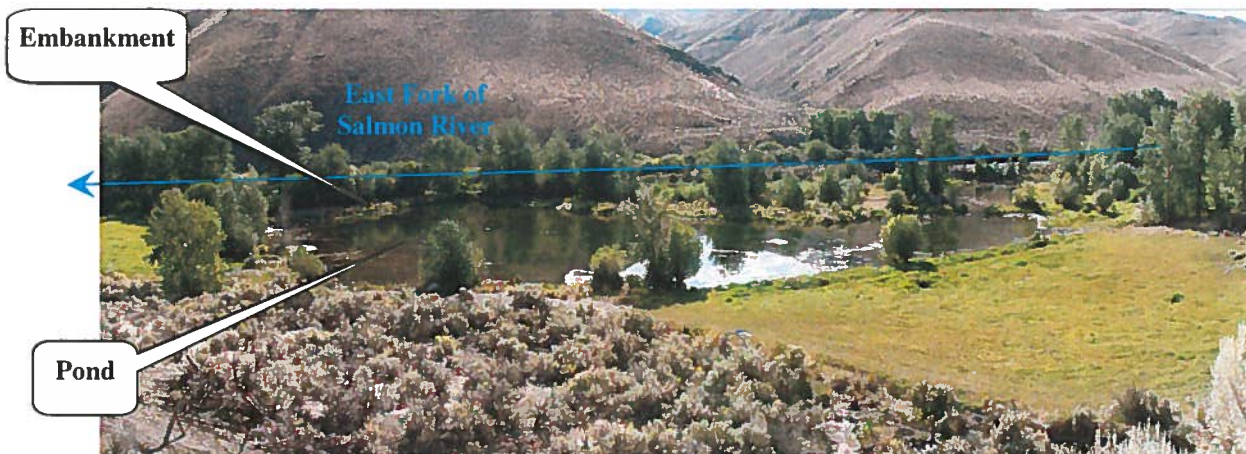
View of the pond from the East Fork Road with the East Fork of the Salmon River visible in the background of the view.

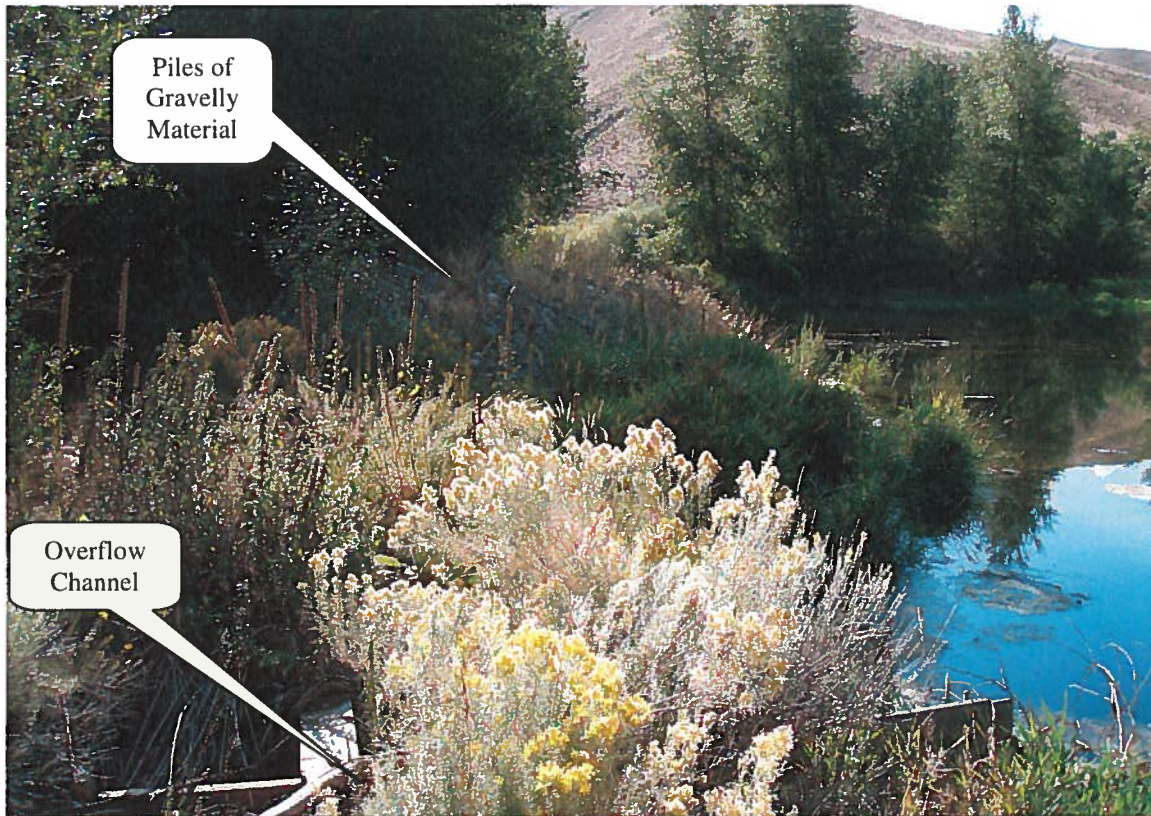
**ABOVE:** View of the embankment along the edge of the pond. Note the overflow channel in the foreground of the view that could convey water to lands below. Also note the piles of gravelly material (apparently excavated from the pond) on the embankment.

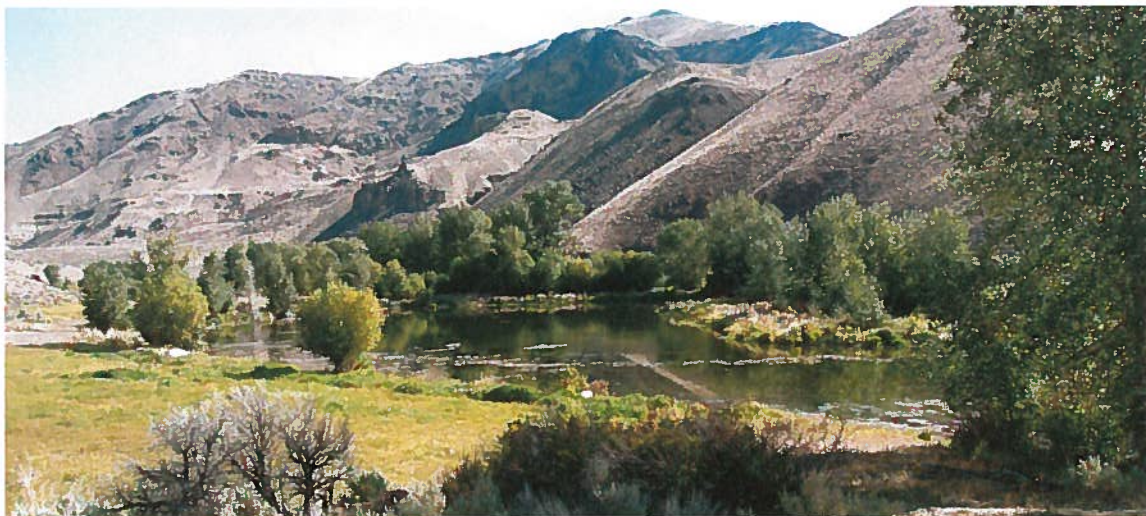
**BELOW:** View of pond from different angle than view shown on previous page.
