**STATE OF IDAHO**  
**DEPARTMENT OF WATER RESOURCES**  
**RECORD OF INSPECTION OF DAM**

Name of Dam: Point of Rock

Stream: Marsh Creek

Name of Owner: Six S Ranch LLC

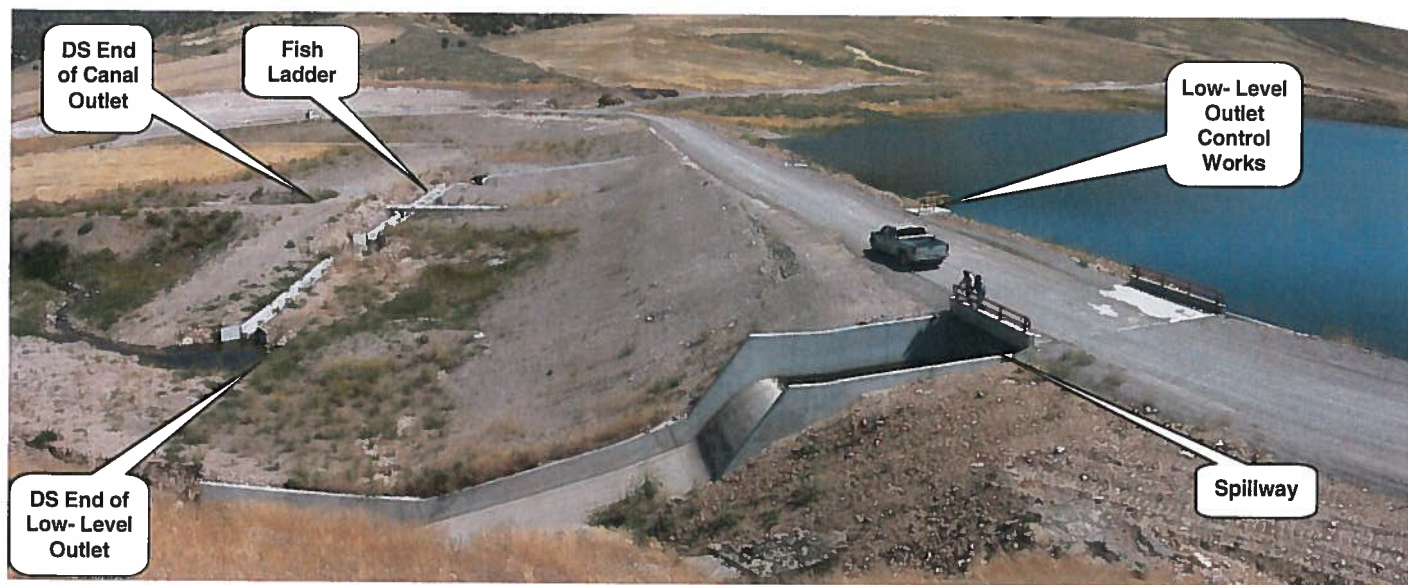
**ABOVE:** View from the left (west) abutment area showing the crest, downstream slope, and the area below the dam with the locations of various points of interest indicated.

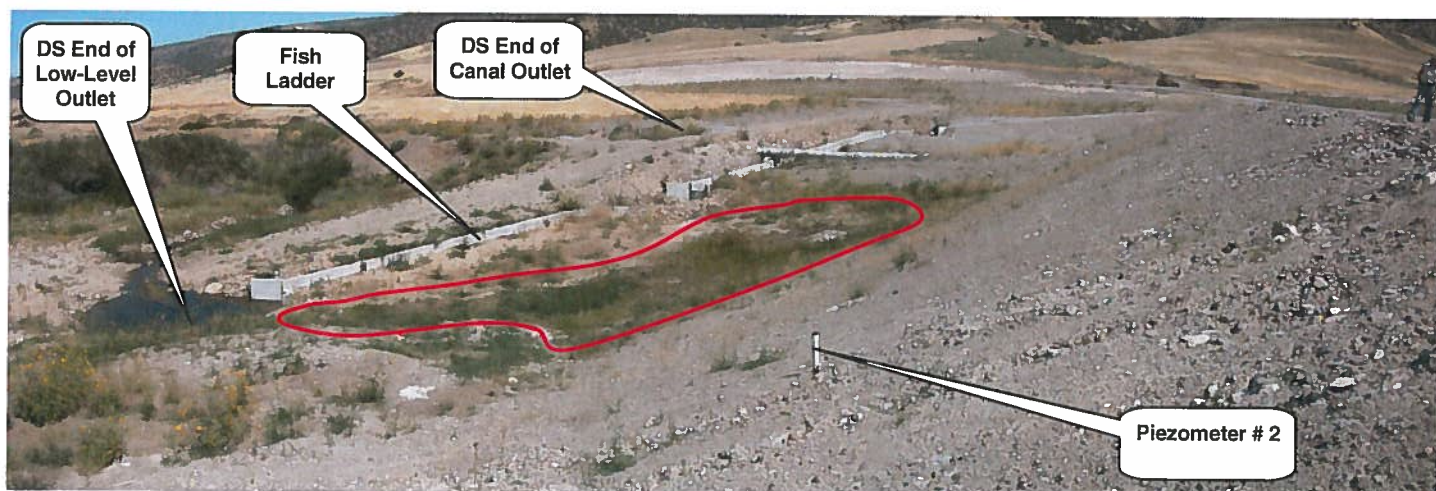
Dam constructed last year. Overall, due to recent construction, the dam and appurtenant works are in excellent condition. Dam experienced a large runoff event earlier this year with spillway flow depth at about four feet (reservoir level at 4502). Piezometer readings indicate higher water elevations than what was expected by the dam's design engineers. Some seepage has also appeared along the toe and was monitored earlier this year, but has basically dried up this summer. Some seepage flow was observed entering the outlet discharge area (see photo).

**BELOW:** View looking across the downstream slope of the dam, towards the toe of the dam and the area below the dam. Note the green growth in the circled area from the seepage that was noted earlier this year. During this inspection, the seepage area was no longer flowing water, but was observed to still be damp. The location of Piezometer # 2 (middle piezometer) is indicated in the foreground of this view.

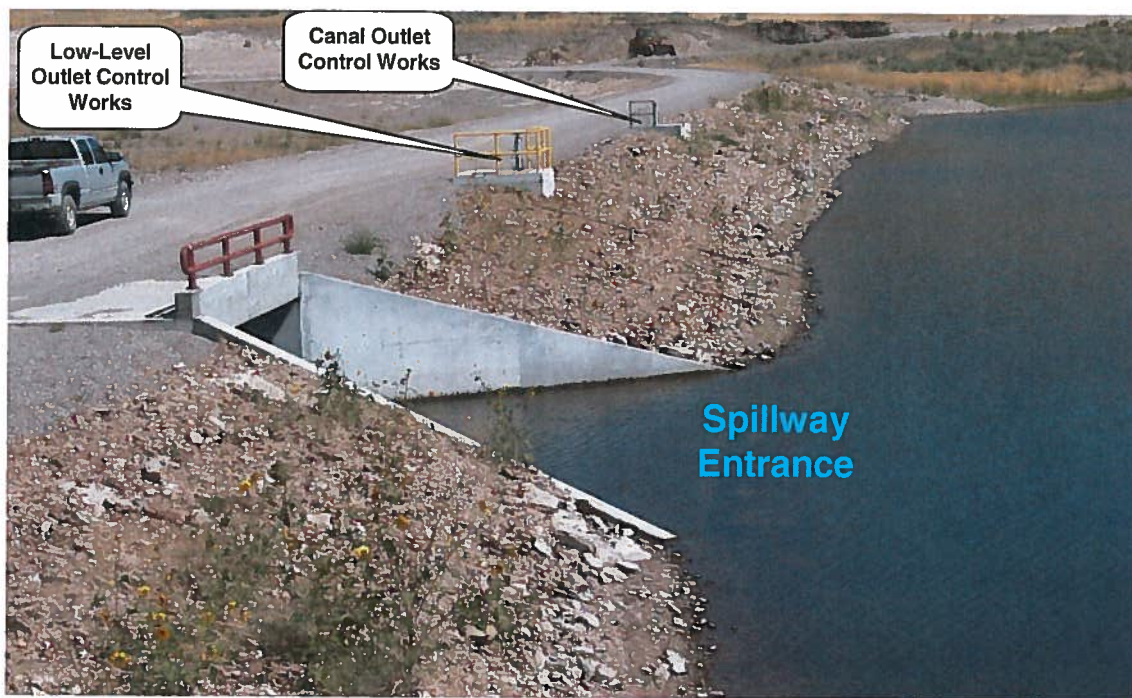
**ABOVE:** View of the dam crest and the upstream slope of the dam from near the left (west) end of the dam with the locations of various points of interest indicated.

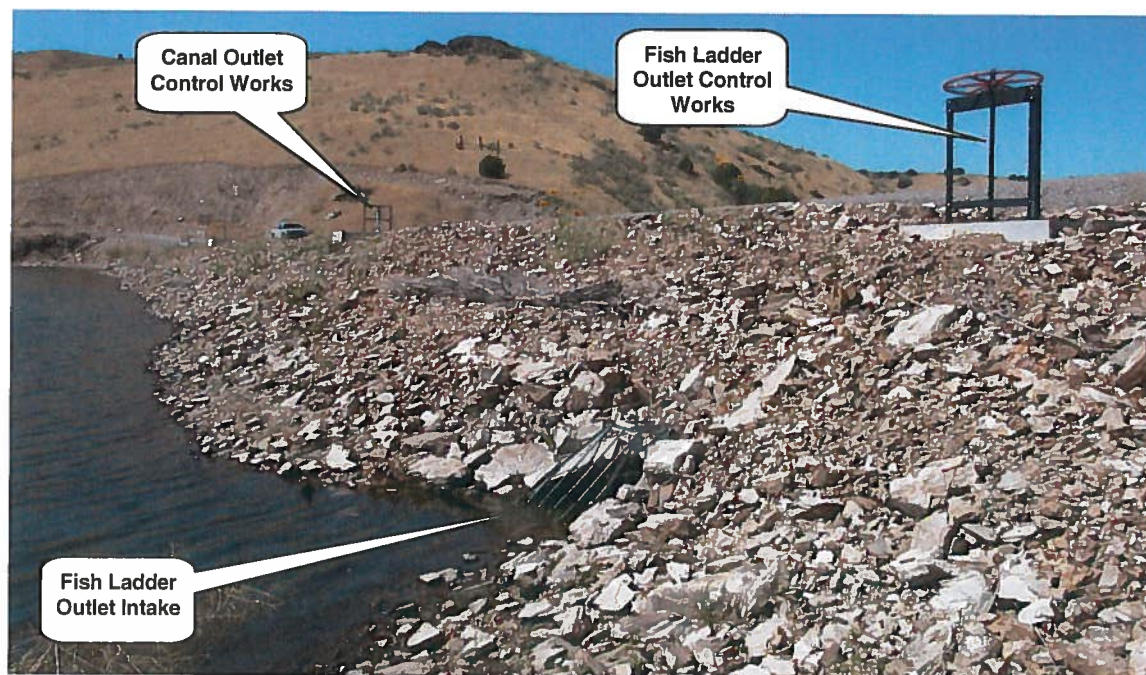
**BELOW:** View of the upstream slope of the dam from near the fish ladder outlet intake showing the reservoir level at the time of the inspection.

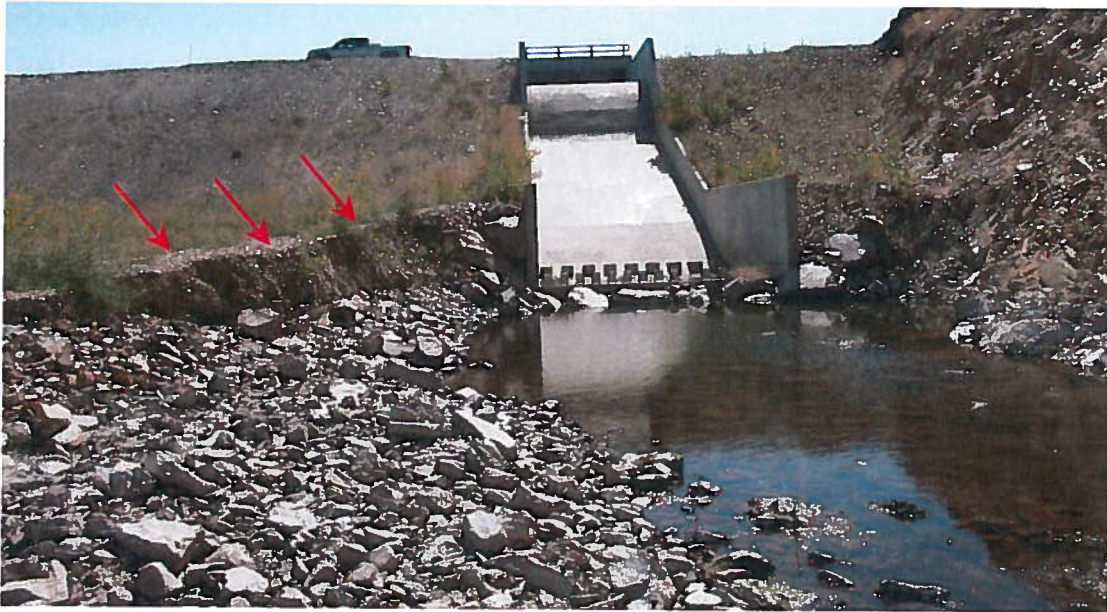
Erosion present: In channel below structure

**ABOVE:** View looking up the spillway channel towards the concrete spillway structure and the downstream slope of the dam. Earlier this year, the dam experienced a large runoff event with spillway flow depth at about four feet (reservoir level at 4502). Note some erosion of along the right (left in photo) side of the spillway channel in the area indicated by arrows.

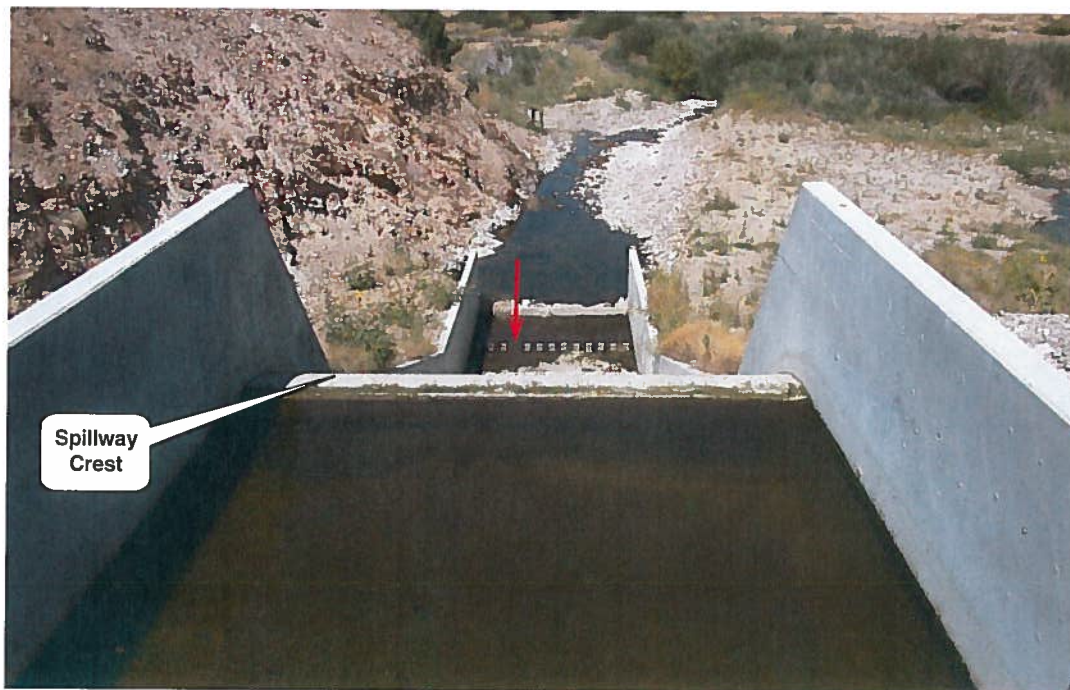
**BELOW:** View from the dam crest looking down the concrete spillway structure, and further down the spillway channel below the spillway structure. Note the missing energy dissipater in the location indicated by the arrow.

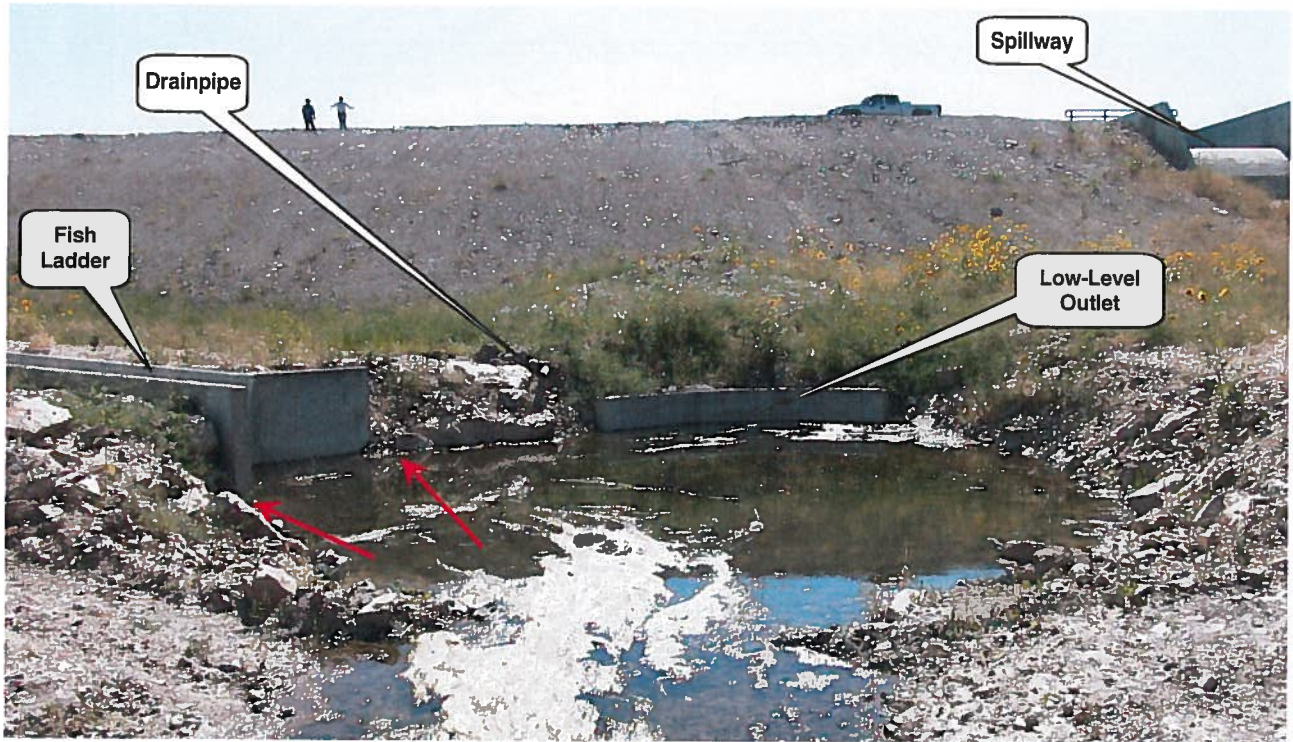
**ABOVE:** View of the low-level outlet and fish ladder discharge basin looking back towards the downstream slope of the dam. The drainpipe, which drains the concrete manhole structure for the low-level outlet, was dripping a small amount of water. The water in the discharge basin was fairly stagnant, but close examination revealed flowing water (seepage) at the locations indicated by the arrows.

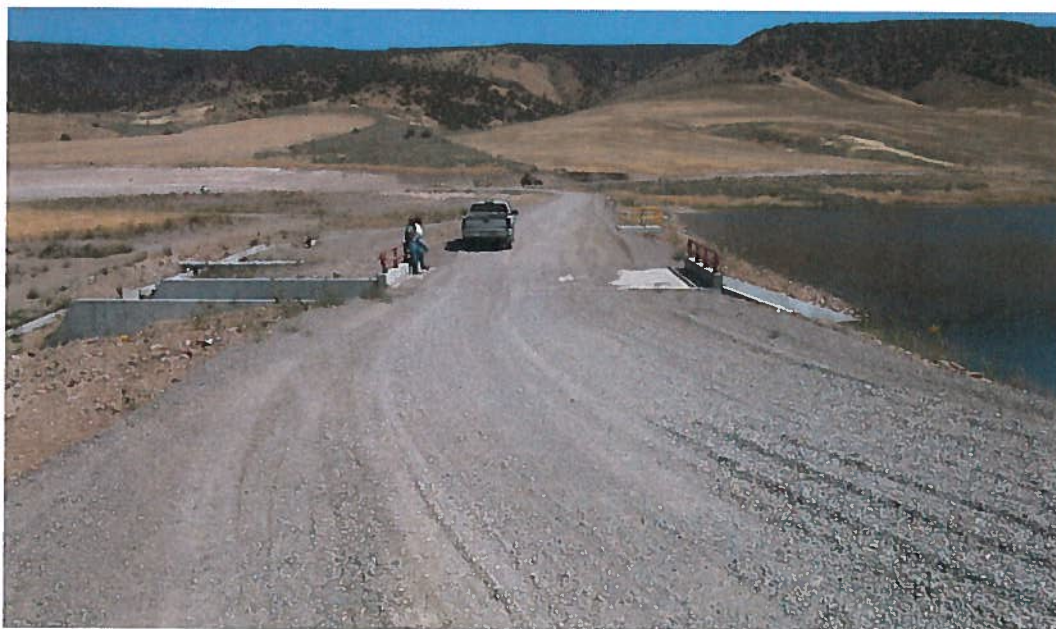
**BELOW:** View of the dam crest from the left (west) end of the dam.
