## IDAHO DEPARTMENT OF WATER RESOURCES

### WELL INSPECTION FORM

1. DRILLING PERMIT NO: NONE OTHER APPLICABLE NO: 47-08147
2. OWNER: MARILYN S. UERLIN BROOK Phone: (208) 734-1845  
Address: 3169 E 3500 N, TWIN FALLS, IDAHO 83301

3. WELL LOCATION: Twp 11S, Rge. 17E, Sec. 02, NW 1/4 SE 1/4  
County TWIN FALLS (Provide sketch map and photo on reverse.)
4. DRILLER: UNKNOWN Lic. No. UNKNOWN  
When Drilled? UNKNOWN

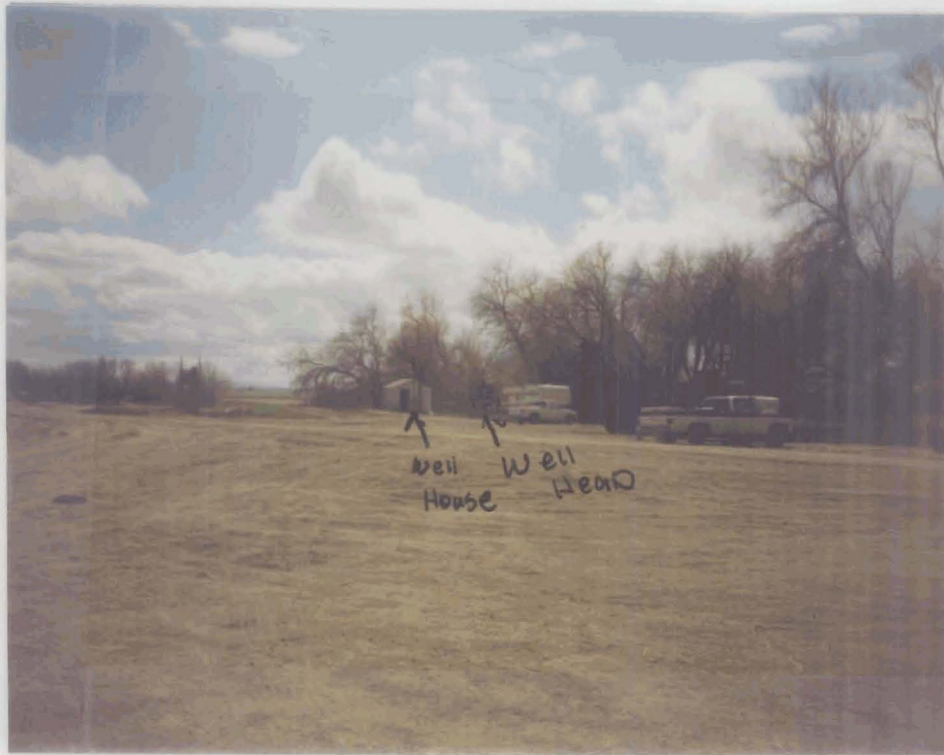
9. REMARKS: THIS WELL LOOKS IN GOOD CONDITION.  
THE POSSIBLE THREAT TO CONTAMINATION WOULD  
BE GROUND SEEPAGE. HOWEVER, THE WELL HEAD  
IS NOT 12 INCHES ABOVE GROUND. THE WELL  
HEAD HEIGHT SEEMS TO BE THE ONLY PROBLEM  
WITH THIS WELL.

← This is a picture of the well head. It is a 6" casing 3" above ground.

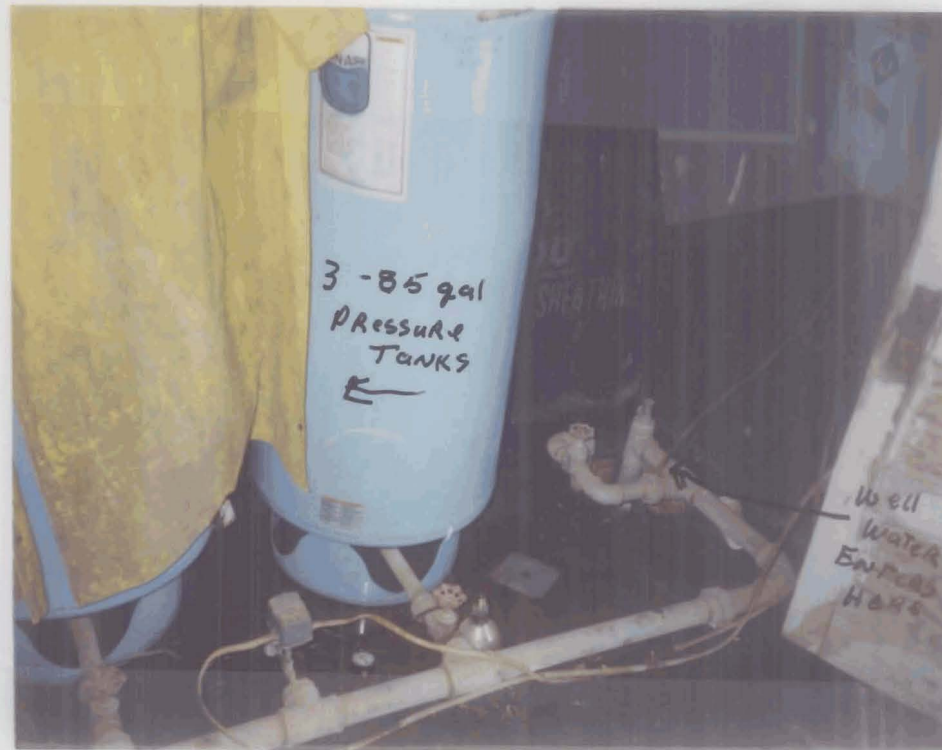
Well #3 Pictures.

↑ This is the interior of the well house. The water enters the well house in the NW corner and then goes to 3-85 gal PRESSURE TANKS
