*no drilling permit*  
IDAHO DEPARTMENT OF WATER RESOURCES

WELL INSPECTION FORM

2. OWNER: Aardena's Heida Dairy Phone: (208) 536-2187  
Address: P.O. Box 140, Weiser, ID 83355

3. WELL LOCATION: Twp 6S, Rge. 1E, Sec. 11, NW 1/4 SE 1/4  
County Gooding (Provide sketch map and photo on reverse.)

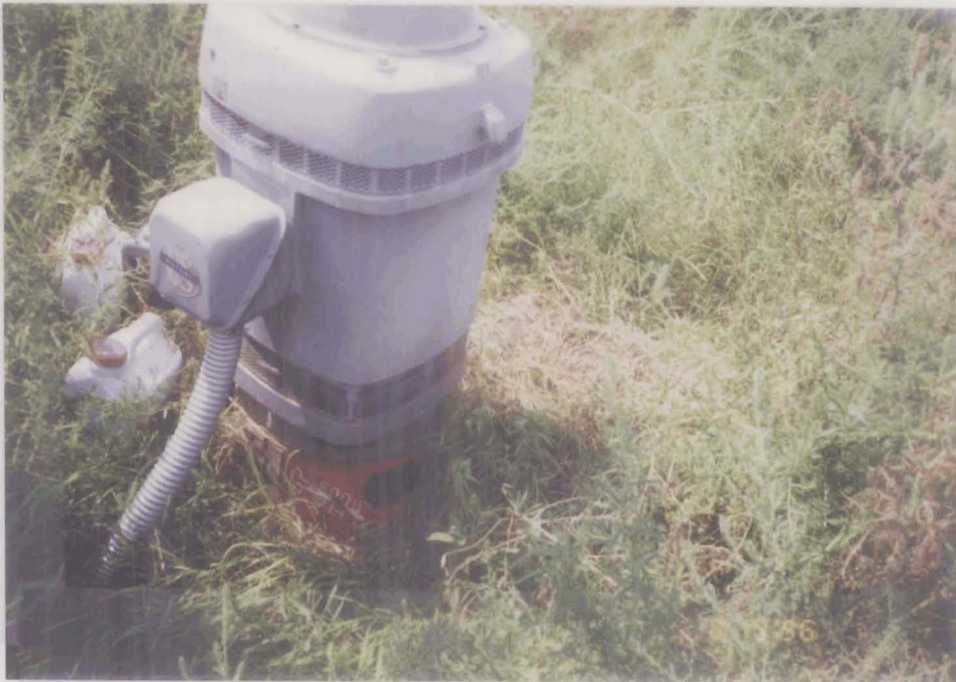
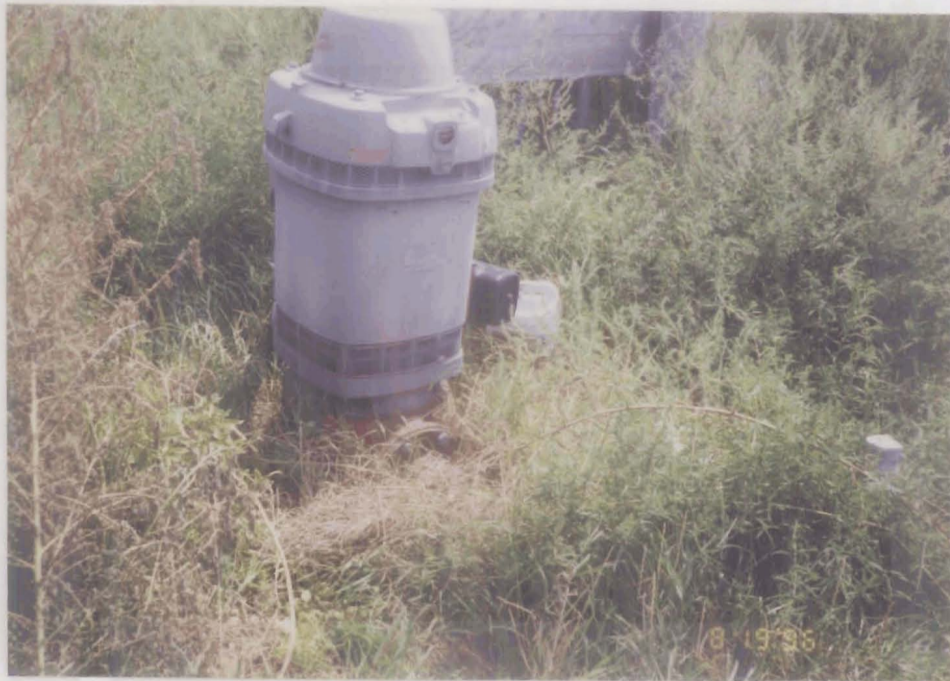
9. REMARKS: The sand from the field has blown and filled in around the pump. Therefore, ground level has raised to the level of the openings in the pump housing. The filter screen is located in the pump housing without a screen cap. This would allow rain or snow to enter the pump housing and enter the well.

THESE ARE PICTURES OF DIRT FILL-IN AROUND PUMP.  
 WITH OUT A CAP ON THE ACCESS PORT & NOW OR DIRT COULD  
 FILL INTO OPENING OF PUMP. THERE IS LESS THAN 2"  
 CLEARANCE FROM GROUND TO PUMP VENT.
