## Dam Safety Section

### TRIP REPORT

TO: Lava Thunder Canyon Golf Course Pond  
FROM: Ryan Madsen, John Falk  
DATE: April 11, 2008  
SUBJECT: Site Visit

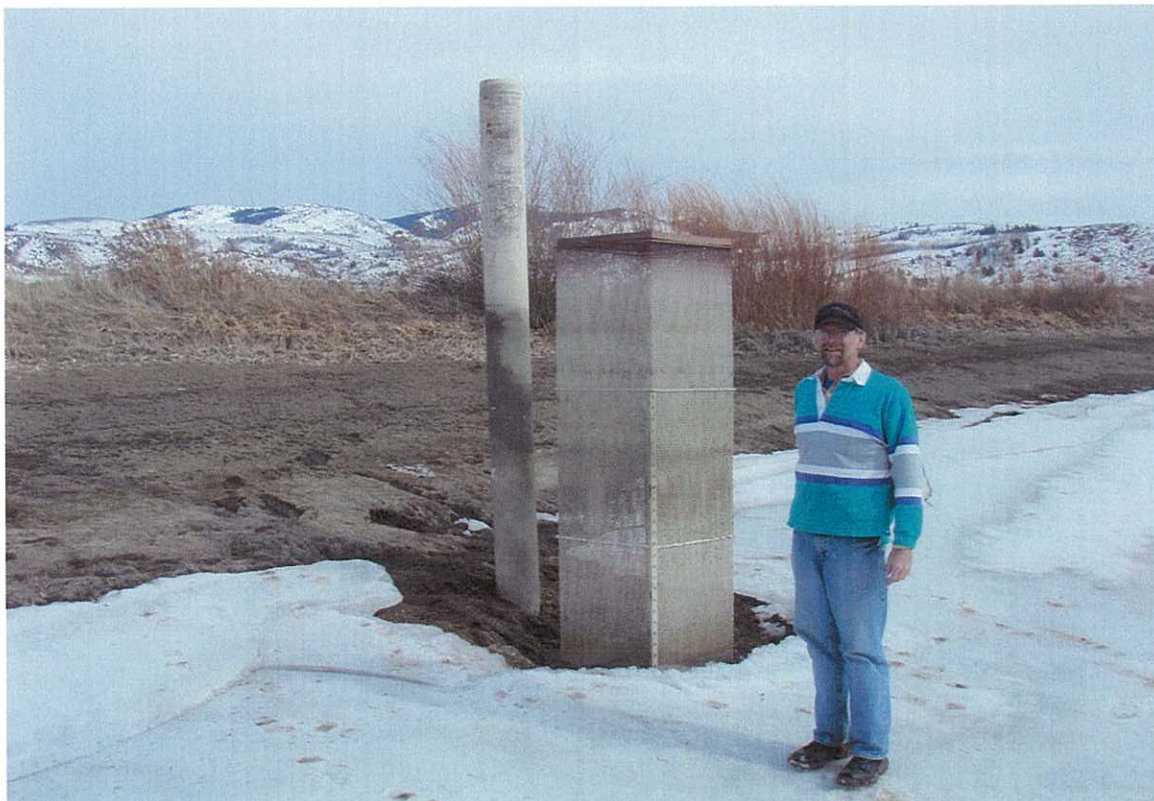
The emergency spillway is located at the northwest corner of the reservoir and discharges back into the supply ditch downstream from its point of diversion into the pond. The primary outlet appears to be located in the bottom of the reservoir, surrounded by a rectangular wire cage (Photo 2). The vertical PVC pipe next to the cage may be the primary overflow spillway (trickle-tube) or perhaps a vent for the buried pipeline to the golf course. Due to the ice we were unable to view the outlet works in detail.

Photo 2 (4/4/08) – Outlet works located in the bottom of the reservoir. In the background is shown a portion of the embankment dam.

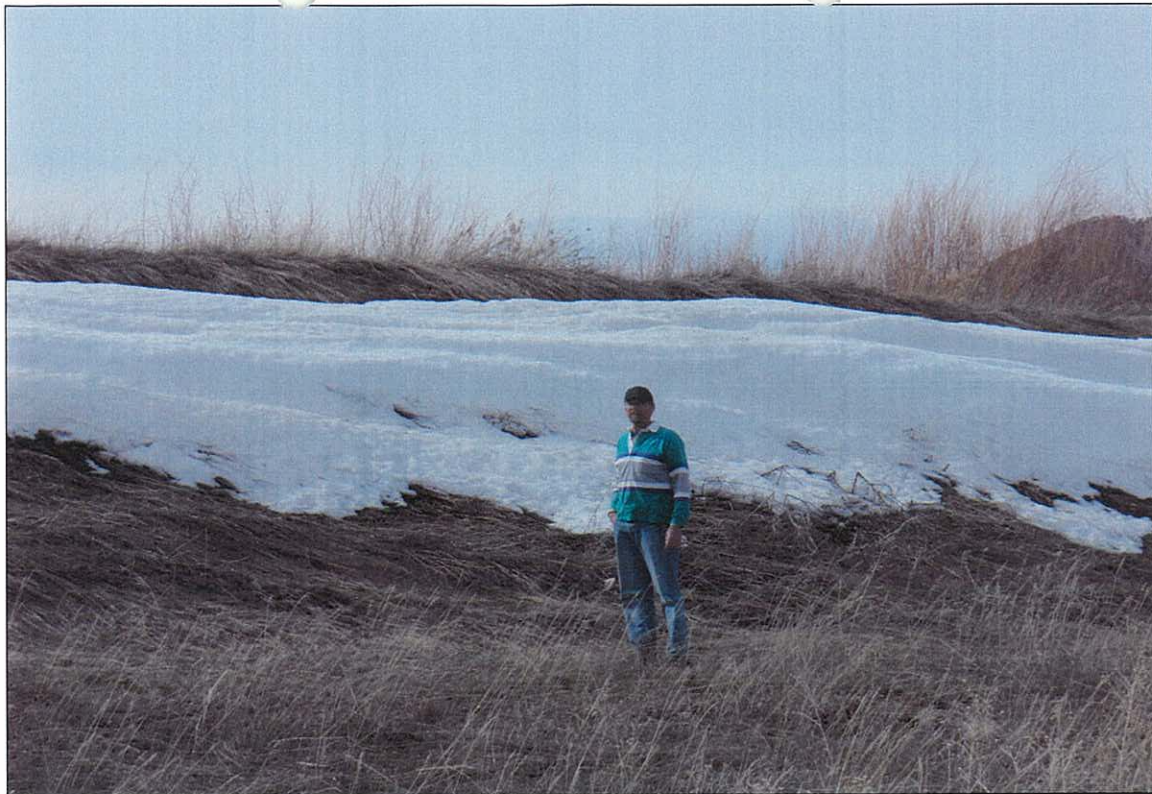
Photo 3 (4/4/08) – Downstream slope of dam near southeast corner

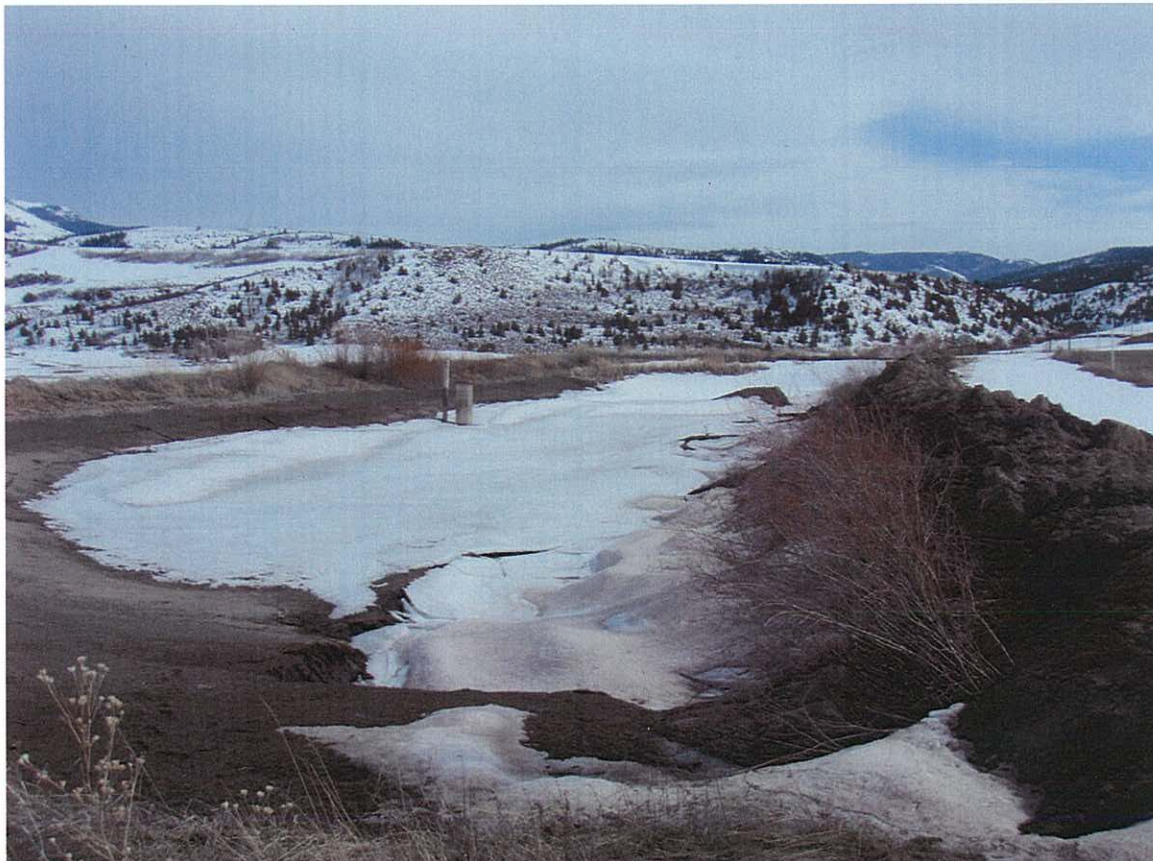
The base of the pond is approximately 400 feet long by 100 feet wide. The estimated slopes upstream and downstream are 3 feet horizontal to 1 foot vertical (3:1) and 2:1, respectively. The maximum pond depth is approximately 6 feet, however the hydraulic height (measured to downstream toe) may be as much as 10 feet. The pond appears to have been cut into the hill and the excavated soils cast on the downhill side to construct the perimeter embankment dam. The maximum height of the embankment is approximately 12 feet and occurs at the southeast corner of the project (Photo 3). The top of the dam is not level and the crest is only about (5) feet wide. The total estimated volume of the reservoir at full pool is approximately 6-7 acre-feet (Photo 4).

Photo 4 – View of the pond from the emergency spillway, looking south. The source ditch is located on the right (uphill) side; the embankment dam is located on the left (downhill) side.
