Dam Safety Section

INTEROFFICE MEMORANDUM

SUBJECT: Grossen Creek Impoundment

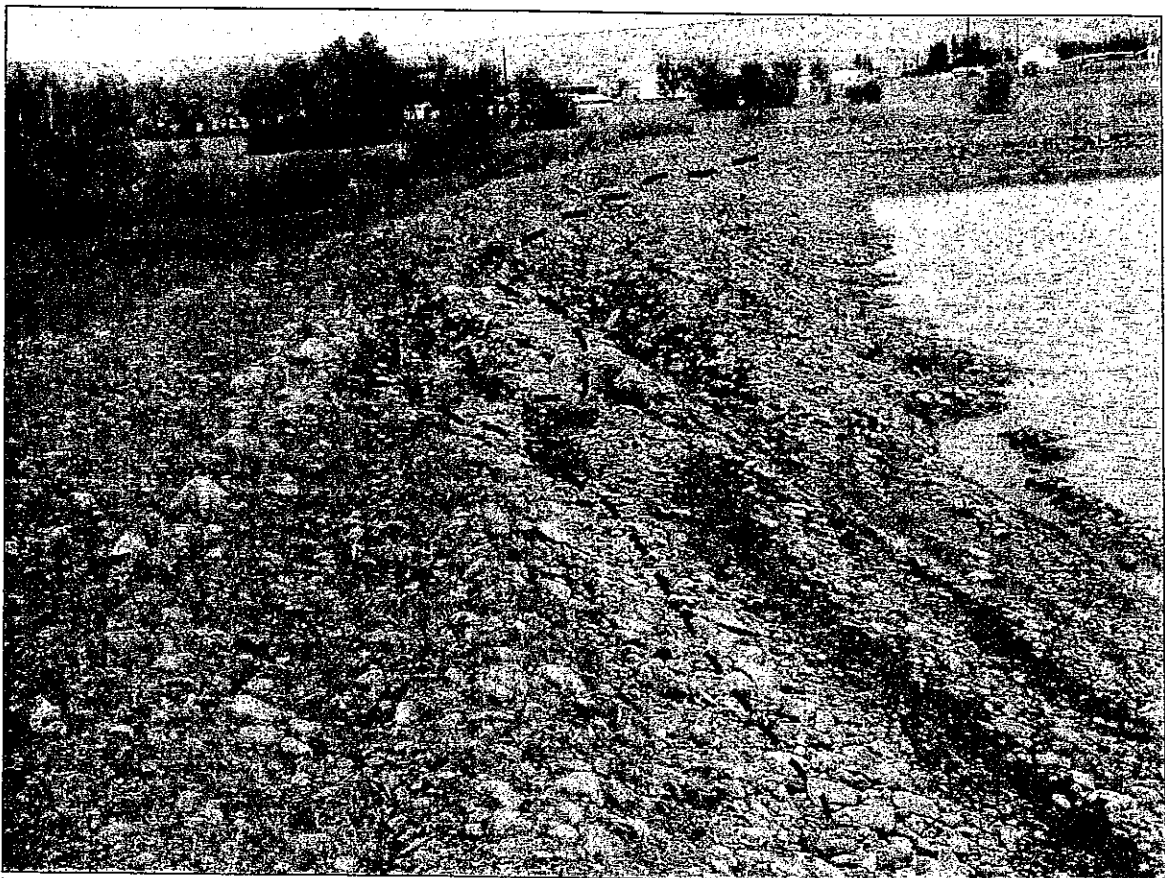
**Photo 1 (6-5-09) - View looking north along the western, centerline axis of the existing embankment dam. The pool level is approximately 4 feet lower than first observed yesterday when it was within just a few inches from overtopping the dam, as indicated by dashed line. At its narrowest dimension, the dam crest is only about 6 feet wide. Construction materials were obtained from the pool area and pushed up to create the perimeter embankment. The dam was built without IDWR dam safety approval; neither was it designed by a licensed professional engineer.**

- A. Modify the embankment to a height six (6) feet or less, or limit the reservoir to store no more than 10 acre-feet of water. This may perhaps most easily be accomplished by constructing an emergency spillway to discharge water out of the reservoir via gravity flow. The spillway channel must have dimensions equal to or greater than the diversion channel that delivers water from Grossen Creek into the reservoir. The bottom of the emergency spillway (invert elevation) must be positioned to provide at least two (2) feet of freeboard as measured to the top of the dam, and it must be located in natural ground at an elevation that will restrict reservoir storage to 10 acre-foot capacity, or less. Further, we recommend the dam crest be leveled to a uniform grade, and nowhere be less than 10 feet wide.

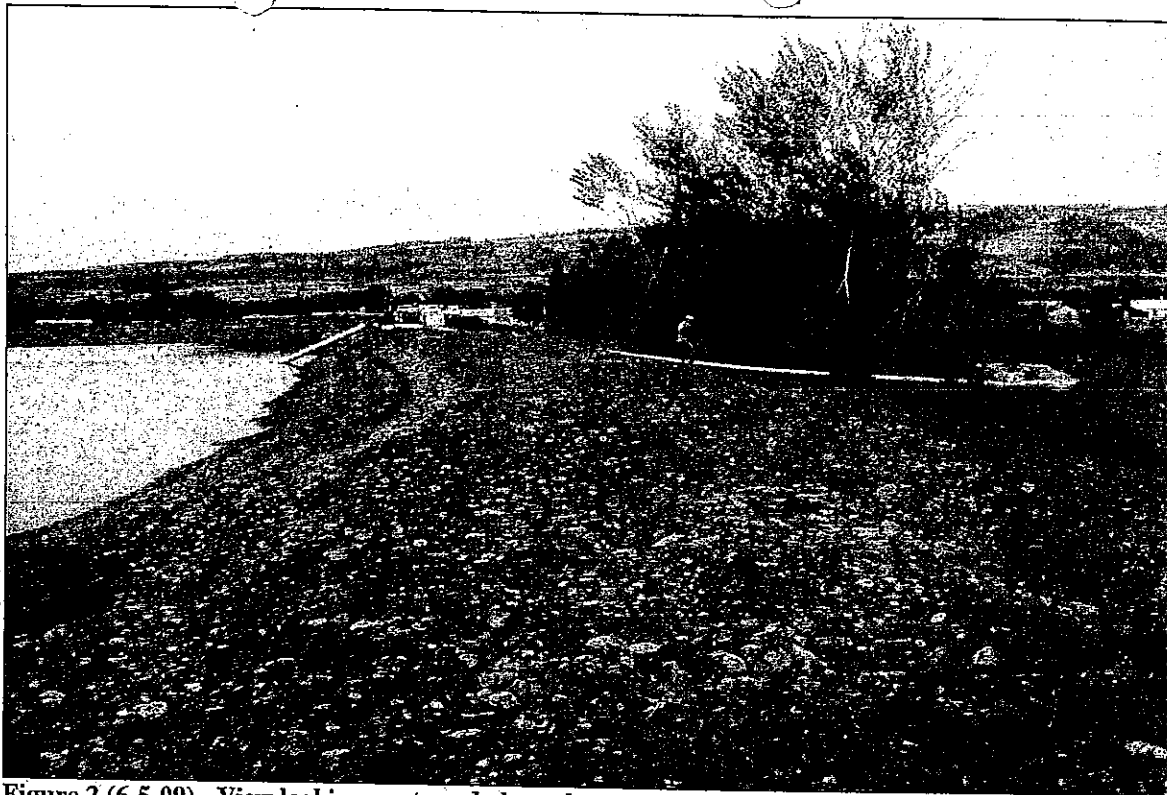
Figure 2 (6-5-09) - View looking westward along the northern side of the dam, taken from near the diversion ditch. The portable pump is discharging water from the reservoir into Grossen Creek.

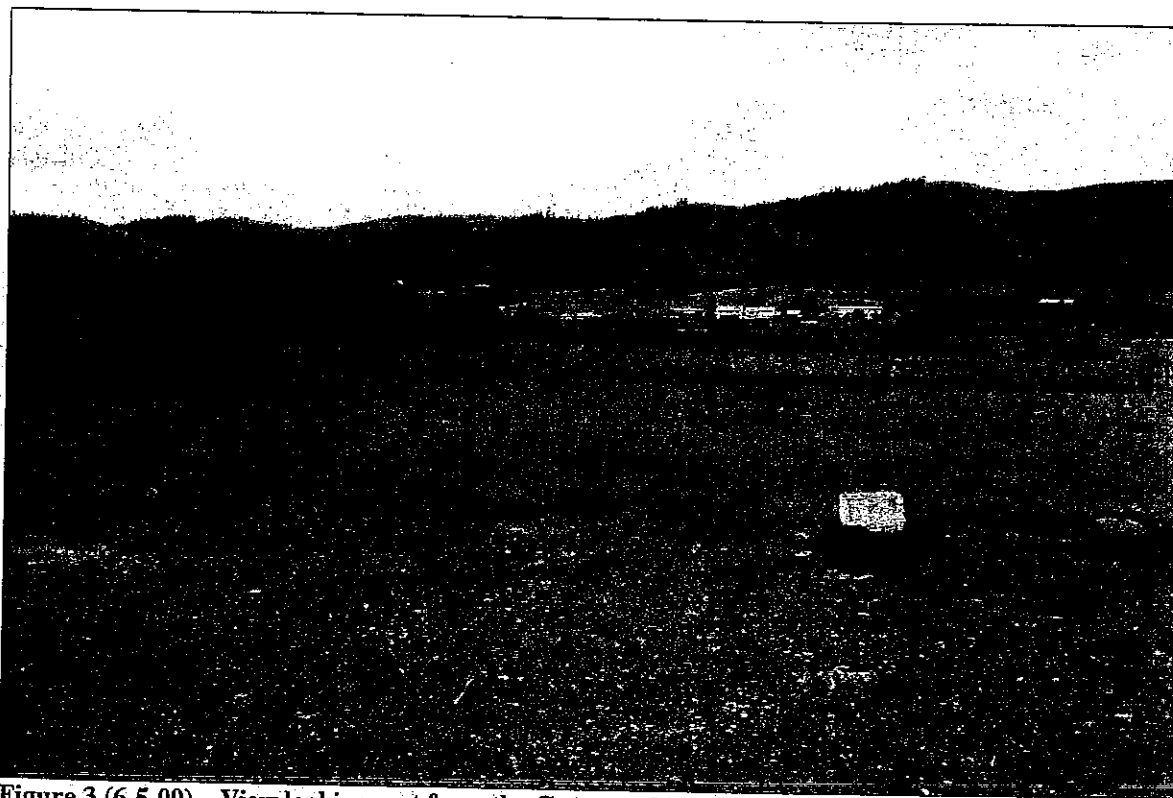
Figure 3 (6-5-09) - View looking east from the Cenex parking lot, upstream toward the existing dam. Along the distant fence-line is a 2-ft high berm that would serve to divert water resulting from a dam failure north toward Grossen Creek, or south into a smaller drainage adjacent to a subdivision.

I totally disagree that a 2ft high berm is adequate to safeguard the Cenex gas station and Highway 95 from a Dam break

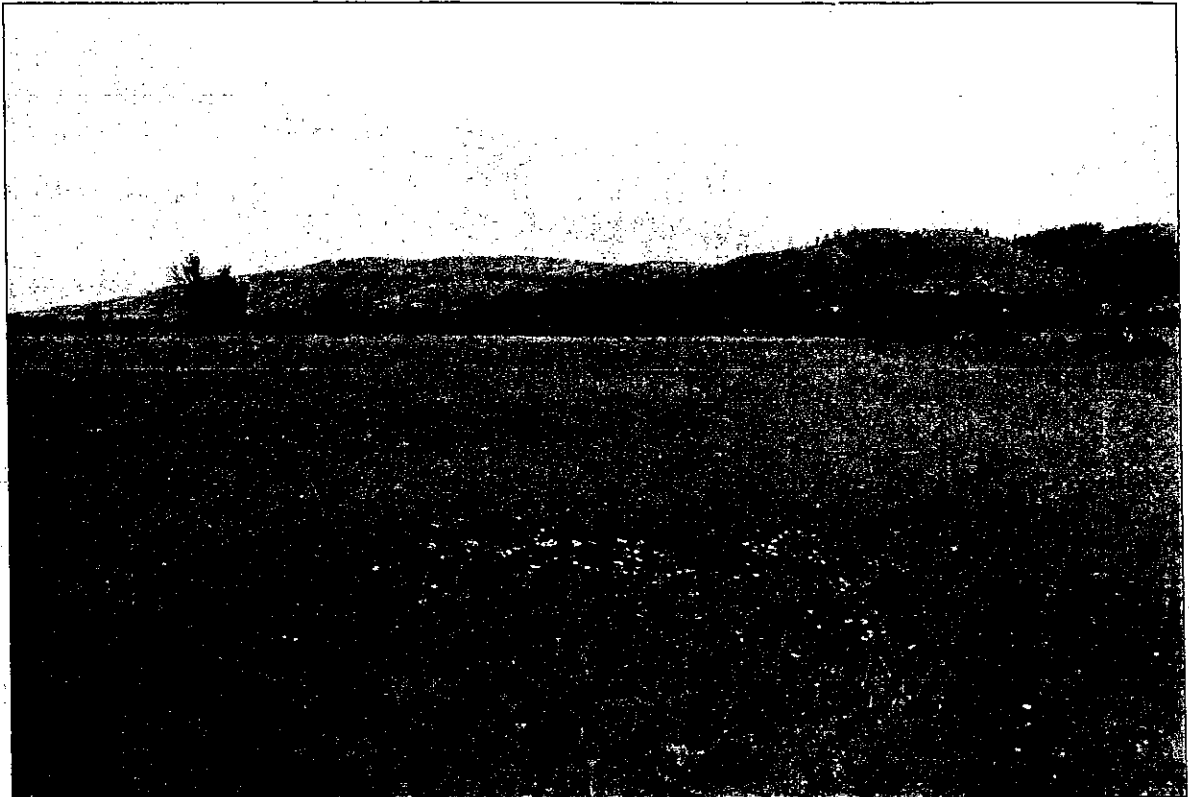
**Figure 4 (6-5-09) - View looking upstream in a north-east direction at the existing dam. The photo was taken near an existing barn located adjacent to a residential subdivision.**

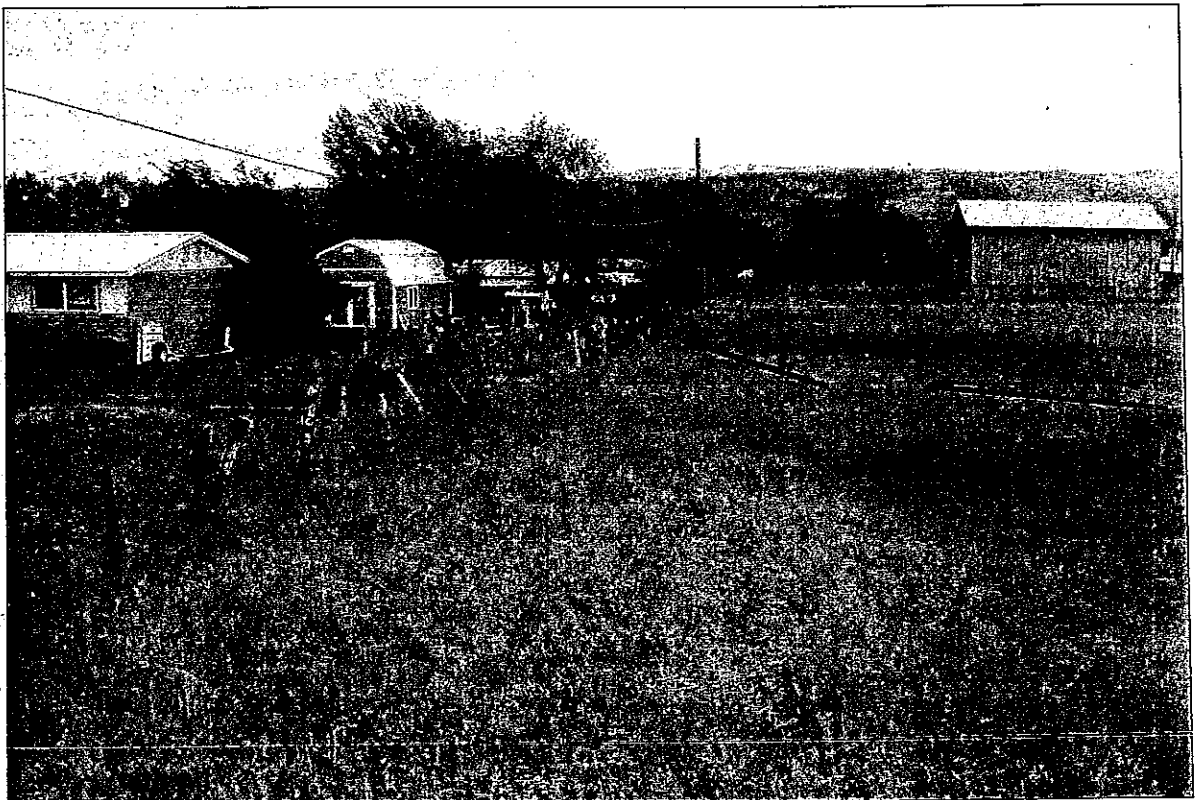
**Figure 5 (6-5-09) - View looking downstream at the small drainage that would receive much of the discharge from a dam failure. Note the location of the barn and residences (mentioned above).**
