State of Idaho  
DEPARTMENT OF WATER RESOURCES

DAM SAFETY PHOTOGRAPHS

BLACKWELL

RECORD OF INSPECTION OF DAM

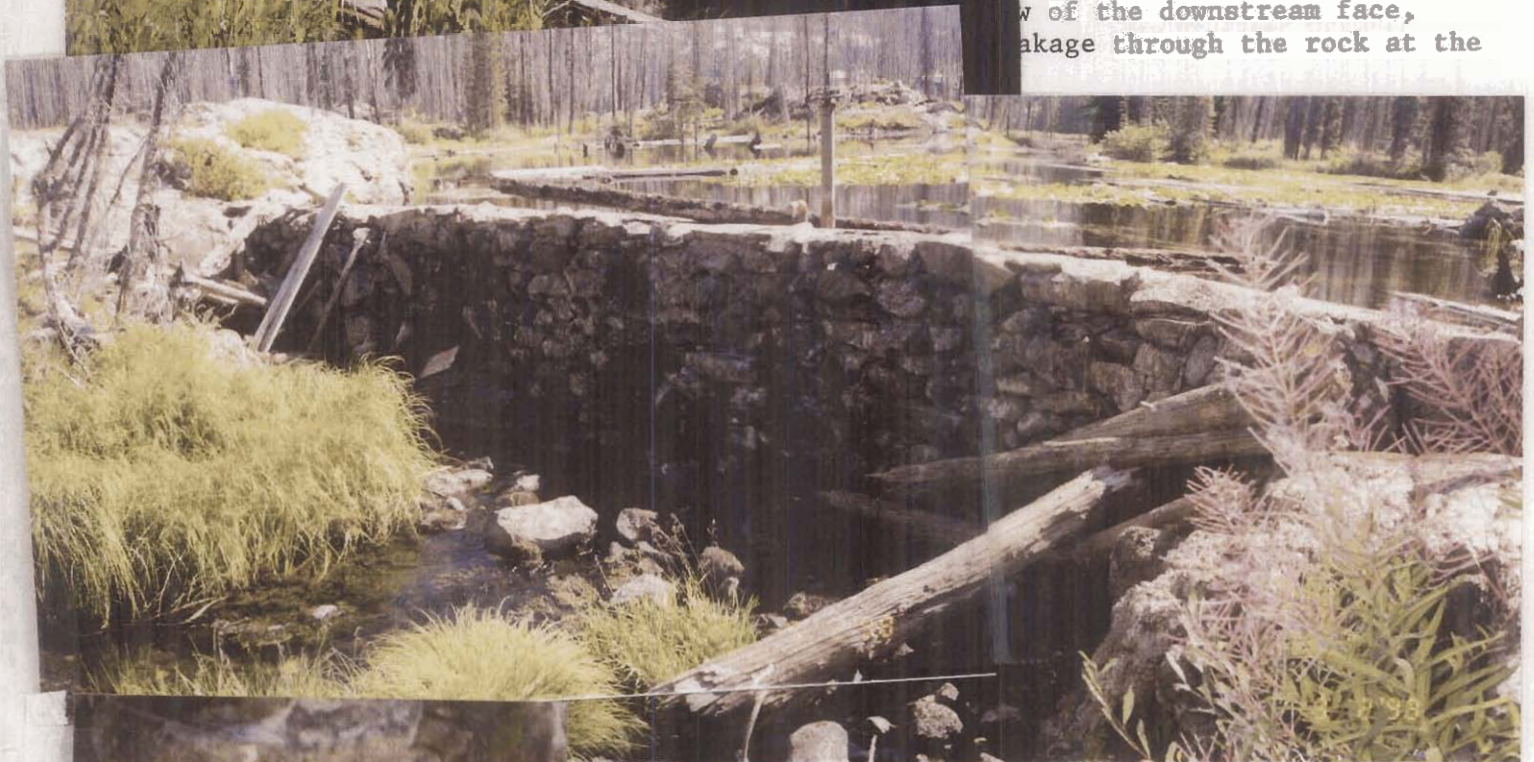
view of the downstream face,  
leakage through the rock at the

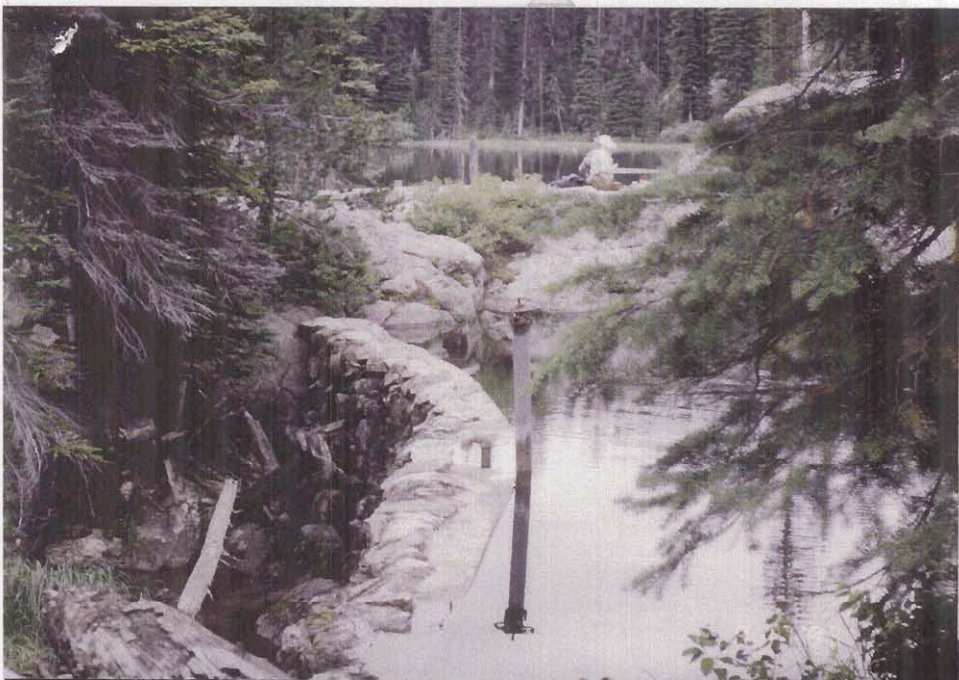
1. Crest and gate control of the rock dam, taken from the left abutment.

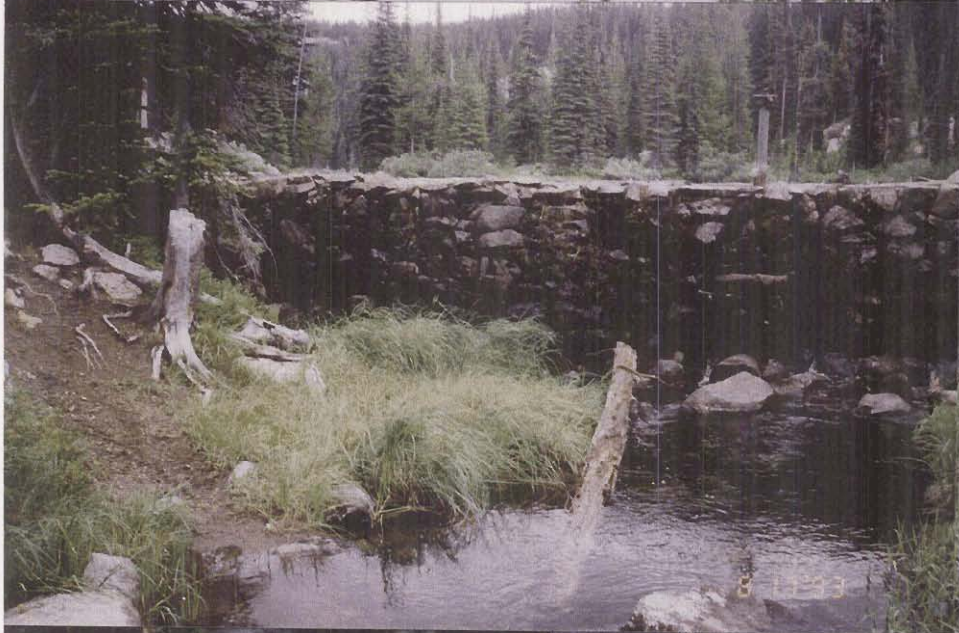
| | TOE AREA | DOWNSTREAM SLOPE | ABUTMENTS | OTHER |
|---|---|---|---|---|
| Flowing water (Est. G.P.M.) | Significant leakage through mortar between rocks near outlet pipe, photo #3 | | | |

GENERAL CONDITION AND DESCRIPTION OF DAM: Fair-Good, the new leasee has done considerable work in removing/burning driftwood, and constructing a new log boom. It appears the dam has always leaked significantly from previous inspections, and this is the case at present, photo #3. The structure appears stable, even though there is some missing/deteriorated mortar.

1. Continue to remove driftwood/debris from the area.
2. Keep outlet gate and control in good working order.
3. Monitor leakage thru the dam, repair mortar where leakage is concentrated.
4. Maintain log boom.
