STATE OF IDAHO  
DEPARTMENT OF WATER RESOURCES  
**BENEFICIAL USE FIELD REPORT**

Permit No: 11-7435

Exam Date: 6/6/2008

# FIELD EXAM 11-7435

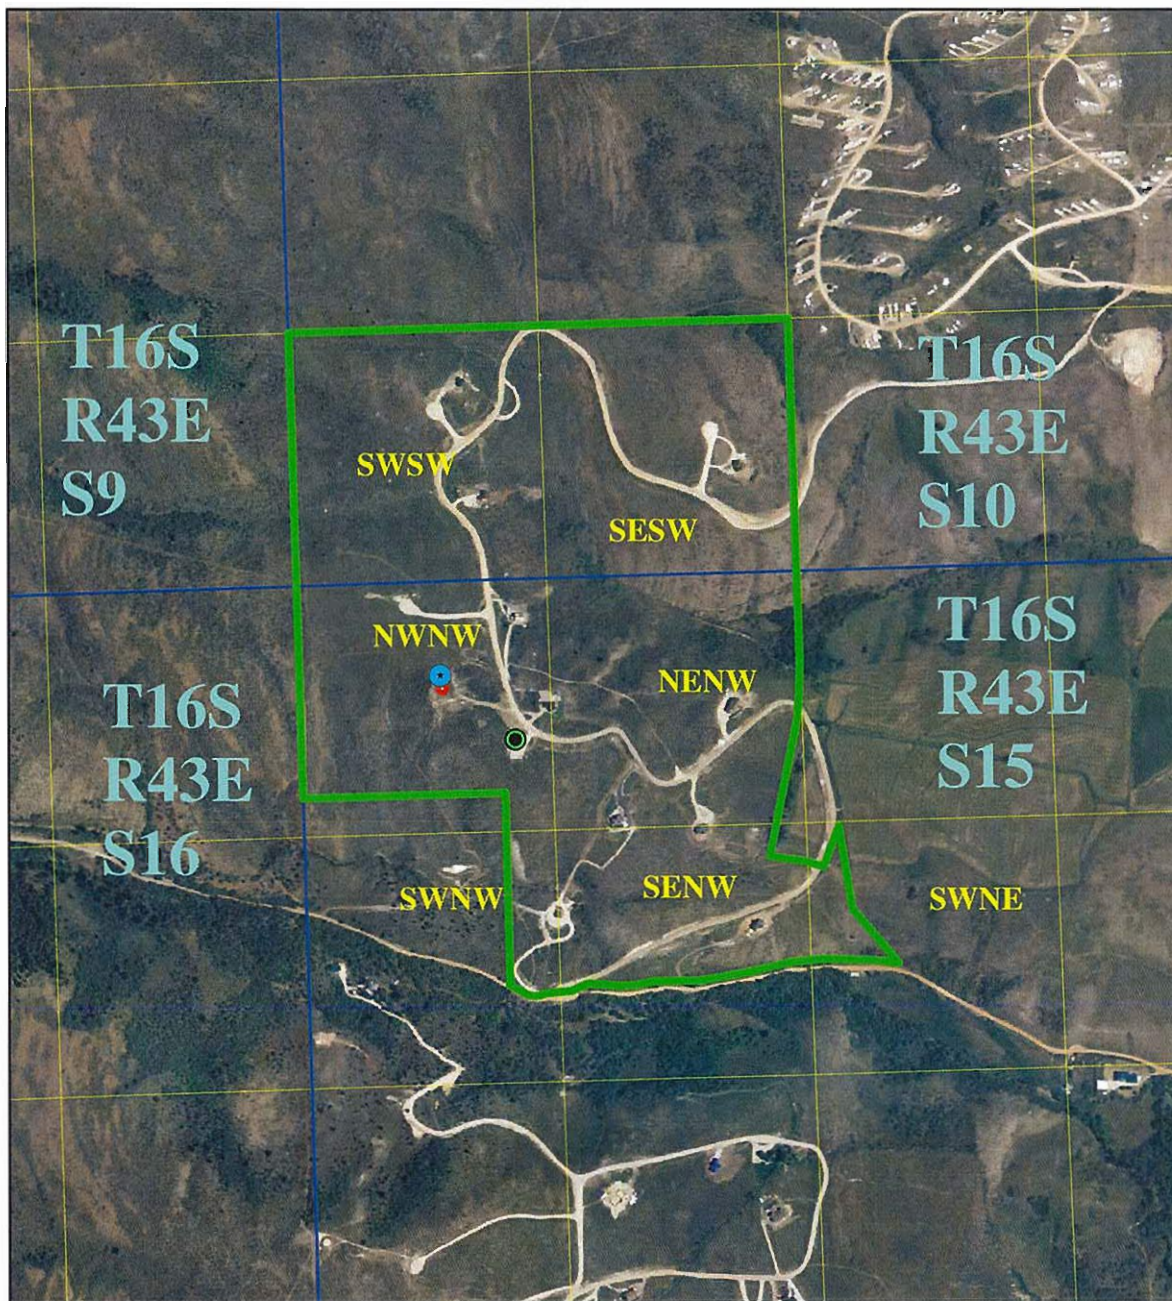
The water for this permit is diverted from the well to a 250,000 gallon storage tank. From the tank the water flows back to well house where it is relifted by a 7 1/2 Hp variable speed pump and a 1/2 Hp pump into the distribution lines. In the distribution lines the water is delivered to the individual homes. There are currently 14 homes on the system, but there is evidence that all 33 lots have been stubbed into the system.

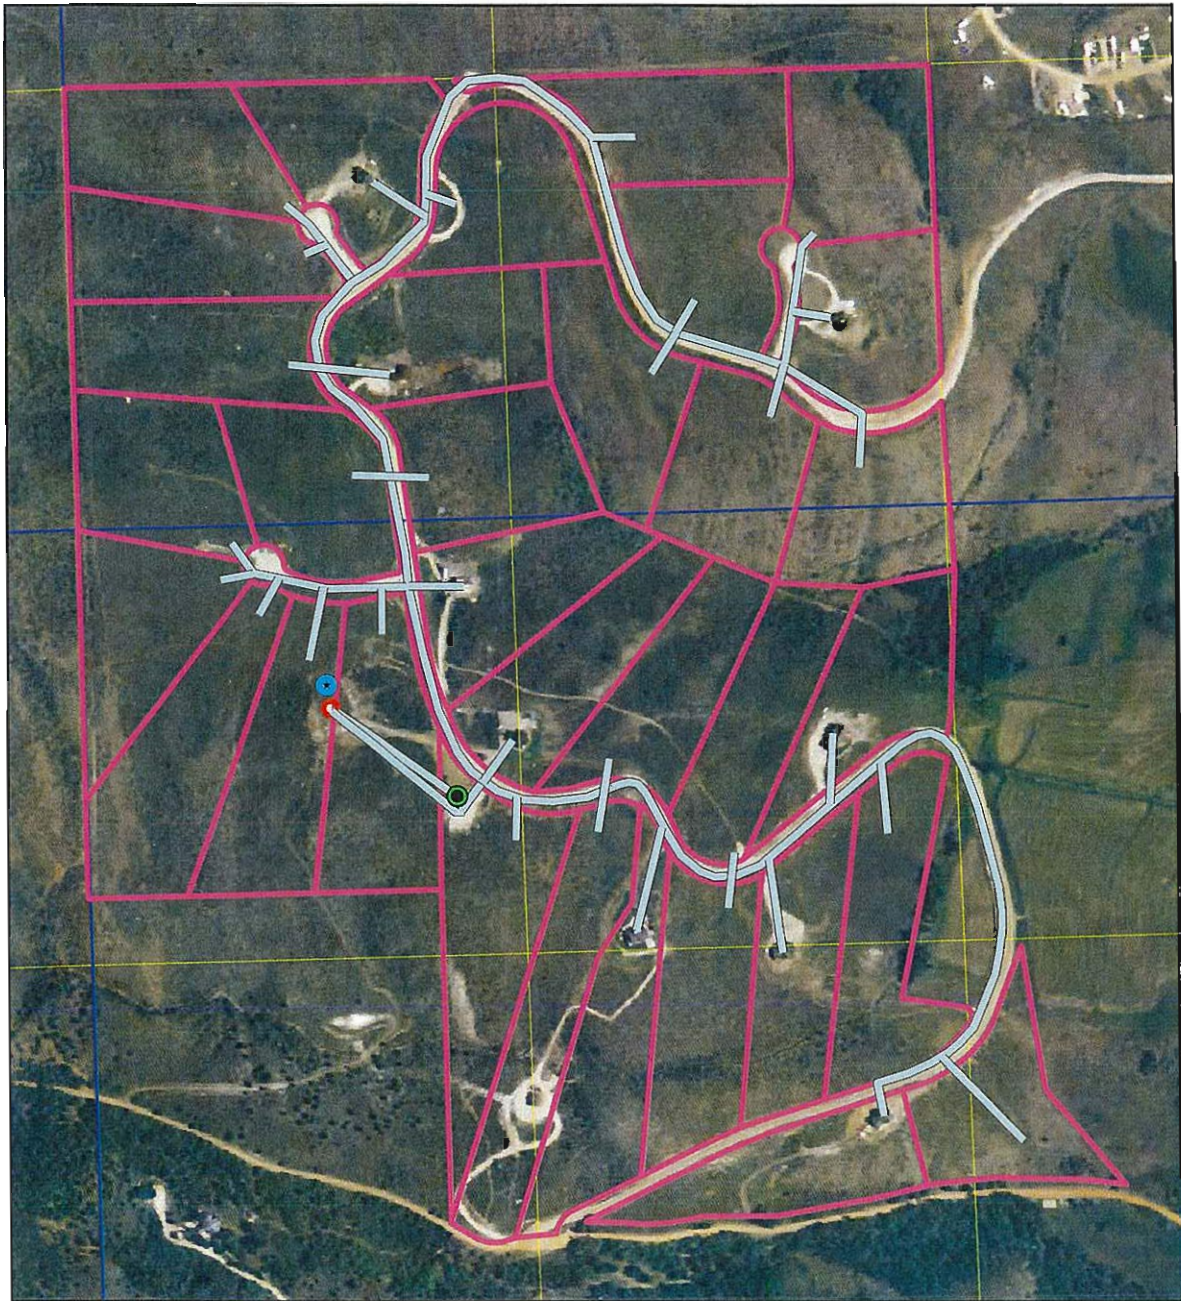
The water for this permit is diverted from the well to a 250,000 gallon storage tank. From the tank the water flows back to well house where it is relifted by a 7 1/2 Hp variable speed pump and a 1/2 Hp pump into the distribution lines. In the distribution lines the water is delivered to the individual homes. There are currently 14 homes on the system, but there is evidence that all 33 lots have been stubbed into the system.

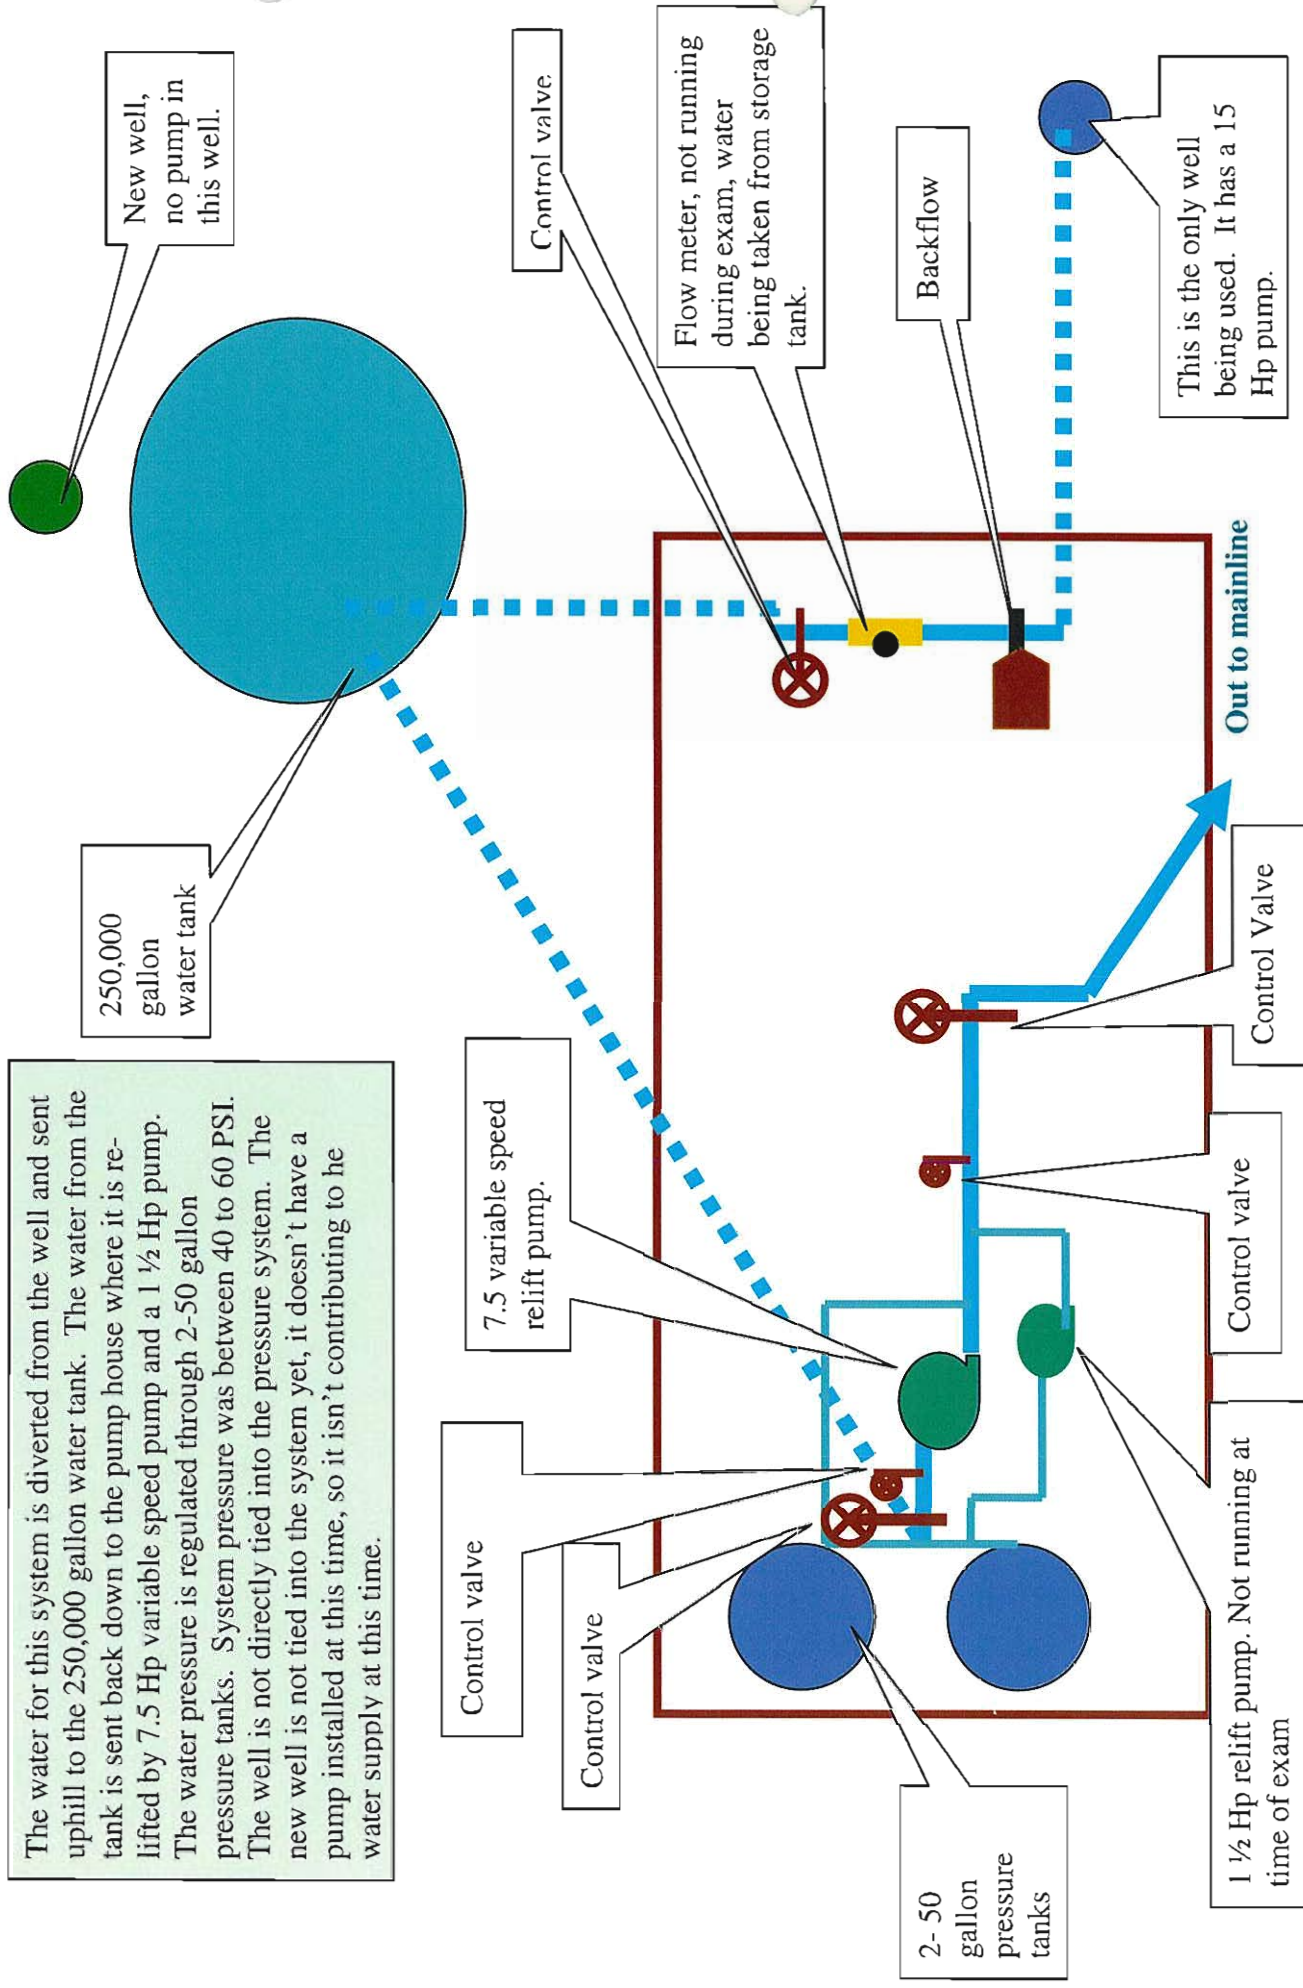
## SYSTEM DIAGRAM

The water for this system is diverted from the well and sent uphill to the 250,000 gallon water tank. The water from the tank is sent back down to the pump house where it is re-lifted by 7.5 Hp variable speed pump and a 1 ½ Hp pump. The water pressure is regulated through 2-50 gallon pressure tanks. System pressure was between 40 to 60 PSI. The well is not directly tied into the pressure system. The new well is not tied into the system yet, it doesn't have a pump installed at this time, so it isn't contributing to the water supply at this time.

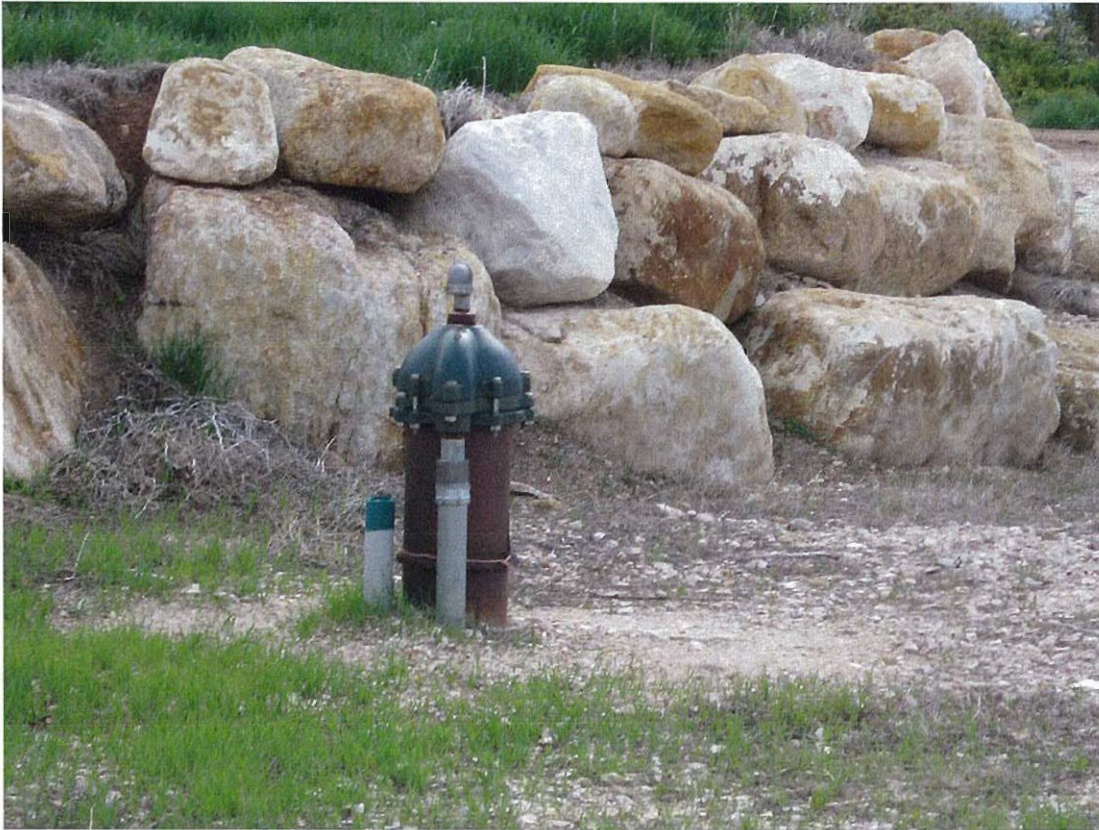
The photo above shows the wellhead for the point of diversion.

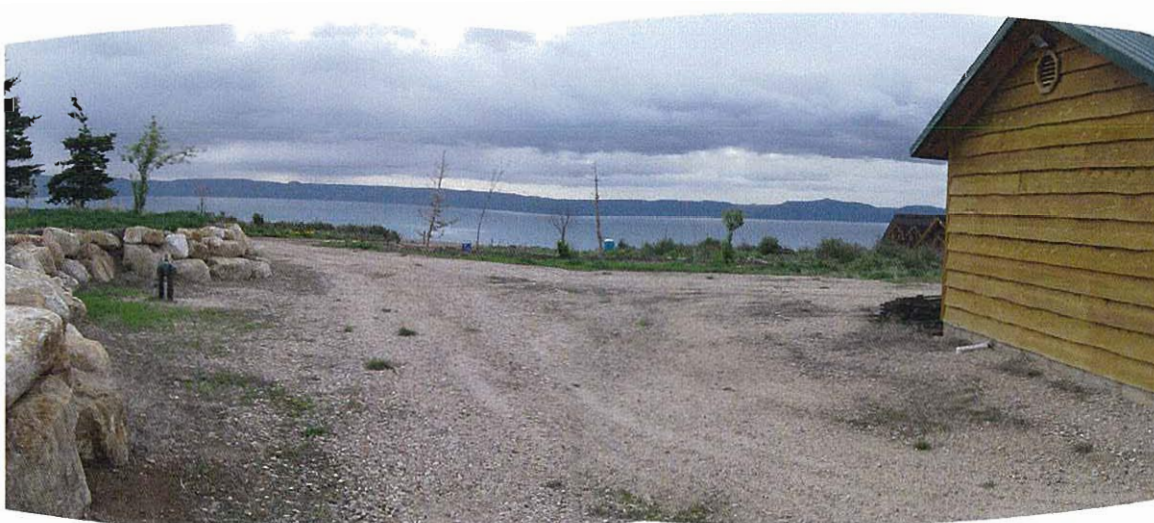
The photo below shows the wellhead location in comparison to the well house shown on the right.

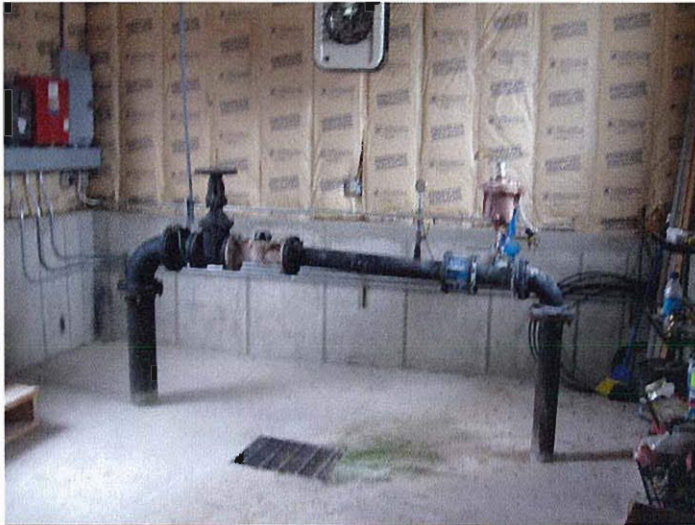
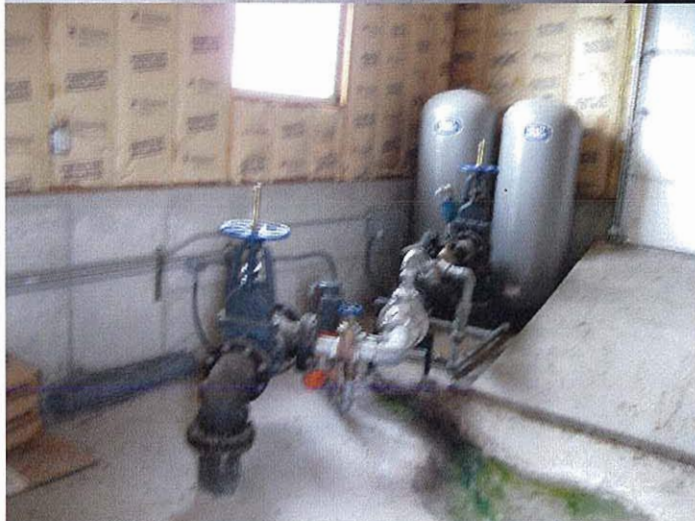
These are photos of the well house. The top photo shows where the well line enters the well house to be measured. The pipeline then leaves the well house and goes up to the 250,000 gallon water tank.

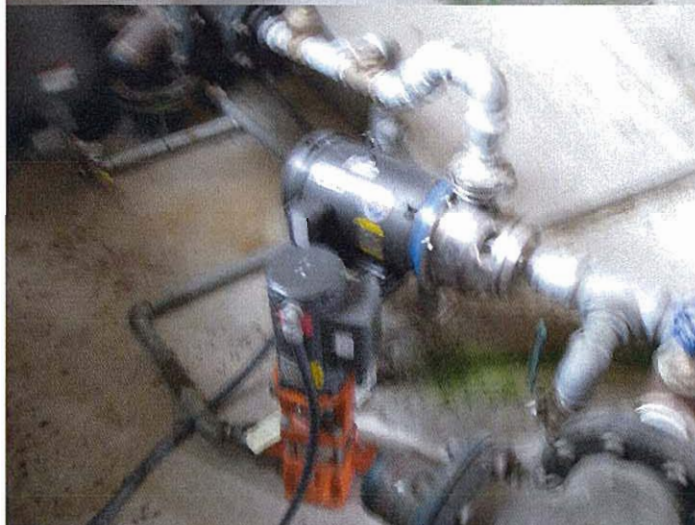
This photo shows where the water re-enters the well house from the water tank. The water comes in and is re-lifted by a 7.5 Hp variable speed pump and a 1 ½ Hp re-lift pump. The water pressure is regulated by the two pressure tanks in the rear of the diversion works.

This photo show the two re-lift pumps. The gray and silver pump is the 7.5 Hp variable speed pump, and the smaller gray and orange pump is the 1 ½ Hp pump.

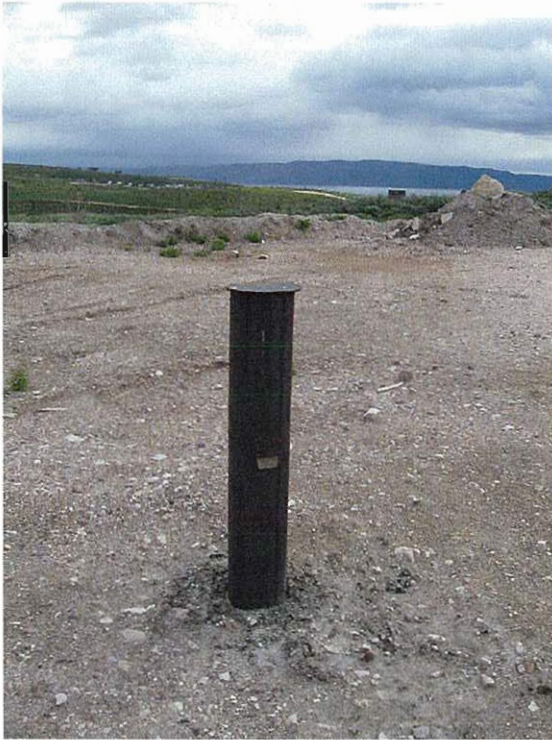
There is a second well, but it doesn't have a pump installed. There is an amendment of permit filed on this permit to include the second well. This shouldn't be a problem, as long as the pump is not installed until the amendments are in place.

These are the photos of the new well. This well is involved in the proposed amendment, so I included these picture for reference. However, there is no pump or electrical wiring connected to this pump at this time.

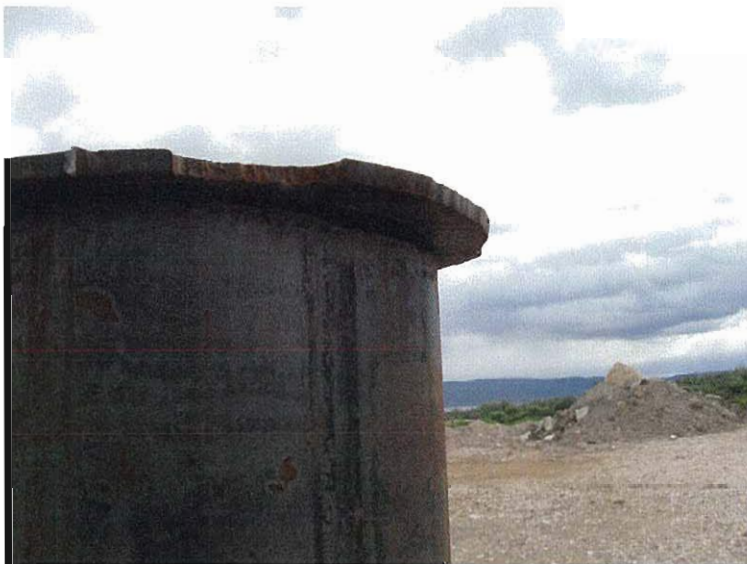
This well head is not properly sealed and there is a gap between the casing and the cover plate. Therefore, there is no water tight seal on this well. I wasn't too concerned about it, since it is waiting for the amendment to be approved before completing the pump installation.

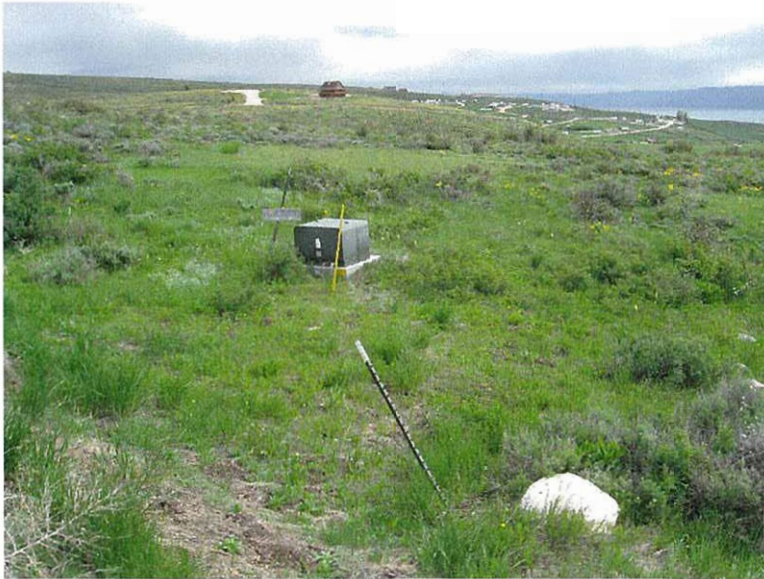
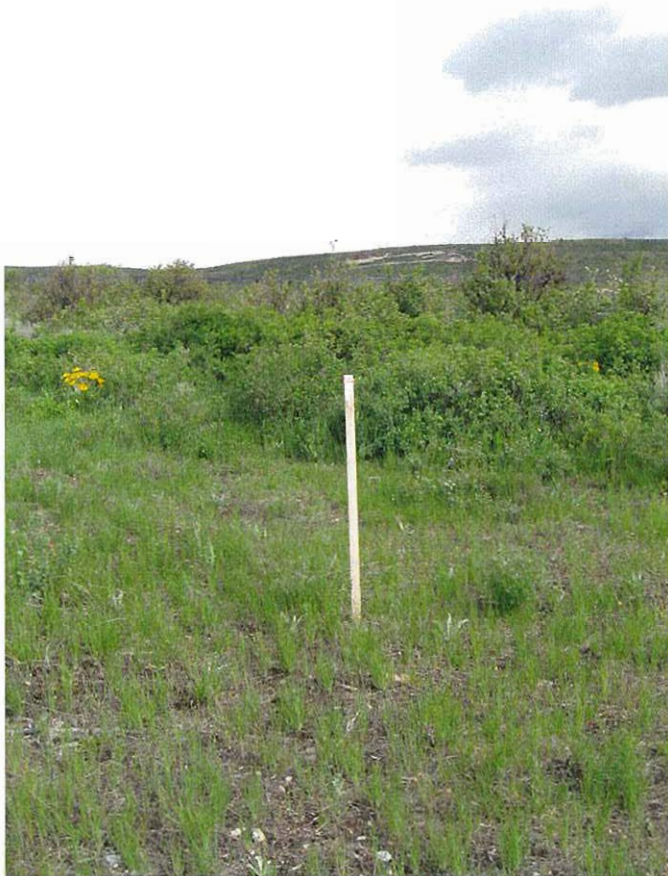
I found that 14 of the 33 lots have been developed, but the remaining 19 were empty. There is evidence that the each of the undeveloped lots have set up to receive both electricity and water from the buried service lines. It appears as though they put in the same trench or a side by side trench.

These photos show how the power and water connections are marked for each undeveloped lot. Each of the undeveloped lots have been stubbed into this system.

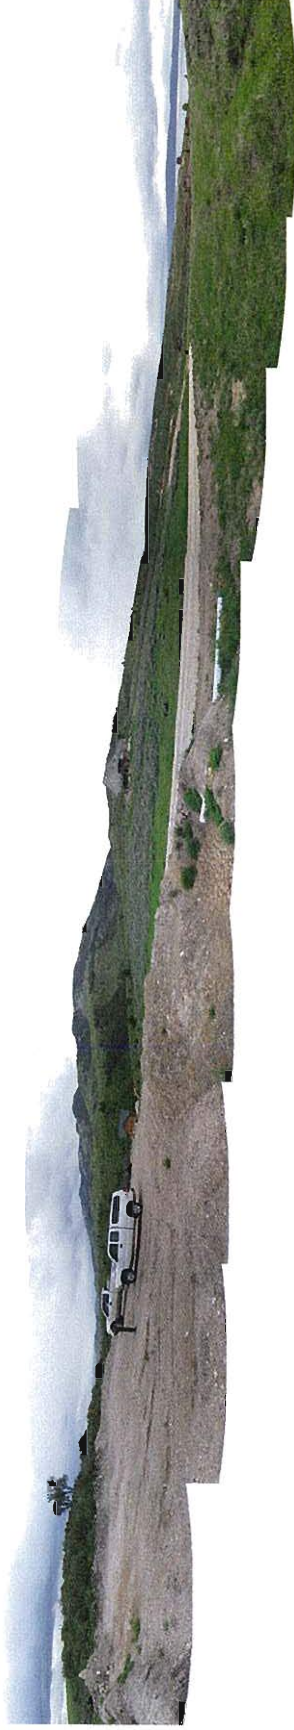
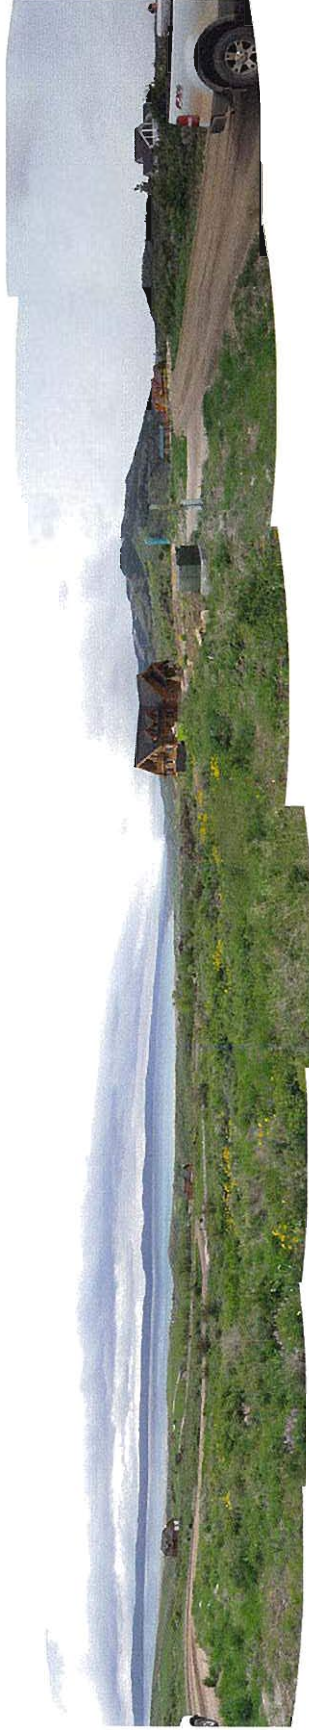
These are panoramic photos of the subdivision. As you can see, there is not a great deal of development completed yet. Approximately 14 of the 33 lots have been developed.
