## MEMORANDUM

**Date:** August 20, 2009  
**To:** Water Right File 47-7861  
**From:** jstanton  
**Re:** Field Report Narrative

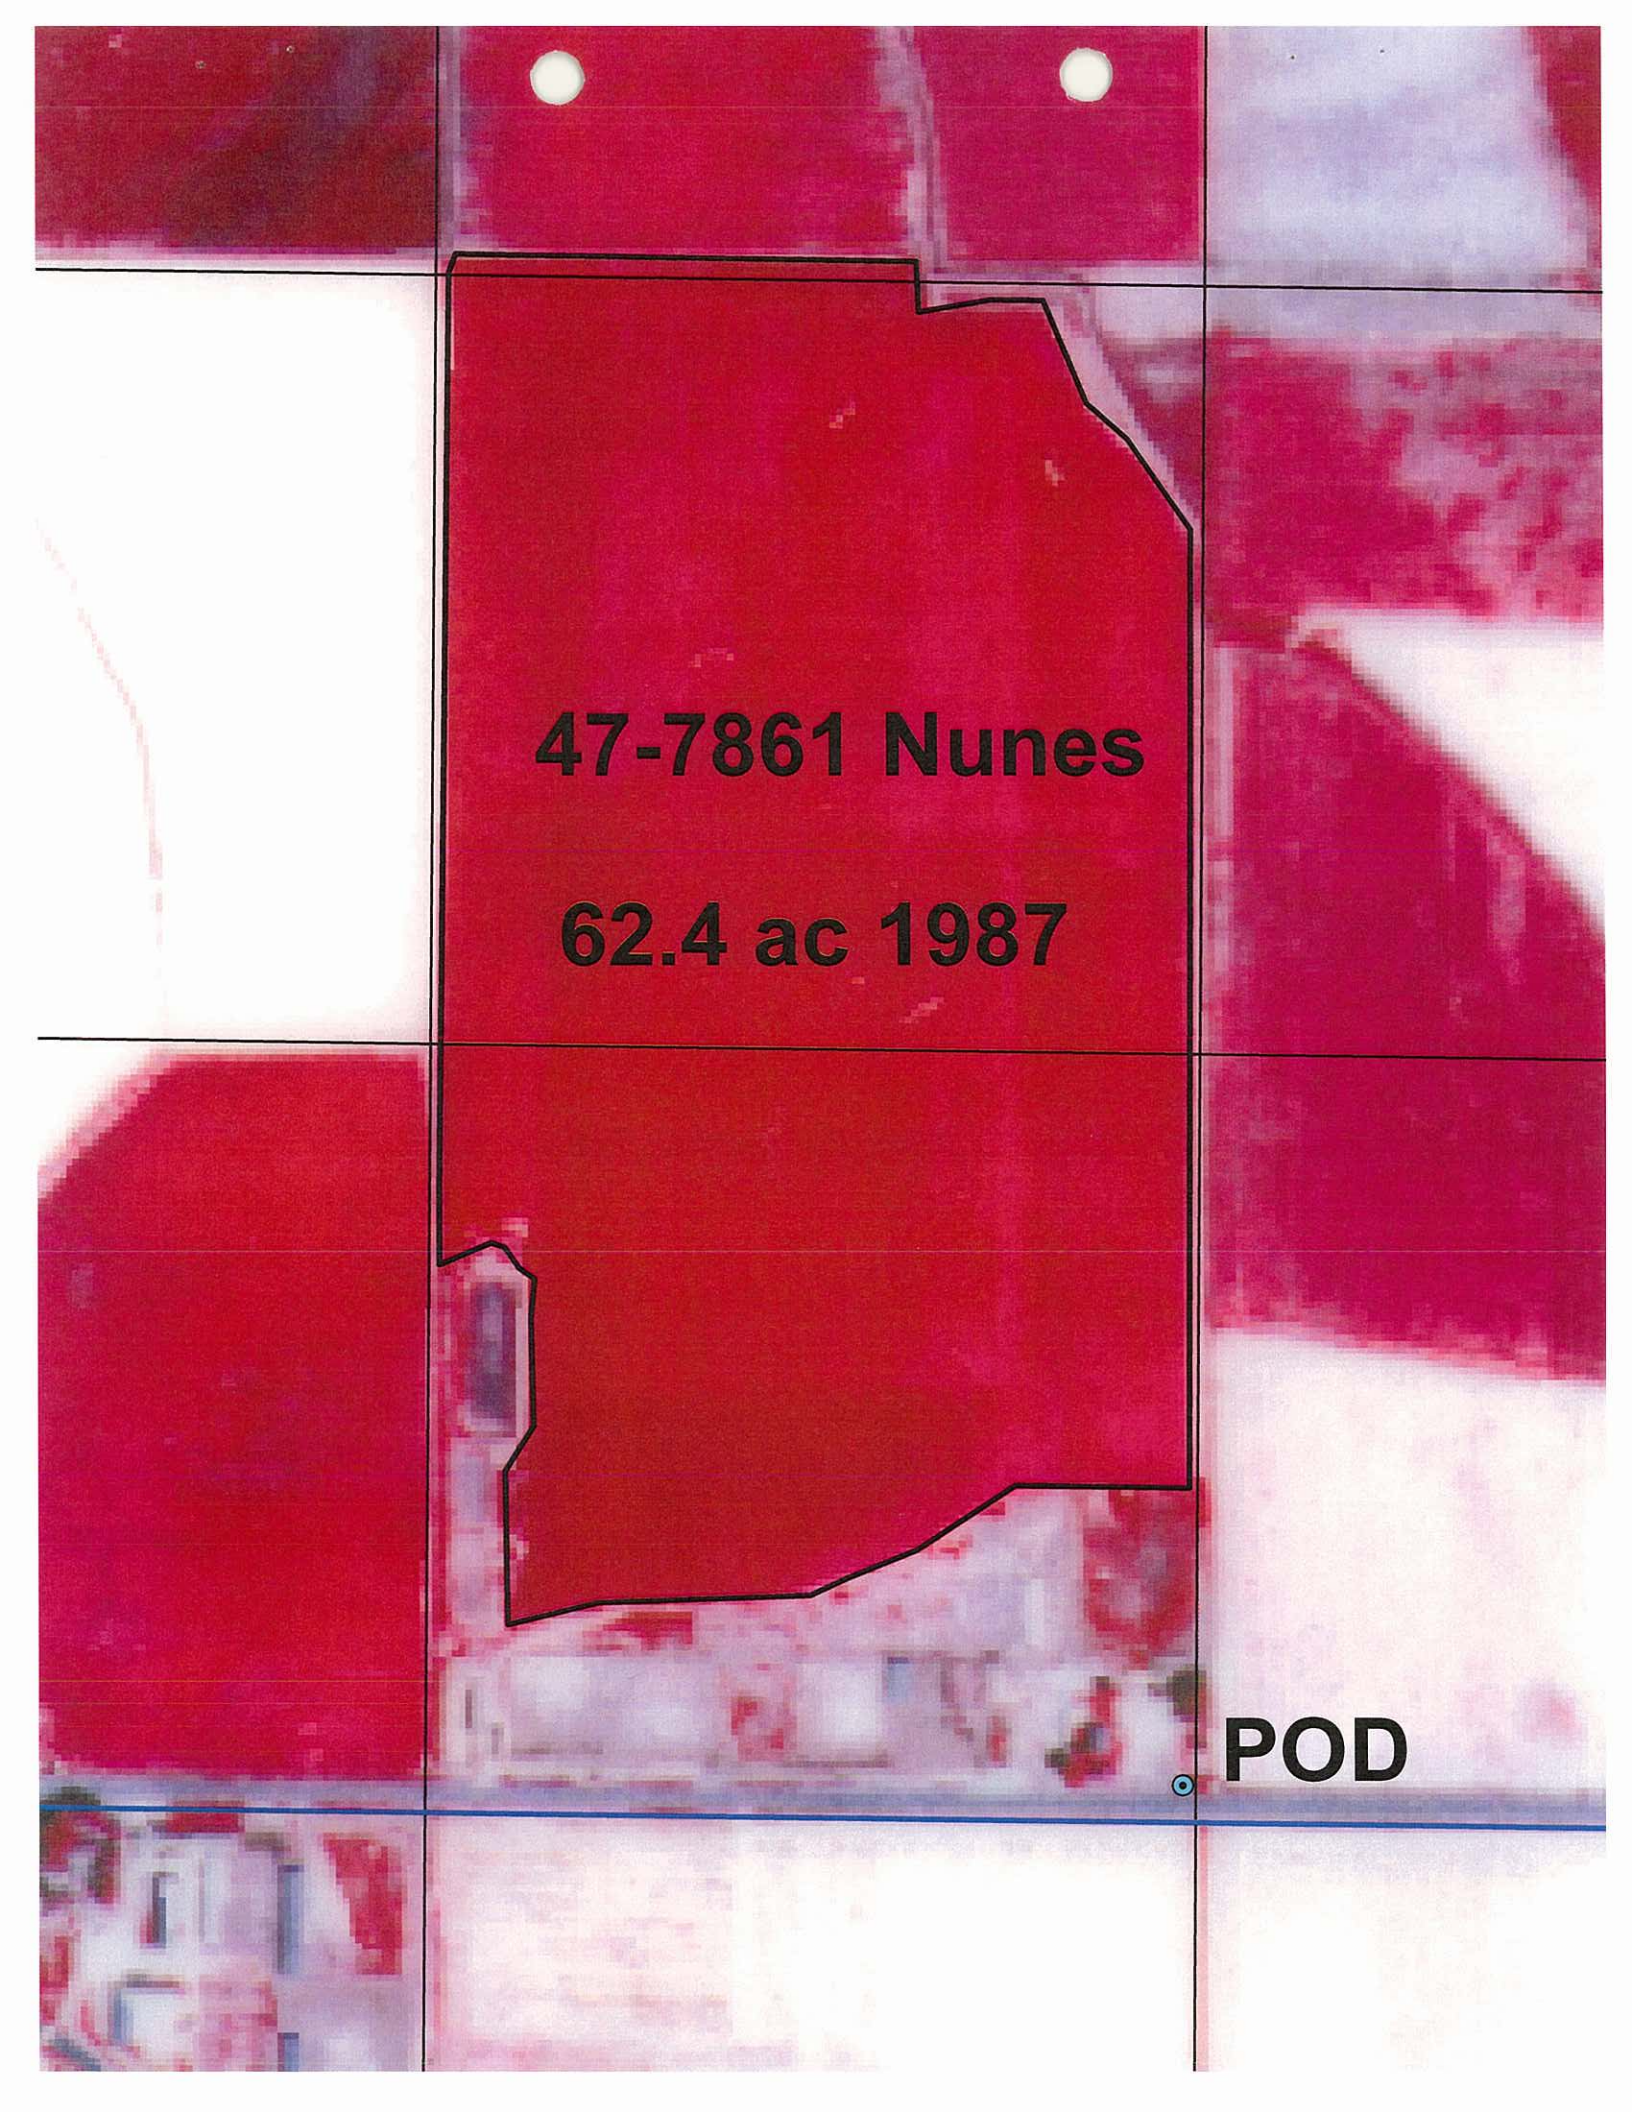
**47-7861 Nunes**

Per instructions from Shelley Keen, I am recommending the place of use based on the 1987 ArcMap photo. I looked at both the original pou under gravity irrigation, and the current pou under sprinklers, and found 1/2 acre of new land to be irrigated under the sprinklers. An irrigation canal originally cut of the NE corner of the property, but that was rerouted when the pivot was installed. The south boundary of the irrigated land changed somewhat when the sprinklers were installed, but the overall acreage in the south 40 has changed very little. The ArcMap rectification appears to be off in both directions, so I believe that the recommended pou is all within the W1/2SE Sec. 6 as originally permitted. The well is located at the highest point of the property, so water flows naturally downhill to the relift pump (same as the canal water).

**62.4 ac 1987**

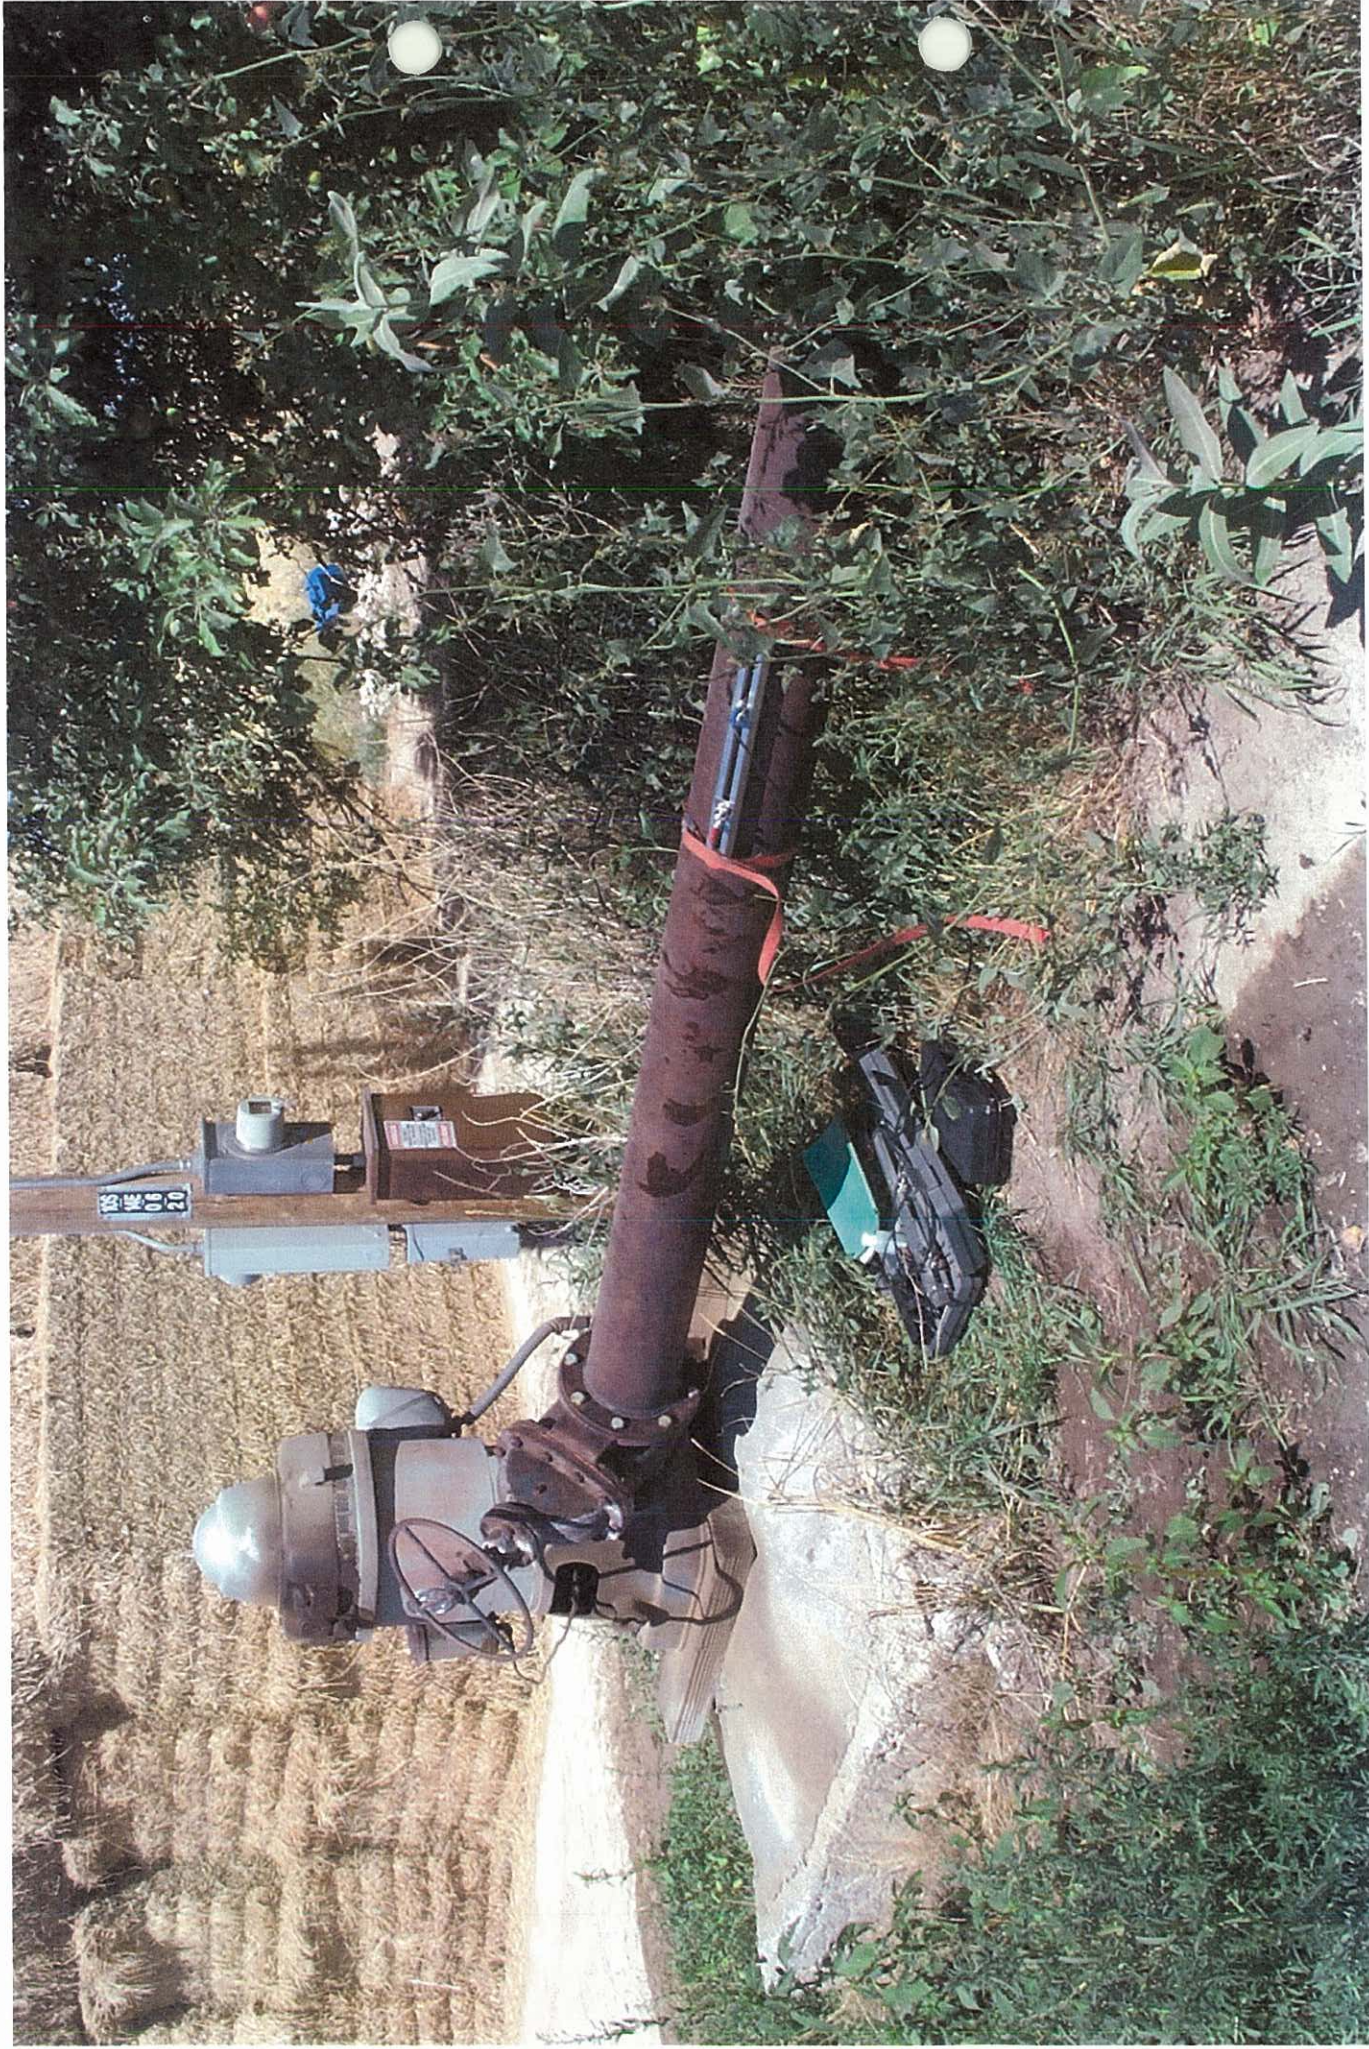
47-7861 Nunes Diversion Works Looking NE 8-17-09 By J Stanton

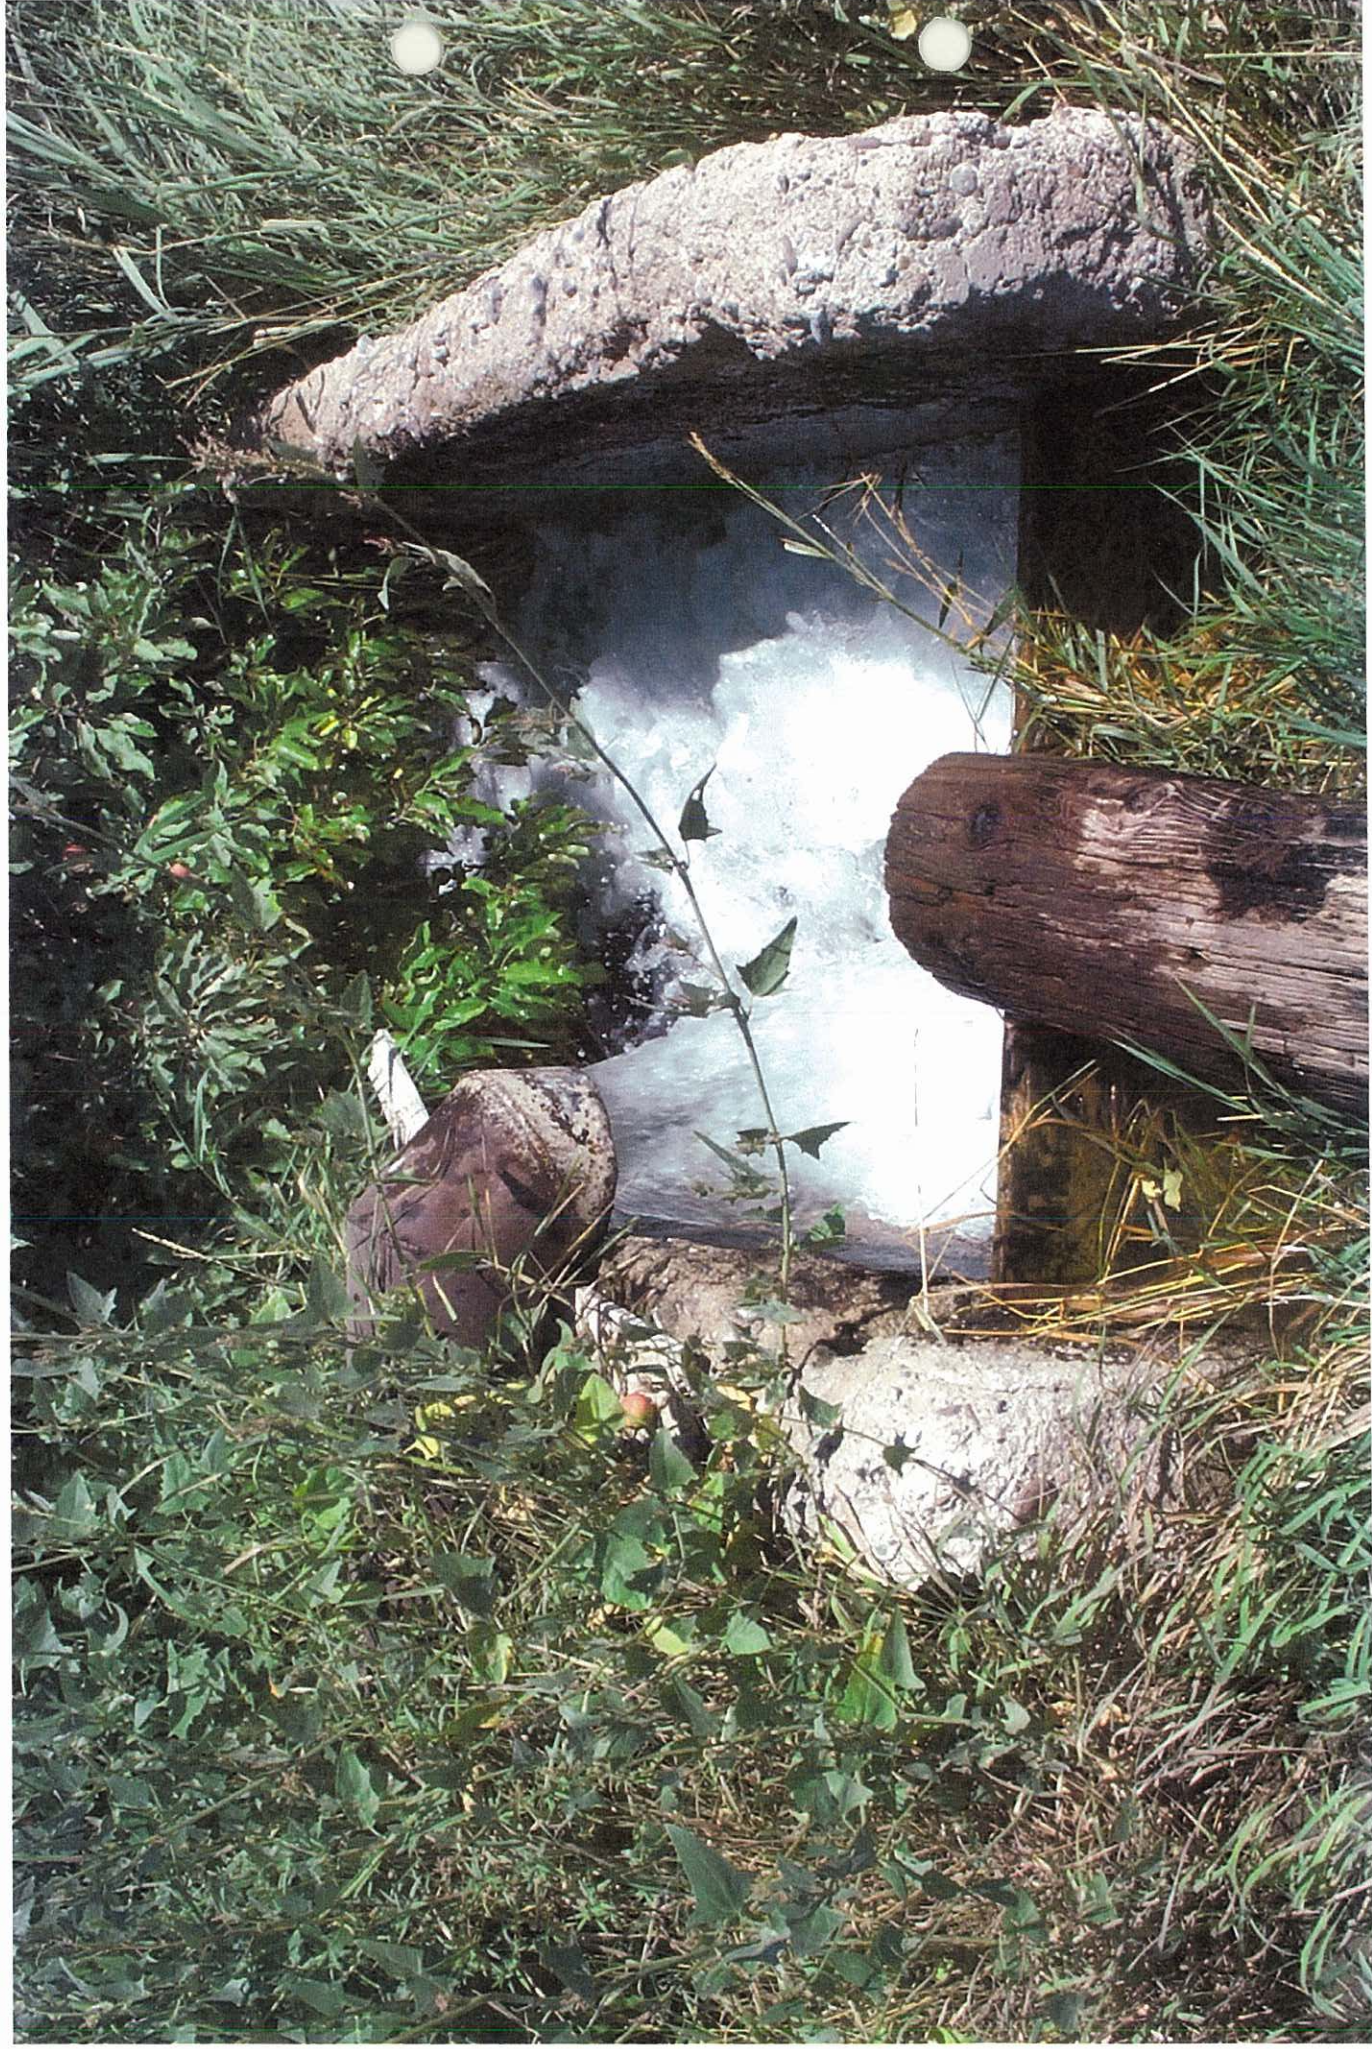
The current irrigation system consists of the well with the original 40 hp motor and pump, about 10 feet of pipe running into a ditch, and a relift pump in the ditch to pressurize one 1/4-mile pivot. The NW pivot corner is still irrigated with gated pipe under gravity flow. Canal water enters the ditch a few feet below the discharge point of the well. There had been some talk of problems with the current system, but I found no such problems; the well pumps over 2 cfs, which is apparently what it has always pumped. The ditch feed into a gravity system until 2001, when the current sprinkler system was installed. I was not able to get the details from the relift pump due to a metal cover being welded over it. A 3-minute measurement with a Fuji meter on the discharge pipe showed an average flow of 2.14 cfs.

47-7861 Nunes Well Discharge Into Ditch (Looking East) 8-17-09 By J Stanton

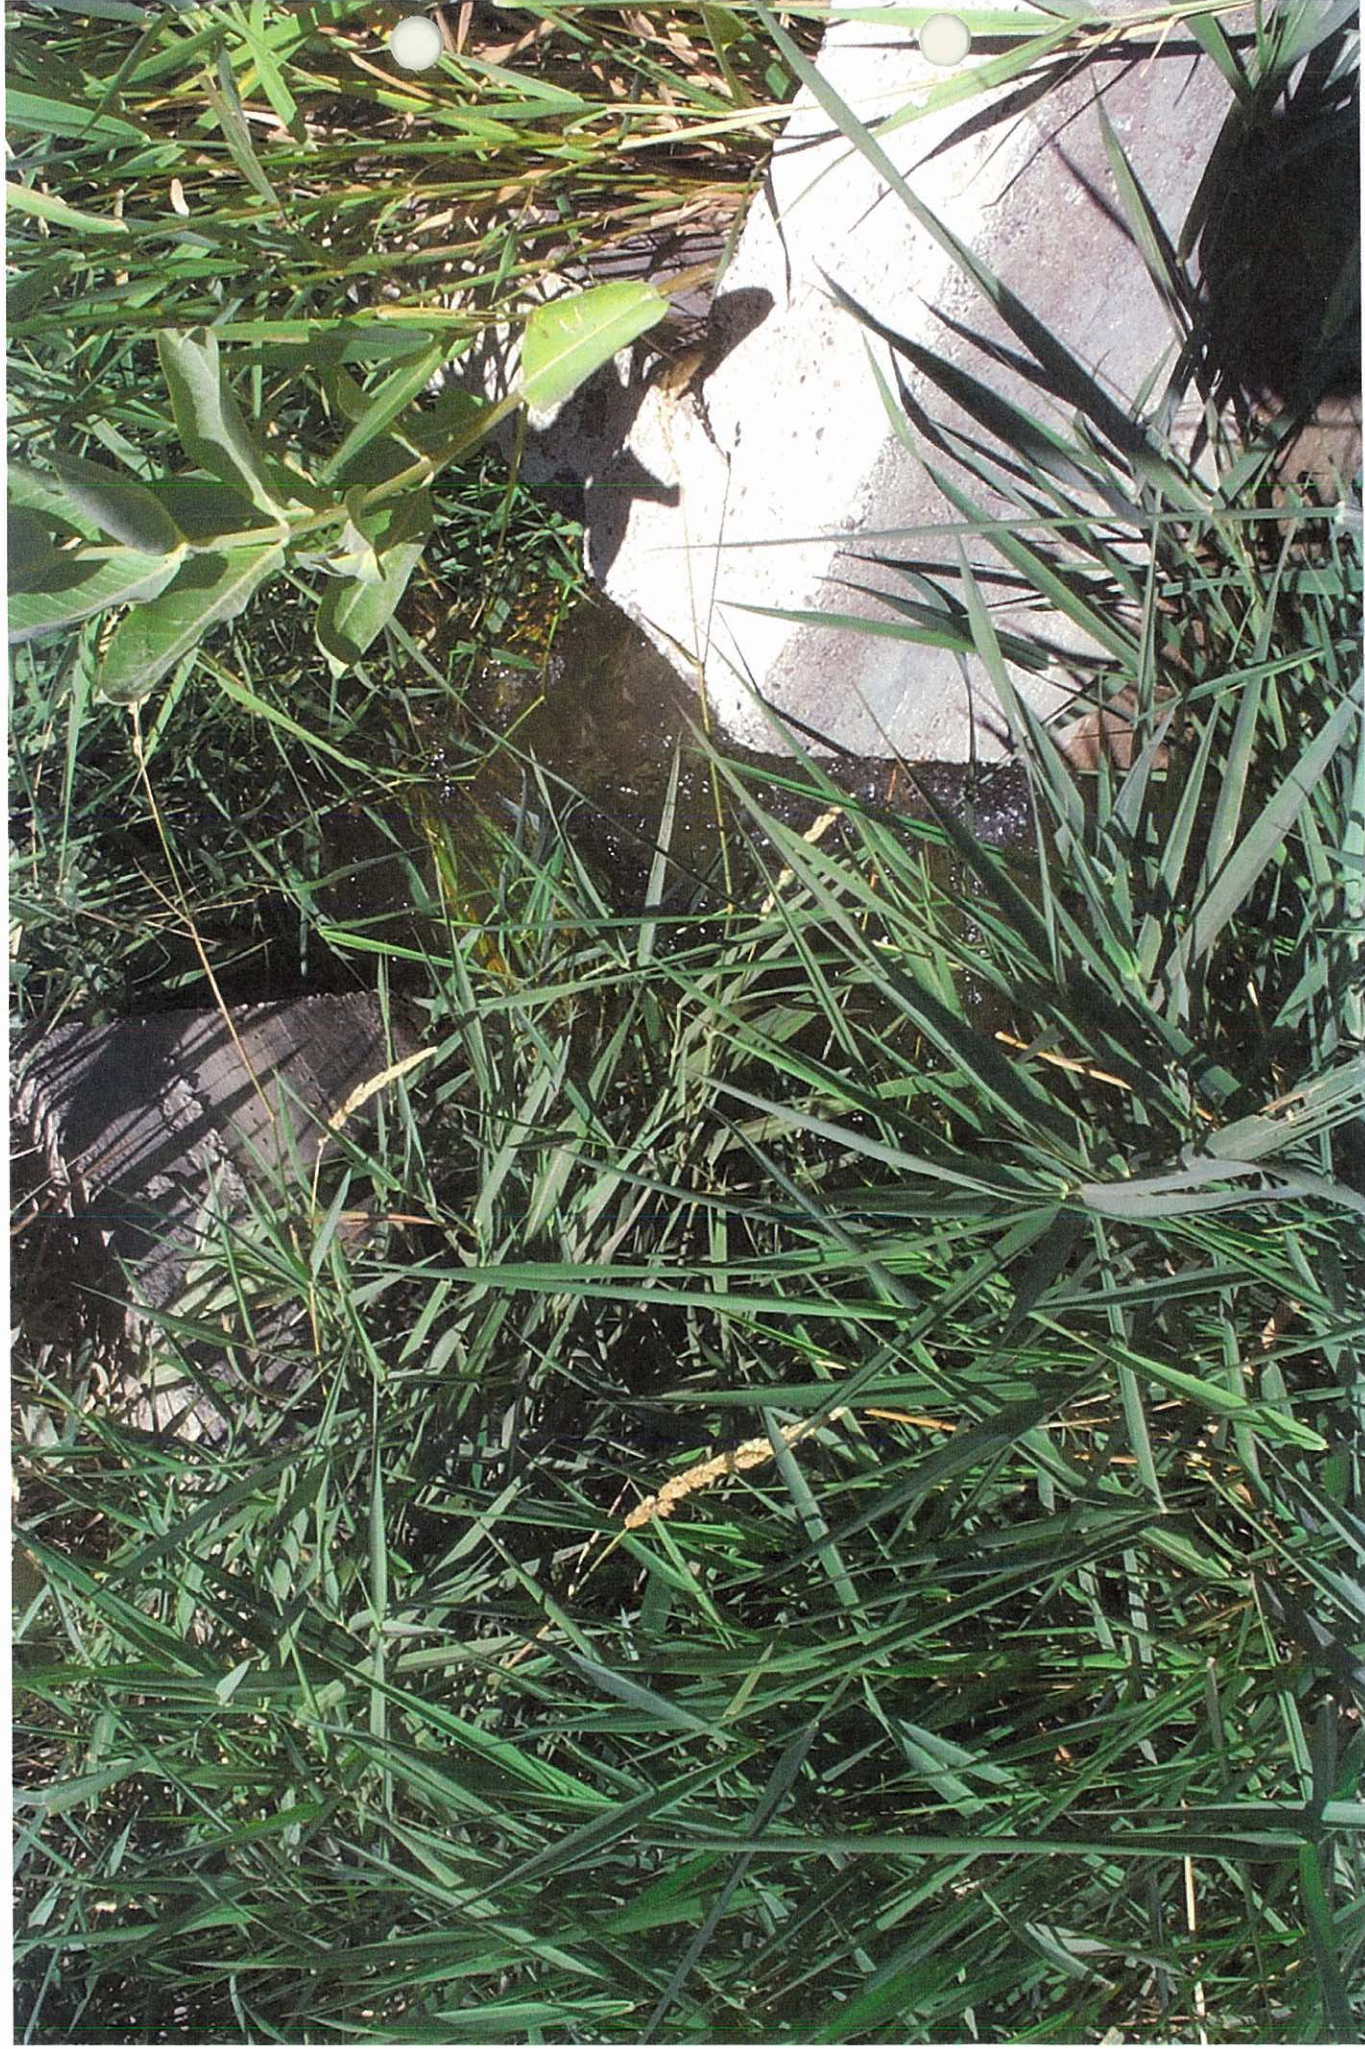
47-7861 Nanes Point Where Canal Water Enters Delivery Ditch (Looking NE) 8-17-09 J Stanton

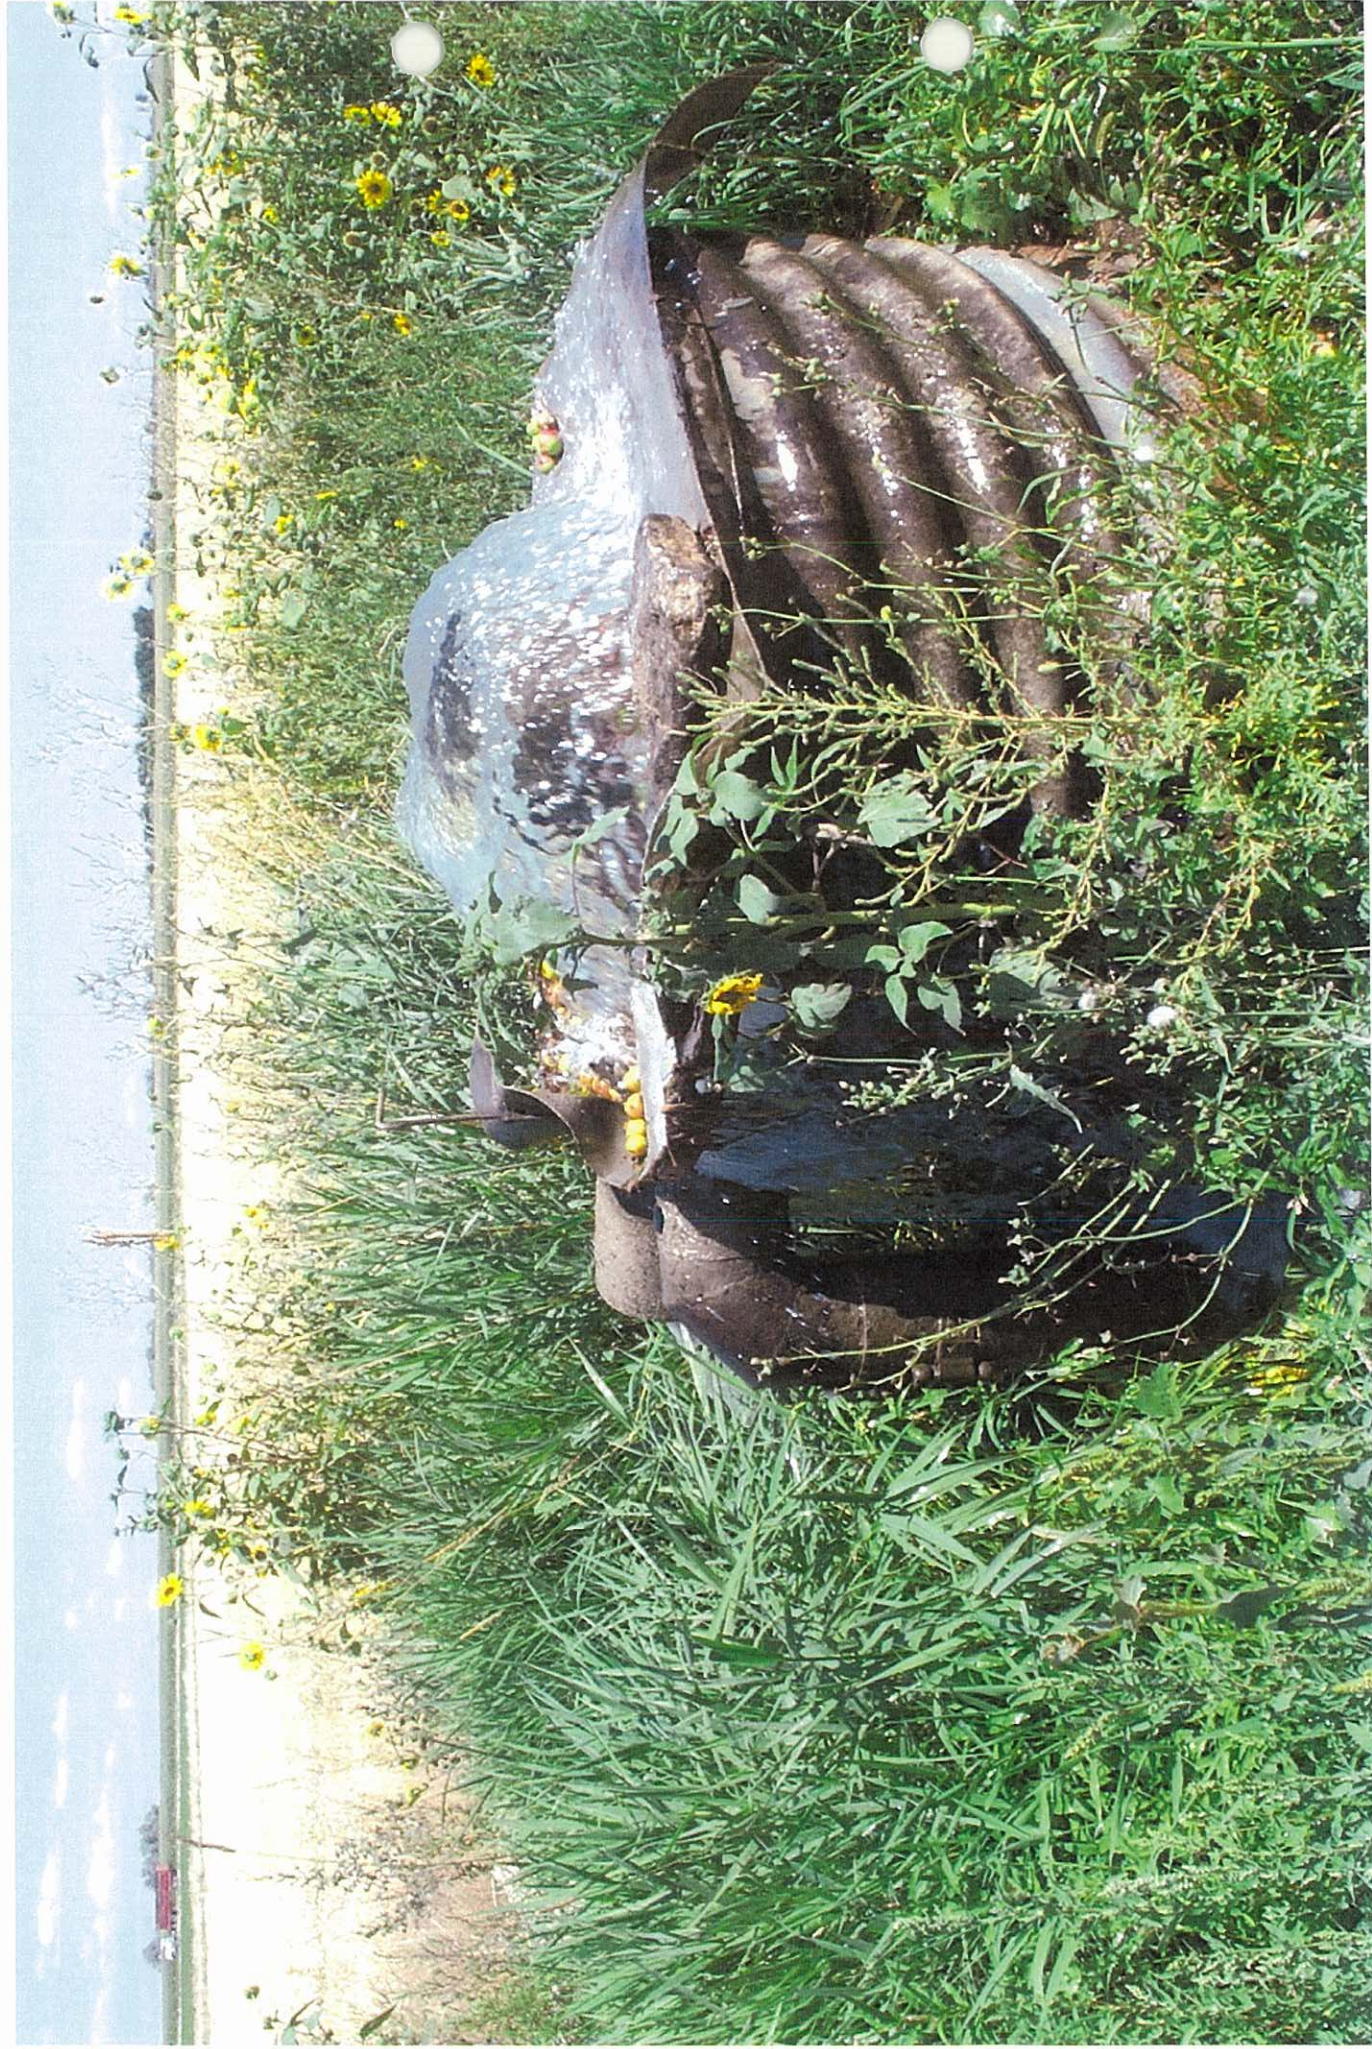
47-7861 Naves Water cleaner In Ditch Looking East 8-17-09 By J Stanton

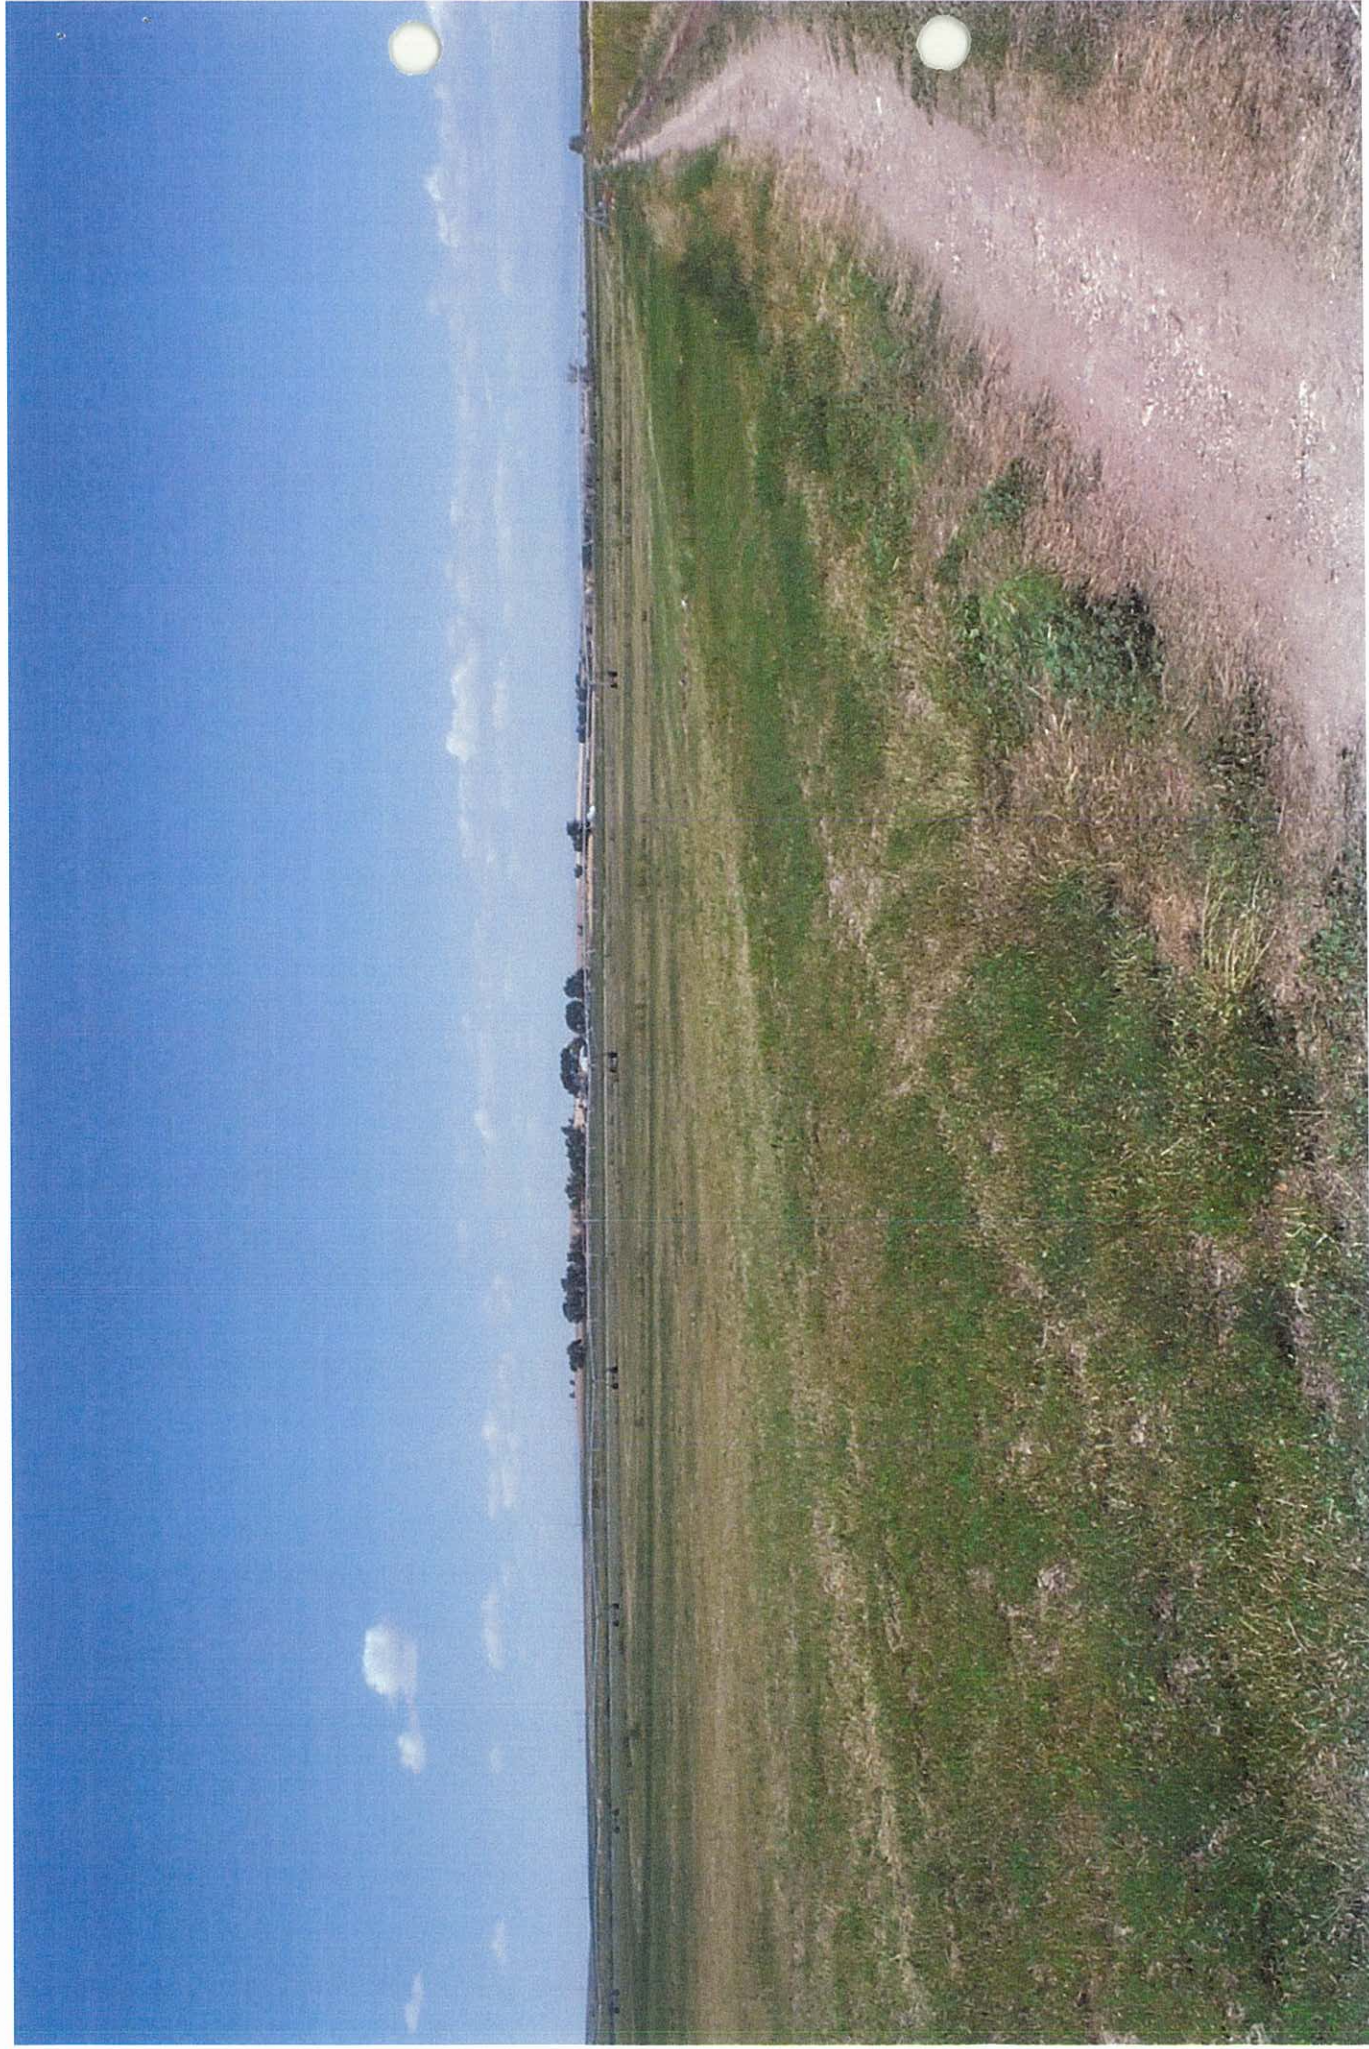
47-7861 Nunes POU Looking North 8-17-09 By J Stanton

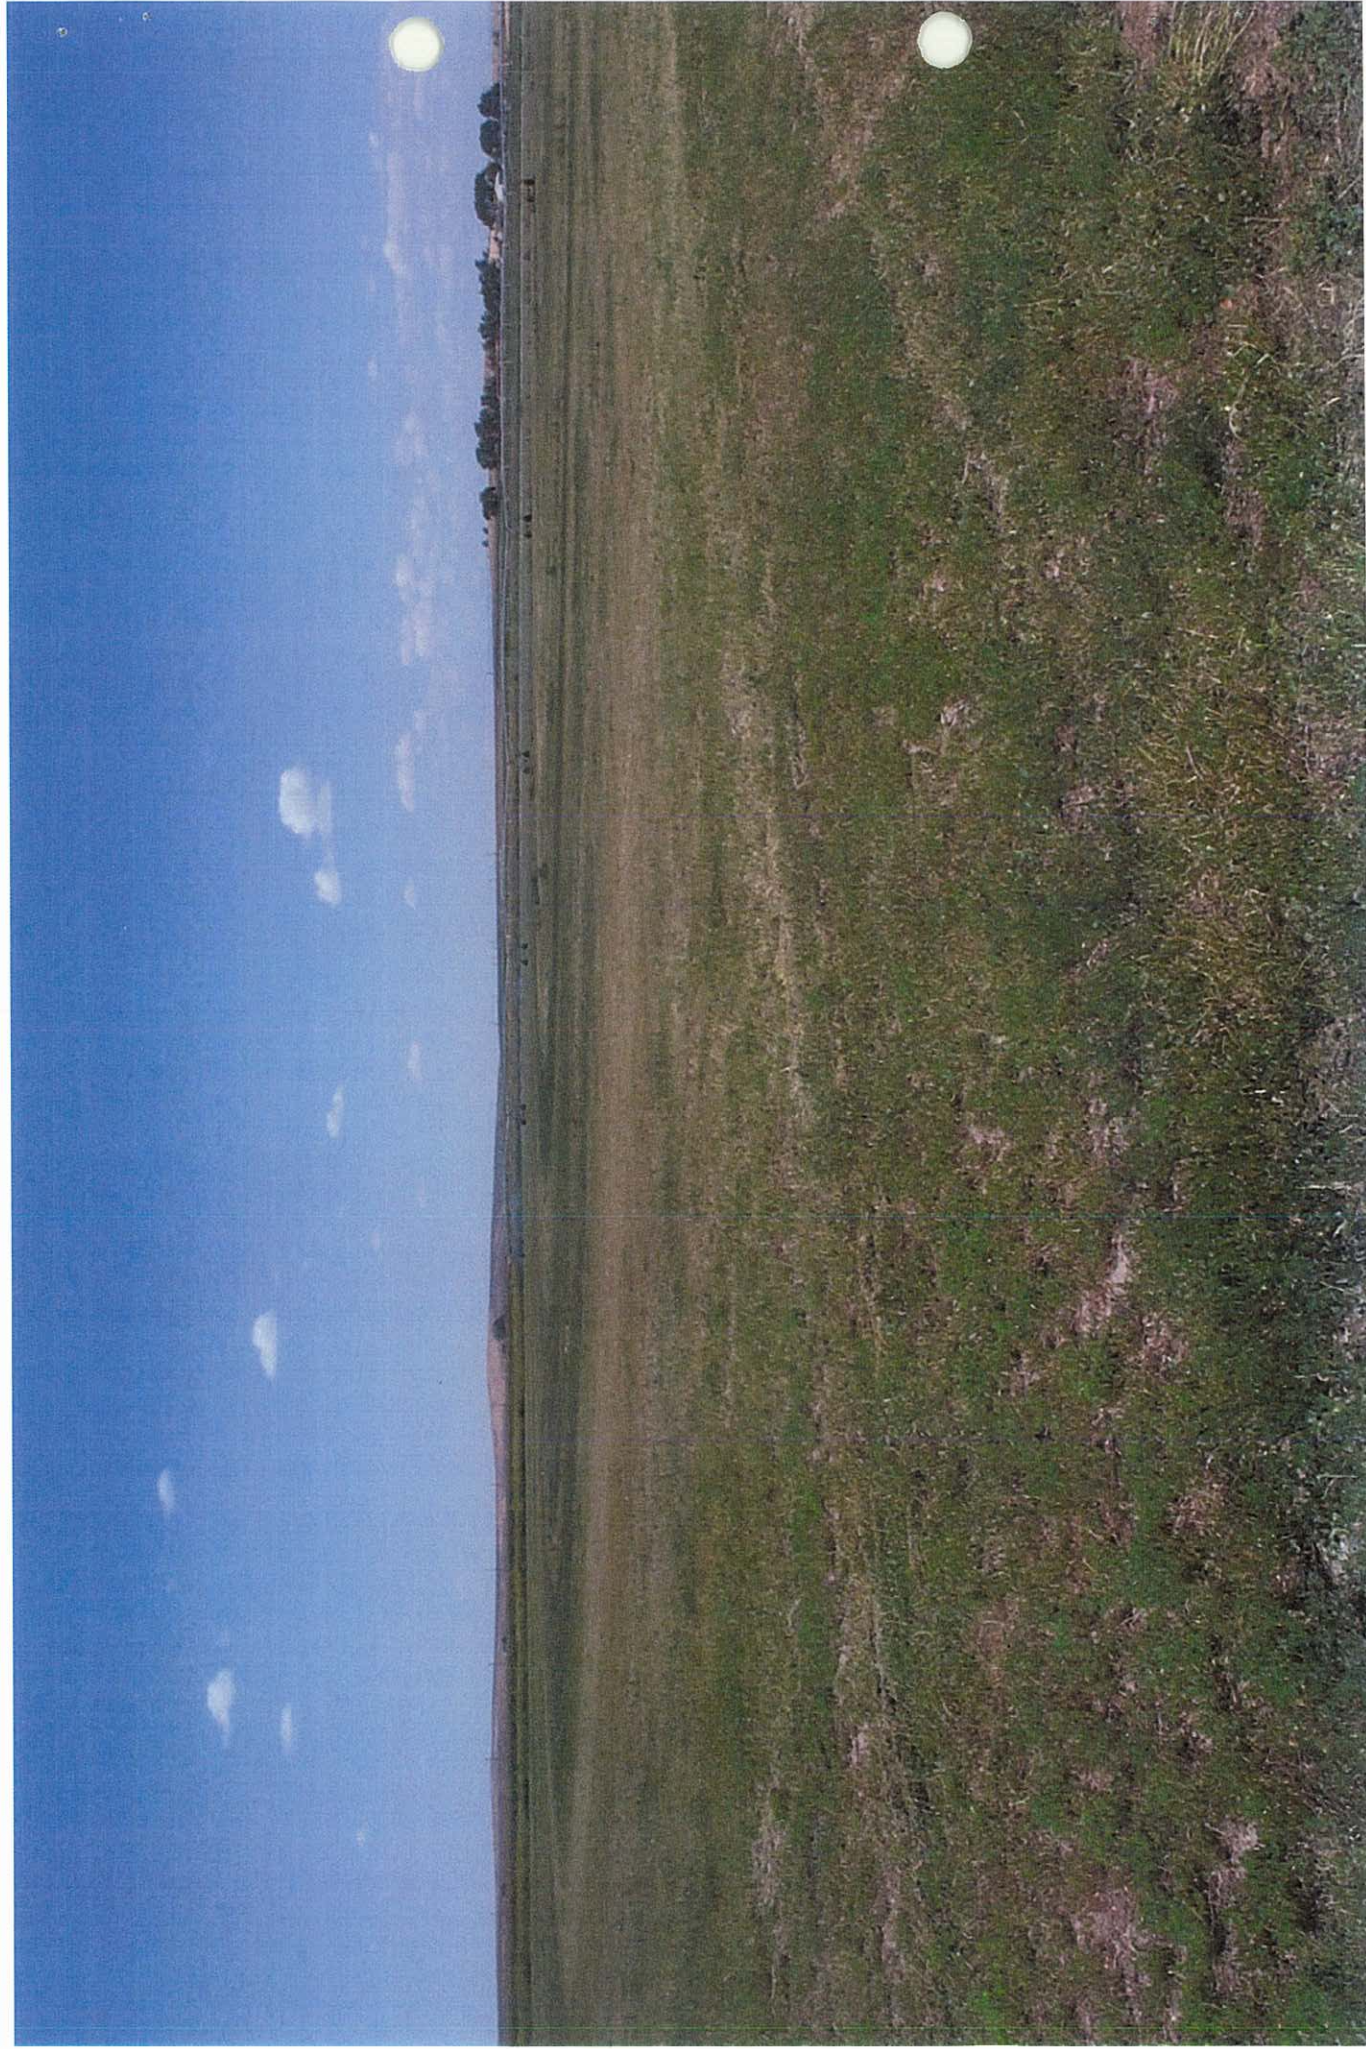
47-7861 Nunes POH Looking NW 8-17-08 By J Stanton
