STATE OF IDAHO  
DEPARTMENT OF WATER RESOURCES

PROOF OF BENEFICIAL USE

1. Permit No. 22-13178 Telephone No. 208-787-8008 Ext 14
2. Name of Permit Holder(s): Teton Springs LLC
3. Mailing Address: One Teton Springs Parkway  
City Victor State Id Zip 83455 Feb 2000 (No. 1)

The purpose of this report is to present a sanitary survey review of the Teton Springs water system conducted on September 27, 2006 and to identify any deficient areas that represent an imminent health risk and require immediate correction.

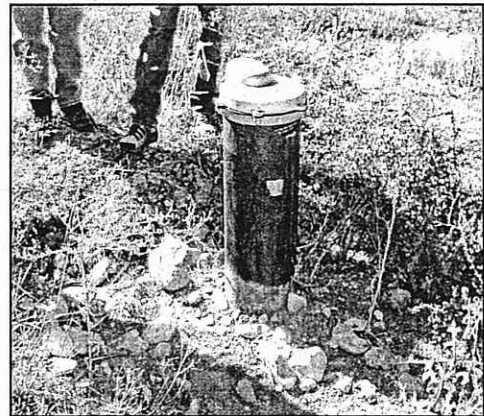
**Fig. 1 - well # 1**

According to the Driller's Well Log, **Well # 1** (E0011791) (**Fig. 1**) was drilled in May of 2001 to a depth of 792 feet and is cased with a non-perforated (10) inch steel casing. The casing adequately extends above the ground surface to protect the well from flooding and potential surface contaminates. The surrounding ground should be graded to slop away from the well to assure no surface water pooling around the well casing. This well is considered a geothermal well. The well was sealed with benitonite to a depth of 57 feet. The static water level of this source was measured at 2 feet. The well cap is properly vented and screened. The sanitary seal is in good condition, though because of the large gap between the cap and the seal it does not provided a water tight seal to prevent contaminated water or other material entering the well. The overall integrity of the well appears to be in reliable operation meeting state requirements.

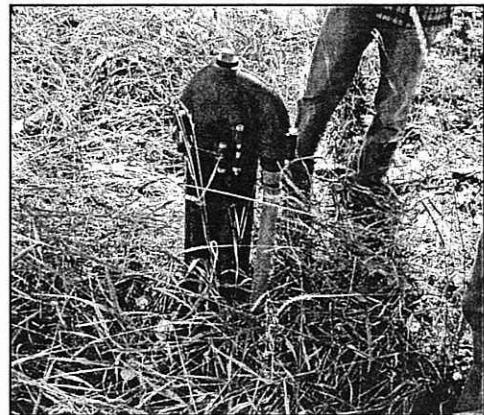
**Fig. 2 – well # 2**

**Well # 2** (E0021651) (**Fig. 2**) was drilled in November 2001 and completed in October 2003 to a depth of 1140 feet. Because this well produced only 45 GPM when originally drilled, in December of 2005 the well was re-cased and lined between 477 and 737 feet with a welded steel liner. A perforated casing was then was placed between 737 and 797 feet. This well provides the majority of the water at this time. The extended casing adequately protects this source from flooding or potential surface contaminates, though the surrounding surface gradient could also be improved upon. According to the Driller's Log Report, this source was sealed to a depth of 58 feet with cement grout. The static water level is at 12 feet. The sanitary seal is in satisfactory condition. The well cap is not vented and the electrical conduit was broken which may allow the introduction of contaminants. The overall integrity of the well appears to be in reliable operation meeting state requirements.

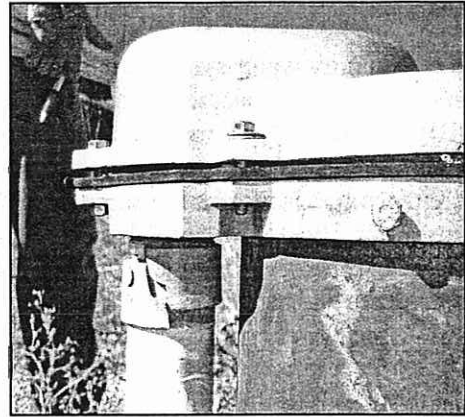
- 1) The well cap for Well # 1 was missing (2) bolts (Fig 3). The bolts must be installed in order to provide an adequate water tight seal to prevent contaminated water or other materials from entering the well in accordance with IDAPA 58.01.08.550.03.1.ii. which states: wells shall be cased and sealed in such a manner that surface water cannot enter the well
- 2) A well vent is required to be installed on well # 2 in accordance with IDAPA 58.01.08.550.03.k. which states: all wells...shall be vented with the open end of the vent screened and terminated downward at least (18) inches above the final ground surface.

Fig. 3 – Well # 1 sanitary seal and conduit

- 3) The conduits that hold the electrical cables that attaches to the well # 1 (Fig. 3 and 11) and # 2 pump has come apart and must be repaired to prevent introduction of potential contaminants in accordance with IDAPA 58.01.08.550.03.1.ii.

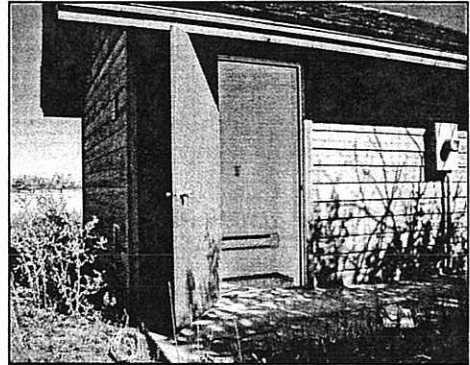
Fig. 4 – well house treatment room

All community water systems that apply disinfection for greater than sixty days are subject to the Disinfection By-Product Rule (DBP). The DBP Rule requires that chlorine residual concentrations are measured at the same time in the distribution system as total coliforms are sampled. Water systems must also monitor for Total trihalomethans (TTHM) and haloacetic acids (HAA5) annually during the month of the warmest water temperature and at the location representing the maximum distribution system residence time.

- 1) Before purchasing a disinfectant verify that the container bears the NSF label to assure it is approved for drinking water use. In accordance with IDAPA 58.01.08.552.02. All chemicals shall conform to applicable American Water Works Subsection 002.02.k and be listed as approved under ANSI/NSF standard 60 or 61 in subsections 002.02.m. and 002.02.l. Non-approved NSF products may contain contaminants that may affect the quality of the water and may not be safe to apply to drinking water. A list of National Sanitation Foundation approved chemicals for drinking water can be found at: <http://www.nsf.org/Certified/PwsChemicals/>

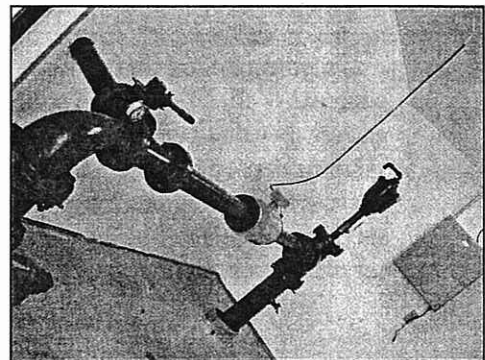
Fig. 5 – distribution line

**Distribution Flow:** Both discharge piping (**Fig. 5**) are similar for both sources unless otherwise noted. Water from the Well flows through 6-inch ductile iron piping past a source sample tap, an air release equipped with an isolation valve, flow meter, and an isolation valve that allows the well to be isolated from the distribution system. A double check valve is installed on the separate line off the main discharge line that serves an outside hose bib. The pump to waste piping is also off the main discharge line which discharges to the outside of the well house. Appurtenances are listed below in order of installation on the discharge line:

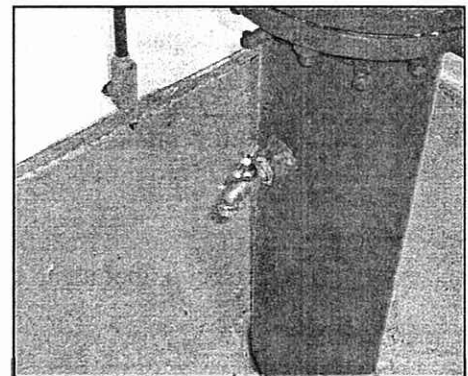
- 1) A threaded sample tap is an area where bacteria can grow as well as a potential cross connection (see Fig. 6). IDAPA 58.01.08.550.03.g. states: *A smoothed-nosed sample tap shall be installed on the discharge line from every well... Any threaded taps installed in the well house must be equipped with an appropriate backflow device.*
- 2) To properly protect against the entrance of potential contamination such as dust or small insects, the end of the exhaust piping needs to be covered with a 24-mesh corrosion resistant screen (see Fig. 7).
- 3) An open ended over flow pipe is an invitation for insects (bees), rodents, and dust that could pose a potential health concern (see Fig. 9). IDAPA 58.01.08.550.08.e. states: *Overflows shall be downward turned, discharge to daylight, and be provided with: (i) An expandable metal screen within the pipe plus a weighted flapper valve.*

- 1) Both wells have “threaded” sample taps (**Fig. 6**) that need to either be equipped with an appropriate (approved) backflow device or the threads must be removed to create a smoothed-nosed connection. In accordance with IDAPA 58.01.08 550.03.g. which states: a smoothed-nosed sample tap shall be installed on the discharge line from every well... Any threaded taps installed in the well house must be equipped with an appropriate backflow device.

**Fig. 6** – source sample tap

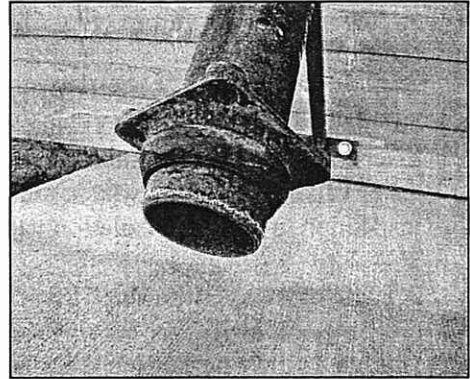
**Fig. 7 – pump to waste piping**

- 3) All discharge piping to daylight such as the pump to waste (**Fig. 7**) piping is required to be provided with an expandable metal screen within the pipe plus a weighted flapper valve to properly protect against the entrance of potential contamination in accordance with IDAPA 58.01.08.550.08.e.

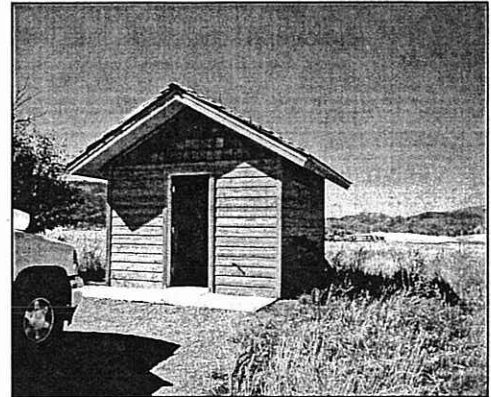
Fig. 8 – well house

Each wooden well house (**Fig. 8**) contains electrical controls, discharge piping and a treatment system. The overall structural condition of each facility is in excellent condition with satisfactory lighting and secured locked door. The walls are adequately insulated to prevent freezing of pipes. The sloped concrete floor shows no evidence of surface water or of past flooding. The floor drain drains to a sump pump 30 feet from the well house and is not connected to the sewer. There is no evidence of potential hazardous

materials stored within the well house or surrounding area. Overall, the well house is kept clean and is in good repair.

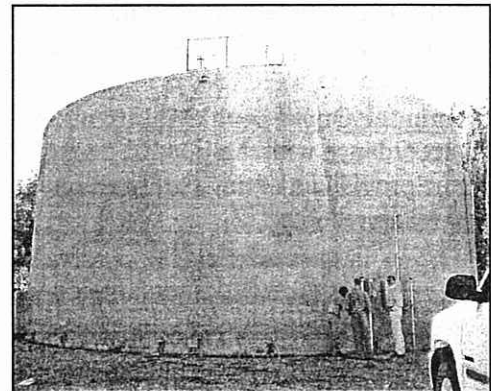
Fig. 9 – 500,000 storage tank

A **500,000 gallon** welded steel storage tank (**Fig. 9**) that is gravity fed into the system provides adequate storage capacity to support future growth. The tank is securely located from unauthorized access and can only be accessed through two locked gates that run through private property. The tank itself can be accessed by a secured metal fabricated ladder. No potential sources of contamination, such as pesticides, fertilizers or other potential hazardous materials are stored or applied in the area of the tank. The tank is adequately protected against any potential flooding. The external surface of this tank

A water heater has also been installed inside the tank to provide additional protection against potential freezing. The overall structural integrity of this steel tank is sound with no evidence of leaking.

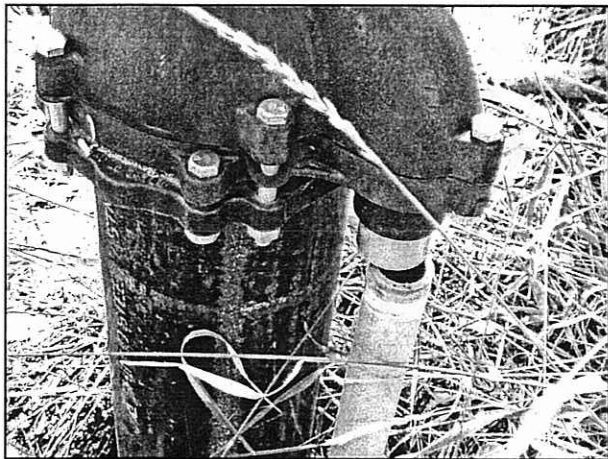
Fig. 11 – well # 2 broken conduit

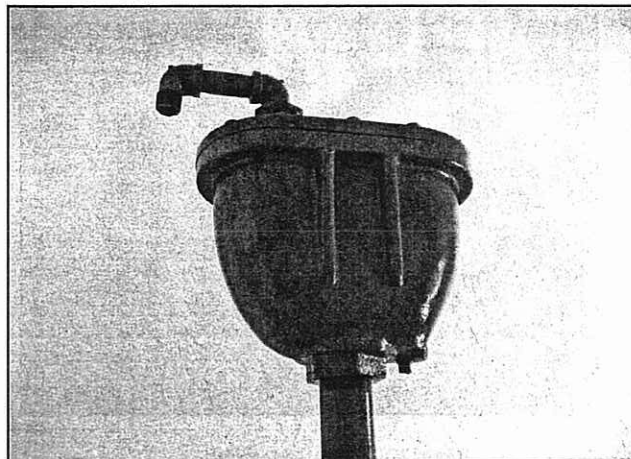
Fig. 12 – air relief valve

- A “threaded” **sample tap (Fig. 6)** representing each source is installed on the distribution line from the well.
- An **air relief valve (Fig. 12)** is installed to allow air to be released from the distribution lines. The discharge piping is terminated downward. At the time of the inspection the isolation valve for the air relief valve of Well # 1 was in the closed position. Corrective actions were taken during the inspection to open the isolation valve to its proper position.
