# SCANLAN ENGINEERING

July 28, 2001

Subject: Final Report on the Quarry View Park Well Project

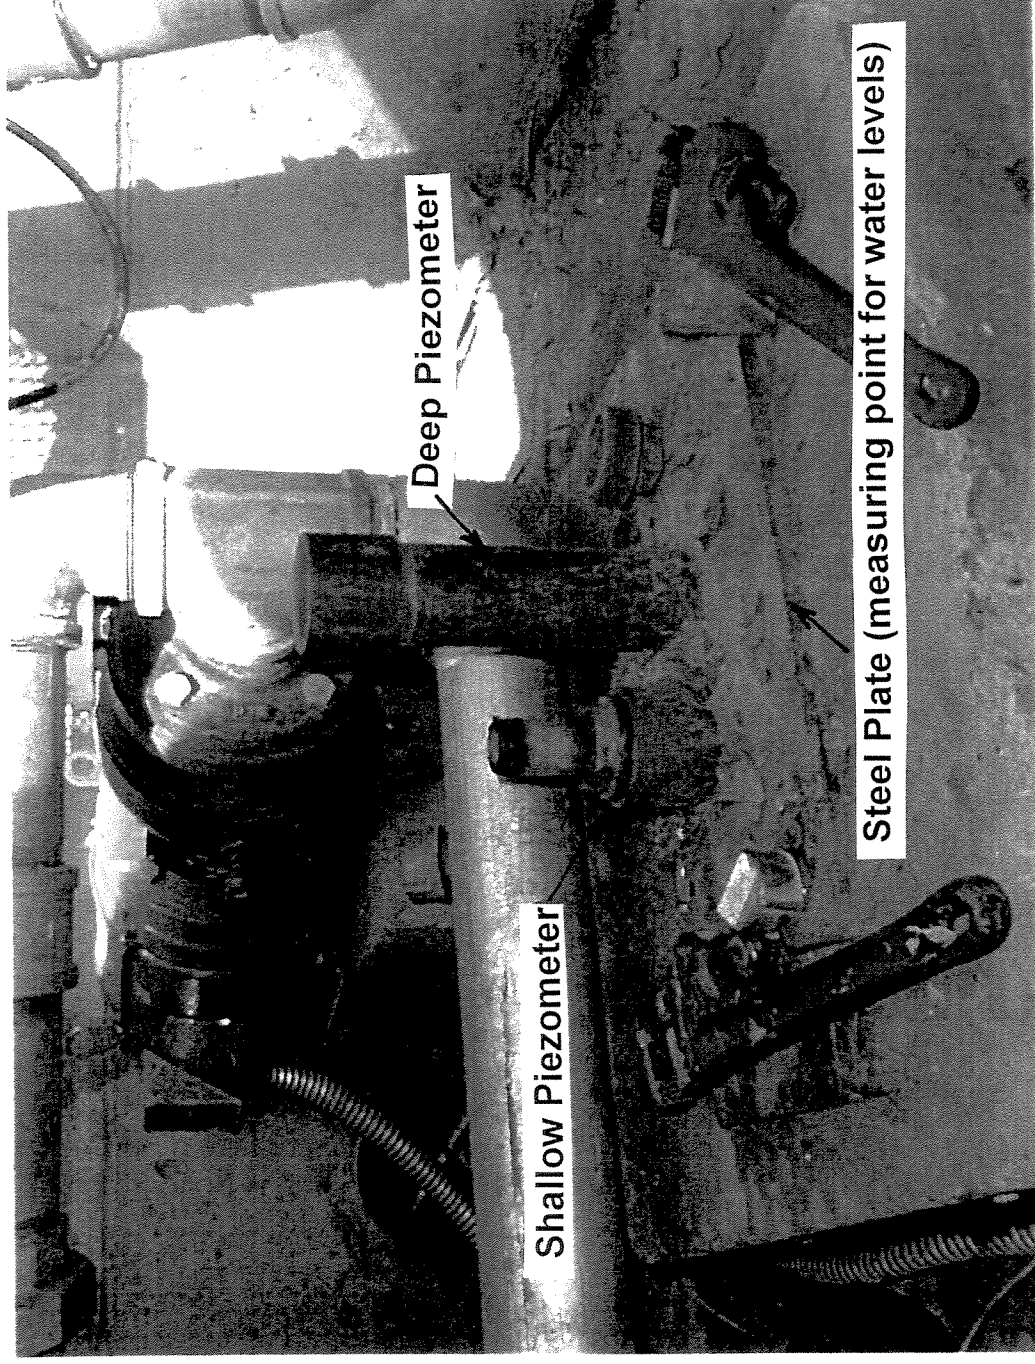
11. The top of the 8-inch casing was sealed with a steel plate with penetrations for the two piezometer pipes. The taller piezometer pipe (0.76 of stickup above the steel plate) is the lower (deep) piezometer. The steel plate is the measuring point for water level measurements.

Completed Well Head

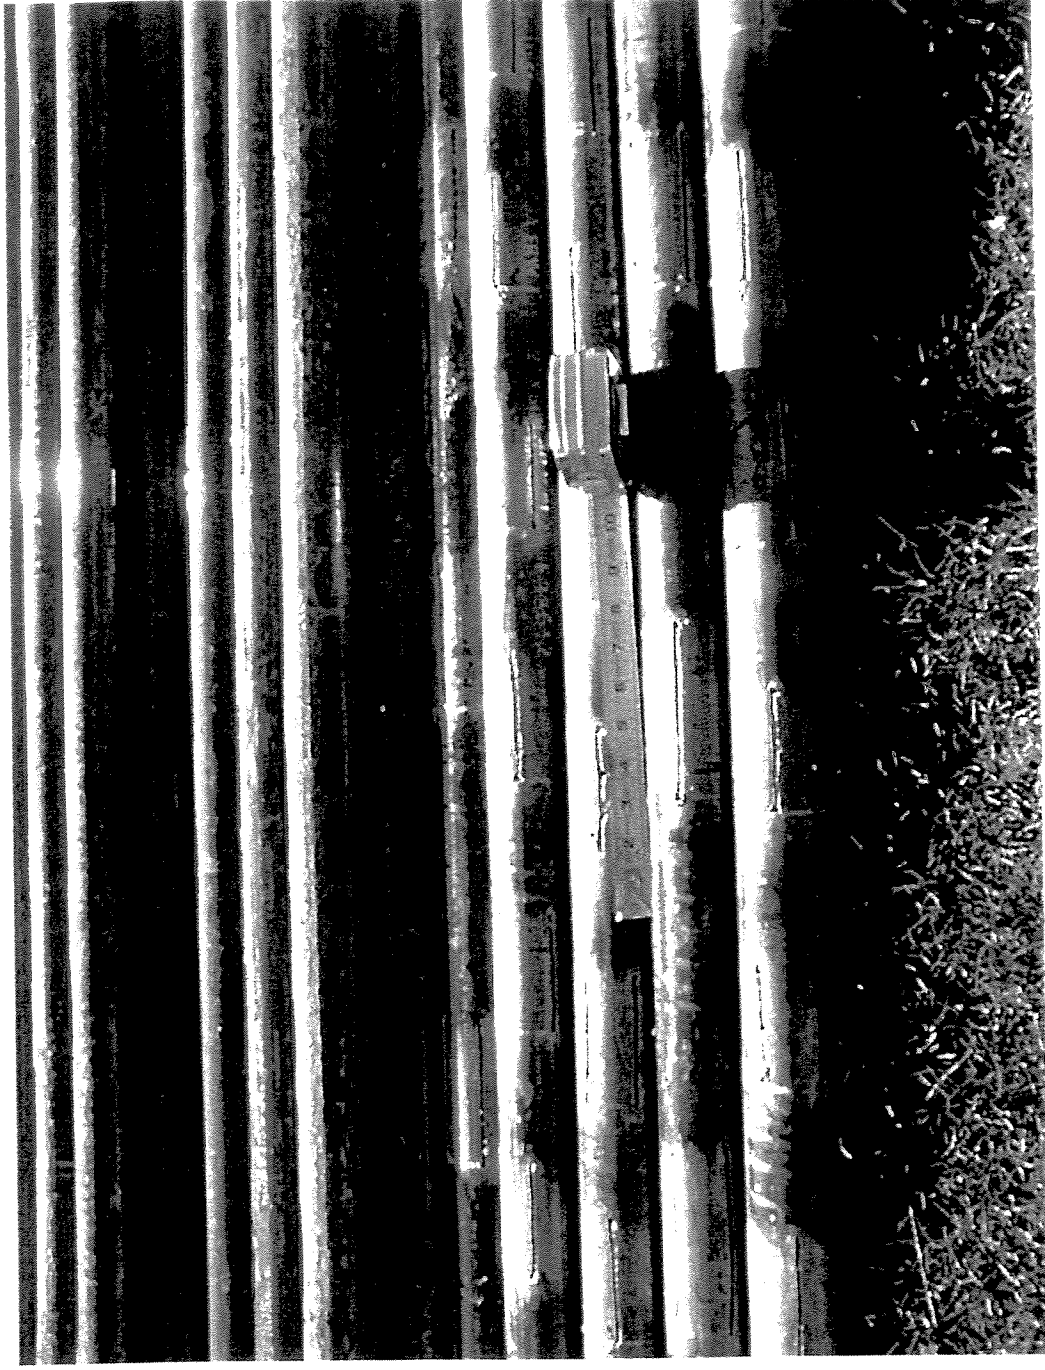
4. The lower piezometer was installed to 848 feet. The lower piezometer is constructed of 2-inch steel pipe that is torch-perforated from 813 to 848 feet.

2-inch Torch Perforated and Blank Pipe

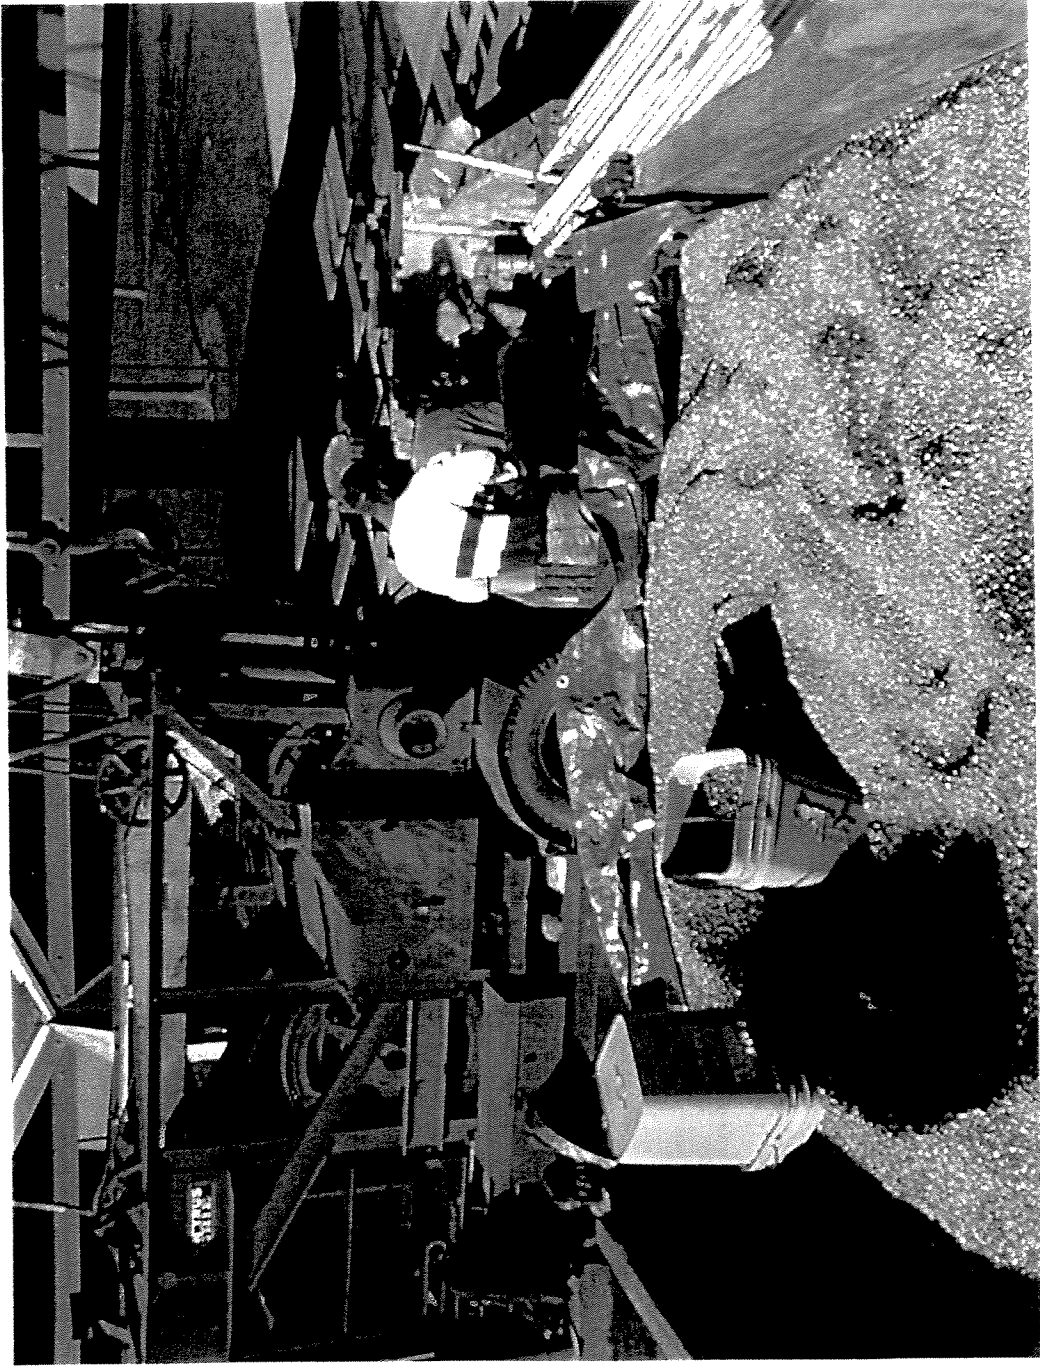
**Gravel Pack Material in Dump Truck**  
(pipe to the right is tremie pipe)
