STATE OF IDAHO  
DEPARTMENT OF WATER RESOURCES  
BENEFICIAL USE FIELD REPORT

Permit No: 95-8457

Exam Date: 8/6/2008

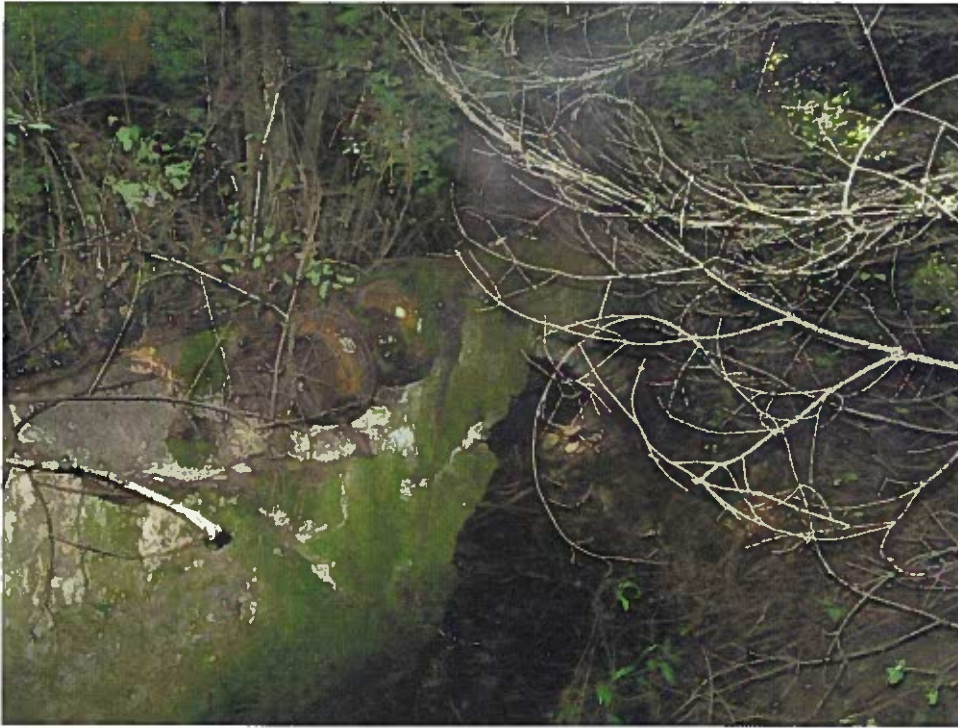
A concrete dam described and photographed in the 1984 Field Report for 95-7719 lies about 50 yards below the springs. A hole was found in 2008 in the concrete at the west end of the dam. The hole currently allows all water to pass through the dam. There was no standing water behind the dam during the 2008 exam. The hole is not visible in the Field Exam photographs for 95-7719, taken in 1984, or described in the 95-7719 Exam report. A white inlet pipe for a pipeline was found in 2008 in the reservoir area immediately upstream from the concrete dam. This inlet pipe is visible in the 95-7719 Exam

95-8457 Dam 1 Hole AUG 08

photographs. Mr. Finman is preparing to repair the hole.

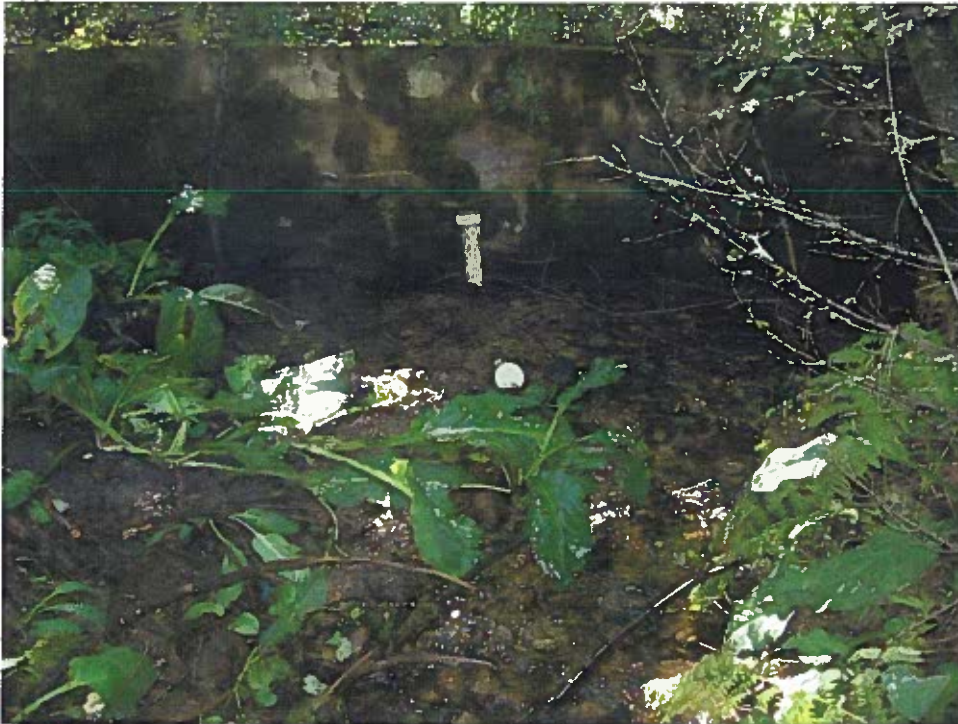
95-8457 Dam 1 Pipeline Inlet

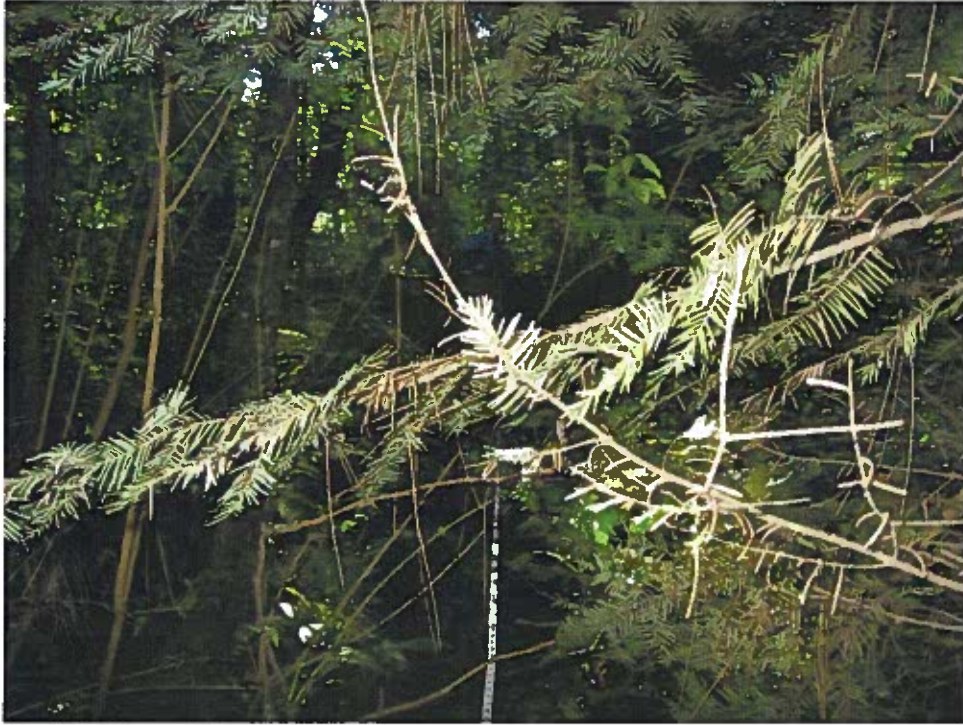
95-8457 Dam 1 Reservoir Rear

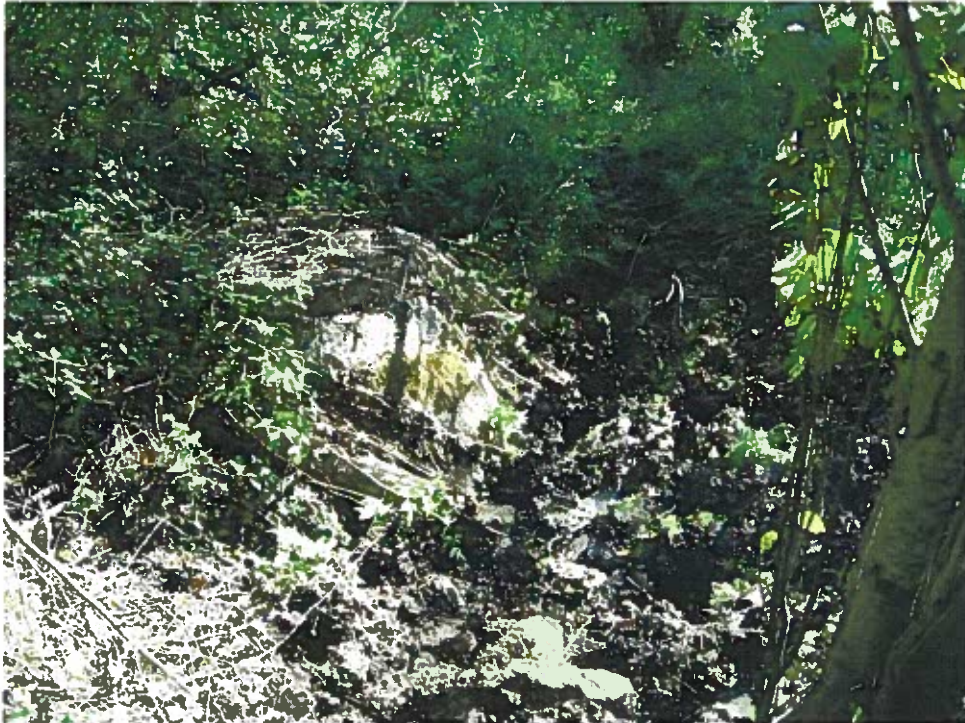
95-8457 Cistern Above Pipeline To Ponds

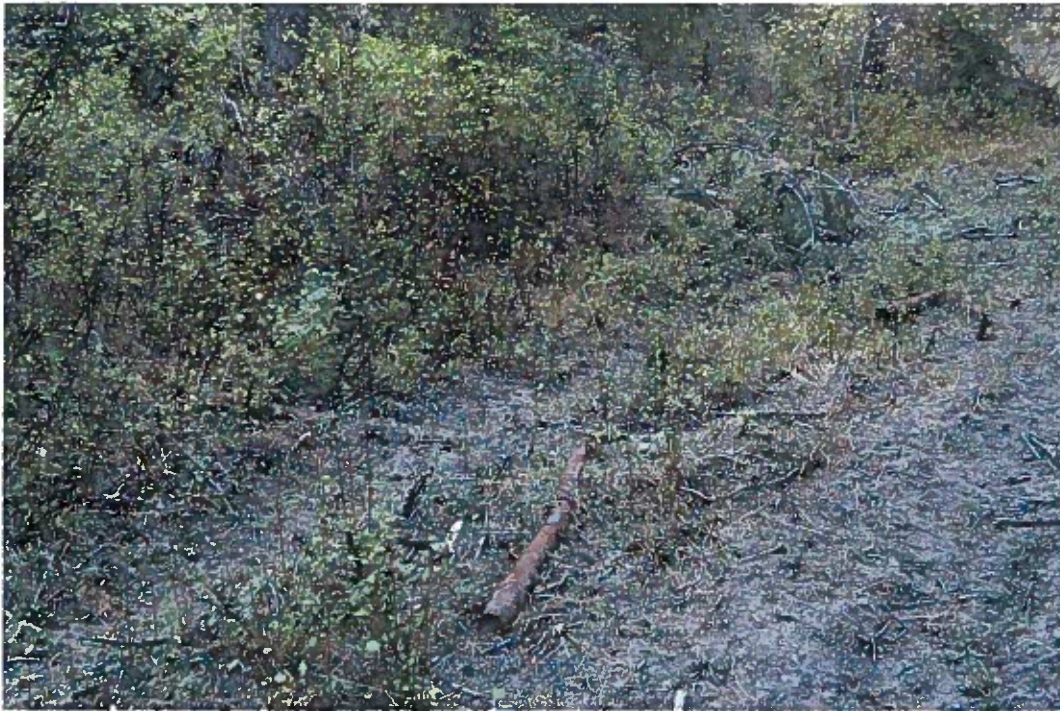
95-8457 Vehicle Damage Above Ponds

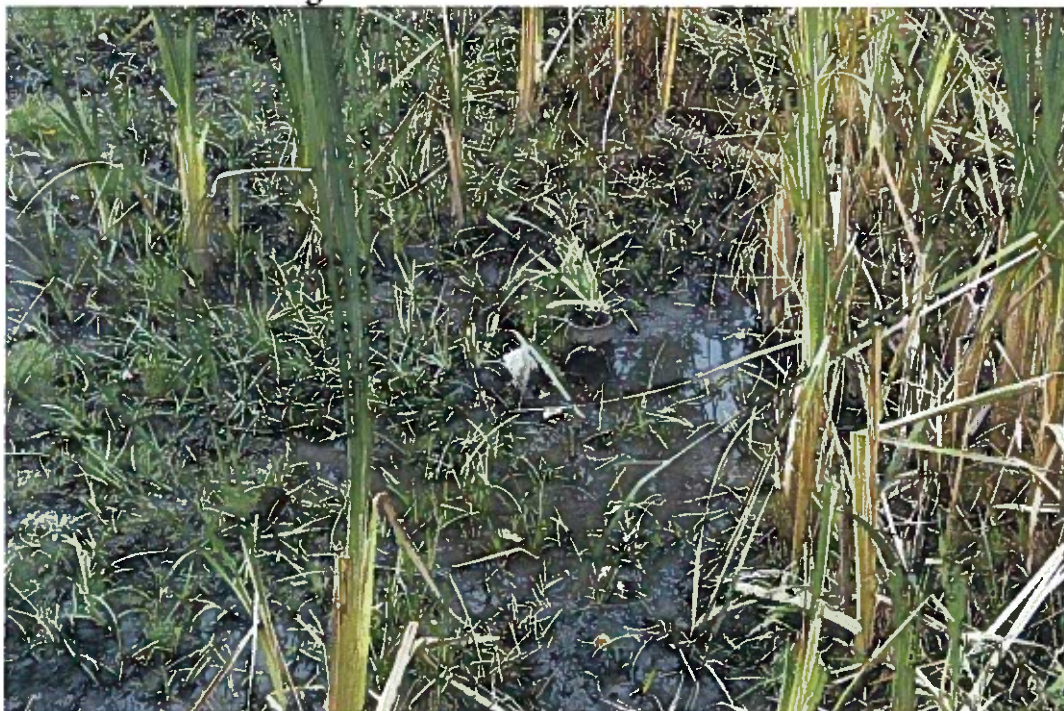
95-8457 Pond Pipes

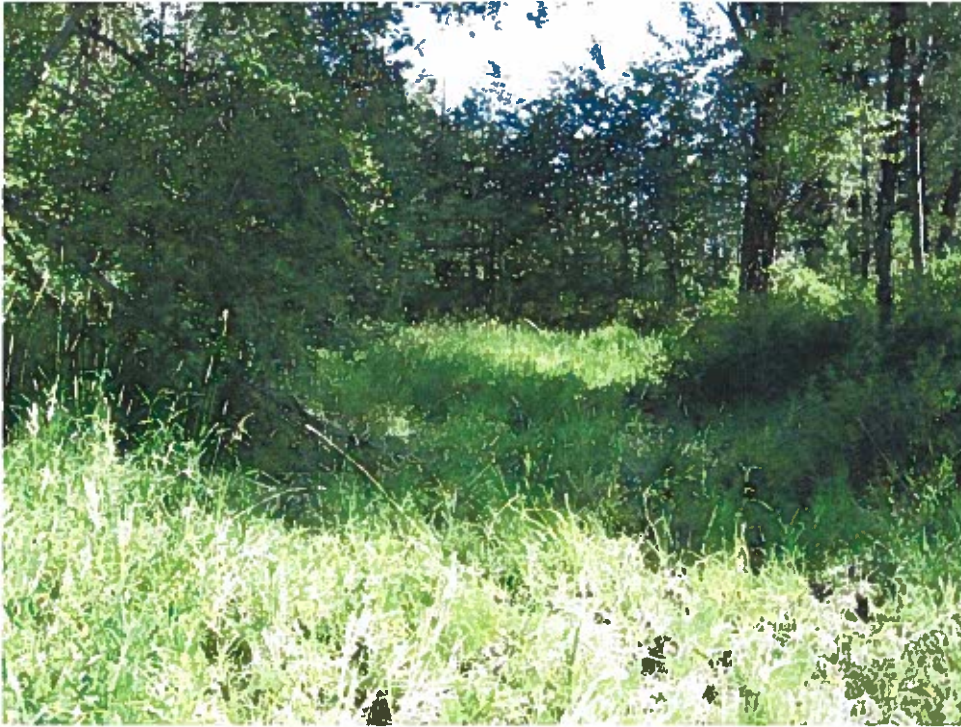
95-8457 Rear of Pond 2

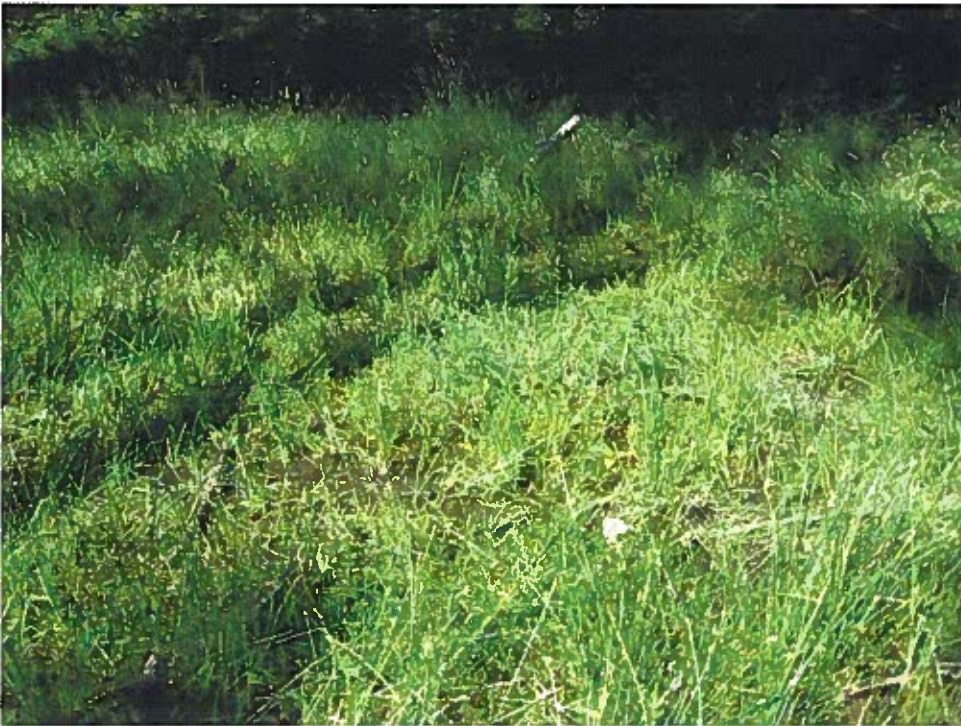
95-8457 Water in Pond 2

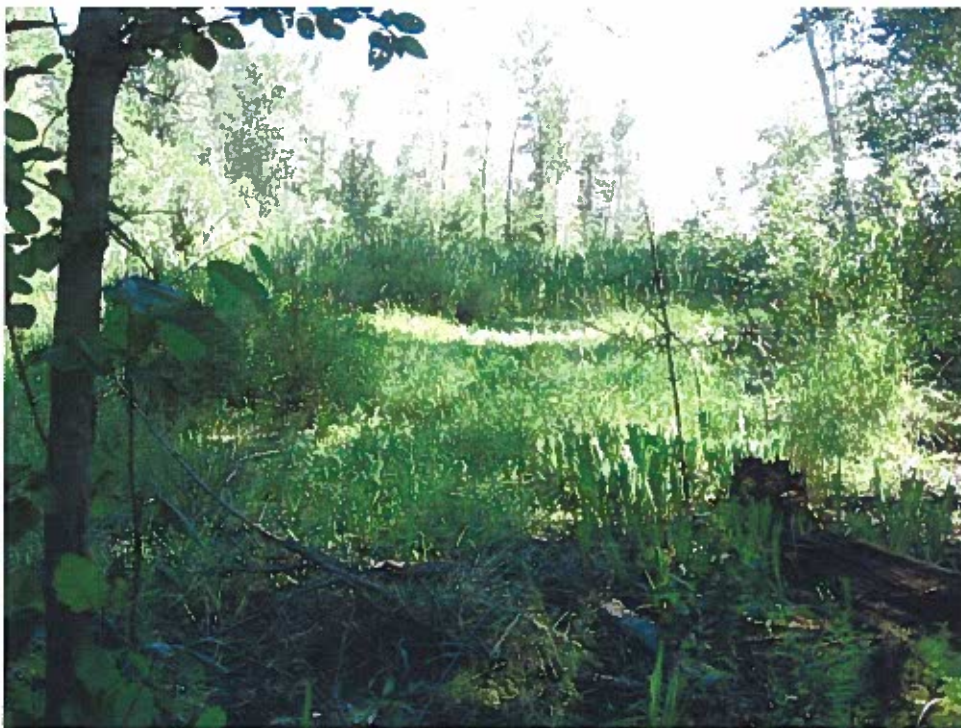
95-8457 Rear of Pond 3

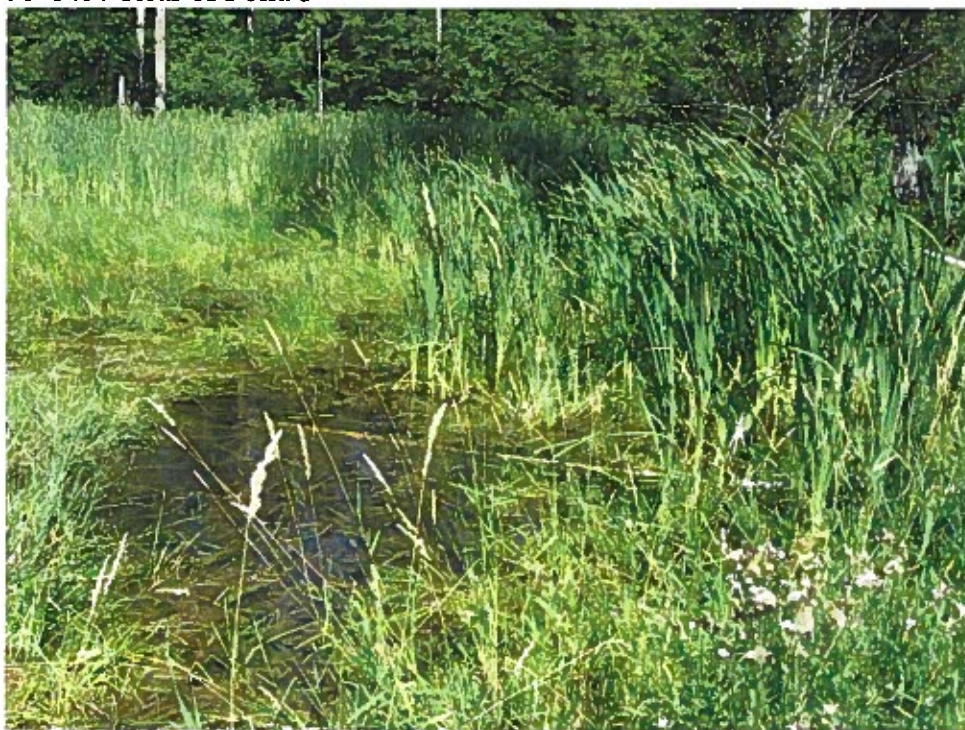
95-8457 Pond 3 Water AUG 08

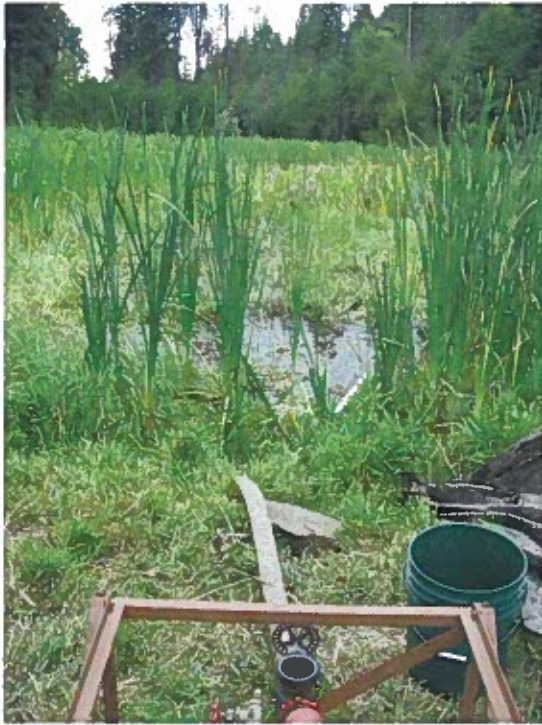
95-8457 Pump Pond 3

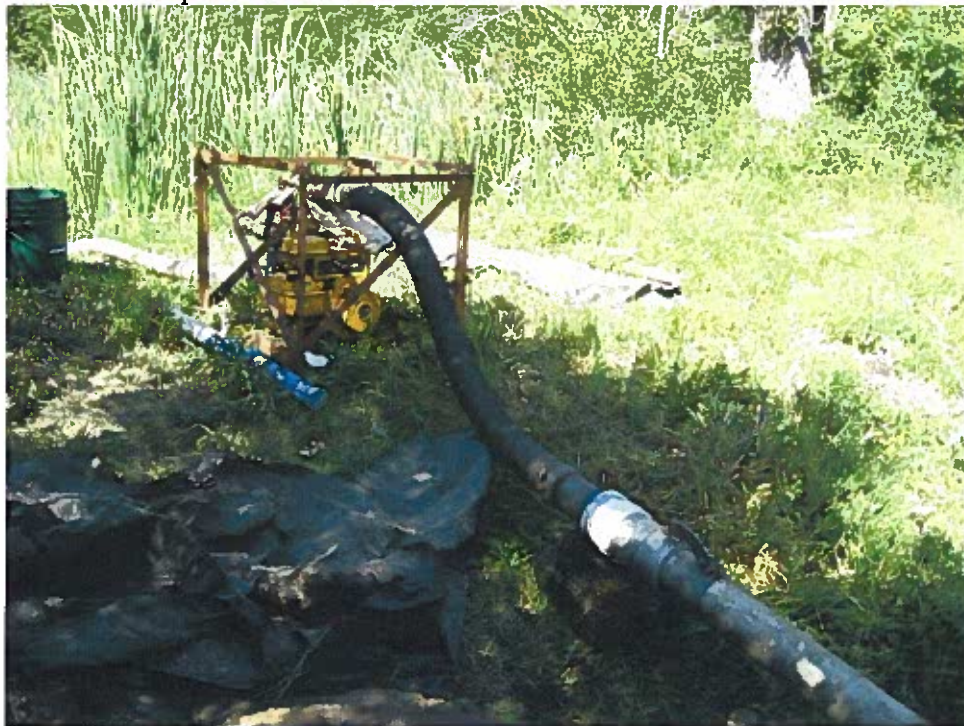
95-8457 AUG 08 Pump Pond 3

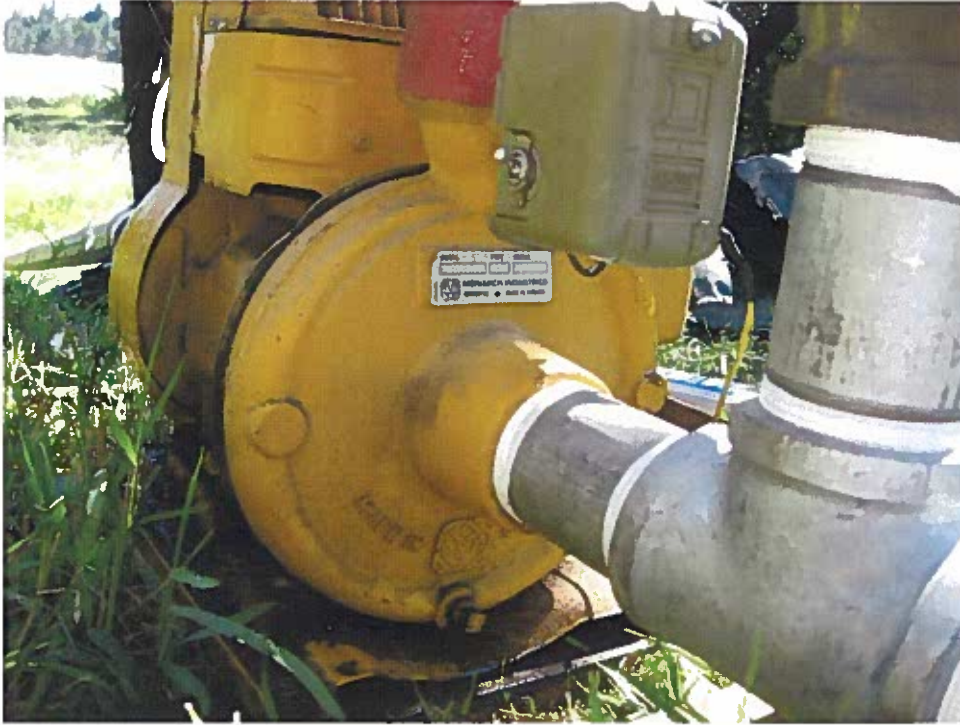
95-8457 Pump Detail

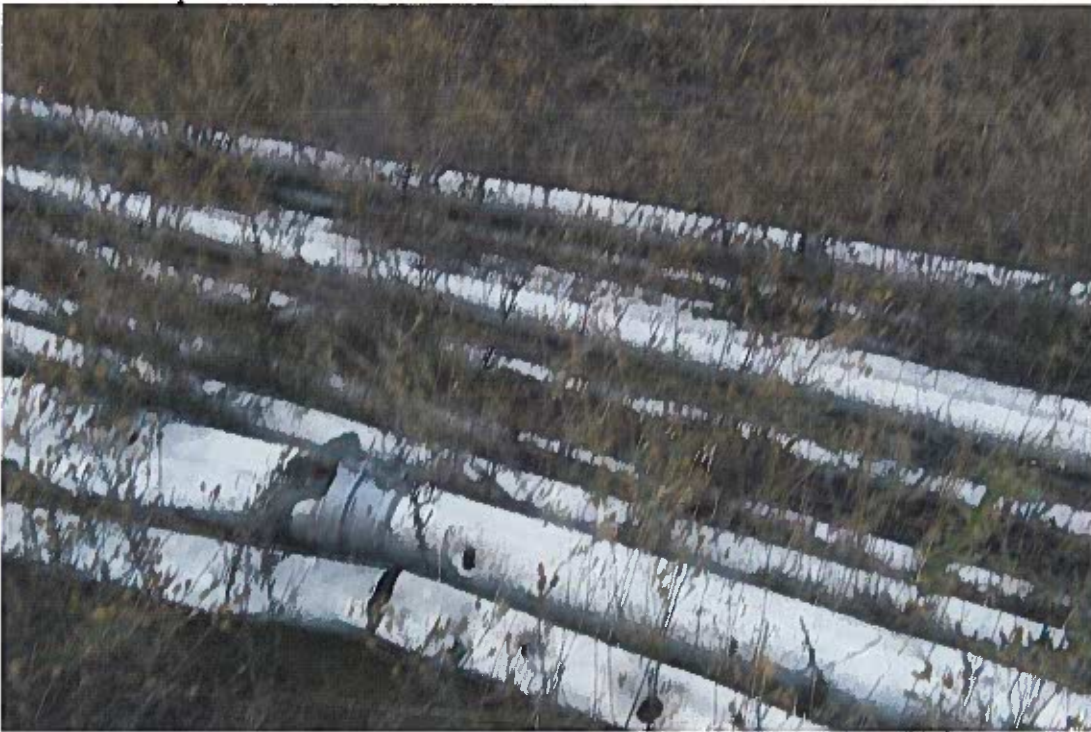
95-8457 Bullet Holes

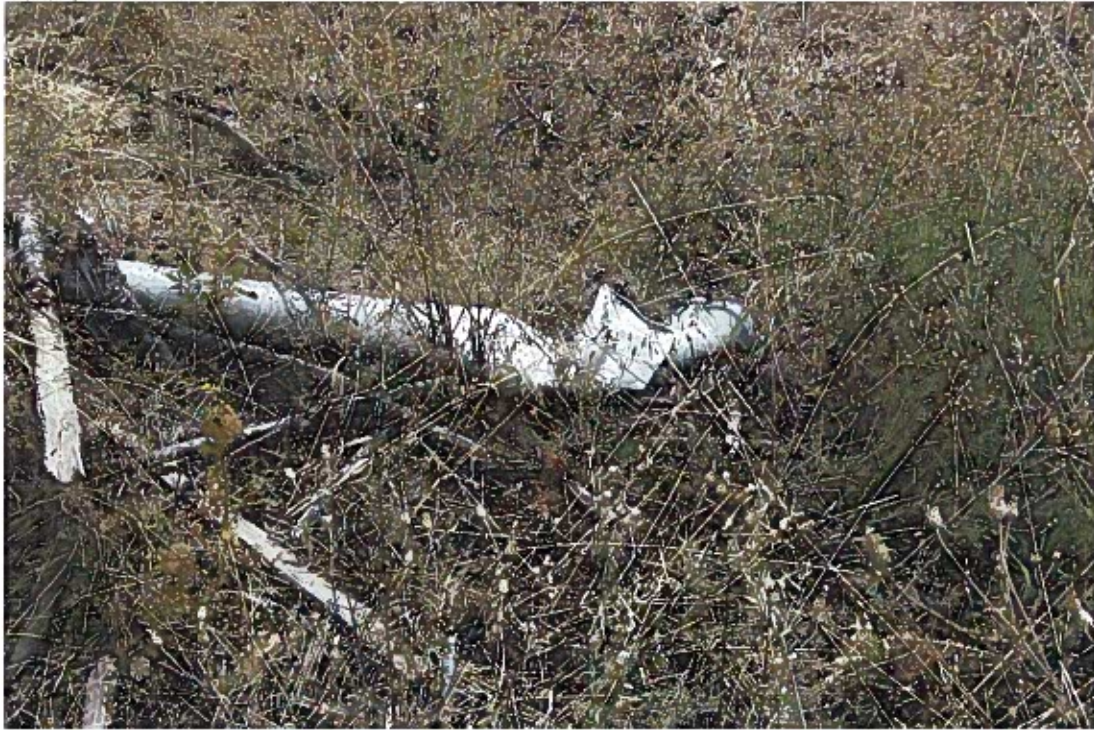
95-8457 Twisted Pipe

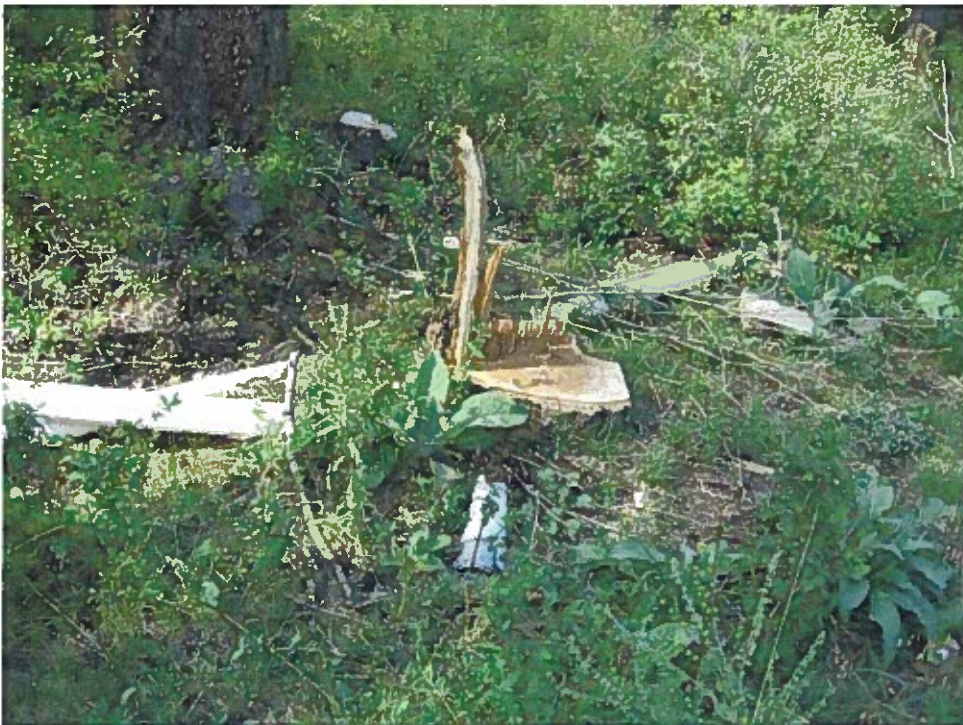
95-89457 Pipe Damage

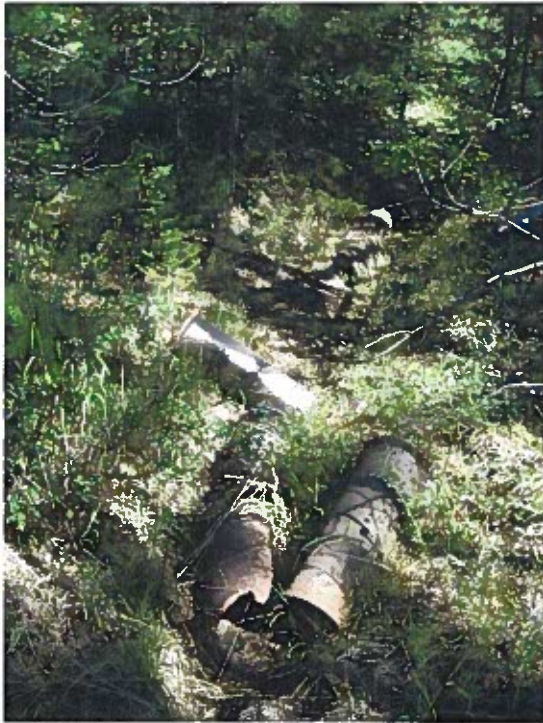
The amount of water standing behind the last and largest earth dam suggested that an additional source of water was supplying this reservoir in August 2008. Mr. Finman and I discovered a dry ditch with large segments of broken pipe that enters the Northeast corner of the reservoir. We followed this ditch from the reservoir northward and found Stream 2. Stream 2 is marked with (Private Water Augmentation Est .02 or .03) CFS on the 95-7719 Exam report and flows and sinks into the ditch. A small diversion dam on Stream 2 diverts part of the water above the ditch for domestic use at the Willadsen farmstead and irrigation in fields near the farm buildings. This source of water was being used to supply a doublewide mobile home on the property in August 2008. I measured the stream volume ~~volume~~ below the diversion dam at .05 CFS.

95-8457 Broken Pipe Ditch Stream 2

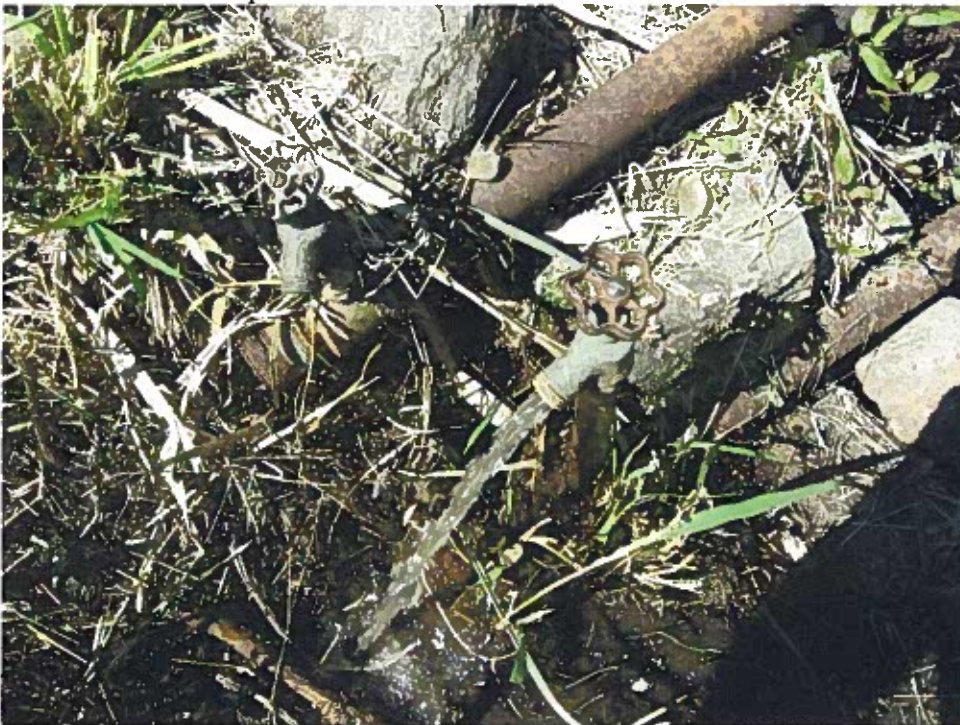
95-8457 Faucets Below Pond 3

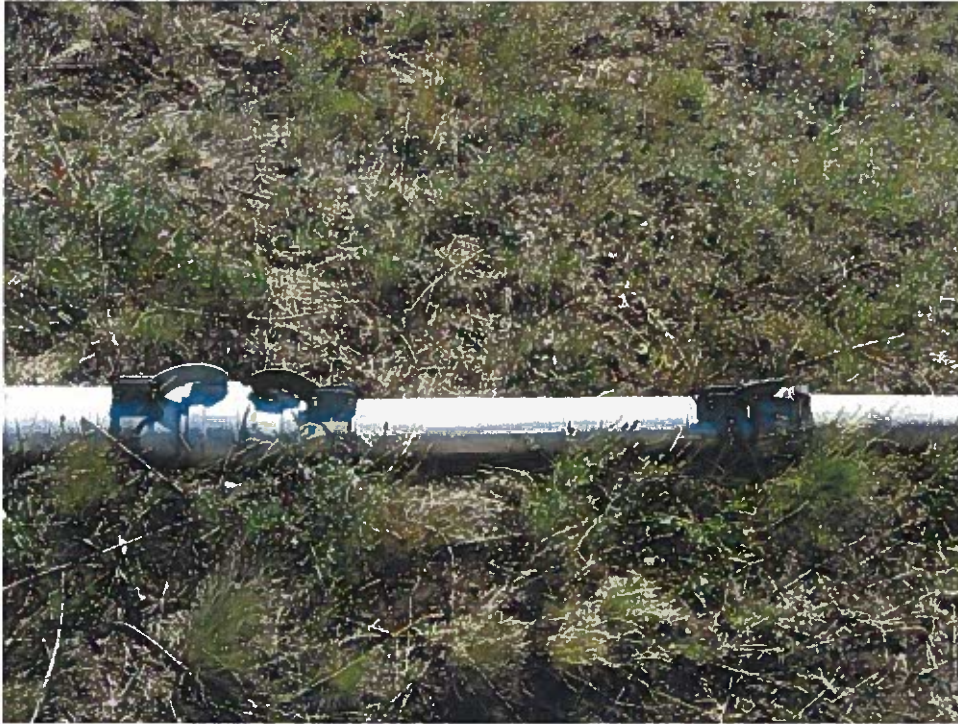
95-8457 Pipeline Different Sizes

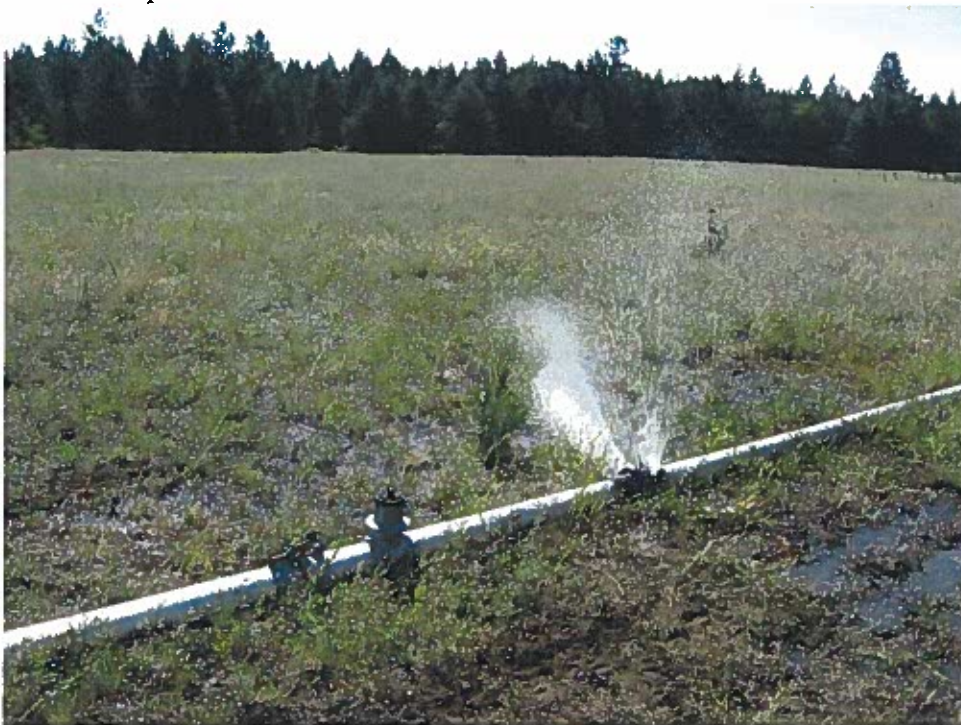
95-8457 Pipeline Leak

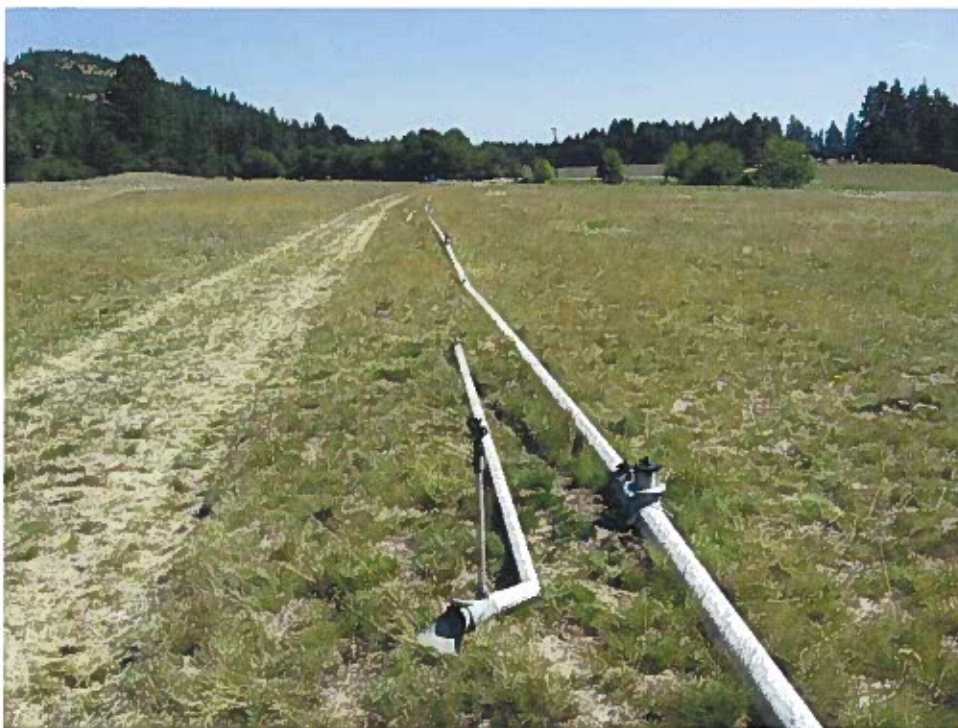
95-8457 Pipeline North to POU

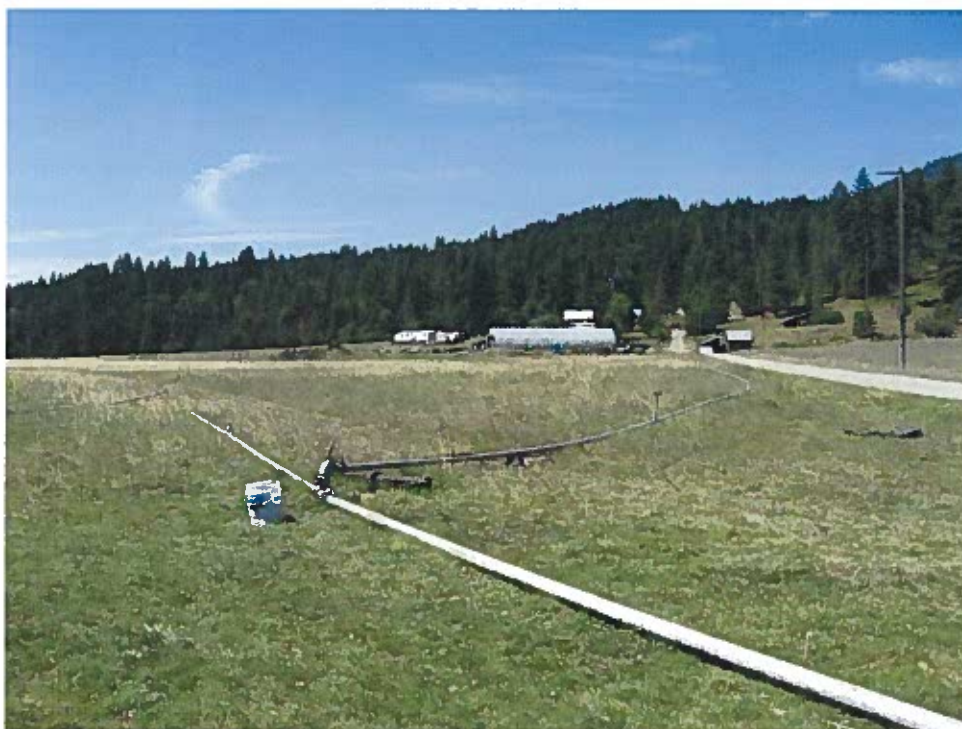
95-8457 View W Farmstead & 95-2011

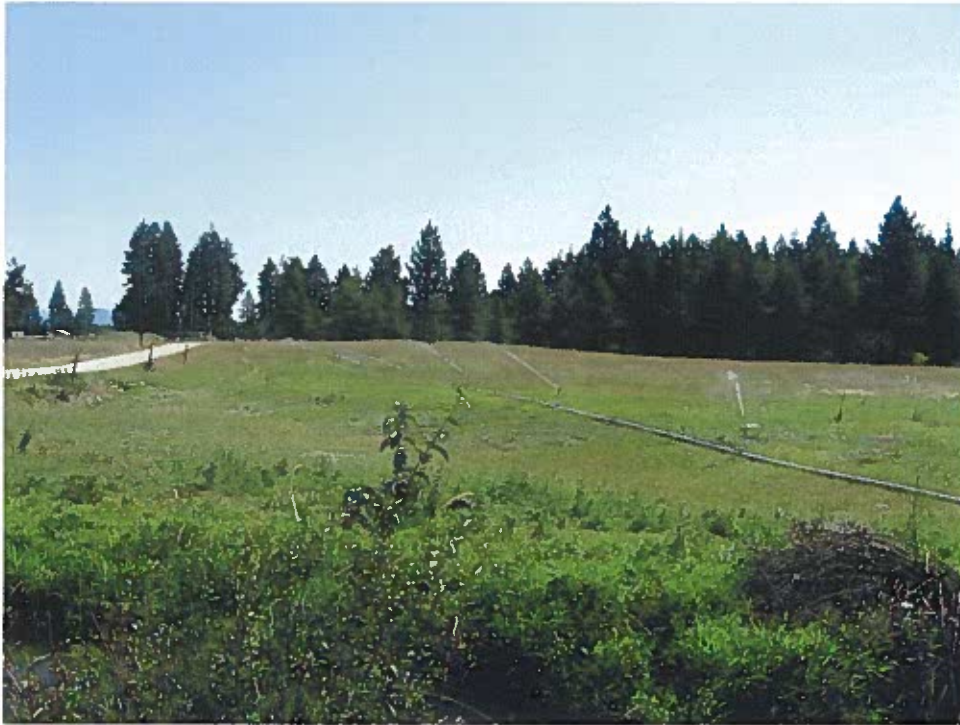
95-8457 Water On POU

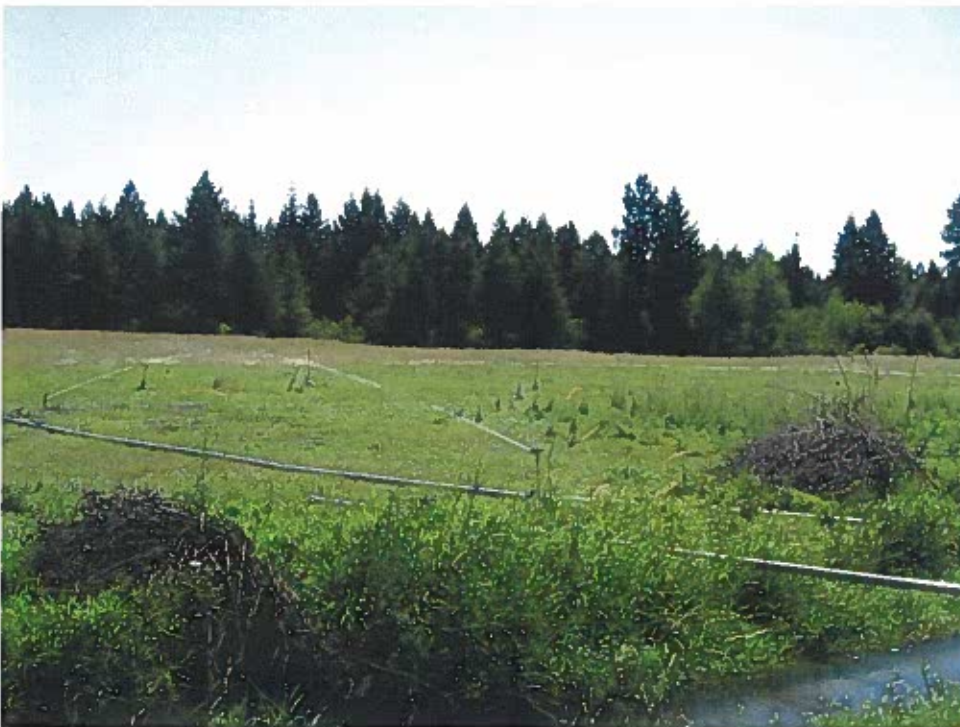
95-8457 IRRIG At POU

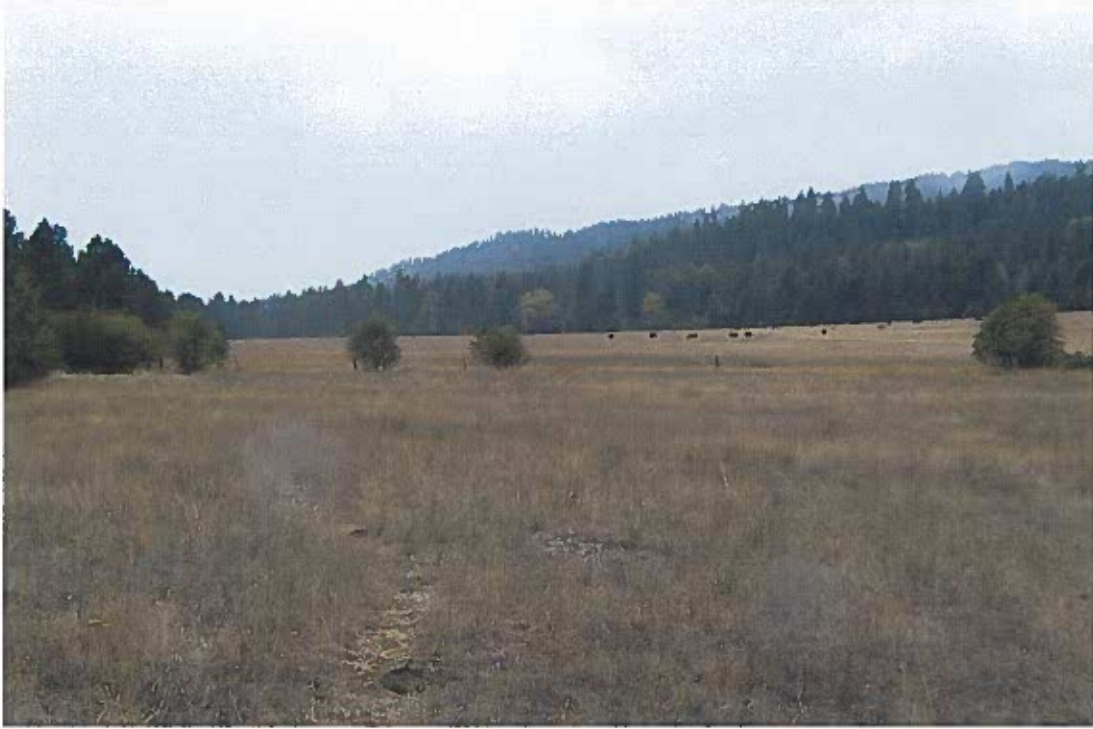
95-8457 Cattle On POU
