## MEMO

SUBJECT: Claim A45-4114, App. For Permit 45-07745, US Forest Service

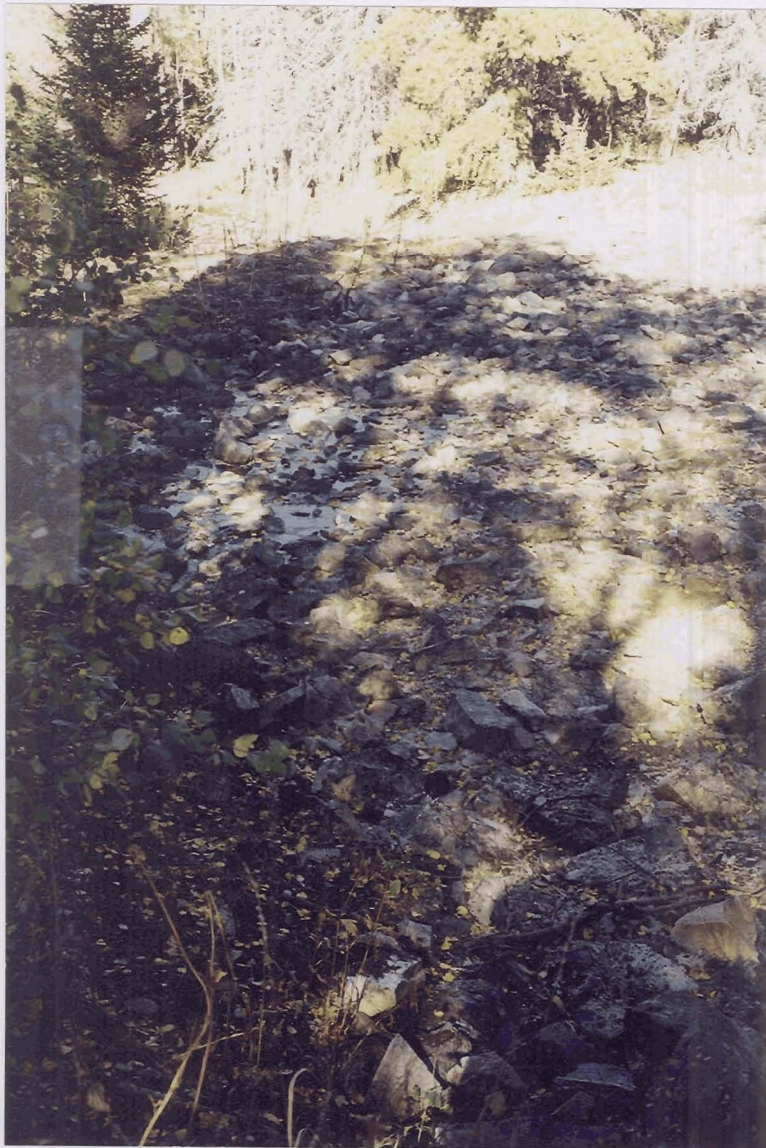
.2/10 of a mile above  
Bennett Springs stand pipe.  
I believe this is the  
beginning of Howell Creek.  
9/26/99 Taken approx.  
14:30 hrs. No moisture  
above this point.

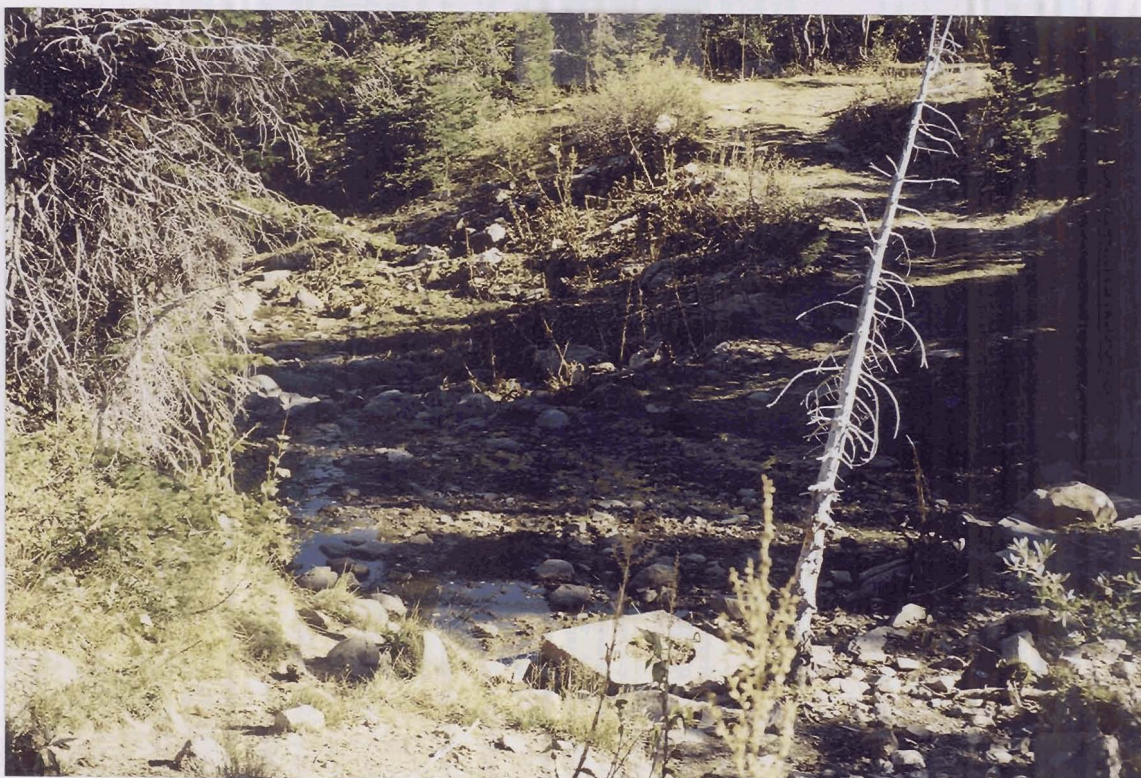
.2/10 above stand pipe at  
Bennett Springs. Right  
tributary of Howell where  
current sistern is located w/  
2 1/2" steel pipe running to  
stand pipe. Taken 9/26/99  
approx. 14:30 hrs. No  
water above this point.

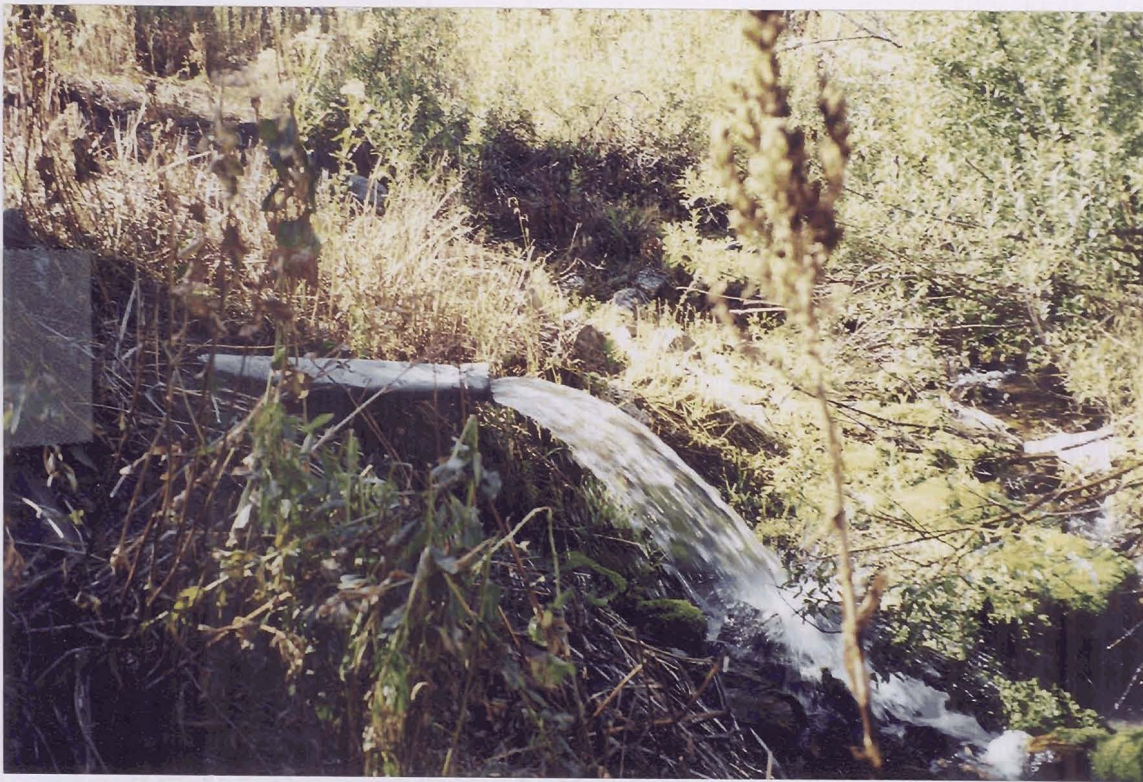
Bennett Springs  
Picture taken 9/26/99  
approx. 13:15 hrs

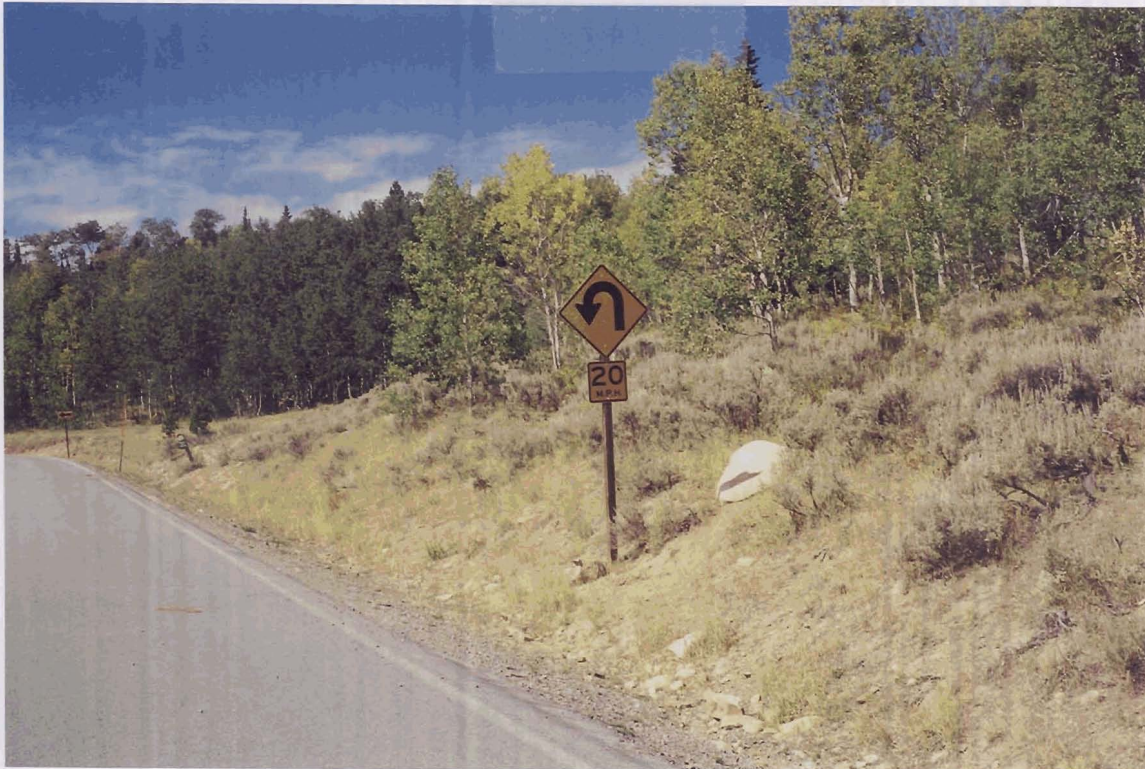
Photo # 5, Taken 9/15/99

This is a point marker of where you turn off road on left side .2/10's of a mile. Cement sistern in stream bed of drainage into Howell Creek which I say is where Bennett Springs creates Howell Creek which is just south of the drainage (left).

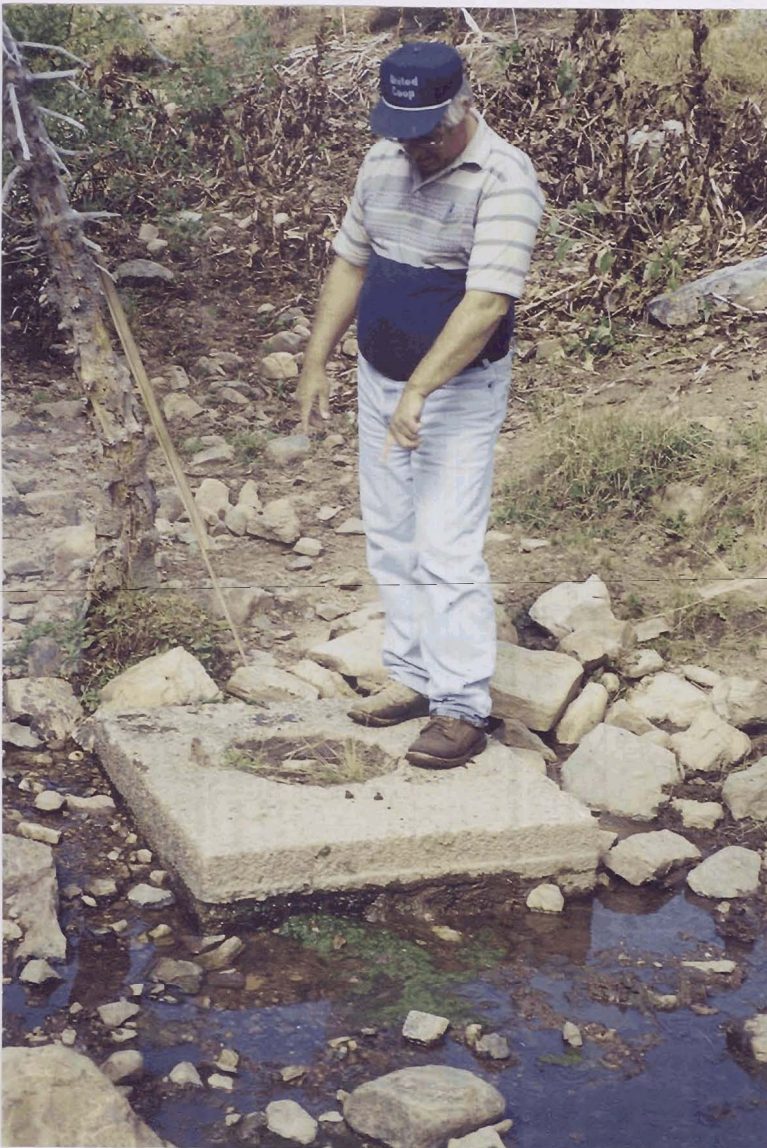
Photo # 6

Water storage (sistern)  
talked about in frame # 5

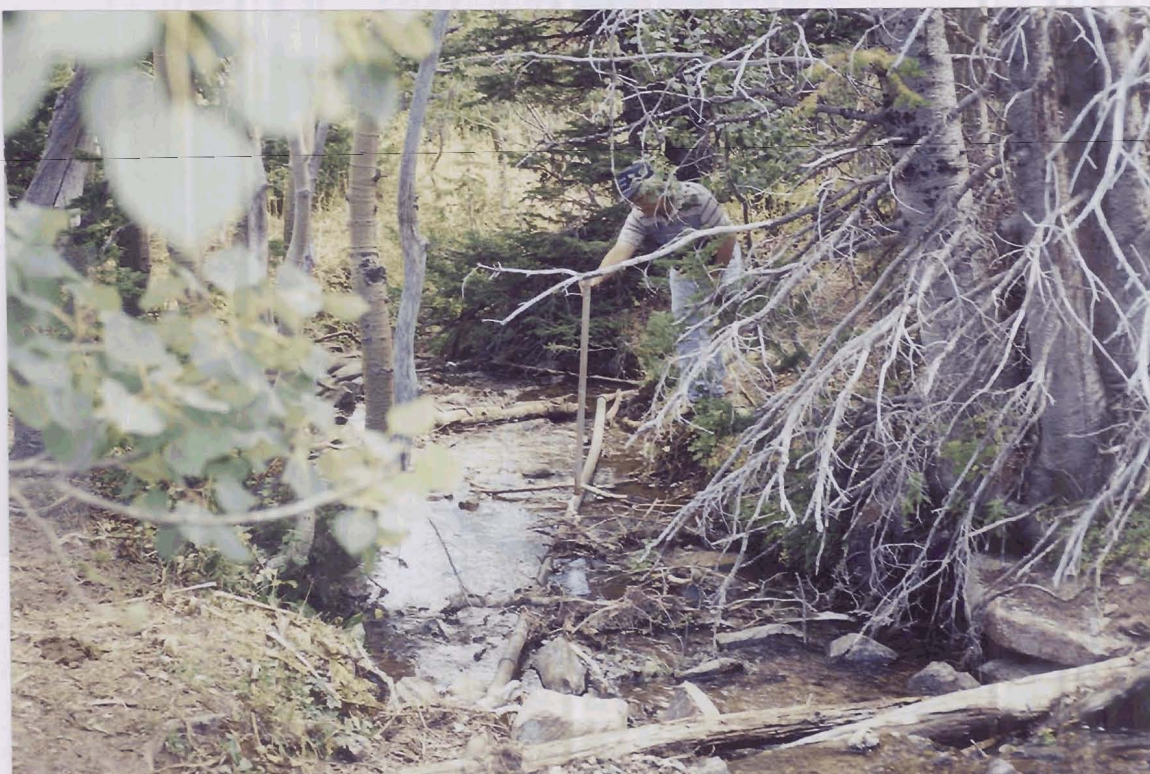
Photo # 7, 9/15/99

First notice of 2 1/2" O D  
steel pipe below cement  
storage frame #6, approx.  
75'.

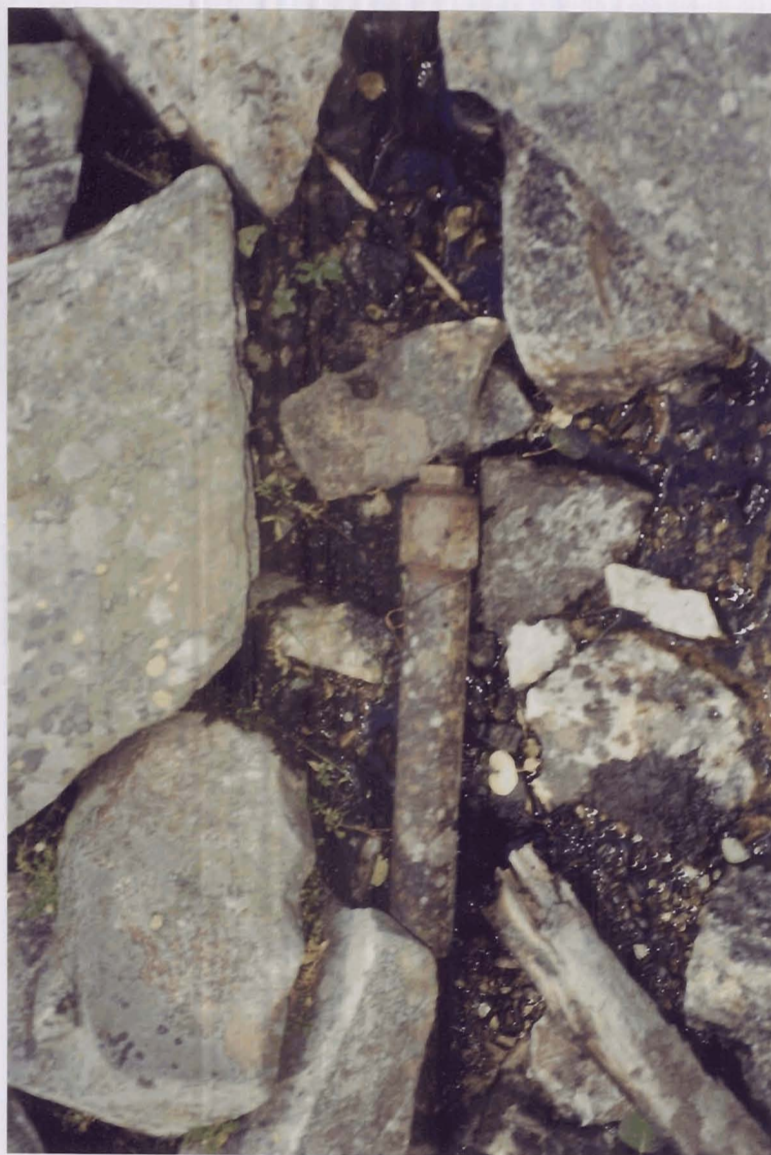
↓ Photo # 11, 9/15/99

Cap off old pipe.

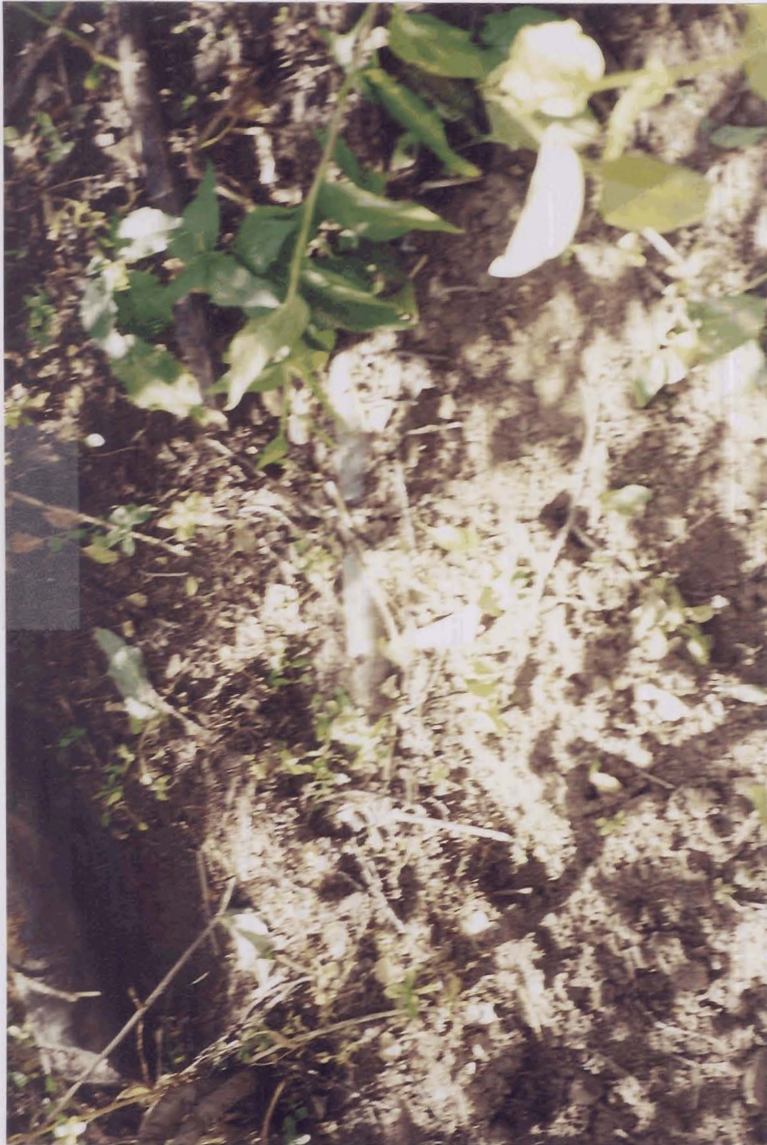
← Photo #12, 9/15/99

New pipe just past cap pipe.

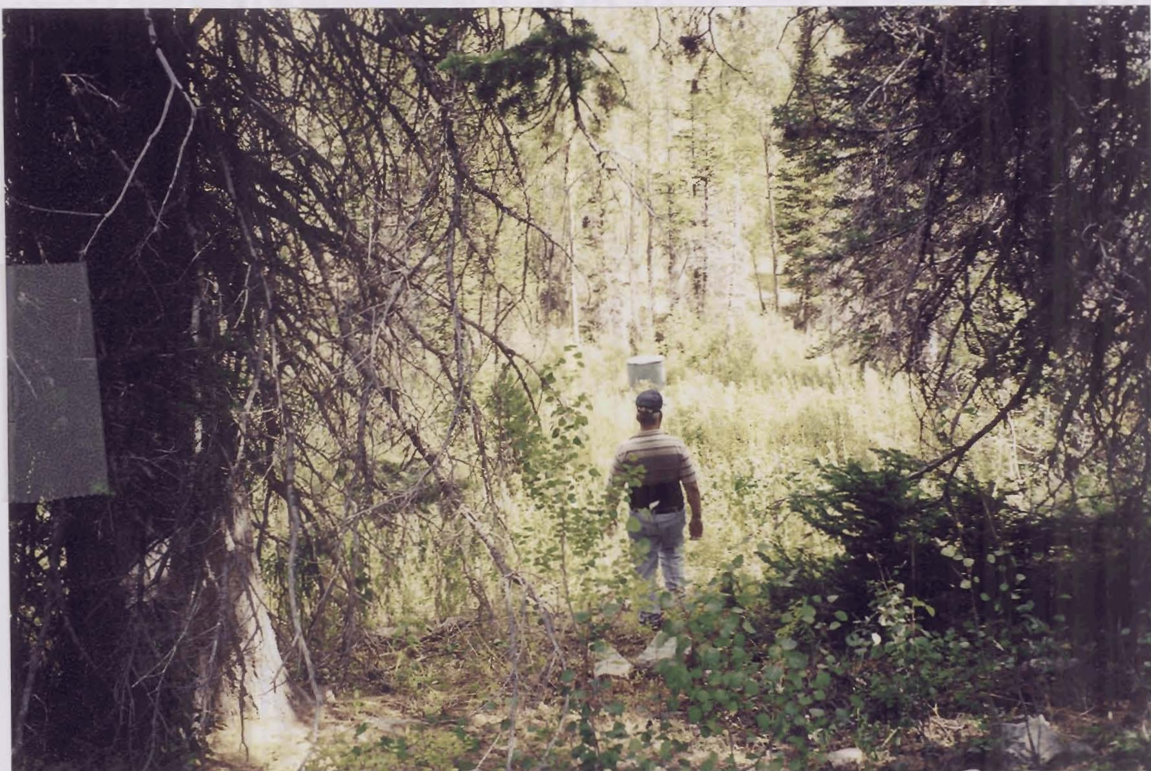
← Photo # 13,  
9/15/99

Headed back to stand  
pipe picture # 2.
