Here is the info on the Williams Lake  
Overflow (or Spillway as the State calls it).  
This is the entire file - # 075-XX05 Williams Lake -  
that is held by DWR's Data and Information  
Division.

WILLIAMS LAKE  
Lemhi County, Idaho  
by W. Gossett  
24 June 1976

WILLIAMS LAKE

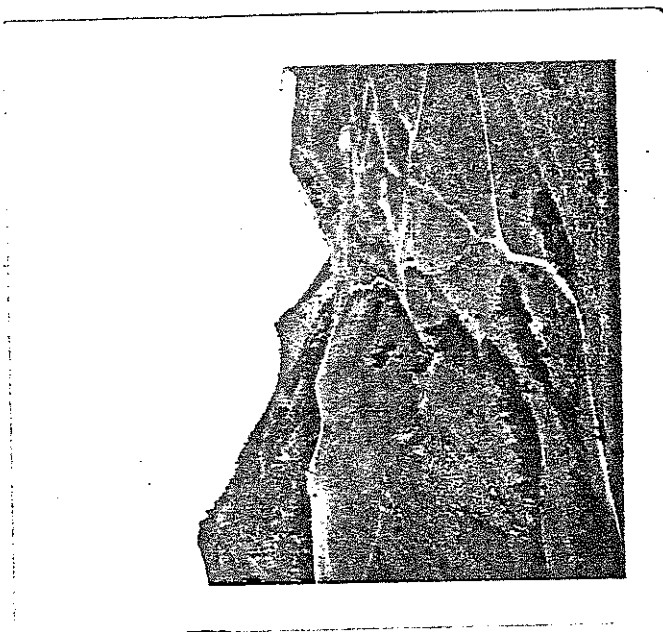
Valley below Williams Lake Outlet

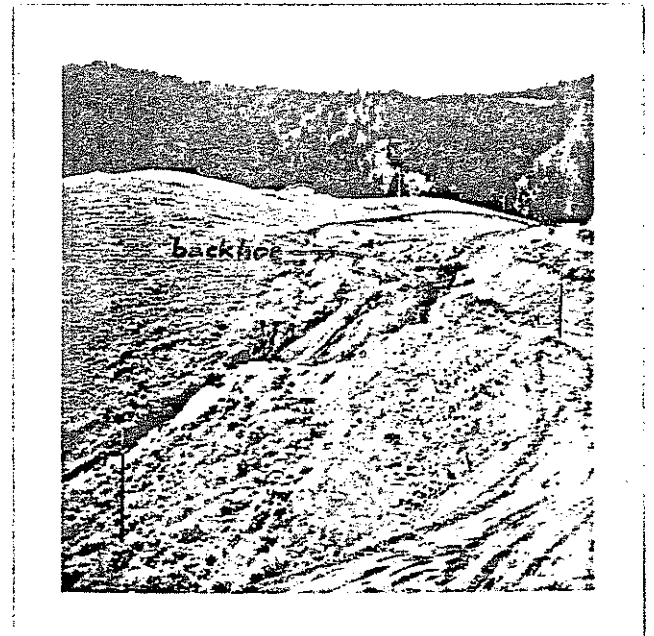
Work along slope where downstream end of outlet is being modified.

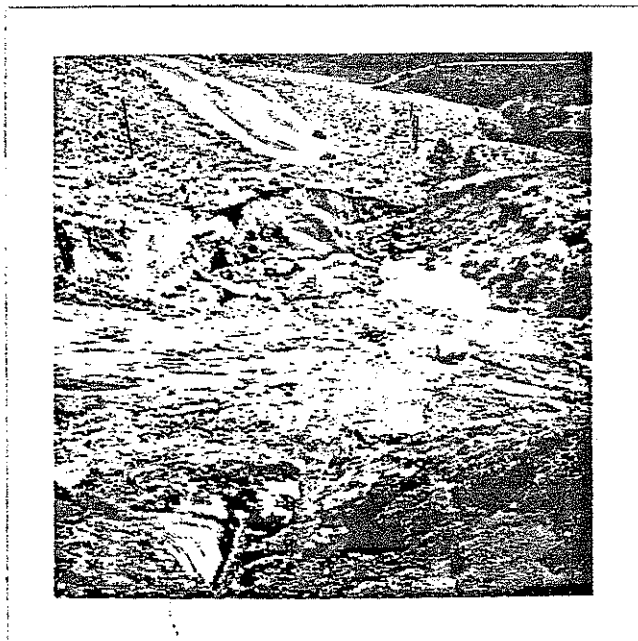
Looking downstream along new portion of outlet pipe. Note water flow to the right of pipe.

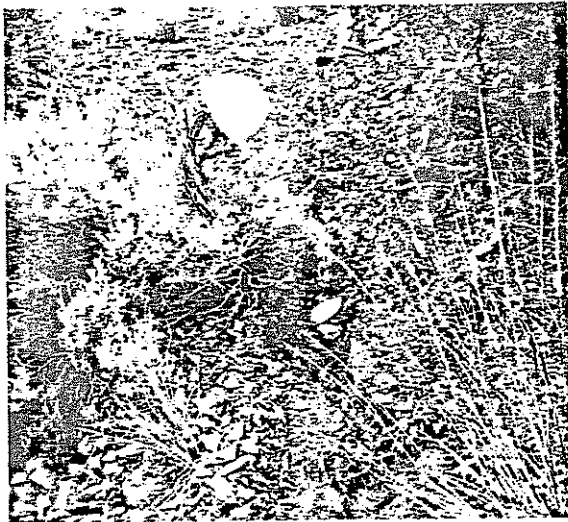
One of the three or four places along a 15 foot width of hillside north of the outlet where new seepage is present.

A new seepage area has developed north of the outlet a considerable distance (see map), and this has worried some people in the area who are nervous because of the recent failure of Teton Dam, according to Mr. Heald. He indicated that the seepage began when the unusually high lake level occurred, and he feels it is decreasing now that the lake is starting to drop again. One reason why it is so apparent may be that access roads to the lake criss-cross the hillside west of the lake, and the seepage is running down onto the road. I estimate that the seepage emerges approximately 70 feet below lake level, and approximately 1/2 mile from the lake. It is running clear at an estimated 10 GPM±, and emerges from several areas in a 15 foot width along the mountainside. Because of the distance the seepage must travel and its small quantity, I am not concerned about it; however, it may be advisable to check it again to insure that it does not increase or to see if it stops when the lake level drops.

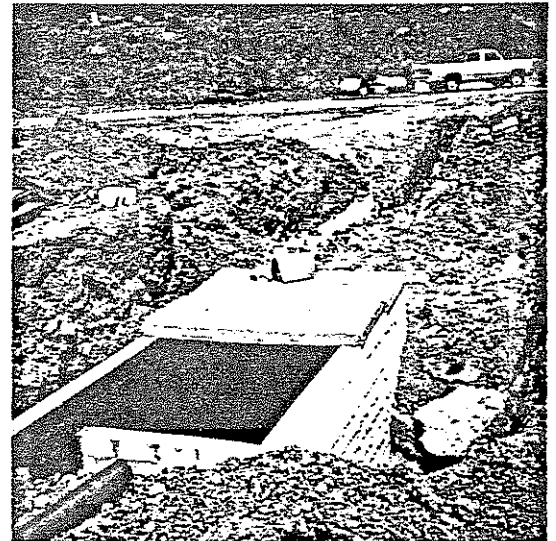
Septic tank and drain-field being constructed above outlet pipe on the embankment.

During the inspection, the presence of a new septic tank and drain field near the edge of the embankment slope was noted, (see photos). This would not endanger the stability of the lake; however, it may result in future seepage being evident along the slope, and could pose a threat to the embankment along the county road.

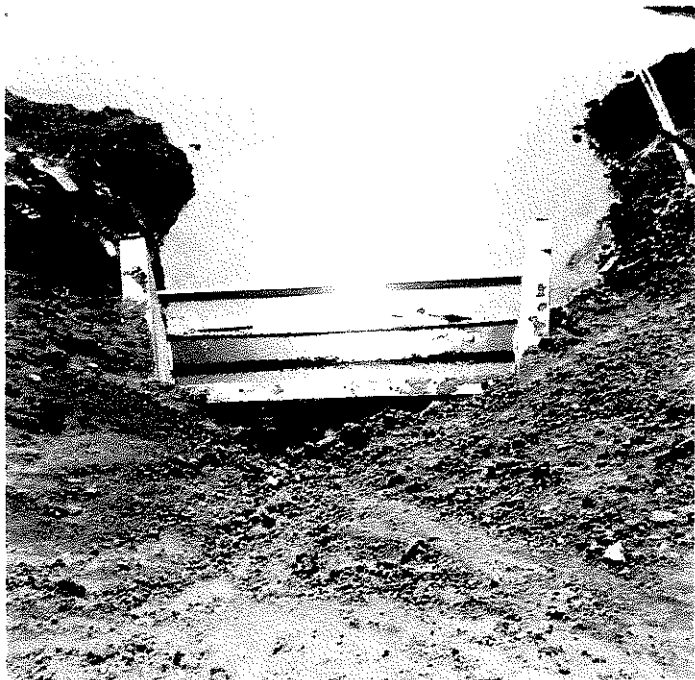
LATE MAY, 1965 WMS. LAKE

4x4 MESH HARDWARE CLOTH SCREEN ON INLET END OF PIPE

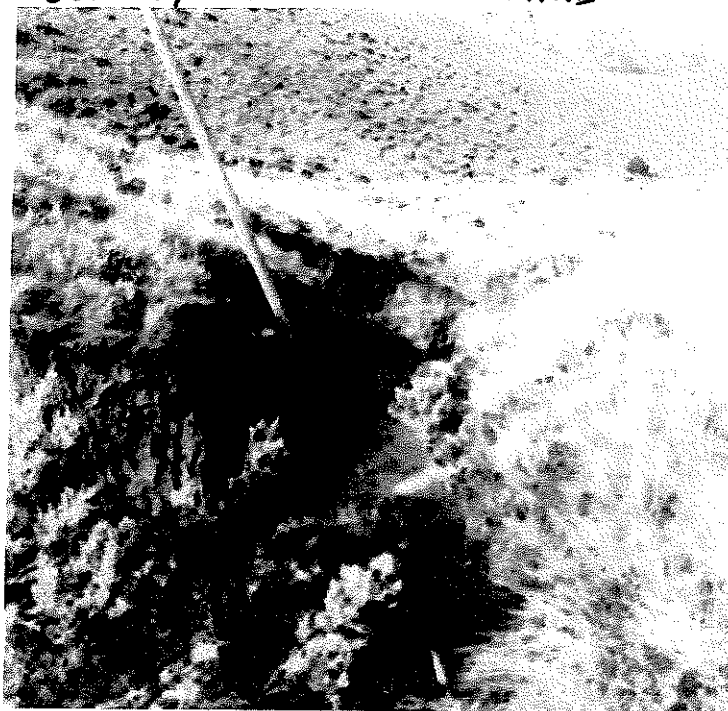
JUNE 4, 1965 WMS. LAKE

GULLY AT END OF SPILLWAY PIPE
