STATE OF IDAHO  
DEPARTMENT OF WATER RESOURCES  
BENEFICIAL USE FIELD REPORT

Permit No: 45-7608

Licensing Exam for Permit 45-7608  
USGS Quadrangle (CC30 & CC80)

**Licensing Exam Photos for Permit 45-7608**

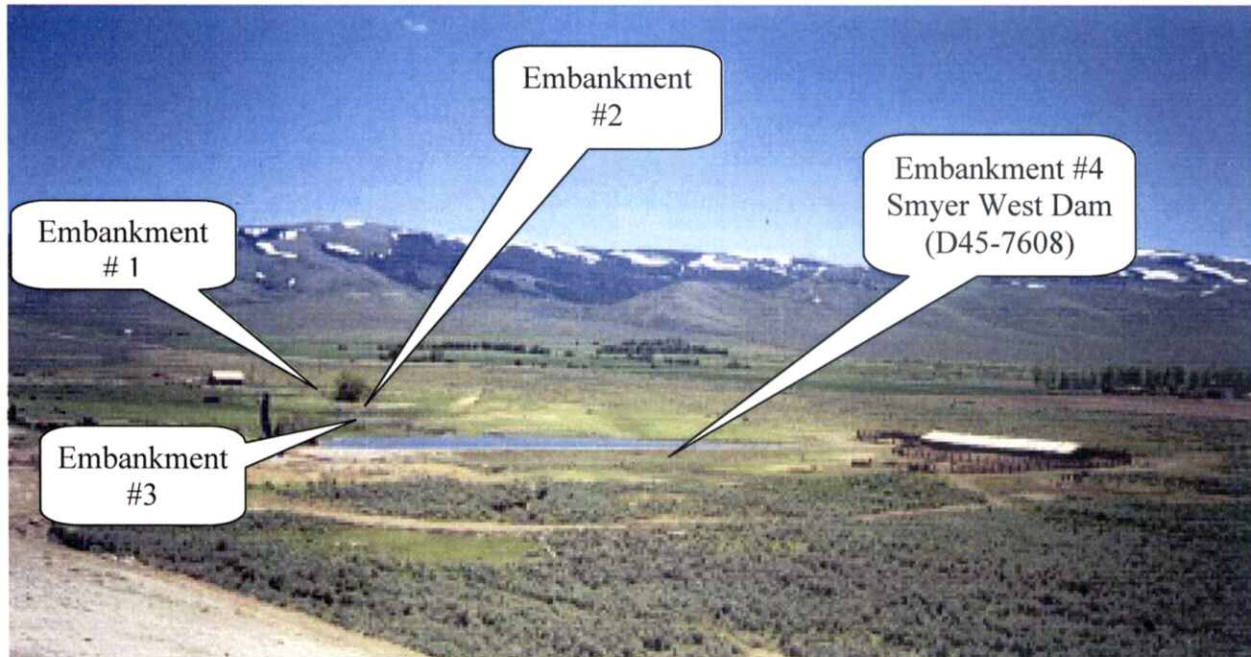
**ABOVE:** View showing the location of the four embankments used to create ponds. Photo, taken on June 1, 1998, was copied from Smyer West Dam IDWR Dam Safety File (D45-7608).

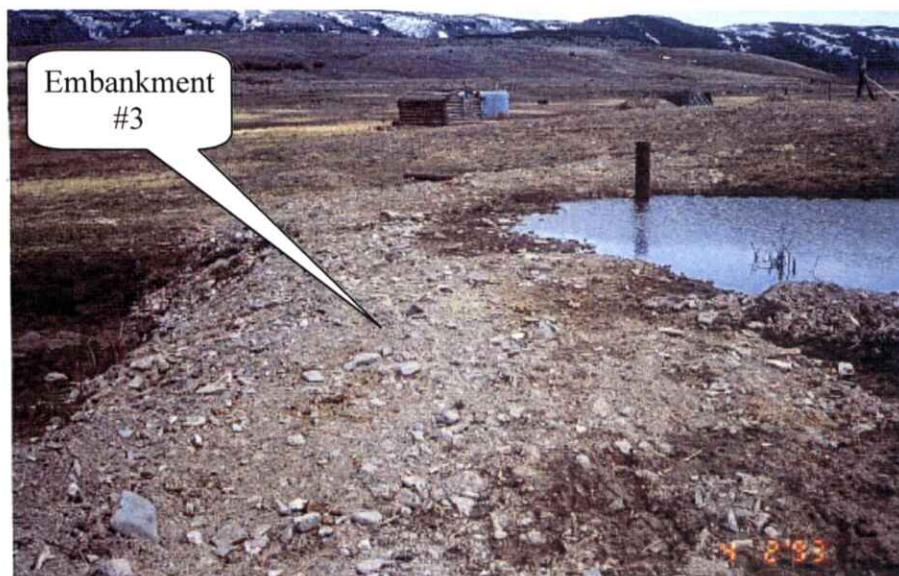
**BELOW:** View showing "Embankment #3". Photo, taken on April 2, 1993, was copied from Smyer West Dam IDWR Dam Safety File (D45-7608).

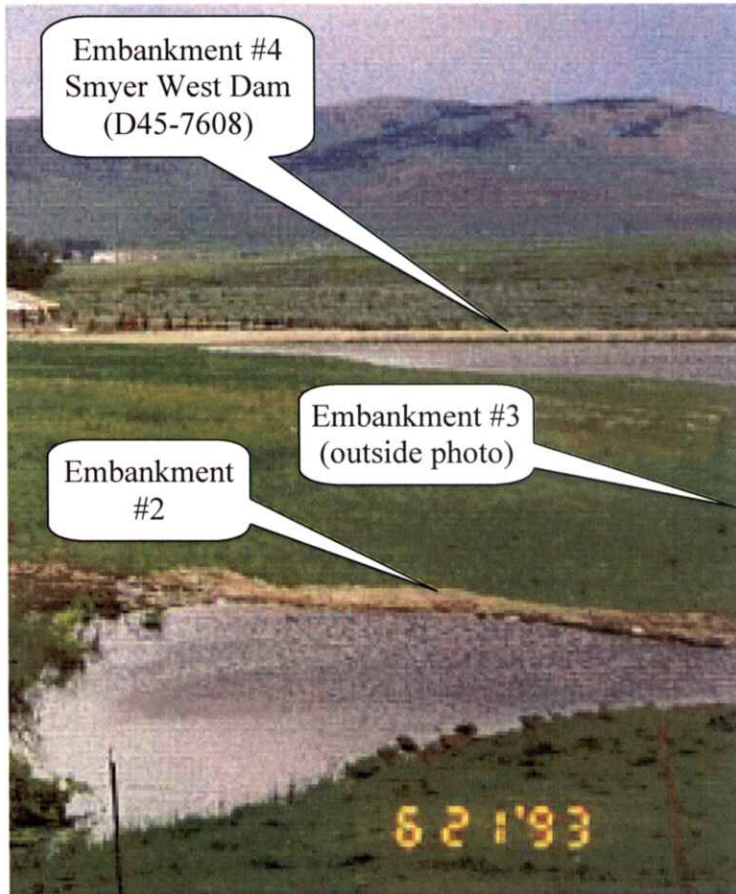
**LEFT:** View showing embankment #2, and embankment #4 (Smyer West Dam) in background. Photo, taken on June 21, 1993, was copied from Smyer West Dam IDWR Dam Safety File (D45-7608).

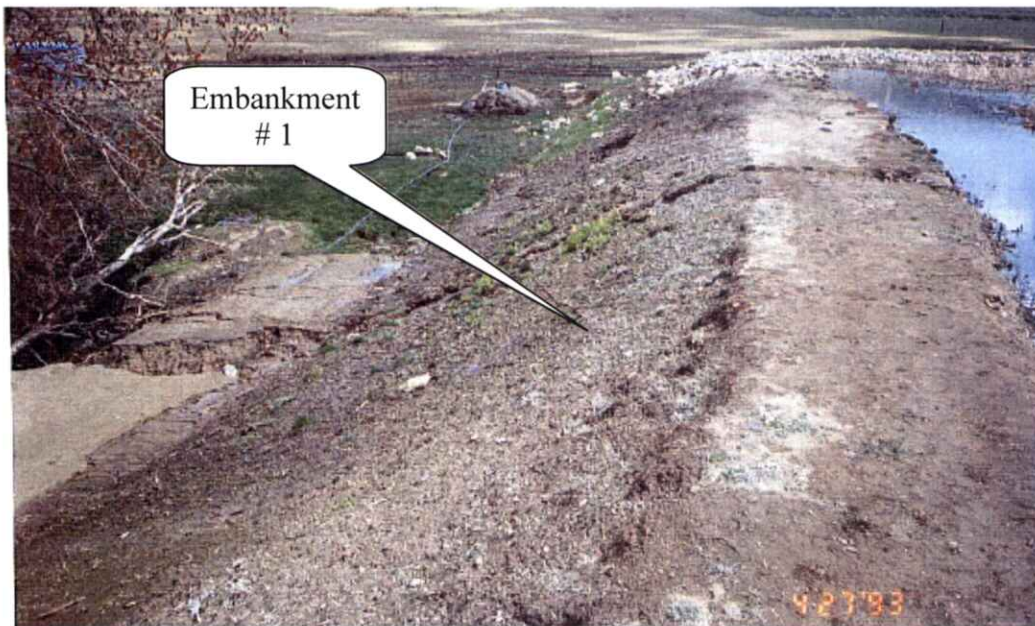
**BELOW:** View showing the upper most embankment, #1, of the four embankments. Photo, taken on April 27, 1993, was copied from Smyer West Dam IDWR Dam Safety File (D45-7608).
