STATE OF IDAHO  
DEPARTMENT OF WATER RESOURCES  
BENEFICIAL USE FIELD REPORT

Permit No: 21-7144

GOLDEN LAKE  
21 - 4040A

RECORD OF INSPECTION OF DAM

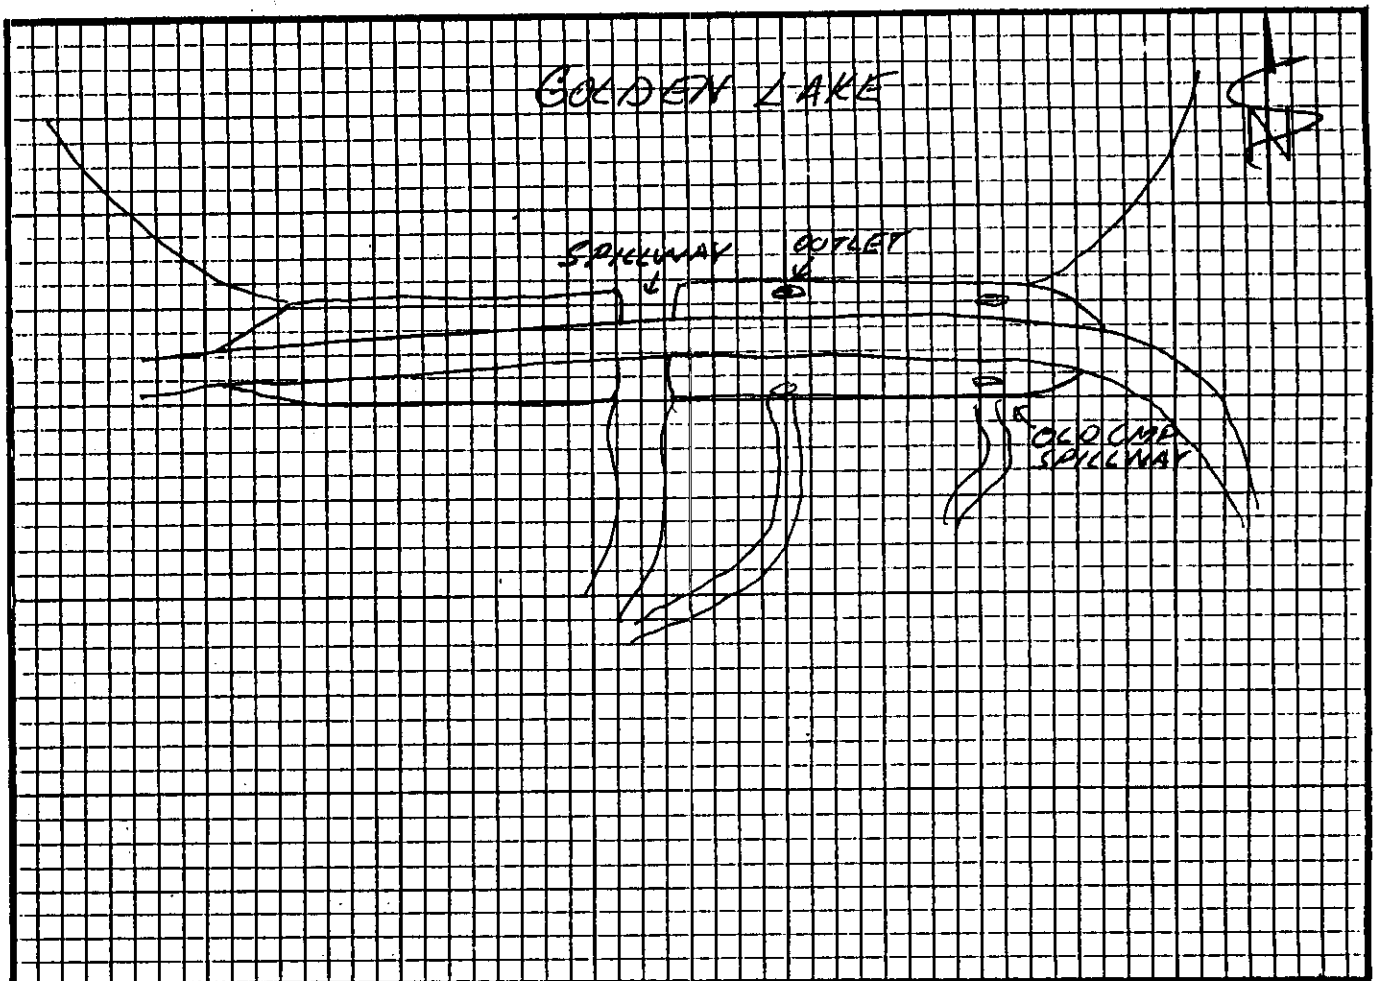
GENERAL CONDITION AND DESCRIPTION OF DAM: Good

SKETCH OF DAM SHOWING LOCATION OF SPILLWAY AND OUTLET WORKS AND ANY MAINTENANCE PROBLEMS:

RECOMMENDATIONS: - ISSUE CERTIFICATE FOR 2 YEARS

- CONTINUE REGULAR MAINTENANCE

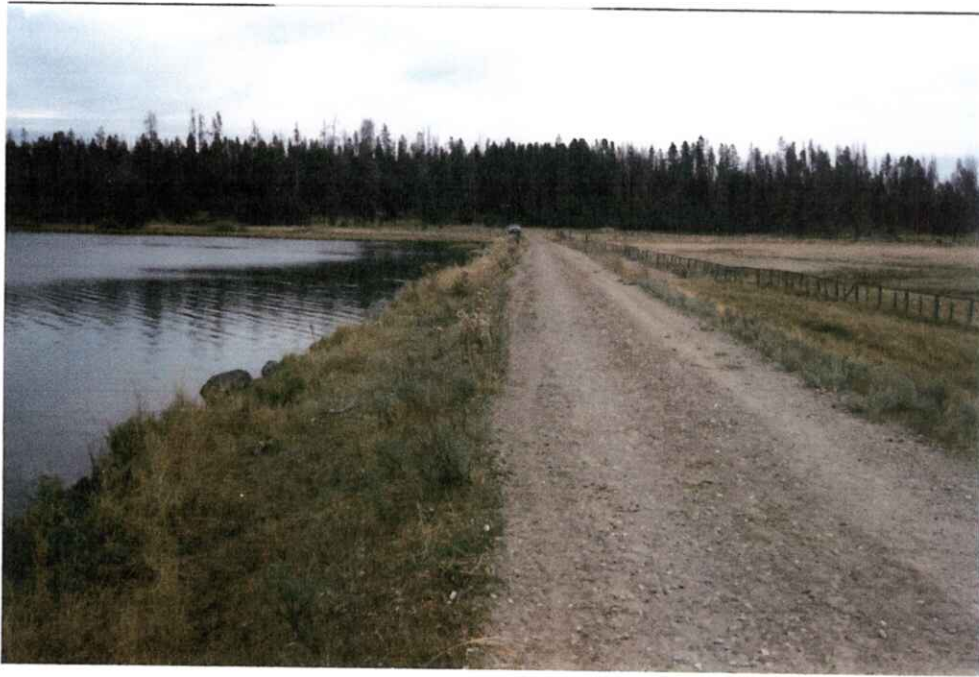
CREST OF DAM.

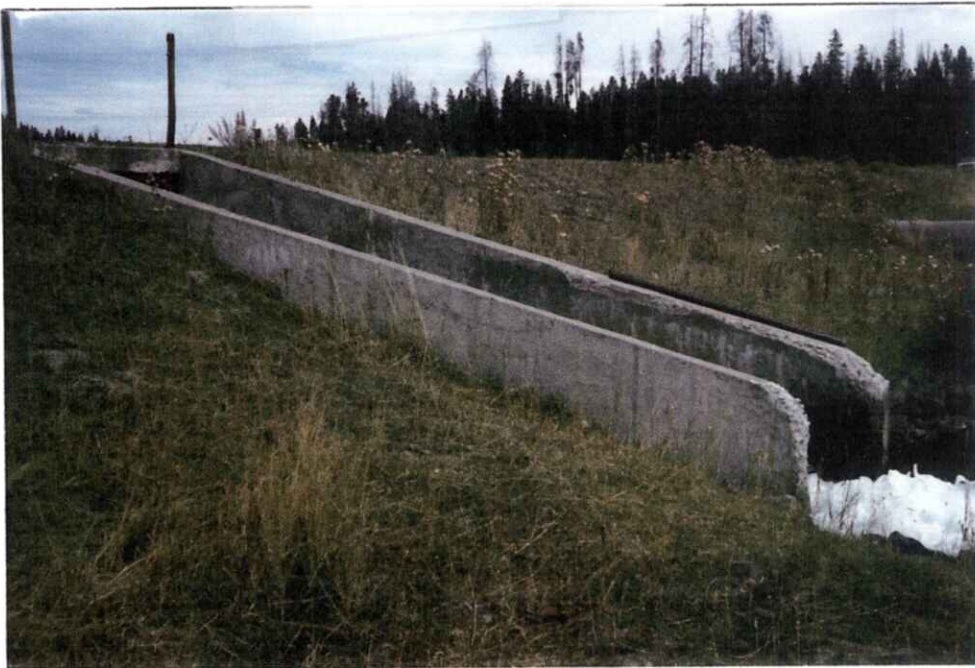
SPILLWAY
