## MEMORANDUM

**Date:** June 17, 2005  
**To:** Water Right File 37-7707  
**From:** eretelle  
**Re:** field evaluation

# 37-7707

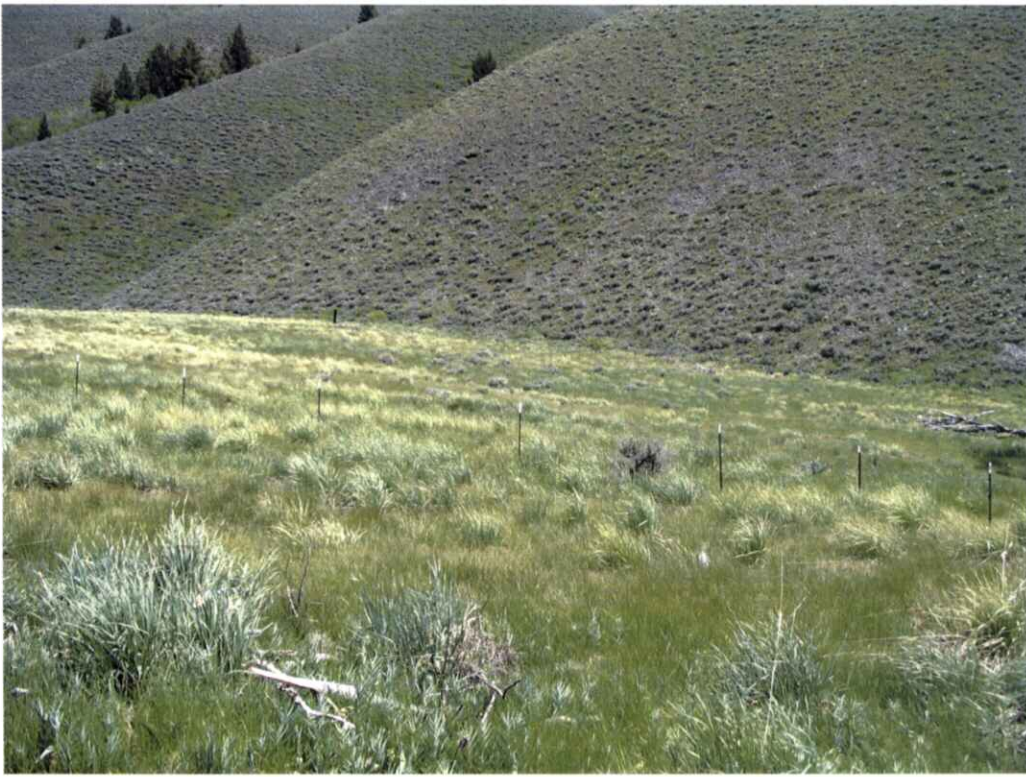
Looking SE from near road into PoU. Land on far side of fence is supposedly irrigated by sprinklers (absent at time of last 2 field exams) attached to pump in pond #1. Land on near side of fence is supposedly not irrigated.

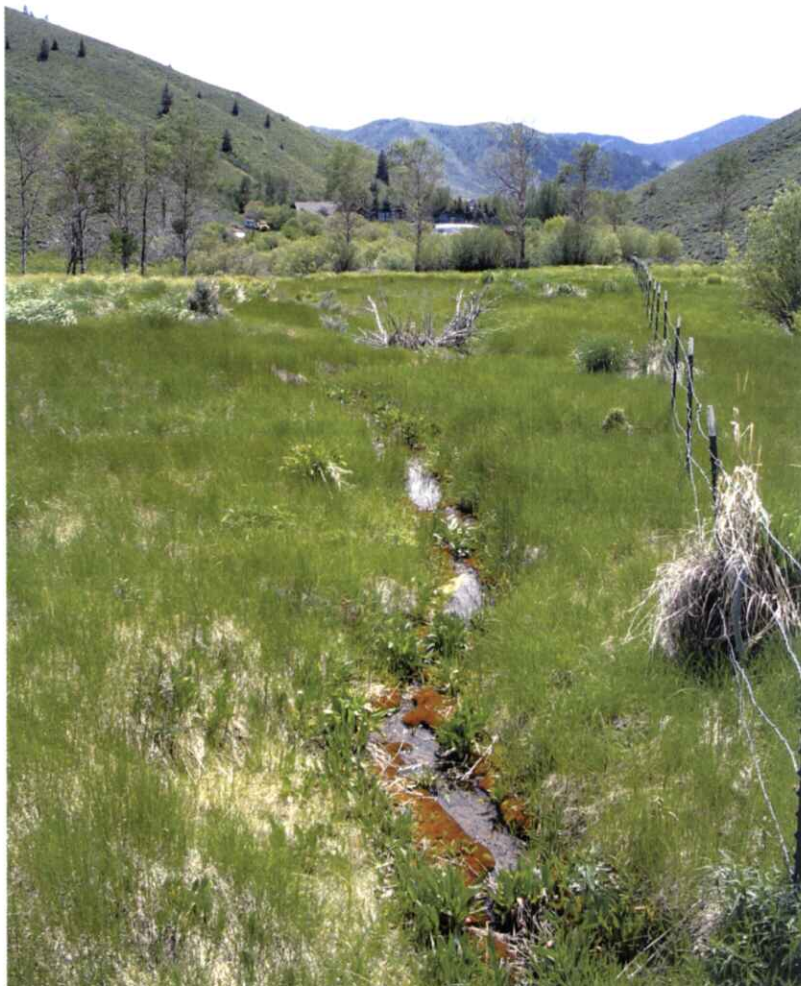
Looking toward the SE down channel #2 from the PoD. Channel goes dry about at those branches.

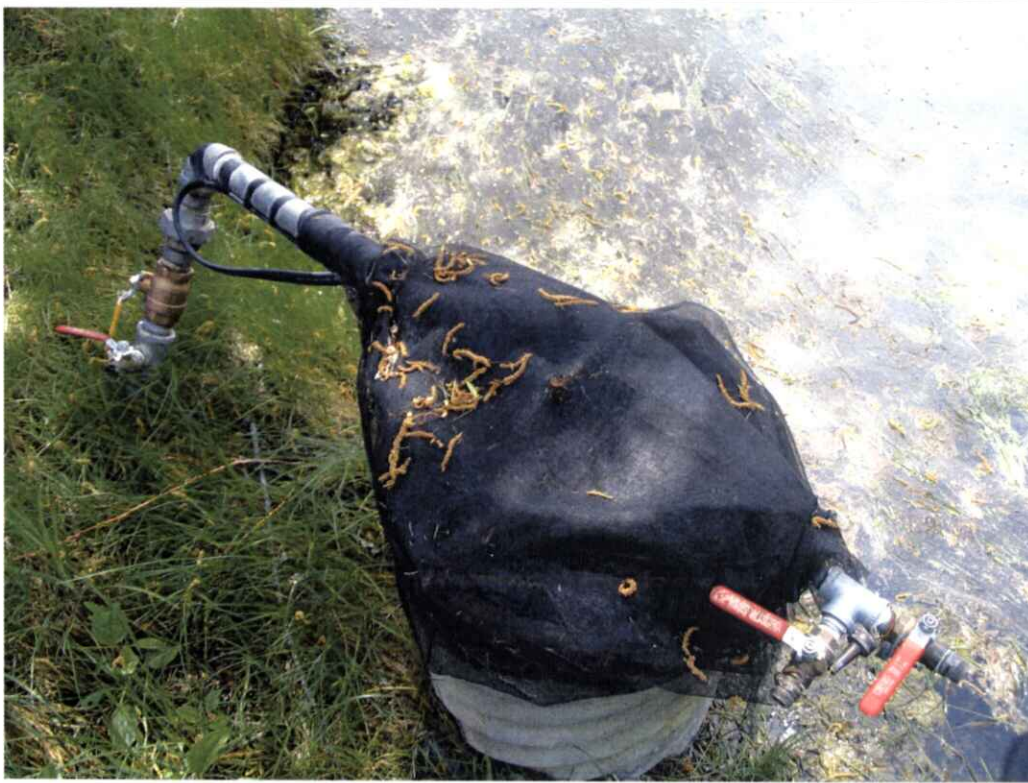
(1hp) pump in  
pond #1 to  
sprinkler system

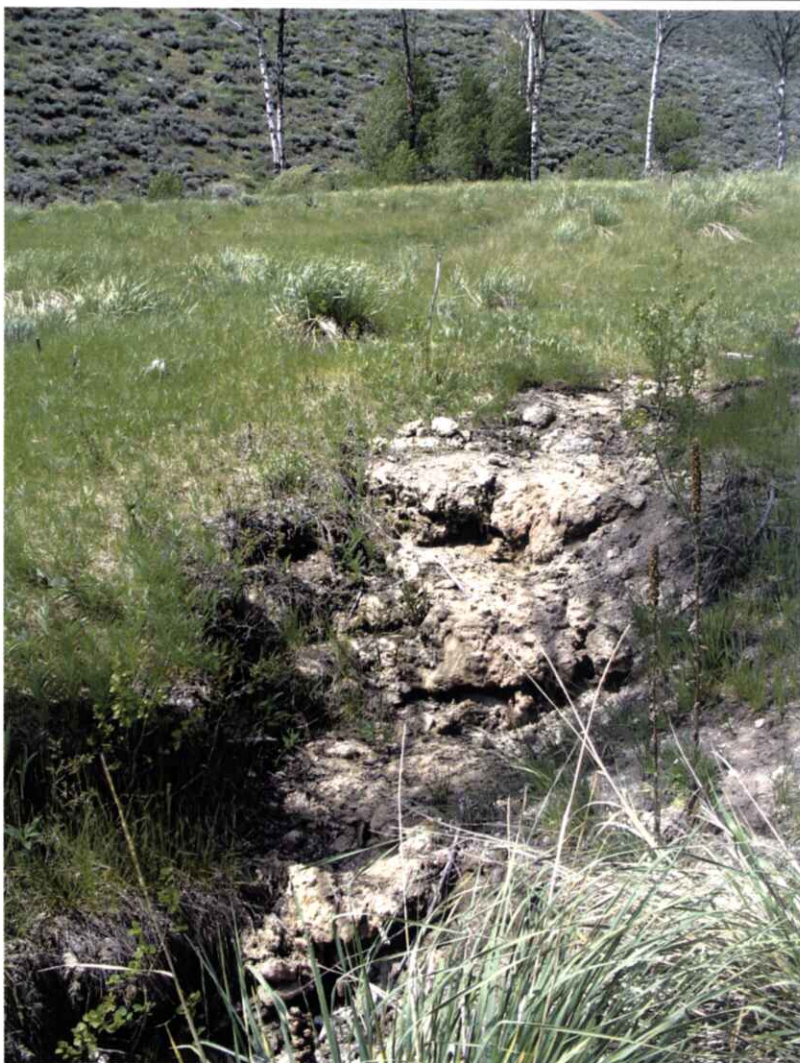
Looking toward the NE up  
channel #2, which is dry above  
the springs.

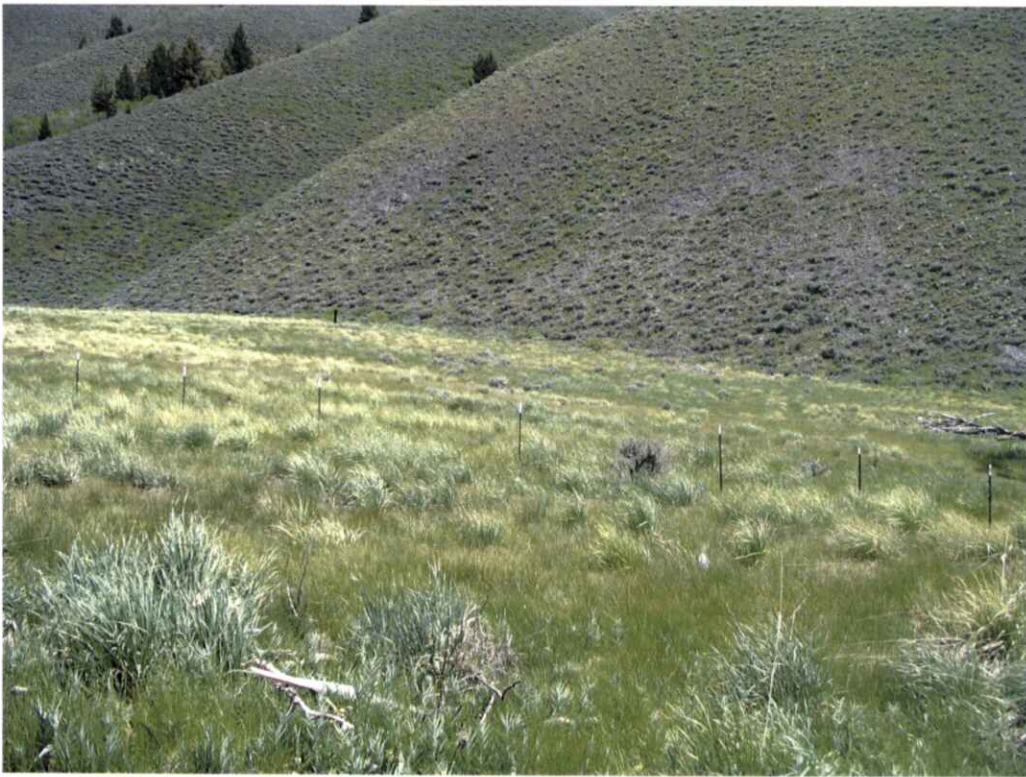
Looking SE from near road into PoU. Land on far side of fence is supposedly irrigated by sprinklers (absent at time of last 2 field exams) attached to pump in pond #1. Land on near side of fence is supposedly not irrigated.

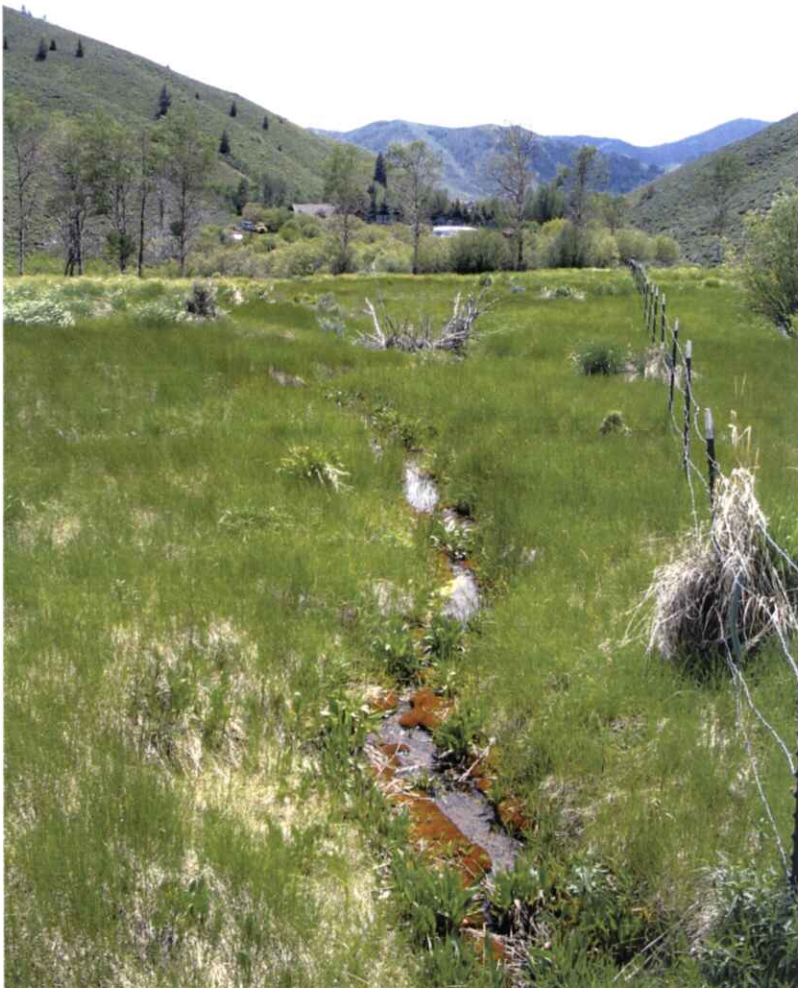
Looking toward the SE down channel #2 from the PoD. Channel goes dry about at those branches.

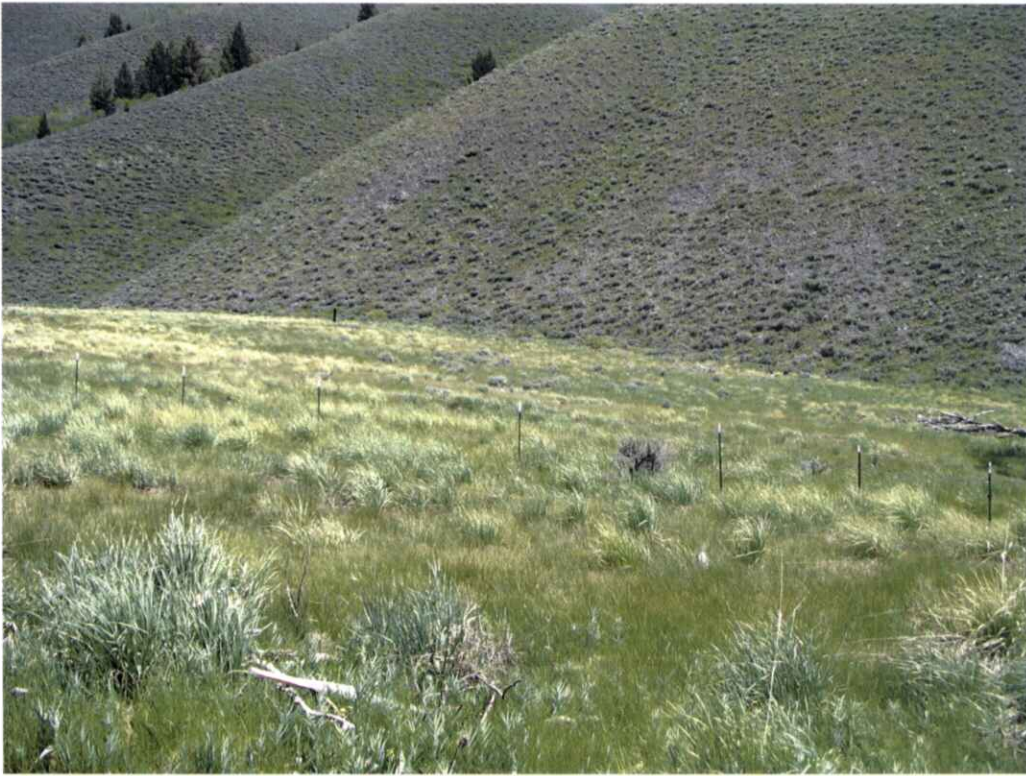
Looking SE from near road into PoU. Land on far side of fence is supposedly irrigated by sprinklers (absent at time of last 2 field exams) attached to pump in pond #1. Land on near side of fence is supposedly not irrigated.

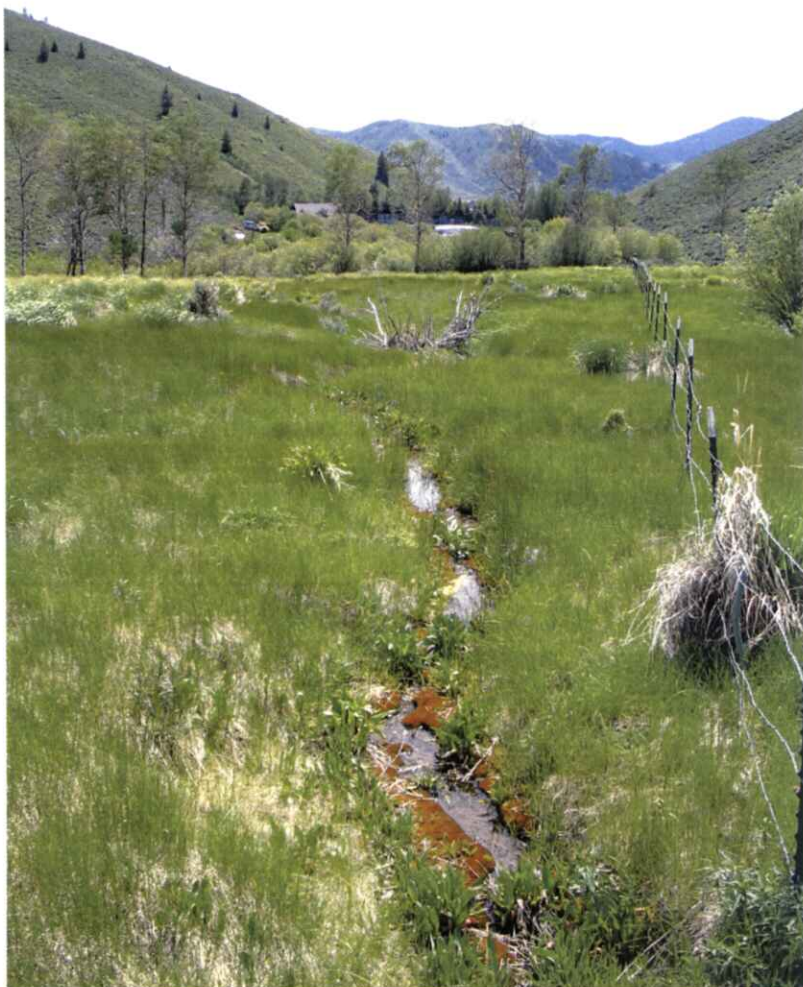
Looking toward the SE down channel #2 from the PoD. Channel goes dry about at those branches.

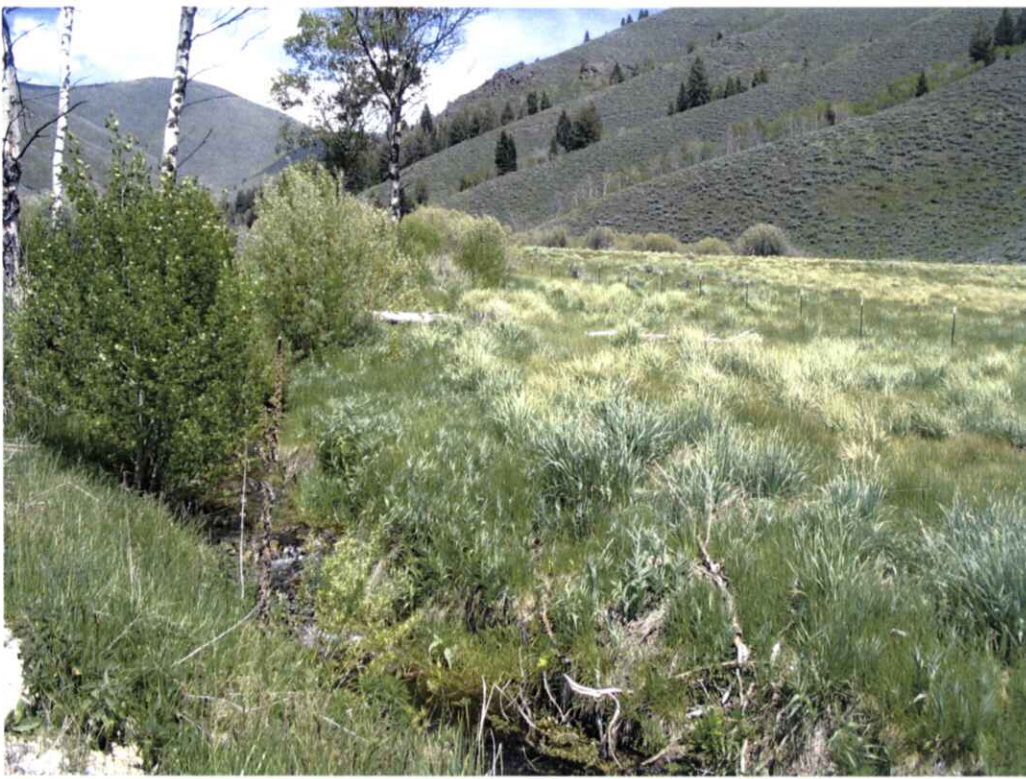
Looking SE from near road into PoU. Land on far side of fence is supposedly irrigated by sprinklers (absent at time of last 2 field exams) attached to pump in pond #1. Land on near side of fence is supposedly not irrigated.

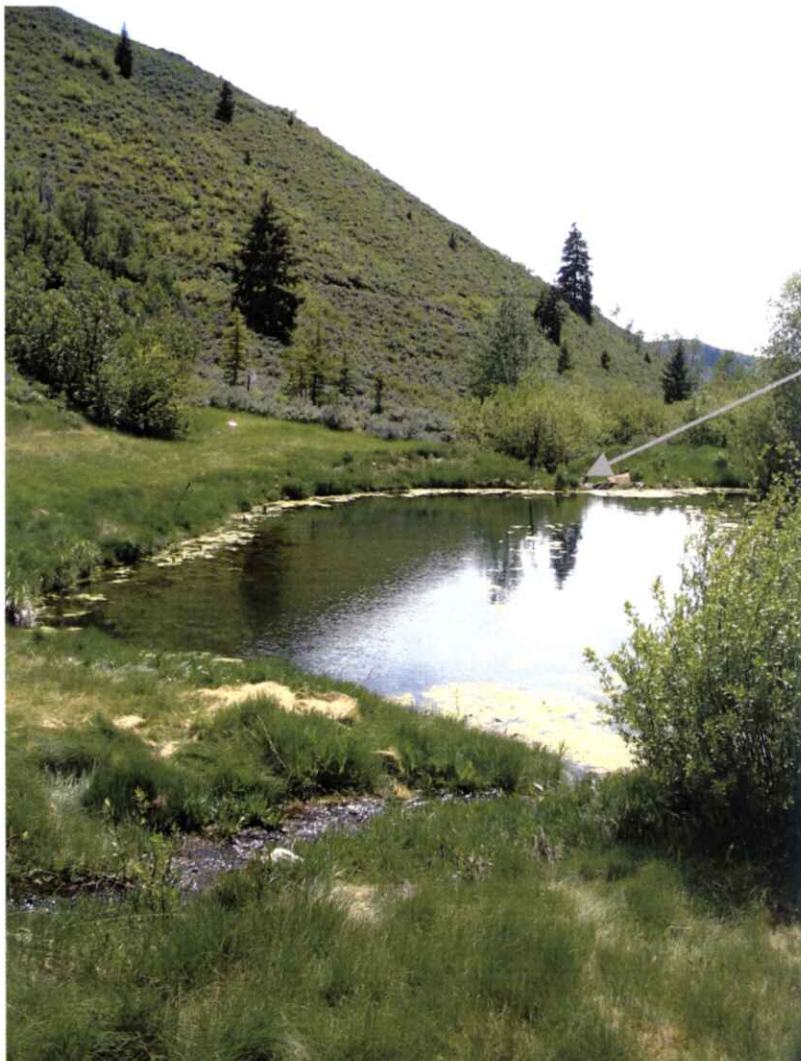
Where spring-fed channel #2 feeds into pond #2. Arrow shows outlet from pond #2.

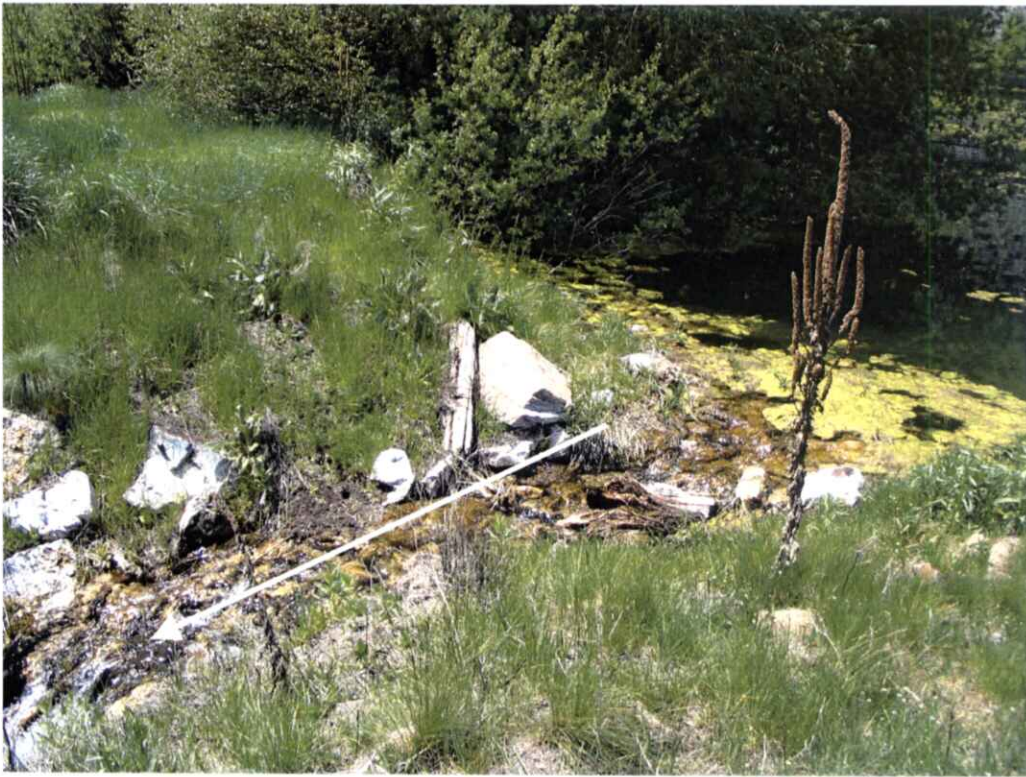
Outflow from  
Pond #2. Arrow  
shows direction of  
flow.

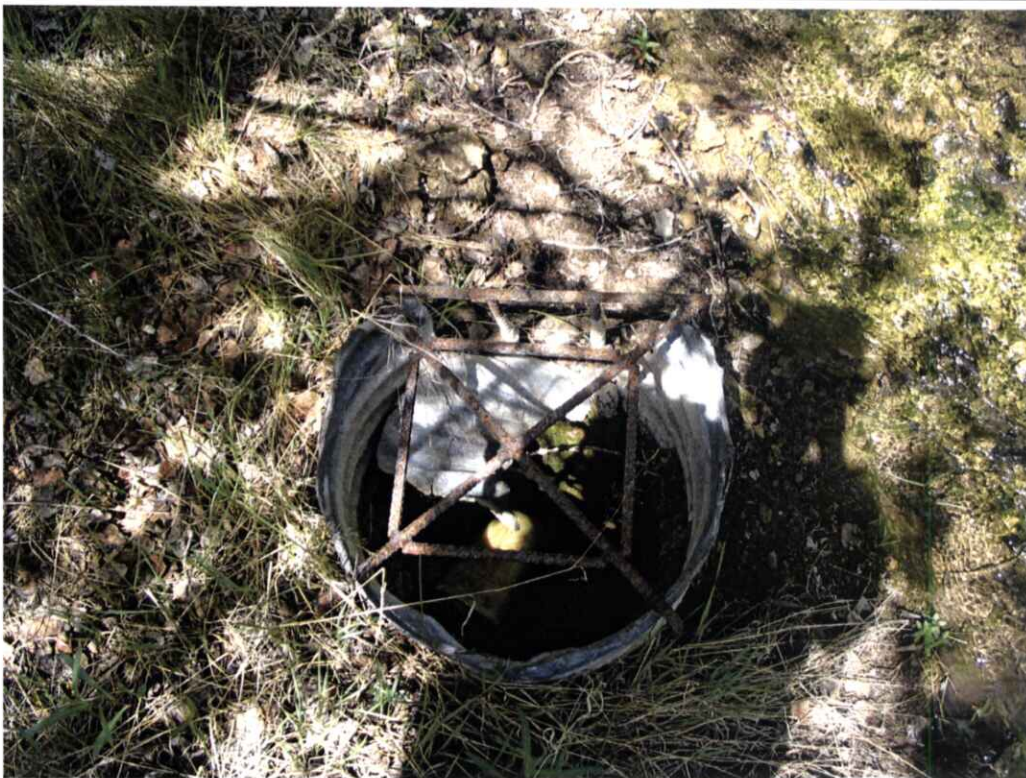
Overflow  
structure directly  
adjacent to  
channel #1 just  
upstream of falls  
to pond #1. Pipe  
in structure to  
unknown  
location.

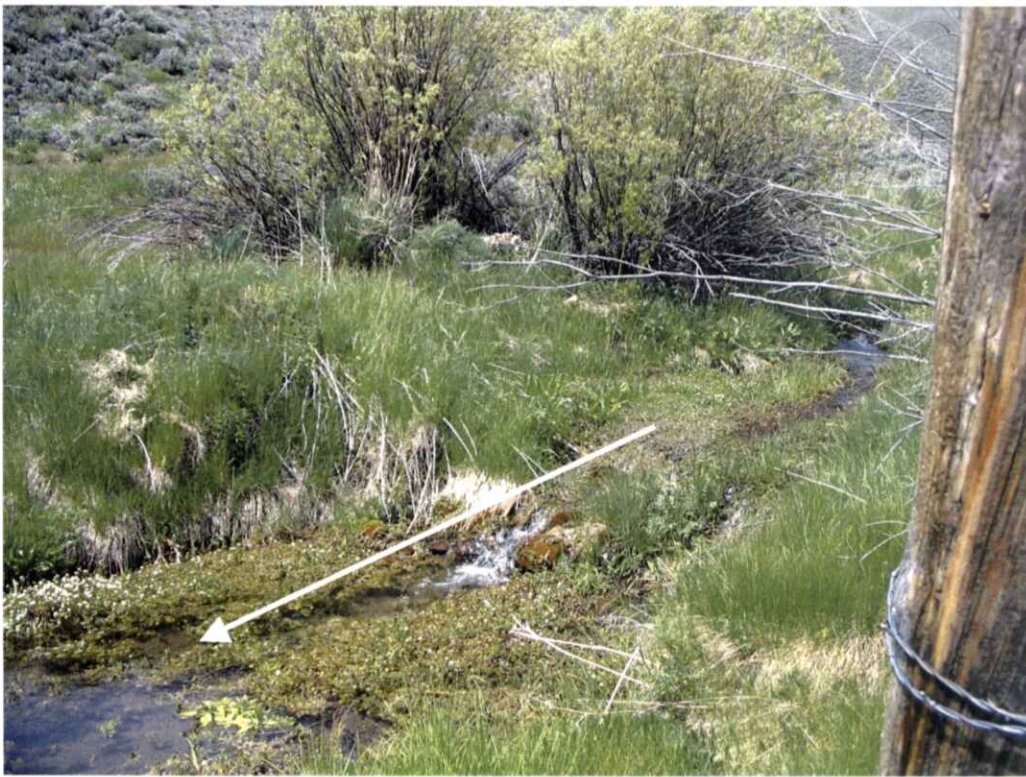
Parker Gulch  
Creek flowing to  
PoD.

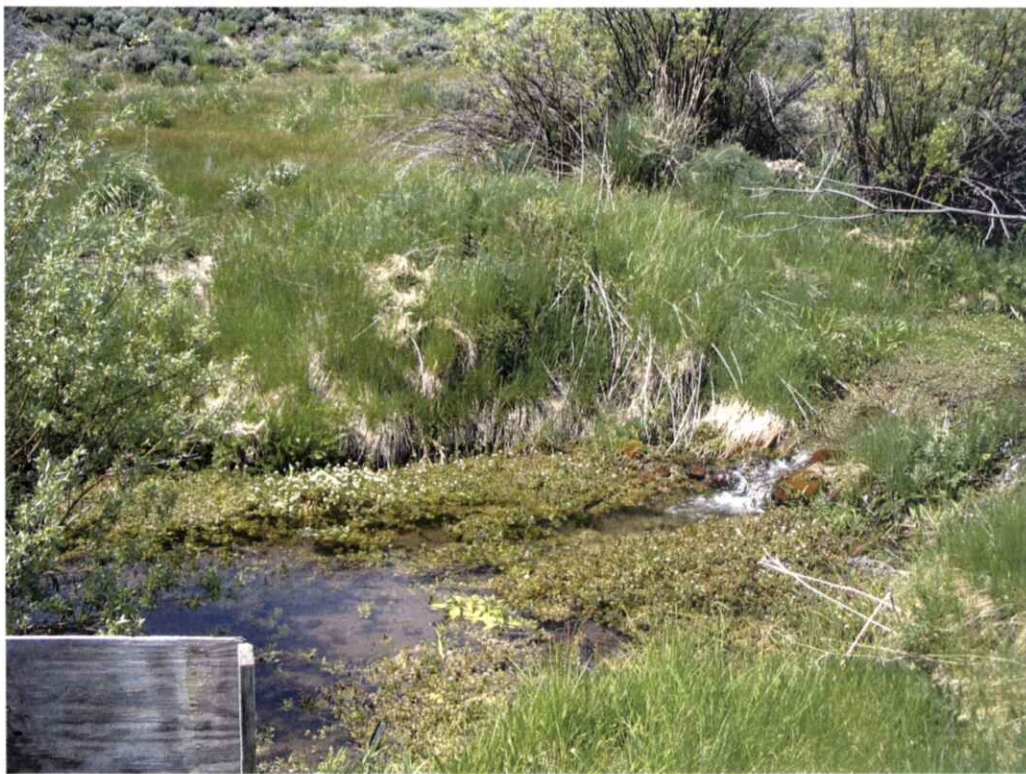
Parker Gulch  
Creek flowing to  
PoD.

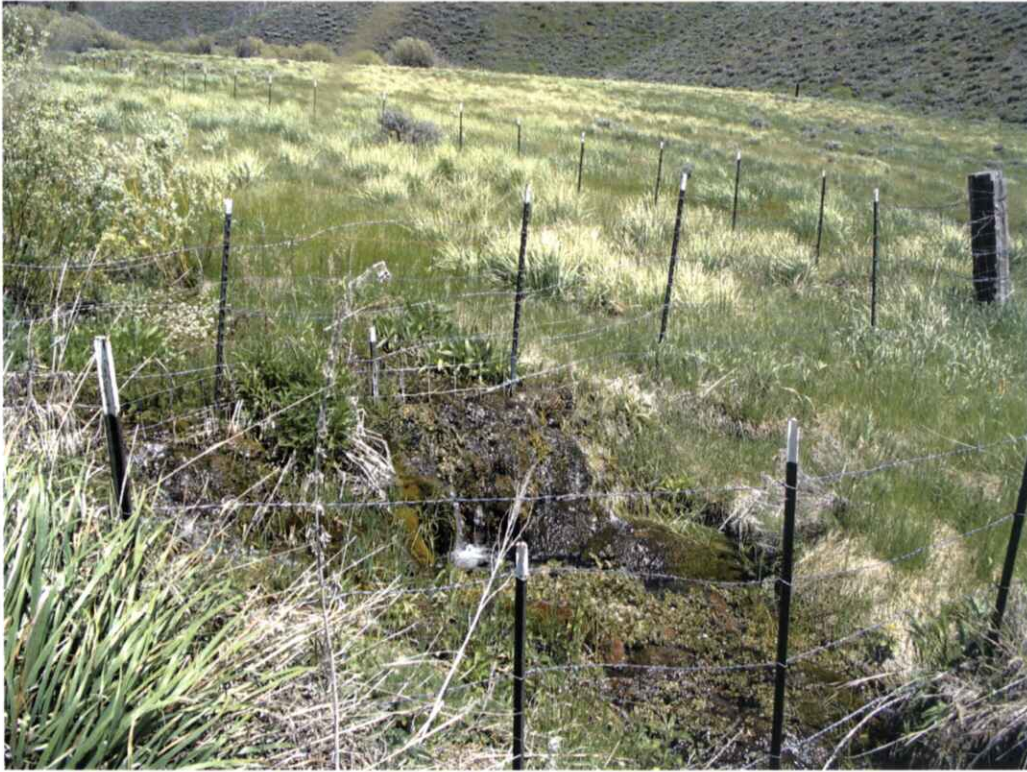
Parker Gulch  
Creek flowing in  
channel 1 toward  
pond #1

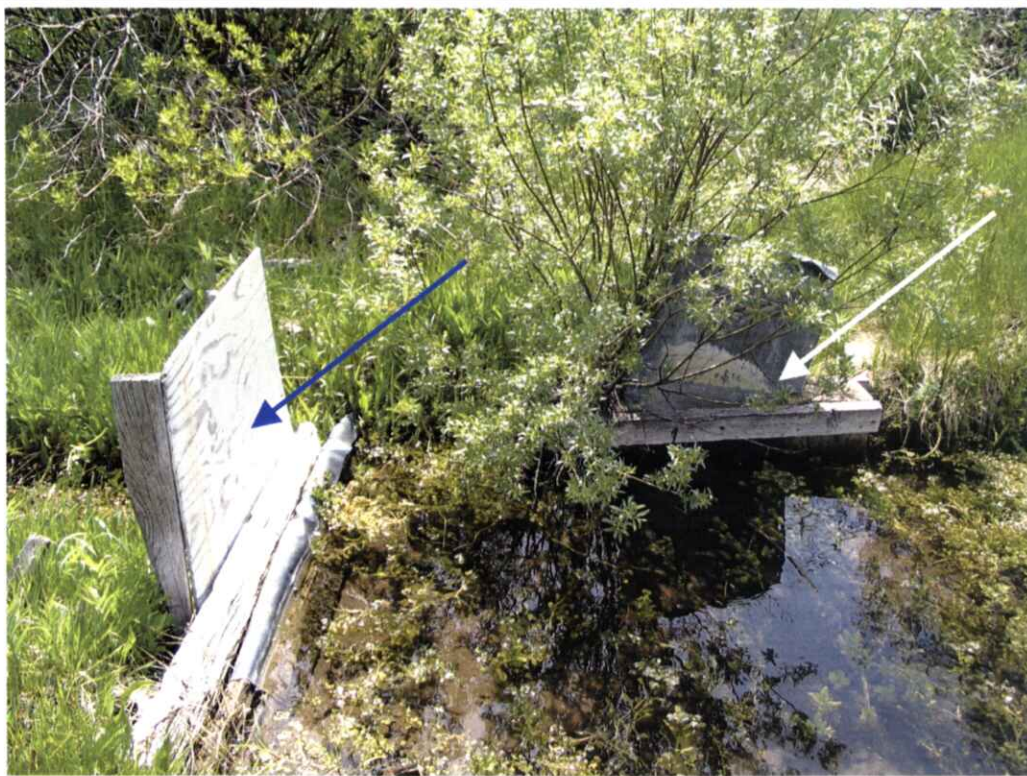
**PoD** was located by GPS in the SESW of Section 10, T4N, R18E. Since this location was not included on the application/permit, it will need to be amended. No flow measurements were attempted because the water flows were extremely low at this time. The measurement from the May, 1998 exam will be used as the system capacity since the permit-holder has the ability to divert 100% of the flow using the 2 small dams at the PoD (see photos).

PoD. White  
arrow into  
channel 1. 95%  
of (very low)  
flow was being  
diverted this  
direction on June  
16, 2005. Blue  
arrow into  
channel #2. A  
small amount of  
water was  
getting into  
channel #2 –  
probably not on  
purpose, dam is  
sort of leaky.

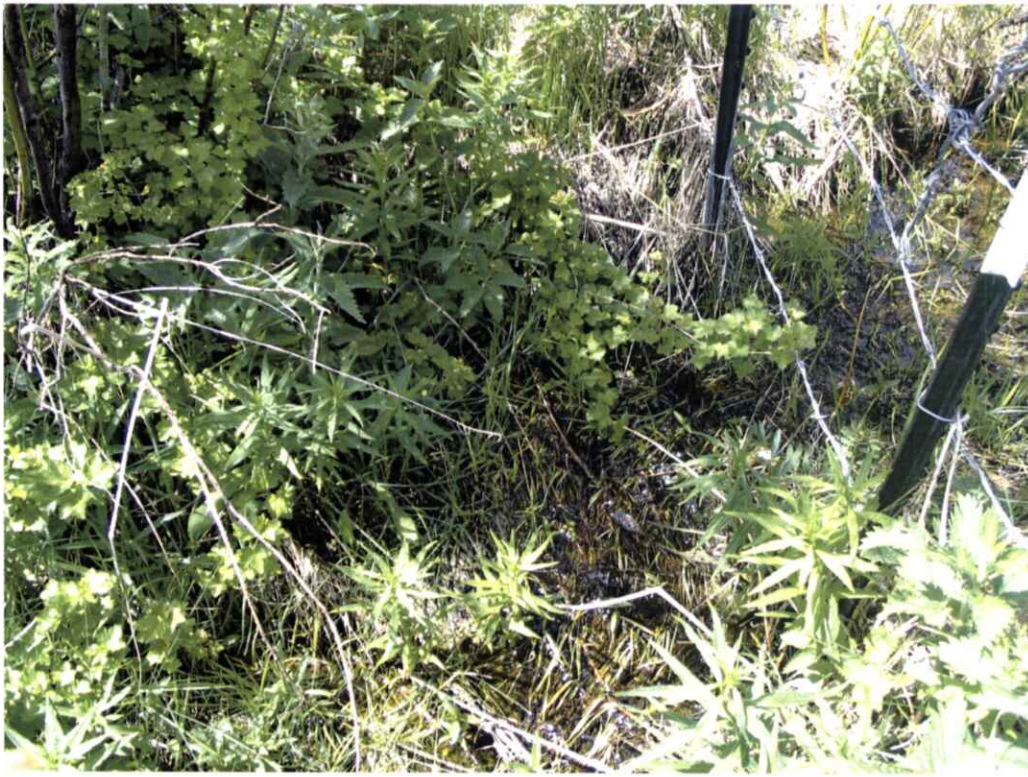
Spring in bed of  
channel #2.

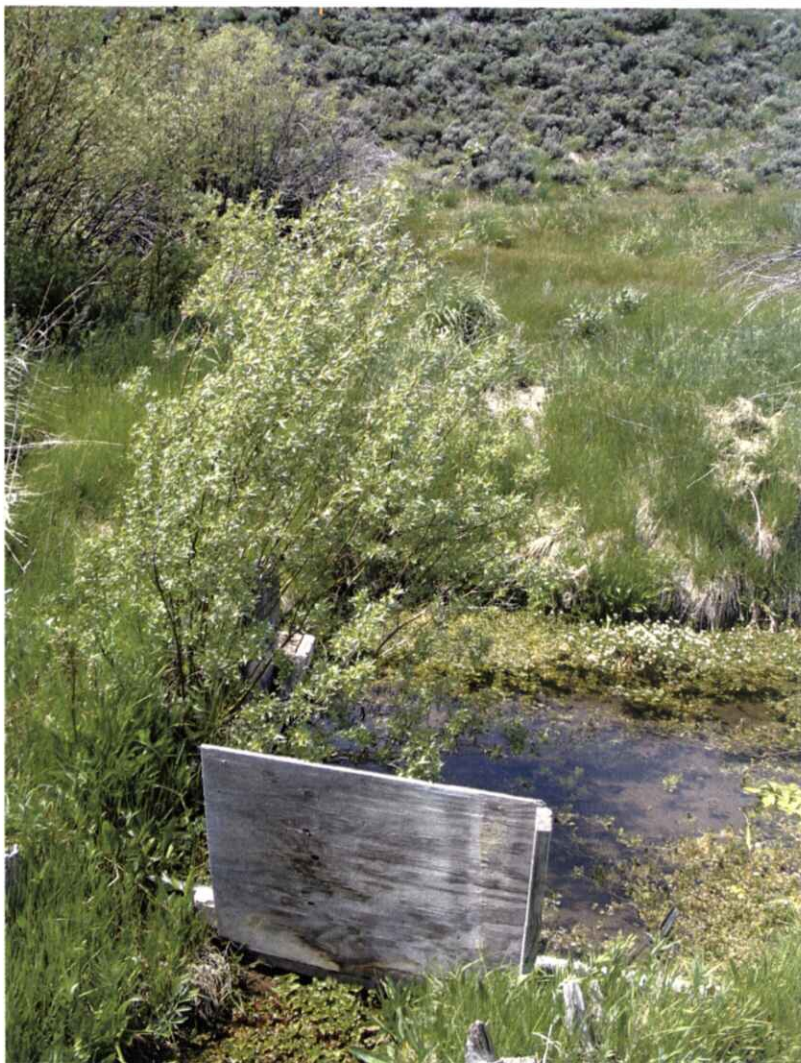
PoD looking NW from channel 2.

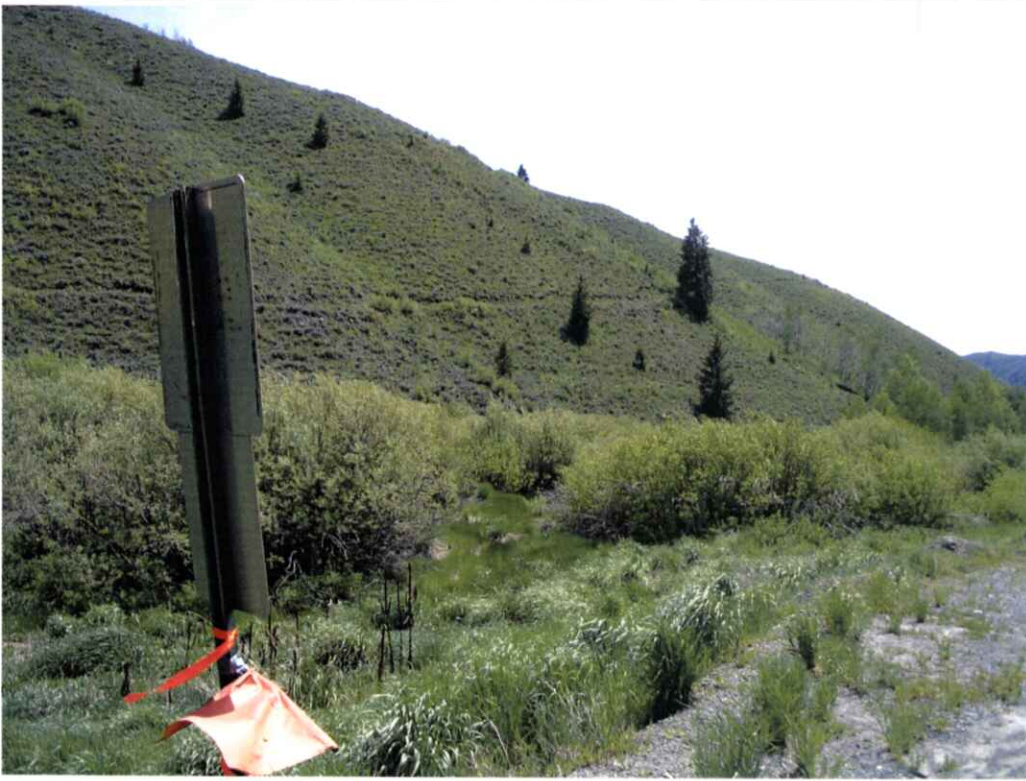
Looking SW down  
side of road at land  
SW of ponds  
which is  
supposedly  
irrigated.

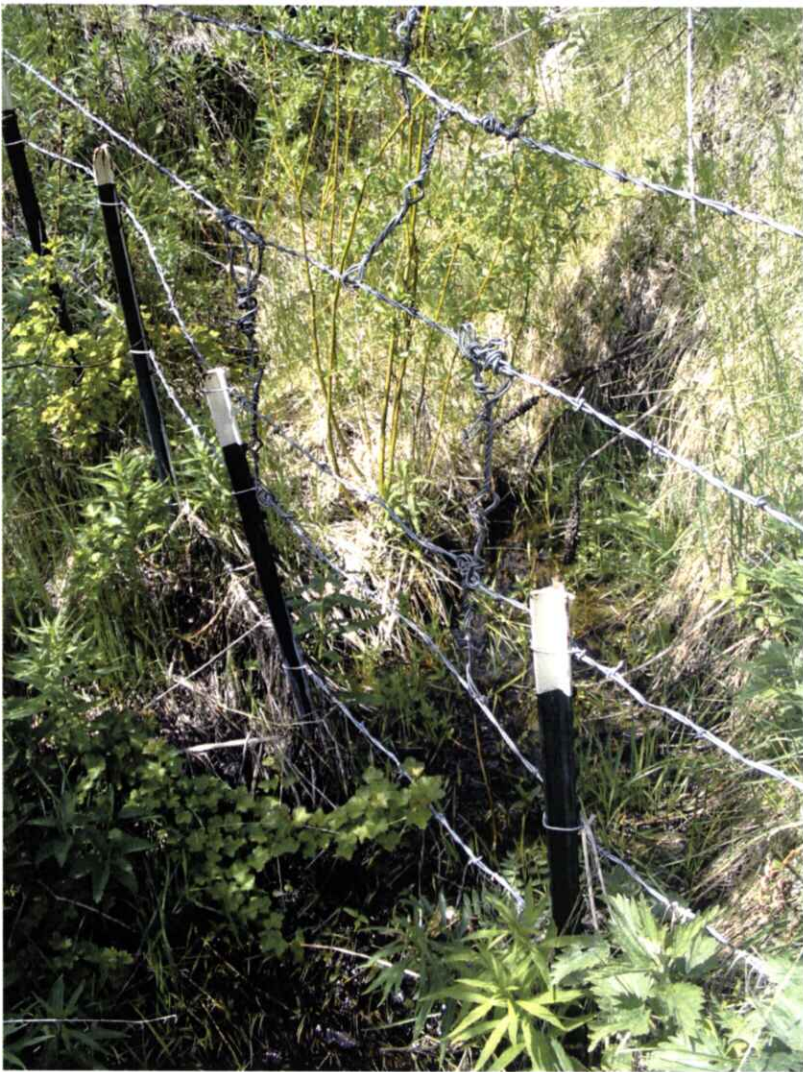
Spring in bed of channel 2.
