### **Drinking Water Supply Report**

County: **Boundary** PWS #: **1110019**  
System: **Mission Creek Water Association**  
System Representative: **Will Parker**  
Surveyed by: **Alan Miller**  
Source: **Well**  
Population/Connections: **90/36**

Date: **September 21, 2004**

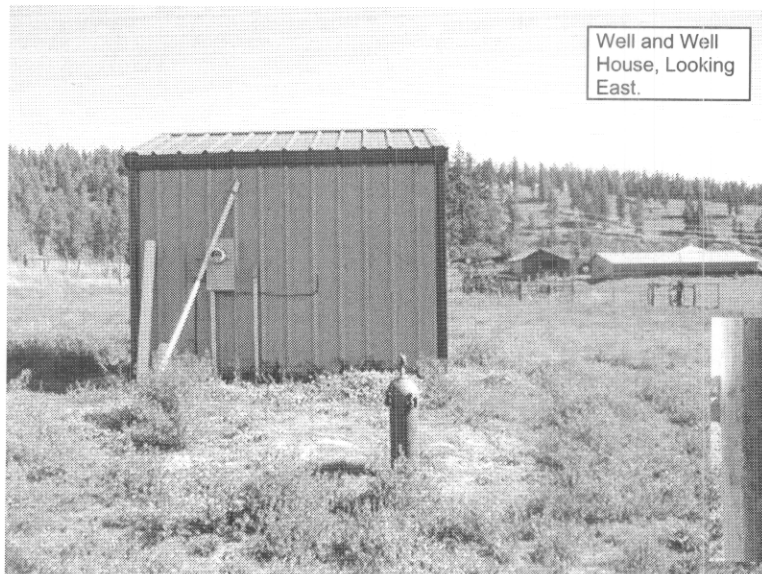
IDWR Well  
Tag # D0003635

Mission Creek Well House, and Well . Location Bob Dillin Property, T64N, R1E, Section 7

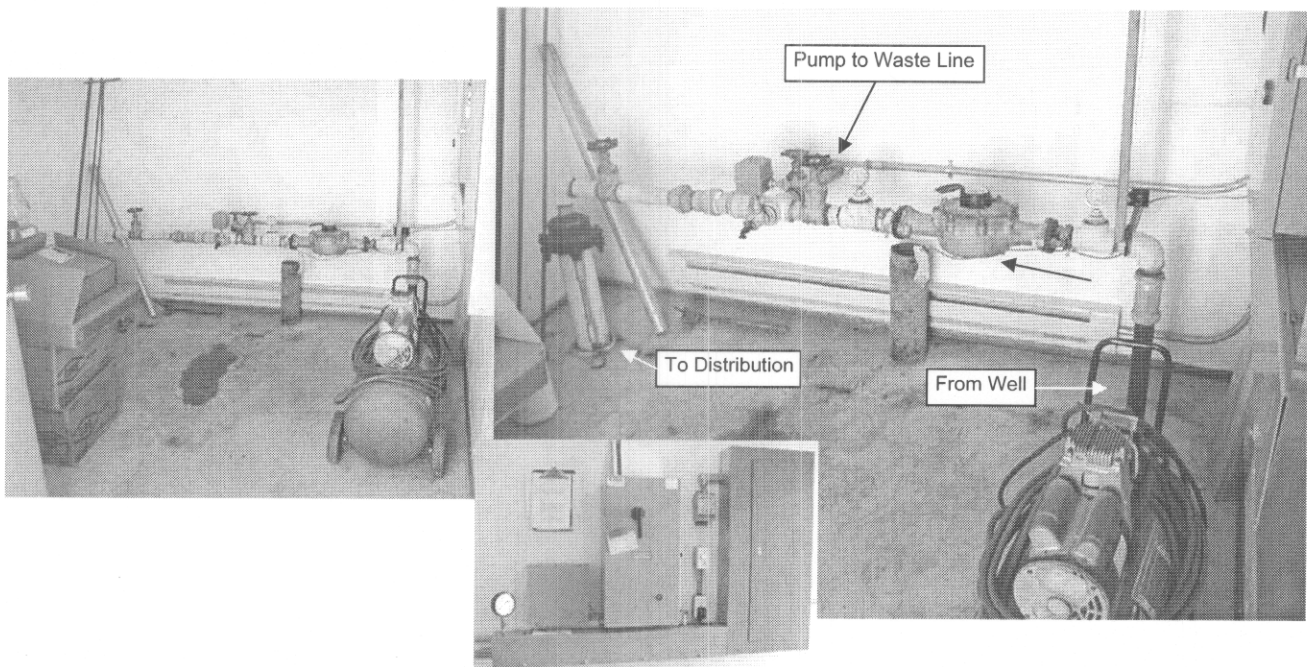
Well House and Control Panel

A plan will need to be established to provide adequate source water for the Association's needs. The DEQ understands the Association is working on this. The alarm system should to be repaired.

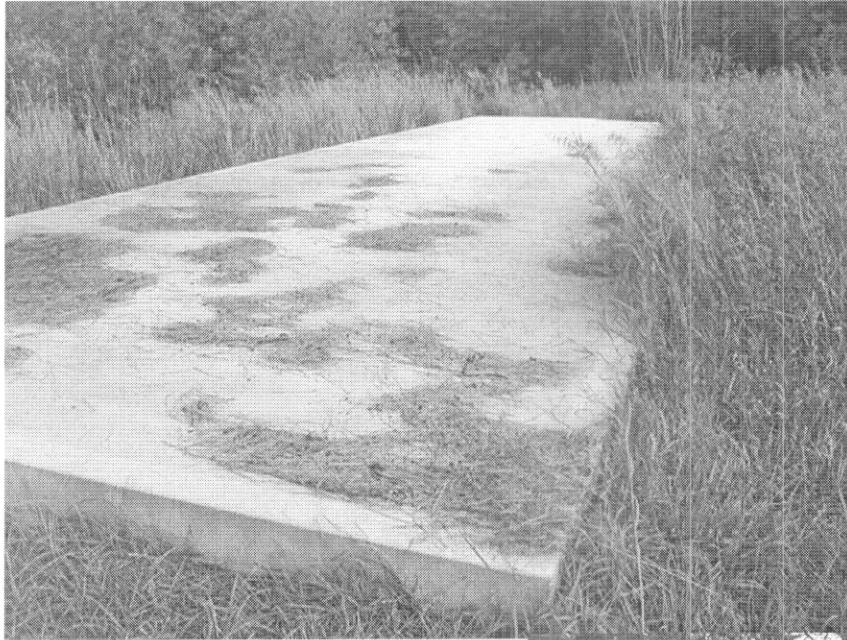
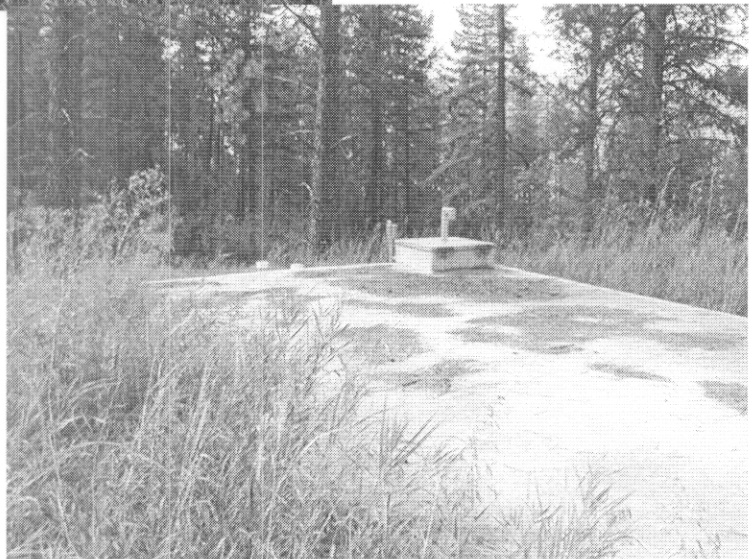
50,000 Gallon Concrete Storage Reservoir (Constructed 1998)

A 50,000 gallon rectangular concrete storage tank was constructed in 1998. It is approximately 8 feet deep. The tank rides on the distribution system and was cleaned by Association personnel in 2003. The drain, overflow and vent screens need finer mesh (#24) screens installed. Tank level controls the well via floats and a dedicated phone line. At the time of the inspection, the alarm system, which should call several board members and illuminate a red light at the well house in the event of failure, was malfunctioning. Repair of the alarm system would have helped reduce the severity of the water depletion situation experienced earlier this year.

The tank drain, overflow, and vent needs to have #24 mesh screen installed over their openings.

1. Install #24 mesh screen on tank vent, overflow, and drain lines.
