MEMORANDUM
Hess Property Site Inspection
(south of Lake Fork)

From: J. Westra, Western Reg.
Date: 10/90/02

RE: Complaint--Pond Construction
E-mail 10/1/02 Attached

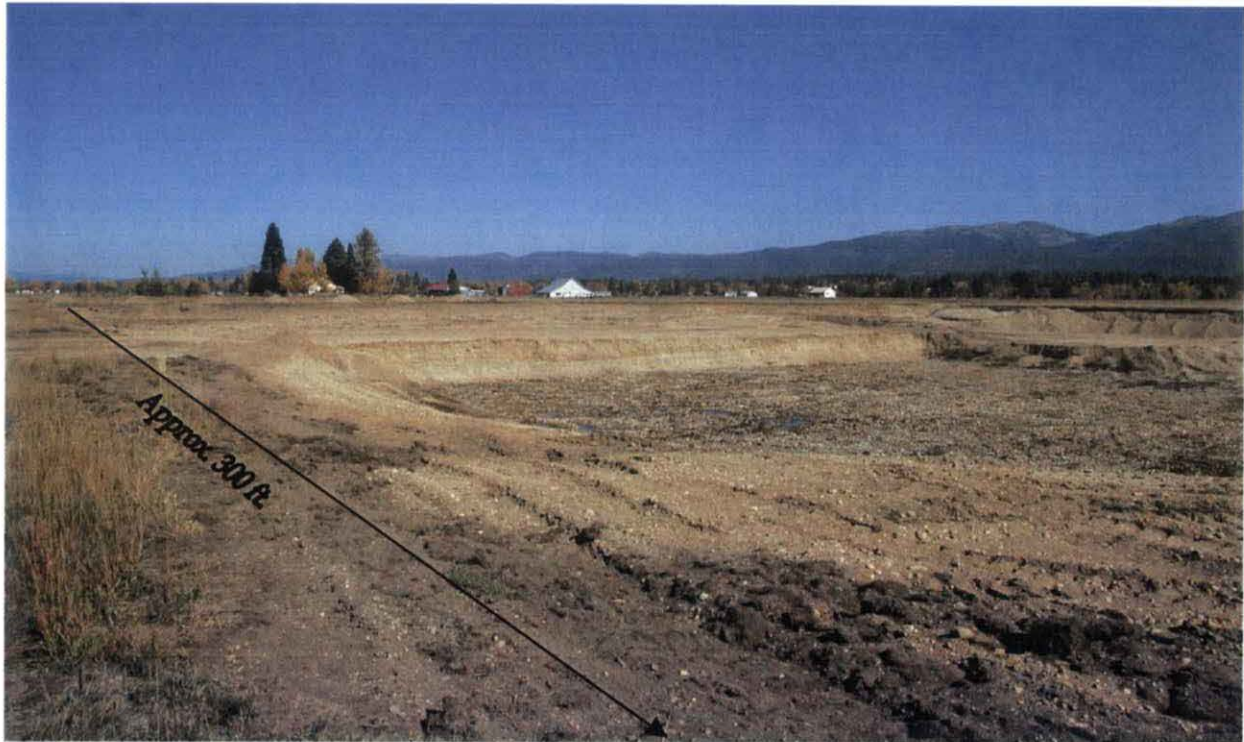
Photo #1: Pit from the southwest corner, The southwest ¼ is approx. 5 ft deep.

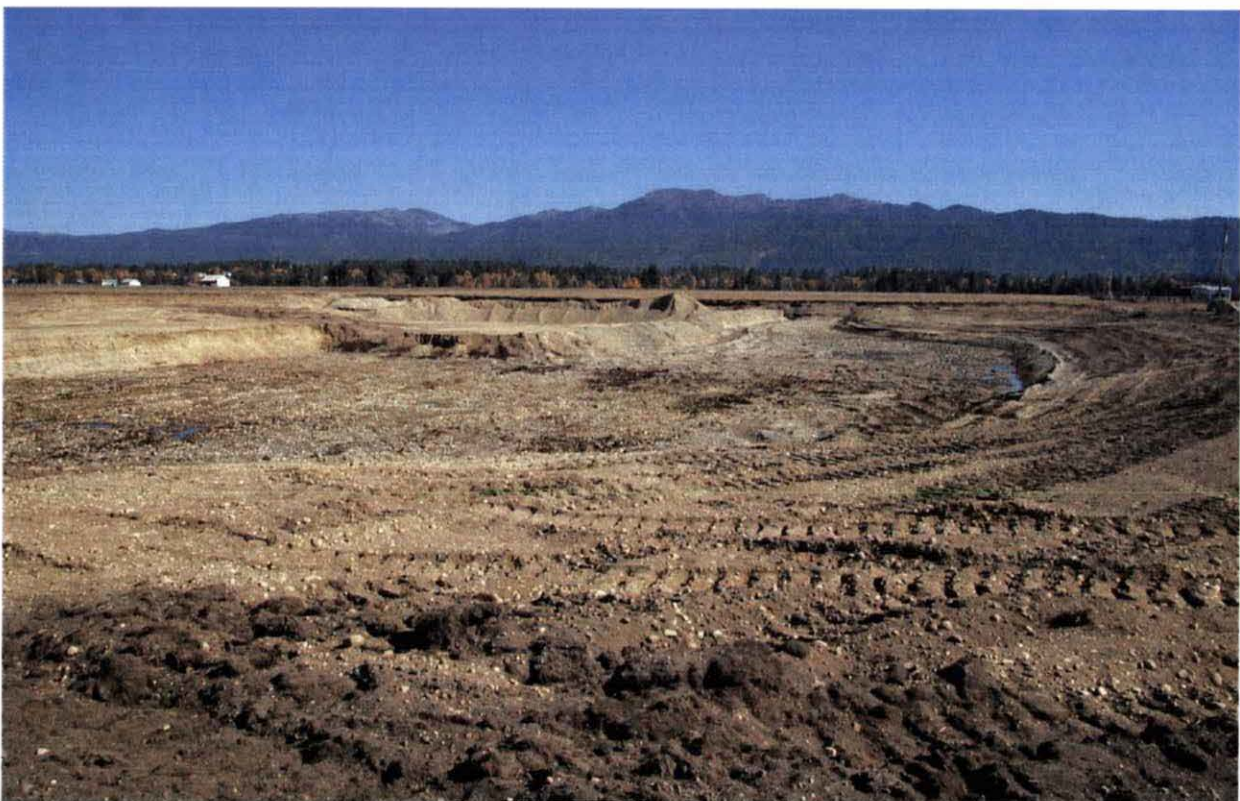
Photo #2: South ½ of the pit, some standing water along the edges, cobble rock along bottom.

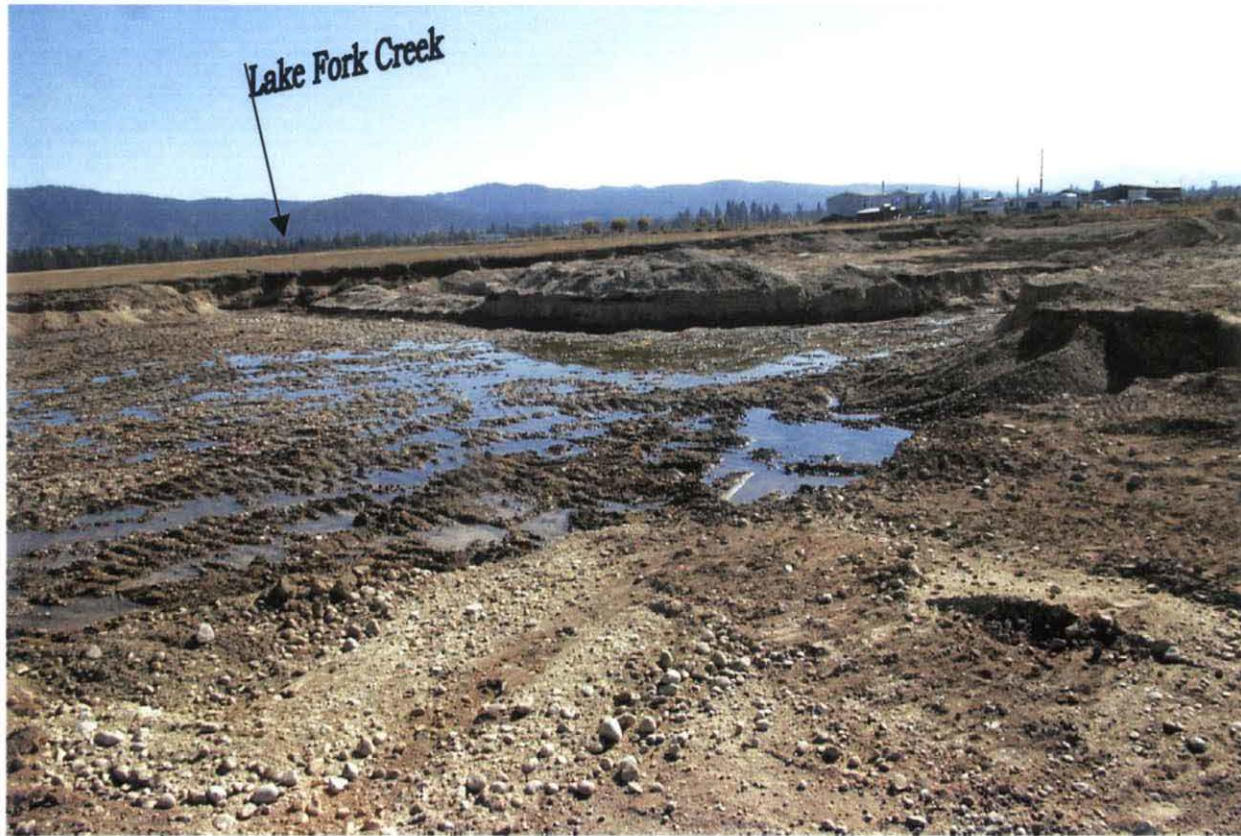
Photo #3: Standing water in the north portion of the pit, considerably deeper.
