WATER RESOURCES WESTERN REGION

Edward Squires
Hydrogeologist
1530 Knights Drive
Boise, Idaho 83712
(208) 342-8369 (answering recorder after 4 rings)

Mr. Dave Tuthill Western Region Manager State of Idaho Department of Water Resources 2735 Airport Way Boise, ID 83705

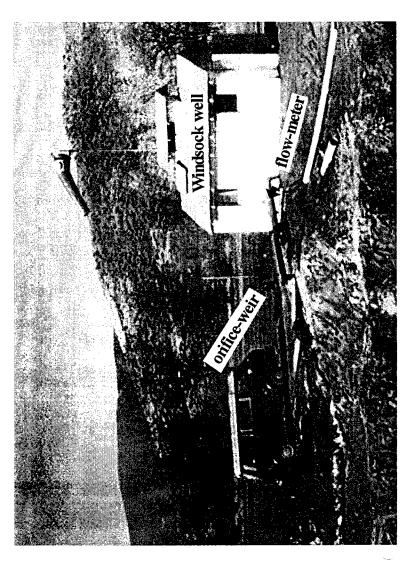
Figure 2. Configuration of circular orifice-weir discharge during hydraulic-testing of the Terteling "Windsock" well during April of 1994.
