# MEMORANDUM

**TO:** Muldoon Creek Water District (37-O) File

**SUBJECT:** Field Visit

On September 9<sup>th</sup>, Corbin Knowles and I visited Muldoon Creek to inventory water diversions and measuring devices in an effort to gather information to assess compliance with the Department's October 2003 order requiring the installation of control works and measuring devices. Corbin and I met Jim Peterson, Water District 37-O water master, and Mr. Peterson proceeded to show Corbin and I around. The various points of diversion were GPSed, some site tags were installed, photos were taken, and some measurements were made. The following documents our observations during our visit...

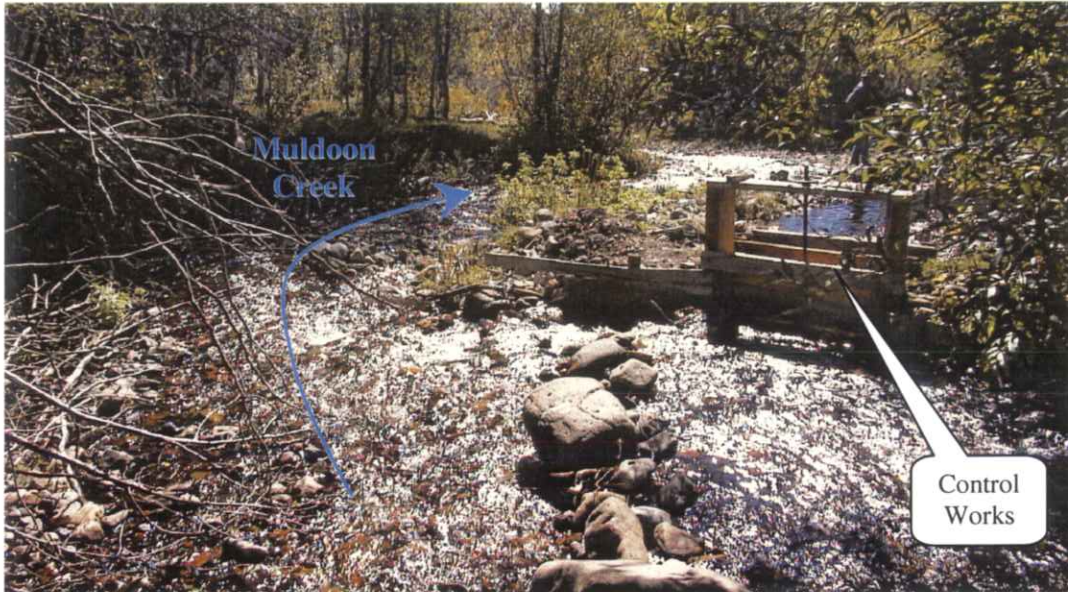
**ABOVE:** View looking down Muldoon Creek with control works visible at the head of Guy Peterson's ditch.

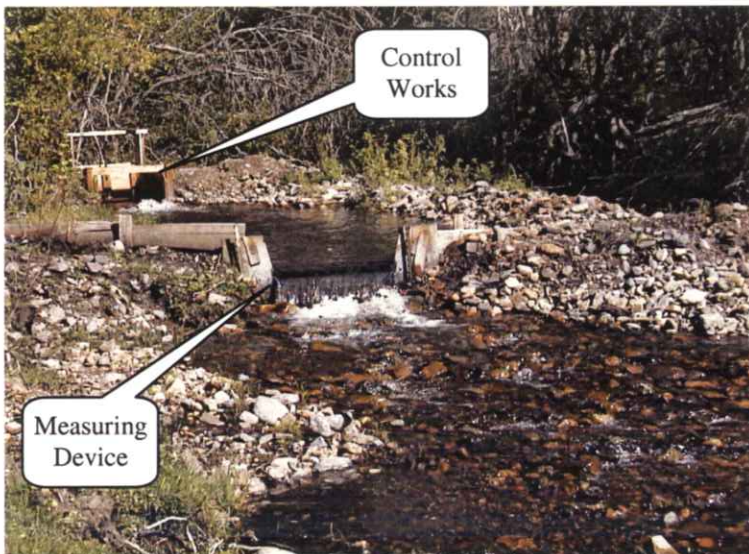
**LEFT:** View looking up Guy Peterson's ditch through the measuring device towards the control works.

Control works consist of wooden gate structure with wooden gate and metal gate stem. Measuring device consists of a 3.0 foot Cipoletti Weir (metal blade in wood structure). No staff gage was present for the measuring device. Flow through measuring device was measured at 2.16 cfs.

**Concerns:** Durability of wooden control works and measuring device structure? Lack of staff gage. Guy Peterson's SRBA filing, 37-1143 for 2.8 cfs, identifies point of diversion in Section 24 (T03N, R21E).

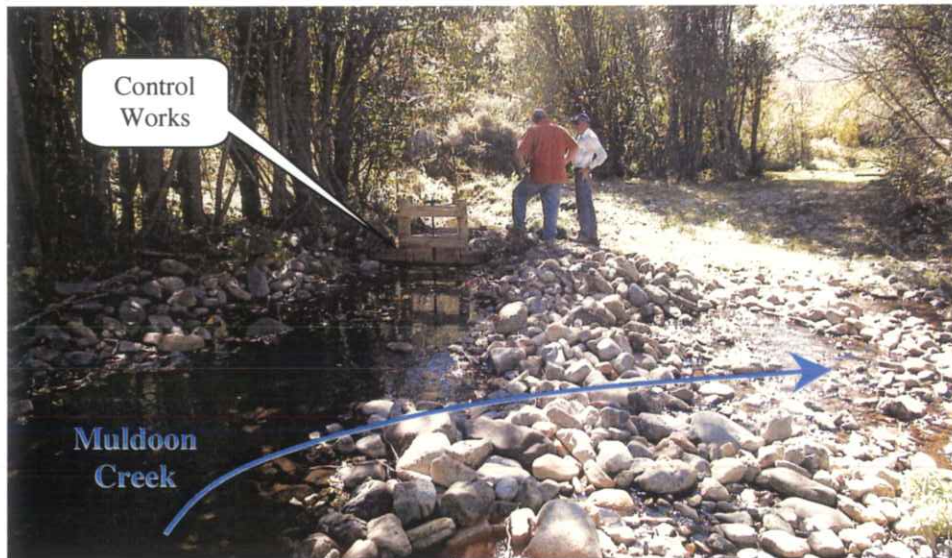
**ABOVE:** View looking down Muldoon Creek with the Muldoon Grazing Association's upper diversion works visible at the head of their ditch.

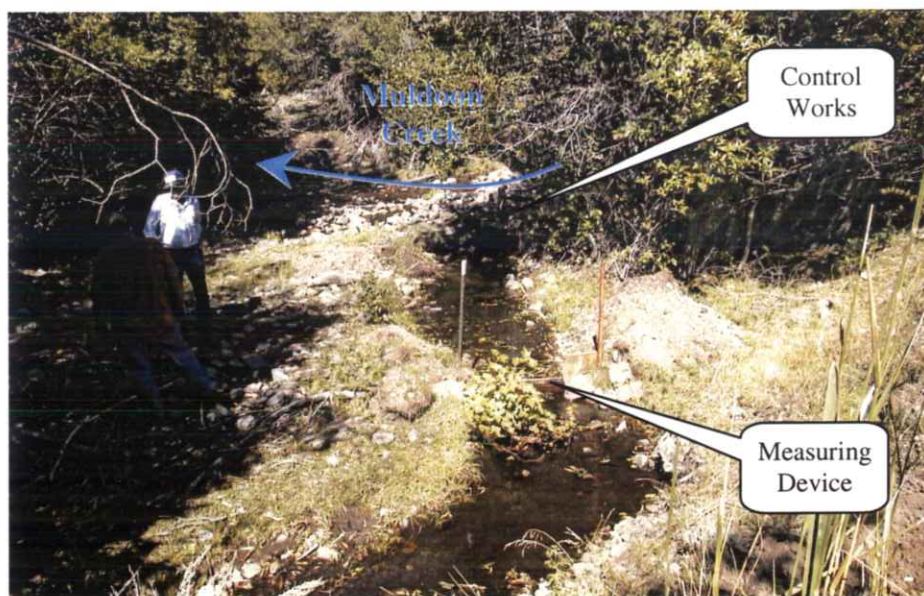
**BELOW:** View from hillside looking down towards the Muldoon Grazing Association's upper diversion works and ditch. Note standing water in ditch, but no flow over the measuring device.

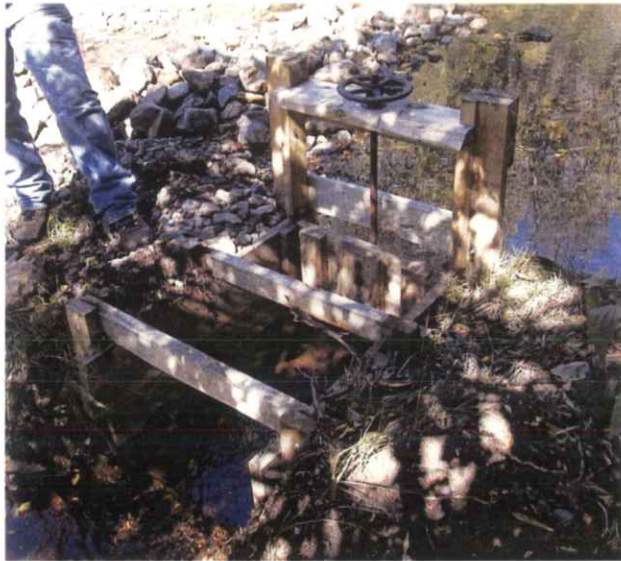
**LEFT:** View of wooden control works at the head of the ditch.

**Concerns:** Durability of wooden control works and measuring device structure? Lack of staff gage and metal weir plate.

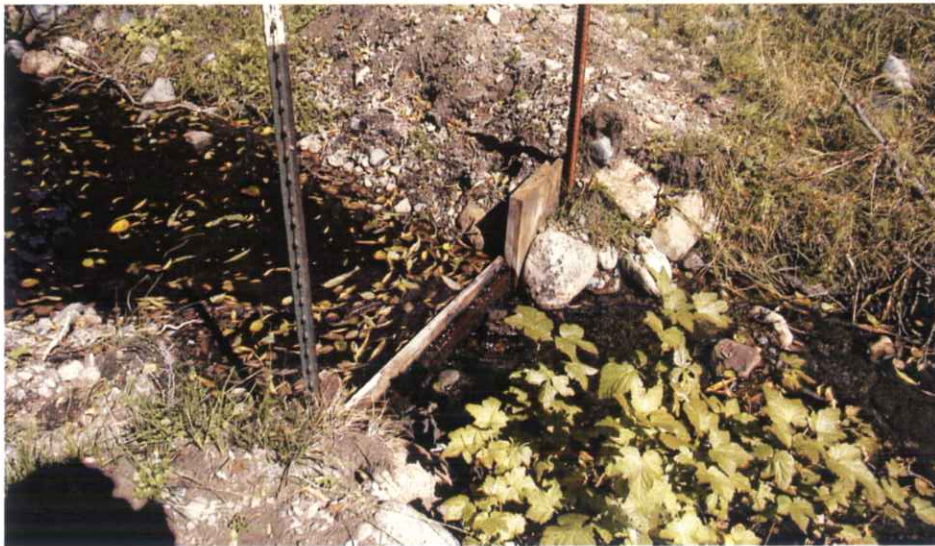
**BELOW:** View of wooden measuring device (rectangular weir). Note lack of a metal weir blade, device leaning downstream, and standing water upstream and downstream (possible leakage?).

Control works consist of wooden gate structure with wooden gate and metal gate stem. Measuring device consists of a 3.0-foot rectangular weir (no metal blade in wood structure). No staff gage was present for the measuring device. The wooden device was leaning and water may have been leaking around device. No flow measurement was made.

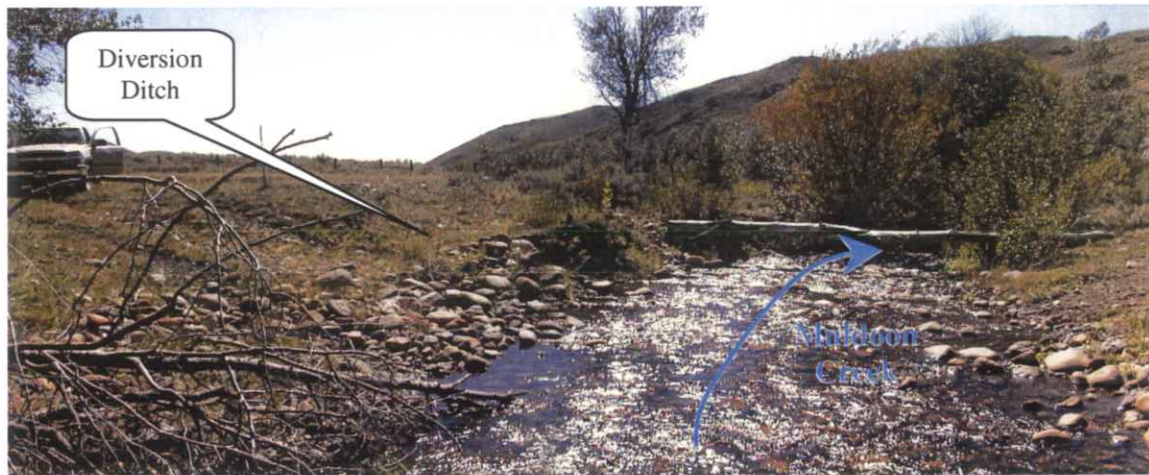
View looking down Muldoon Creek at the head of the Muldoon Grazing Association middle diversion ditch. Note relative height of ditch in relation to the creek, lack of control works, measuring device, and overall appearance that appears to indicate lack of recent use of this diversion.

**Concerns:** No control works or measuring device present. Possible lack of use of this particular diversion? Muldoon Grazing Association's SRBA filing, 37-2751 for 5.33 cfs, appears to identify this point of diversion in the SWNE of Section 26 (T03N, R21E).

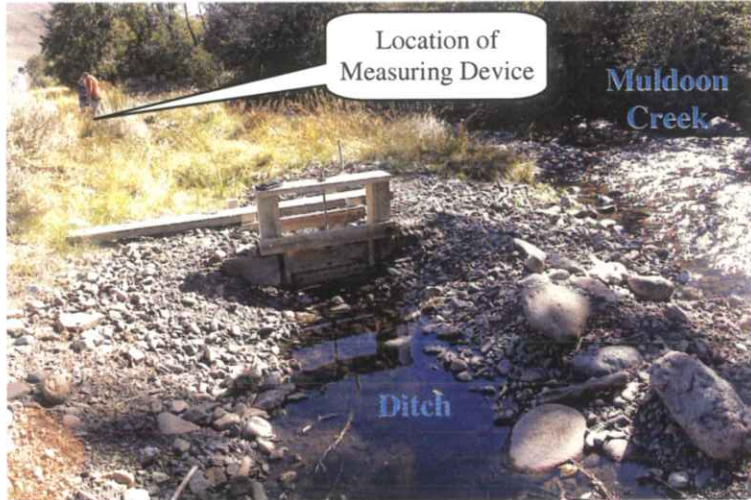
**LEFT:** View looking down Muldoon Creek showing the diversion works for the Muldoon Grazing Association Lower Diversion Ditch.

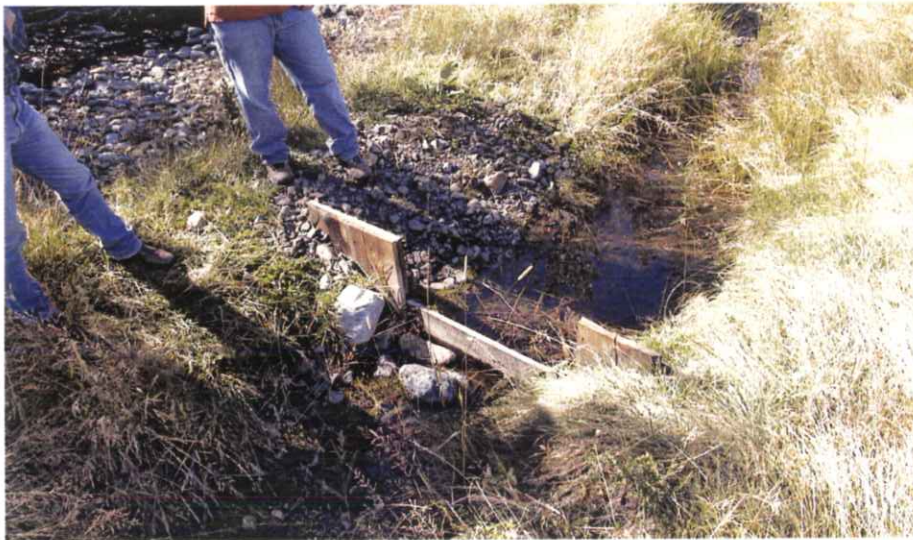
**BELOW:** View of wooden measuring device (rectangular weir). Note lack of a metal weir blade, device leaning downstream, and standing water upstream and downstream (possible leakage?).

Control works consist of wooden gate structure with wooden gate and metal gate stem. Measuring device consists of a 3.0-foot rectangular weir (no metal blade in wood structure). No staff gage was present for the measuring device.

**Concerns:** Durability of wooden control works and measuring device structure? Lack of staff gage and metal weir plate. Muldoon Grazing Association's SRBA filing, 37-2751 for 5.33 cfs, appears to identify this point of diversion in the NENW of Section 35 (T03N, R21E).

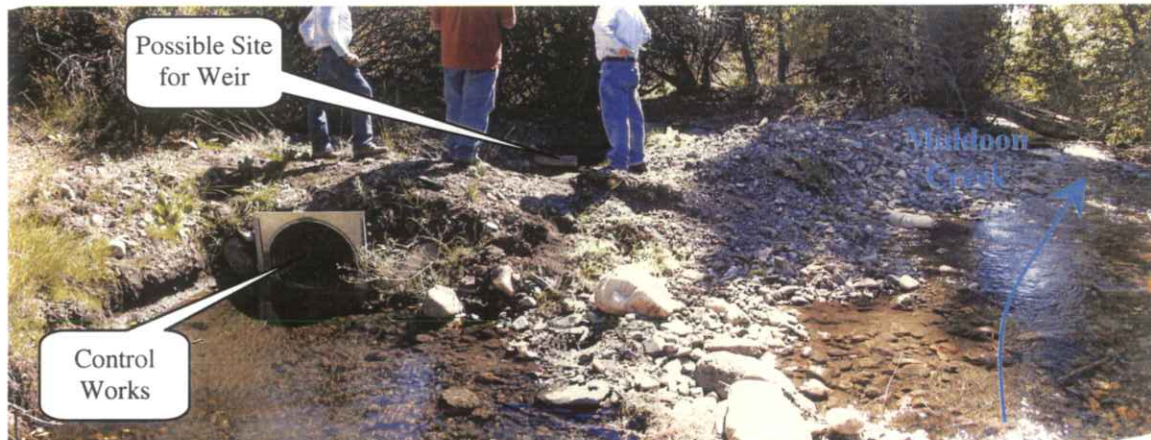
**ABOVE:** View looking down Muldoon Creek showing the diversion works for the Upper Clark Diversion.

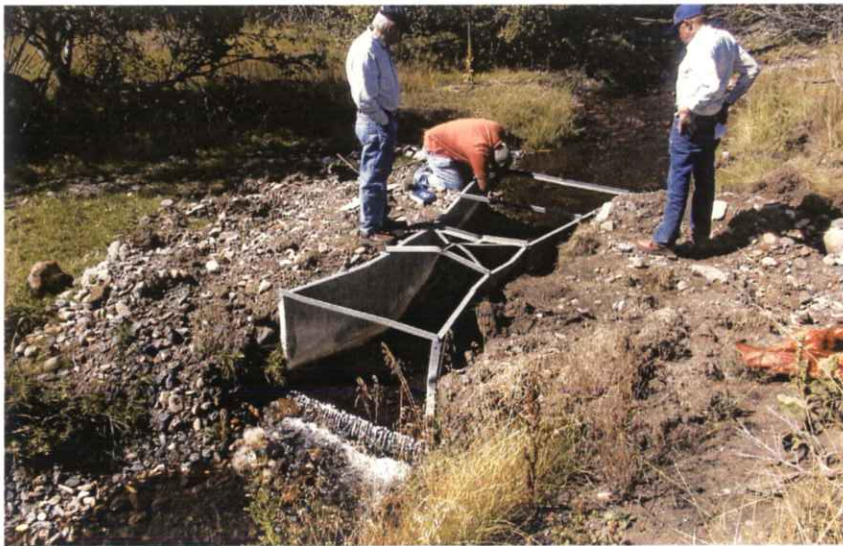
**LEFT:** View of the measuring device (2.5 ft Parshall flume) on the Clark Upper Diversion Ditch.

Diversion works consist of metal slide gate structure, but gate was not on the structure. Measuring device consists of a 2.5 foot Parshall flume. Converging section of the flume was not level. Flow through measuring device was measured at 0.81cfs. Device appears large for small flows later in summer. It may be possible to install a weir just downstream of the diversion to measure smaller flows.

**Concerns:** Lack of gate on diversion works. Accuracy of the device? Flume may be too large for measurements at lower flows (< 0.20 ft of head). Clark's SRBA filings, 37-1120 and 37-1140, for 7.3 total cfs?, identifies point of diversion in NSW Section 35 (T03N, R21E).

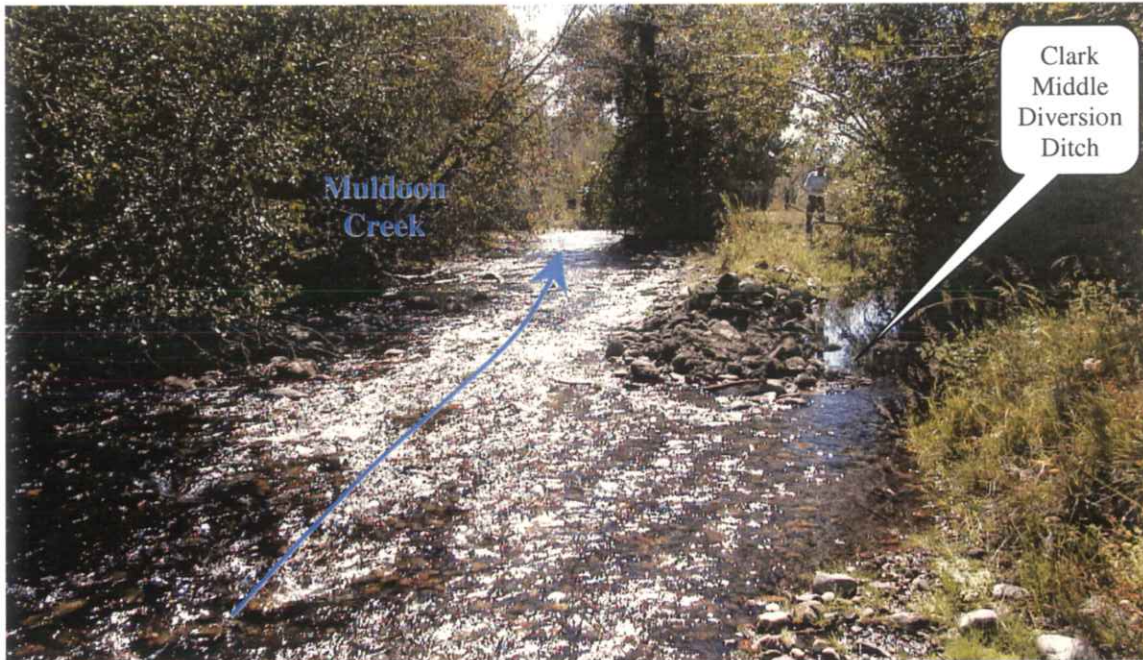
View looking down Muldoon Creek at the head of the Clark middle diversion ditch. Note lack of control works. In addition, no measuring device was present on this particular ditch.

**Concerns:** No control works or measuring device present. Clark's SRBA filings, 37-1120 and 37-1140, for 7.3 total cfs?, identifies point of diversion in NWSW Section 35 (T03N, R21E).

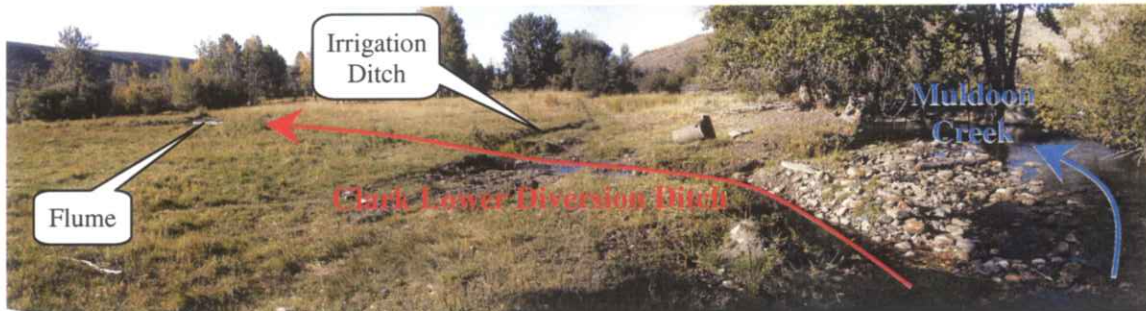
**ABOVE:** View looking down Muldoon Creek with Clark Lower Diversion Ditch shown. Note lack of control works and irrigation ditch, off of the main diversion ditch, located upstream of the flume.

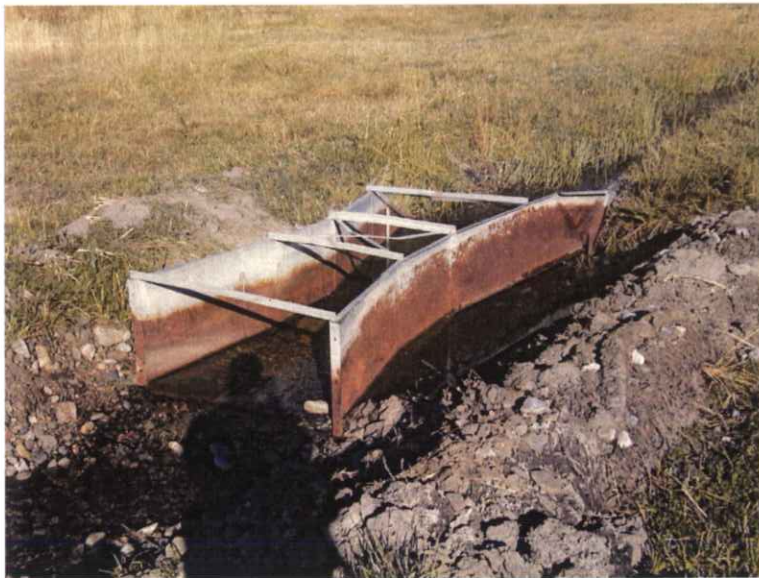
**LEFT:** View of Parshall flume on the Clark Lower Diversion Ditch. Note flow around the flume and overall condition, and installation of the flume. The survey revealed that the converging section slopes up, as you move downstream, and the left side is actually lower than the downstream end of the flume.

No diversion control works are present. Measuring device consists of a 2.5 foot Parshall flume. A level survey of the flume reveals that part of the converging (upstream) section is actually lower than the downstream end of the flume. In addition, the converging section was 0.16 feet lower on the right side than the left side. Quite a bit of water was flowing around the flume. An irrigation ditch, off of the main diversion ditch, was also located upstream of the flume. The gage on the flume measured 0.23 feet of head, but the problems with the device did not provide an accurate measurement of flow through the ditch.

**Concerns:** Lack of diversion control works. Accuracy of the device? Flume may be too large for measurements at lower flows (< 0.20 ft of head). Water in ditch upstream of device will not be measured with current flume location. Clark's SRBA filings, 37-1120 and 37-1140, for 7.3 total cfs?, identifies point of diversion in NWSW Section 35 (T03N, R21E).

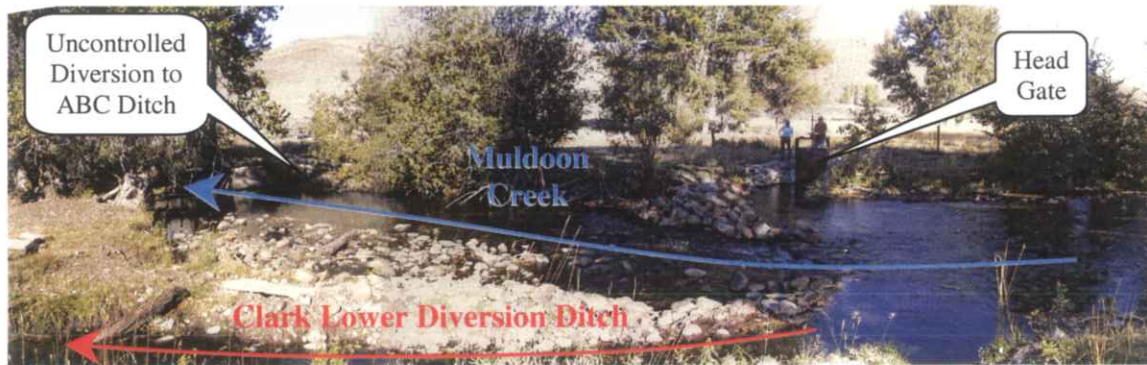
**ABOVE:** View looking across Muldoon Creek towards the ABC Agra Upper Diversion(s). Note a head gate has been installed, but water from Muldoon Creek still enters the diversion ditch via an uncontrolled diversion just downstream of the recently installed head gate. The head of the Clark Lower Diversion Ditch is visible in the foreground of this view.

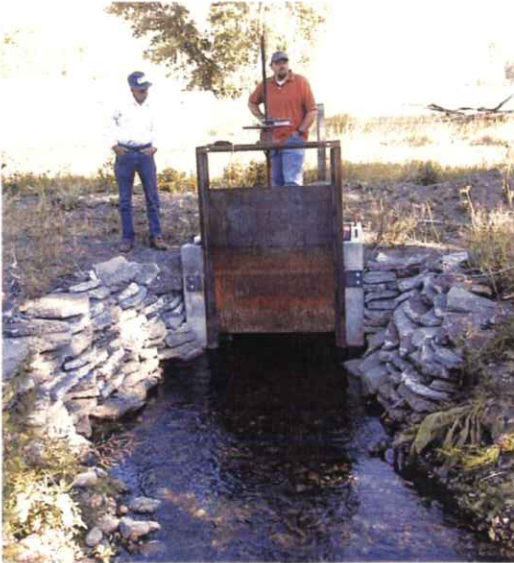
**LEFT:** View of the recently installed head gate for the ABC Agra Upper Diversion. This head gate is tied into a buried 30" diameter pipeline that discharges into the upper diversion ditch.

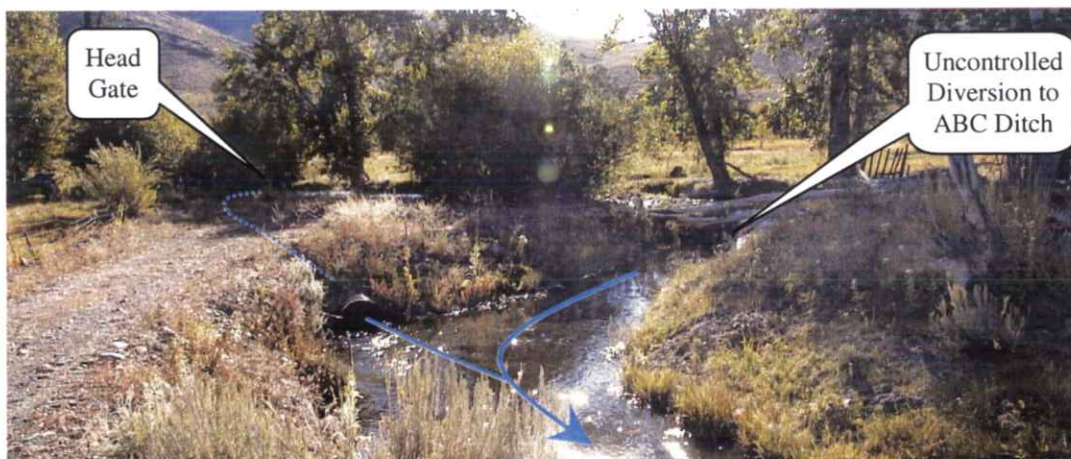
**BELOW:** View looking back up the ABC Agra Upper Diversion Ditch showing the location of the discharge from the pipeline from the head gate. Also note uncontrolled water from Muldoon Creek entering the ditch.

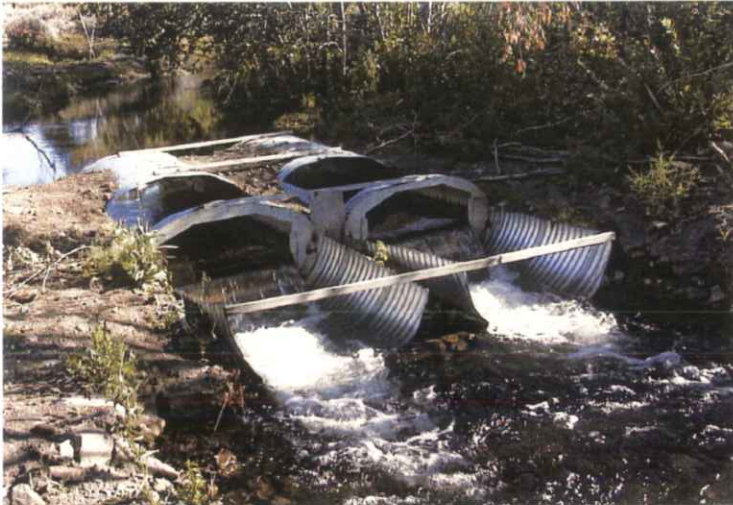
**LEFT:** View of measuring device, two 42" rectangular weirs, in ABC Agra Upper Diversion Ditch.

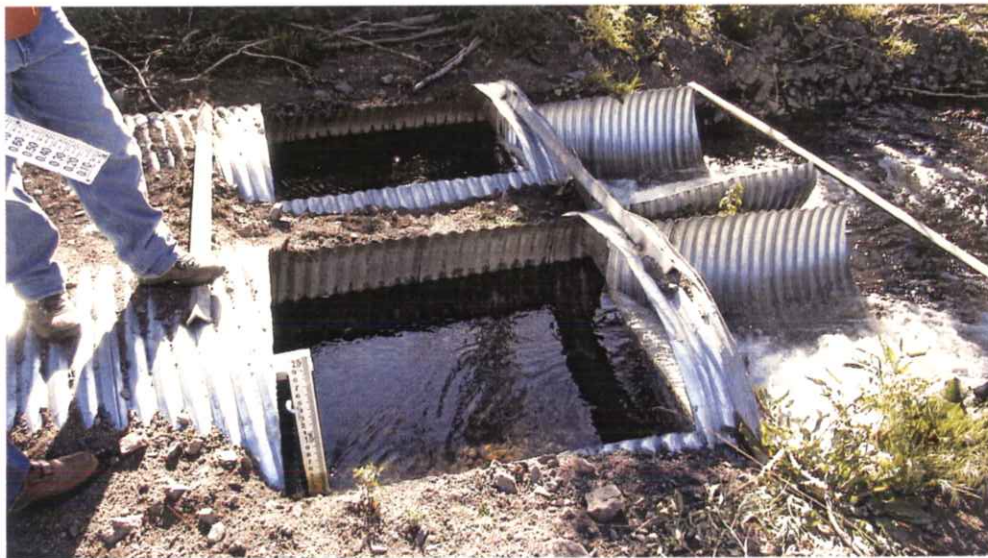
**BELOW:** Close up view of measuring device showing presence of only one staff gage, but weirs are not at the same elevation.

Diversion works consist of metal screw gate structure. However, another uncontrolled diversion also enters the ditch. Measuring device consists of two 42-inch rectangular weirs placed in parallel. One staff gage was present for one of the weirs, but the two weirs were not at the same elevation. Flow through left (east) weir was measured at 3.52 cfs and flow through right (west) weir was measured at 3.88 cfs.

**Concerns:** Lack of control on all of the water entering the ditch. Measuring device needs a staff gage on both weirs. ABC Agra's SRBA filings identify point of diversion in SWNE Section 3 (T02N, R21E).

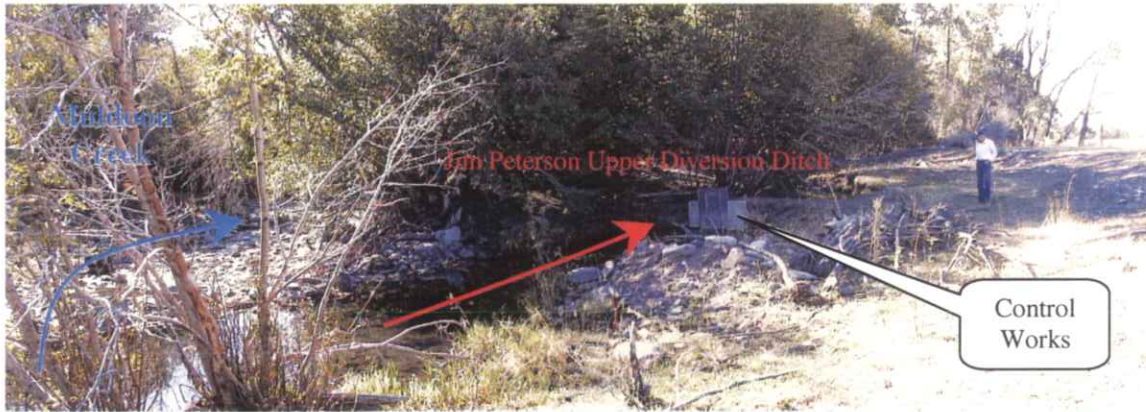
**ABOVE:** View looking down Muldoon Creek showing the diversion location for the head of Jim Peterson's upper diversion ditch.

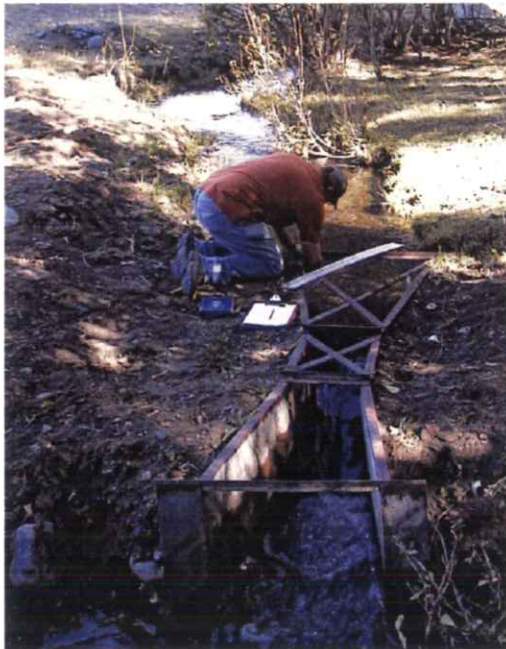
**LEFT:** View of one foot Parshall flume installed in Jim Peterson's upper diversion ditch.

Control works consist of a concrete structure with metal slide gate. Measuring device consists of a 1.0 foot Parshall Flume. The staff gage on the flume was bent and read 0.84 feet, but the actual head reading was 0.95 feet. Flow through measuring device according to the gage was 3.07 cfs, but the actual flow was 3.70 cfs.

**Concerns:** Bent staff gage. Jim Peterson's SRBA filings, 37-99 and 37-1141, have claimant ownership issues (Muldoon Livestock vs Muldoon Grazing Assoc). Maybe database issues?

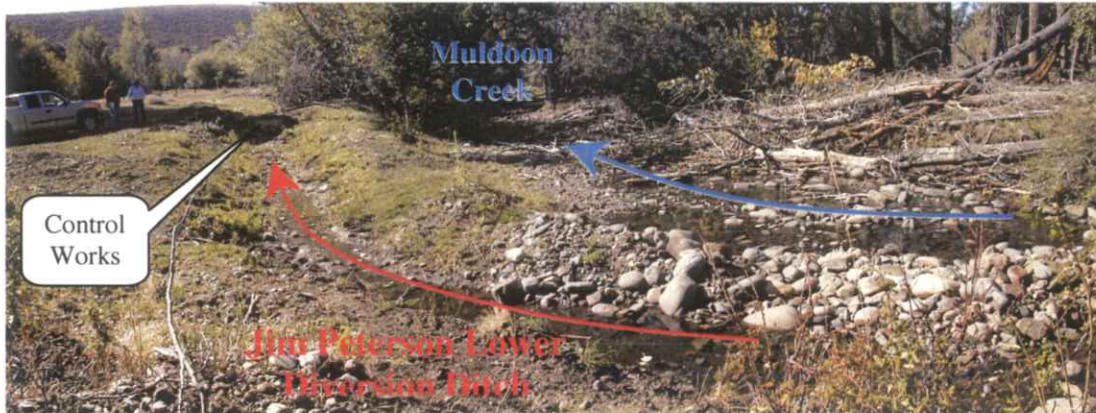
**ABOVE:** View looking down Muldoon Creek showing Jim Peterson's lower diversion ditch.

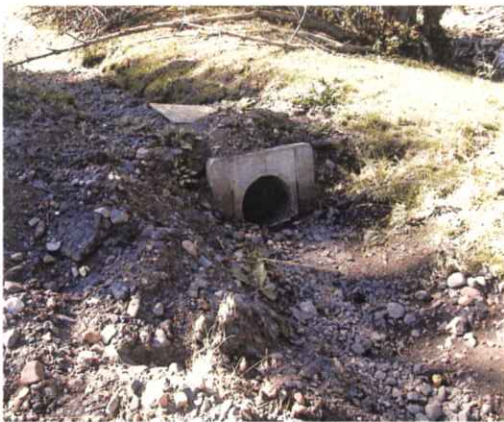
**LEFT:** View of control works in Jim Peterson's lower diversion ditch

Control works consist of a concrete structure with no slide gate. Measuring device consists of a 1.0 foot Parshall Flume. The staff gage on the flume was bent. At the time of the inspection, no water was flowing through the flume.

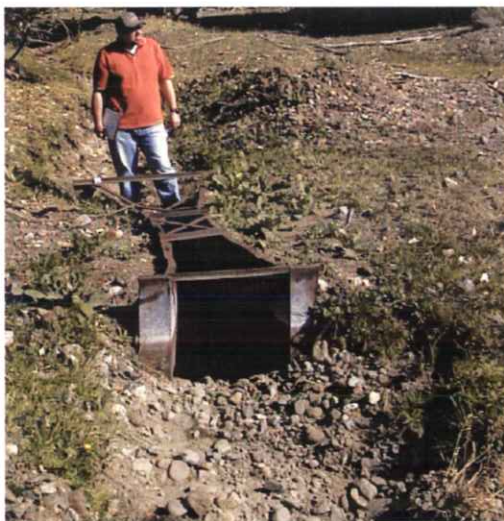
**LOWER LEFT:** View of one foot Parshall flume installed in Jim Peterson's lower diversion ditch.

**Concerns:** Bent staff gage. Jim Peterson's SRBA filings, 37-99 and 37-1141, have claimant ownership issues (Muldoon Livestock vs Muldoon Grazing Assoc). Maybe database issues?

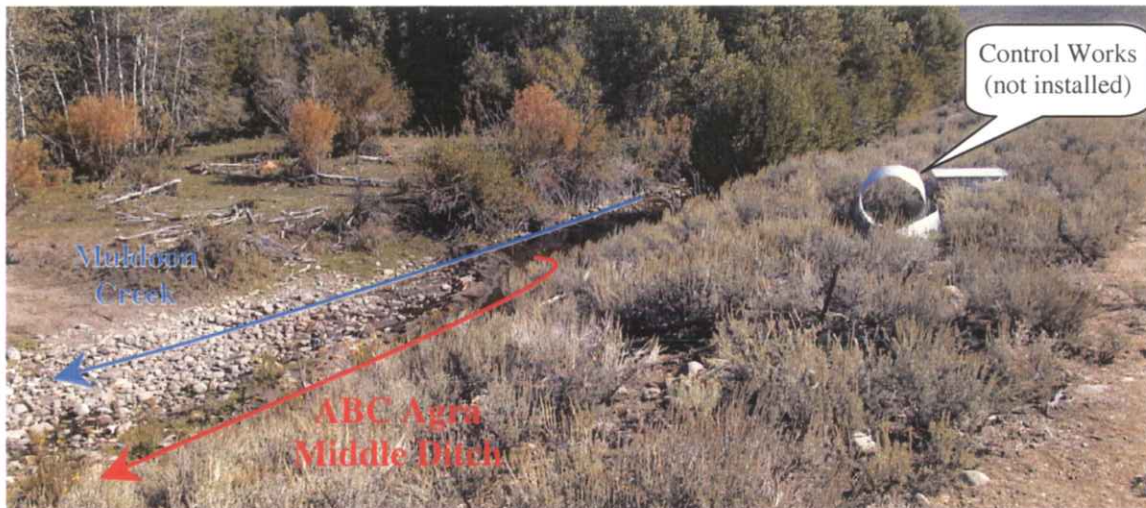
**ABOVE:** View looking down on the ABC Middle Diversion. Note control works not yet installed.

**Concerns:** Lack of control works. Measuring device located quite a ways downstream from the point of diversion.

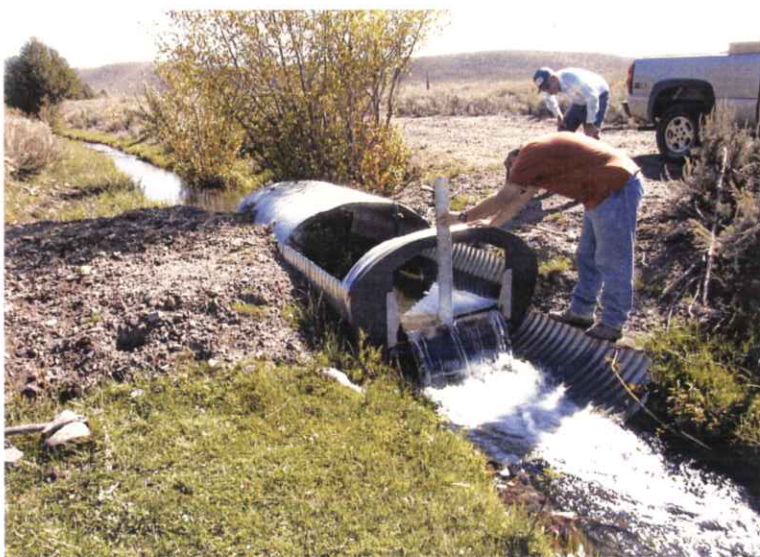
**LEFT:** View of measuring device located in the ABC Middle Diversion Ditch. Note that this point is approximately 0.20 mile downstream of the diversion location shown in view above.

Control works not yet installed. Measuring device consists of a 2.5 foot Cipoletti weir. However the measuring device is located approximately 0.20 mile down the ditch from the diversion point. Flow through measuring device was measured at 1.05 cfs. Only SRBA claim 37-1142 lists this diversion location.

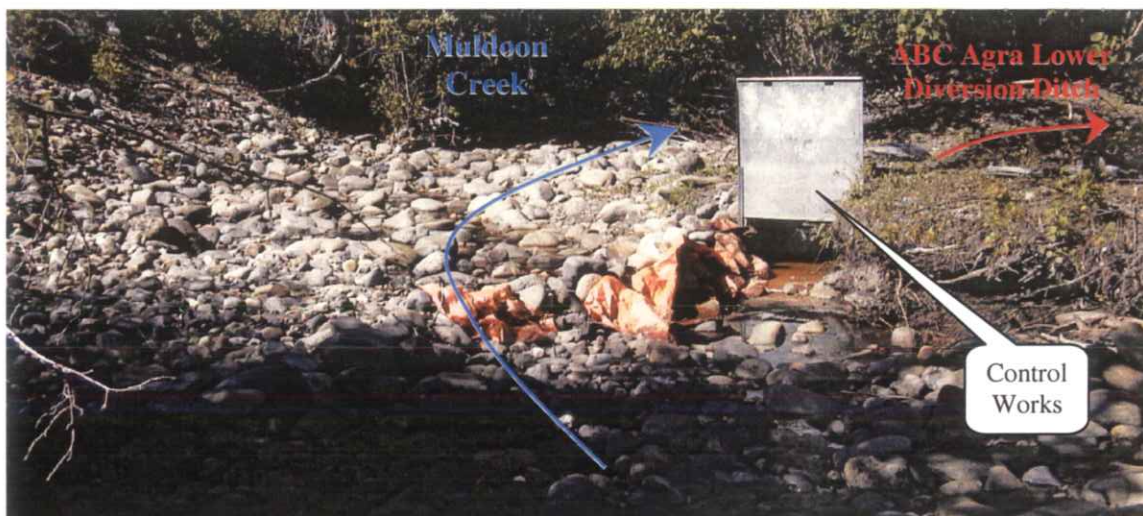
**ABOVE:** View looking down Muldoon Creek towards the ABC Agra Lower Diversion.

**Concerns:** No water right or SRBA filings list a point of diversion in the NWNW Section 16 (T02N, R21E). Perhaps, claim 37-7006 with a claimed point of diversion in the NENE of Section 17 is supposed to describe this diversion? Note that this claim also identifies other diversions further down Muldoon Creek that have not been documented.

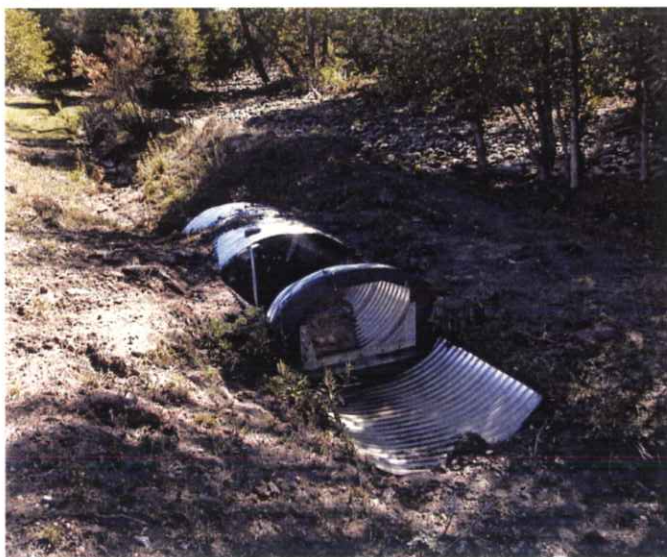
**LEFT:** View of measuring device located in the ABC Agra Lower Diversion Ditch.

Diversion works consist of metal slide gate structure. Measuring device consists of a 2.5 foot Cipoletti weir. No flow through the diversion or device at the time of the inspection.
