RE: Water District 34 Water Measurement Matters.

# **EIM CANAL PRESEASON COMPLIANCE REPORT**

RE: Compliance Report Notification

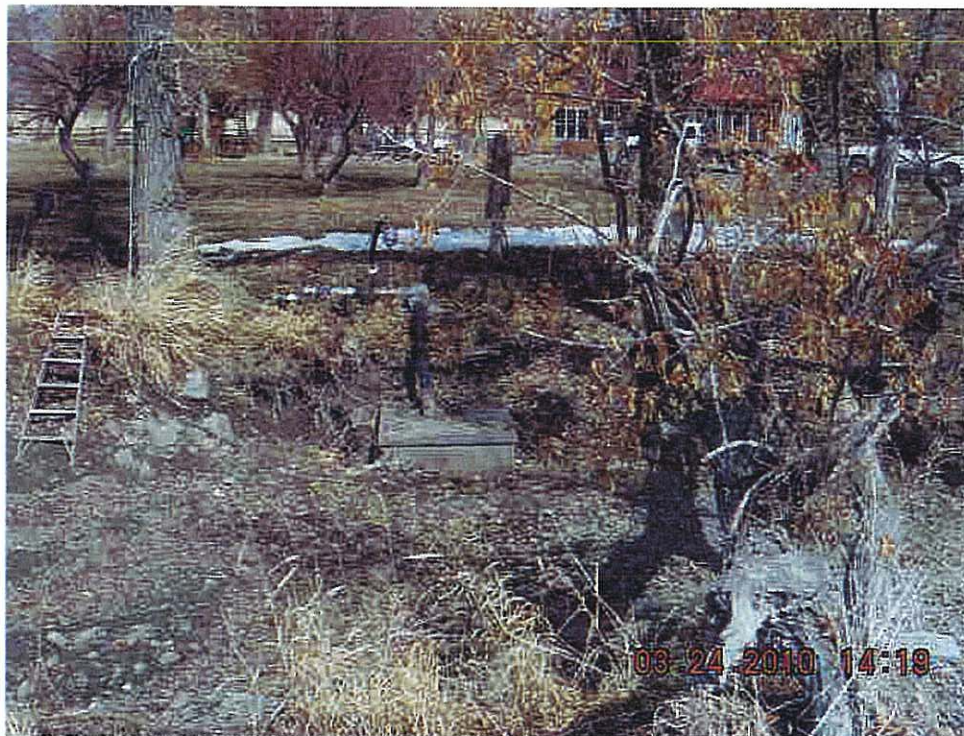
Unknown if this account is active or inactive. No measuring device.  
Control is not adjustable and lockable.

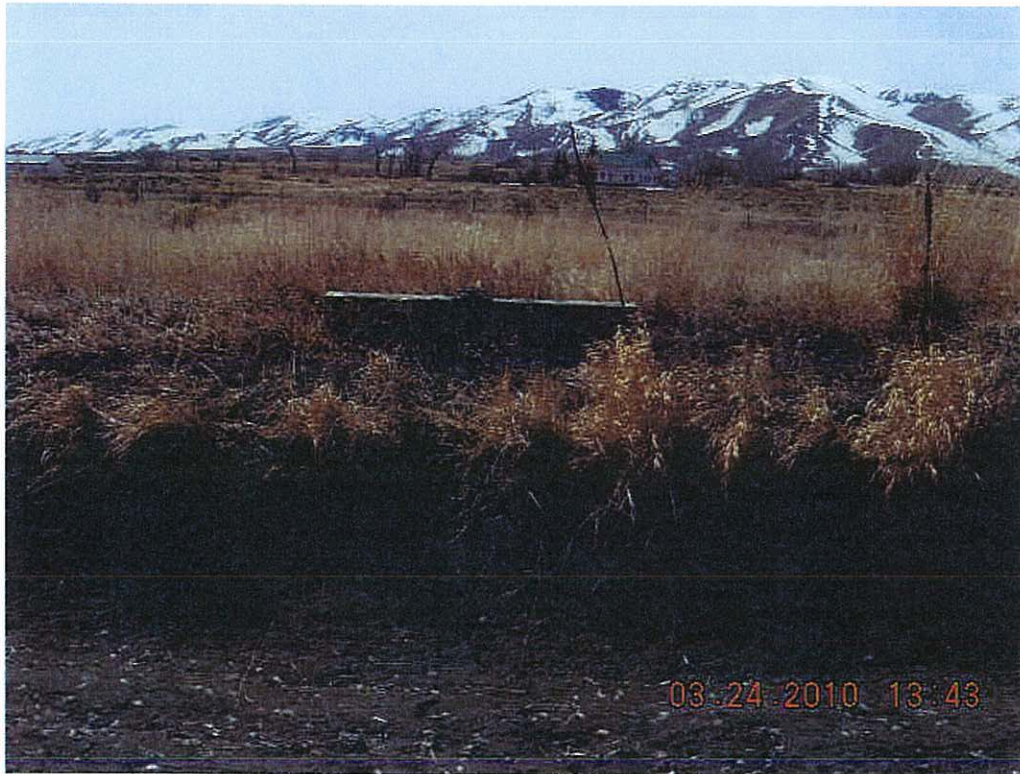
South of Steve Keller's home and North of 3400.  
Inactive headgate.

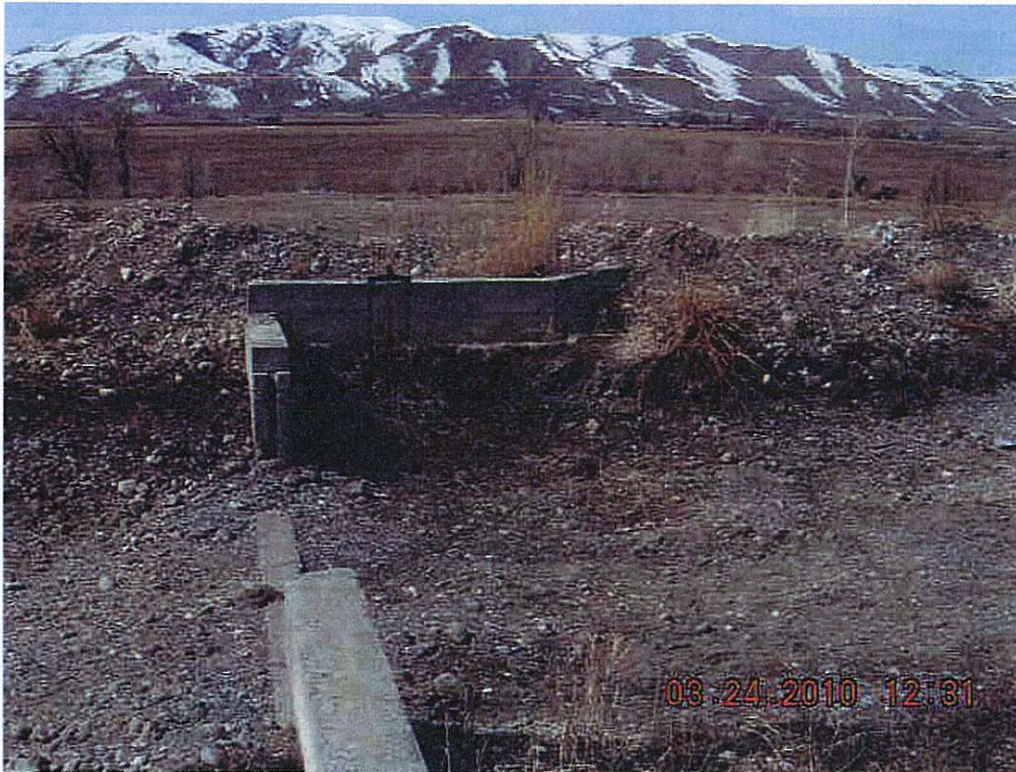
Inactive headgate.

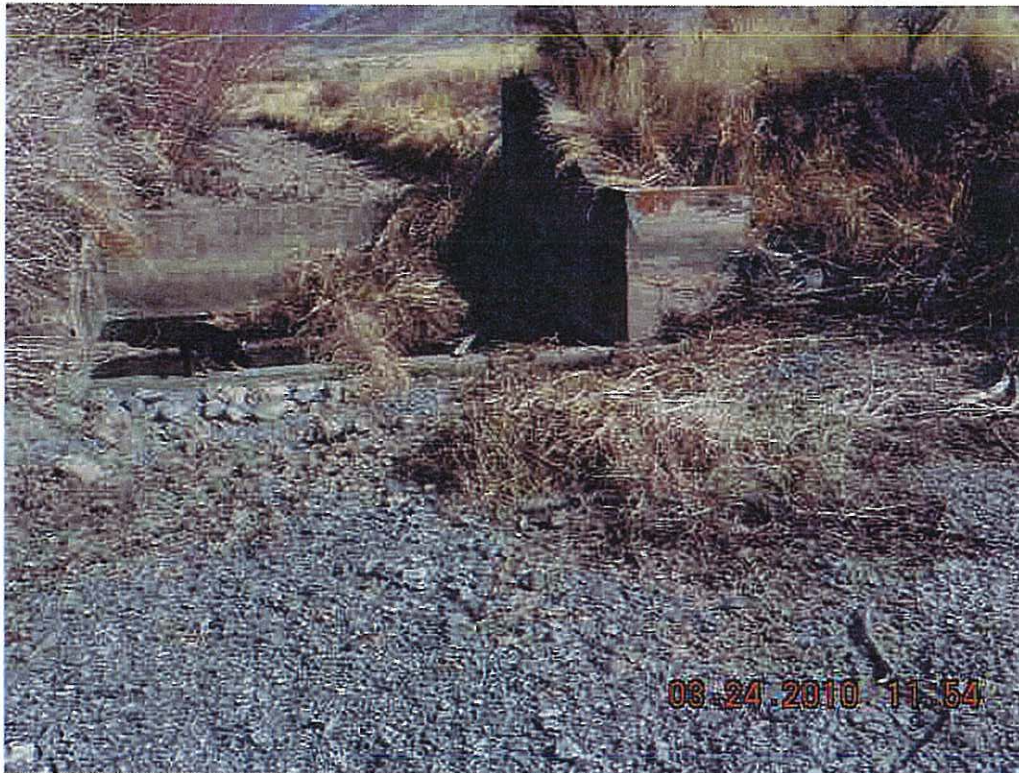
Debris needs to be removed up and down stream of check.

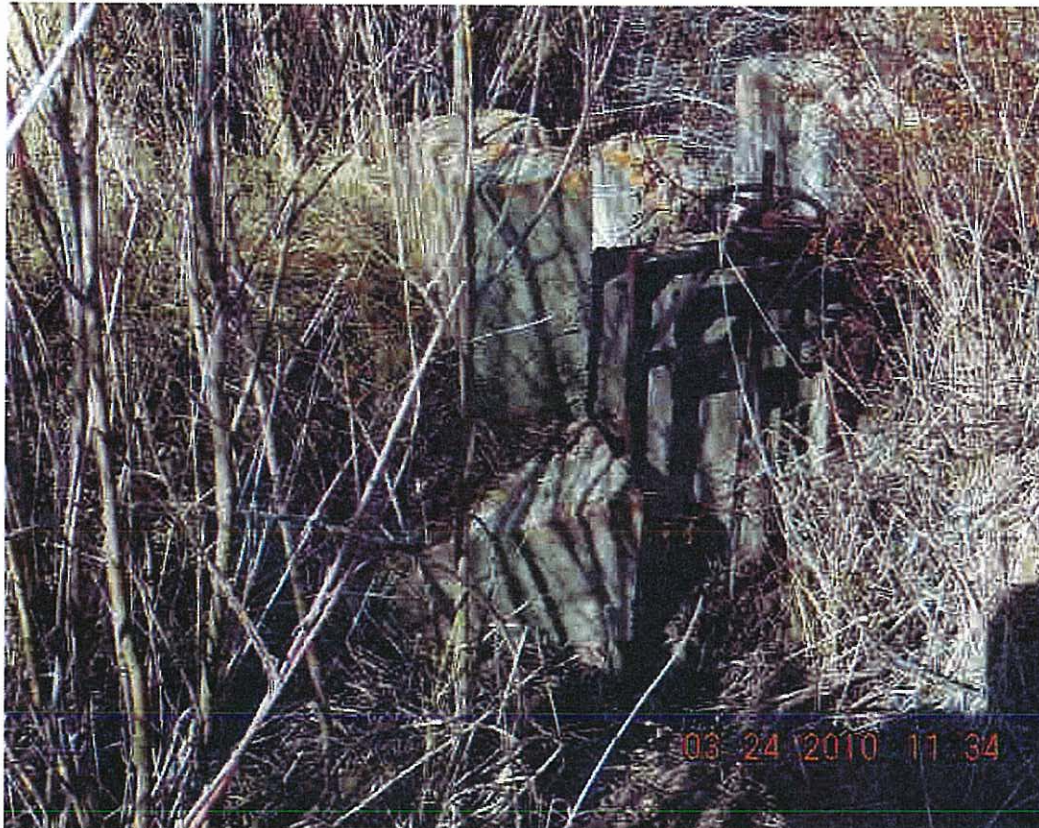
Inactive headgate. Water appears to have washed sediment through gate leaving a small ditch through sediment on bank. Flow losses added to over all shrink. Headgate is adjustable and lockable.

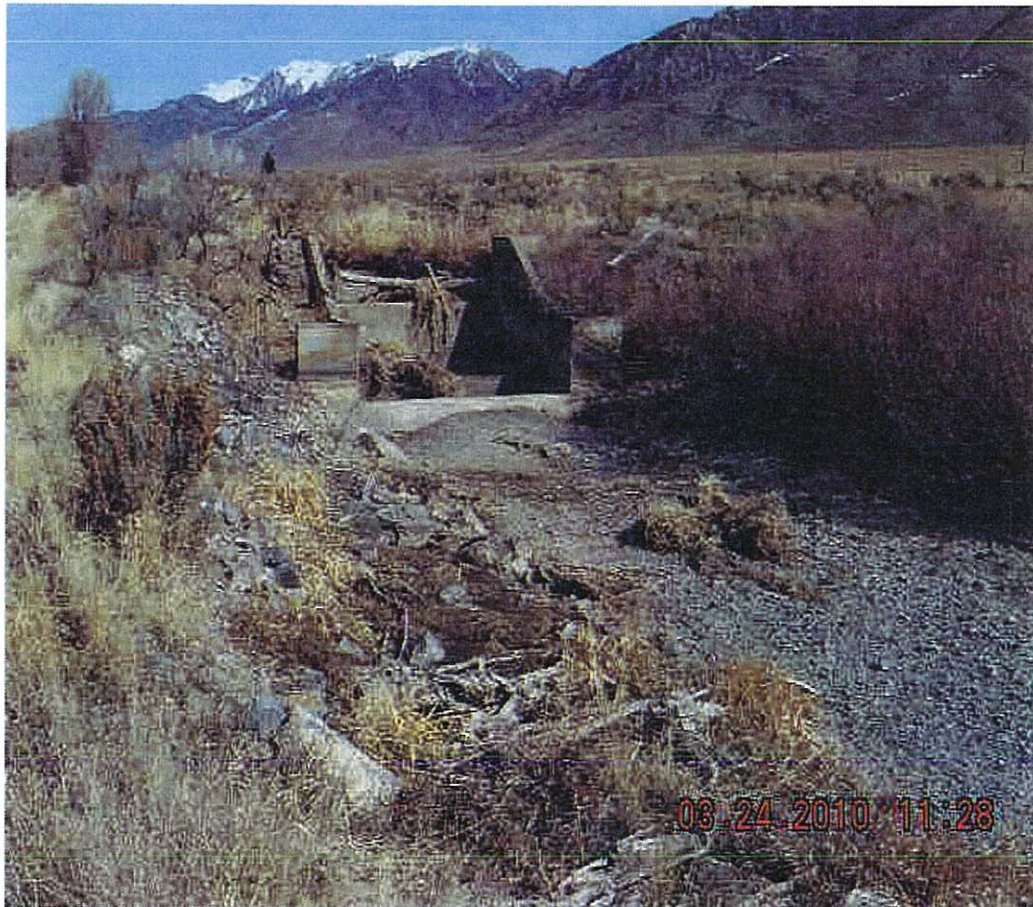
Drop structure with pole lodged in spill way causing debris to be caught and backing or stacking water levels in canal.

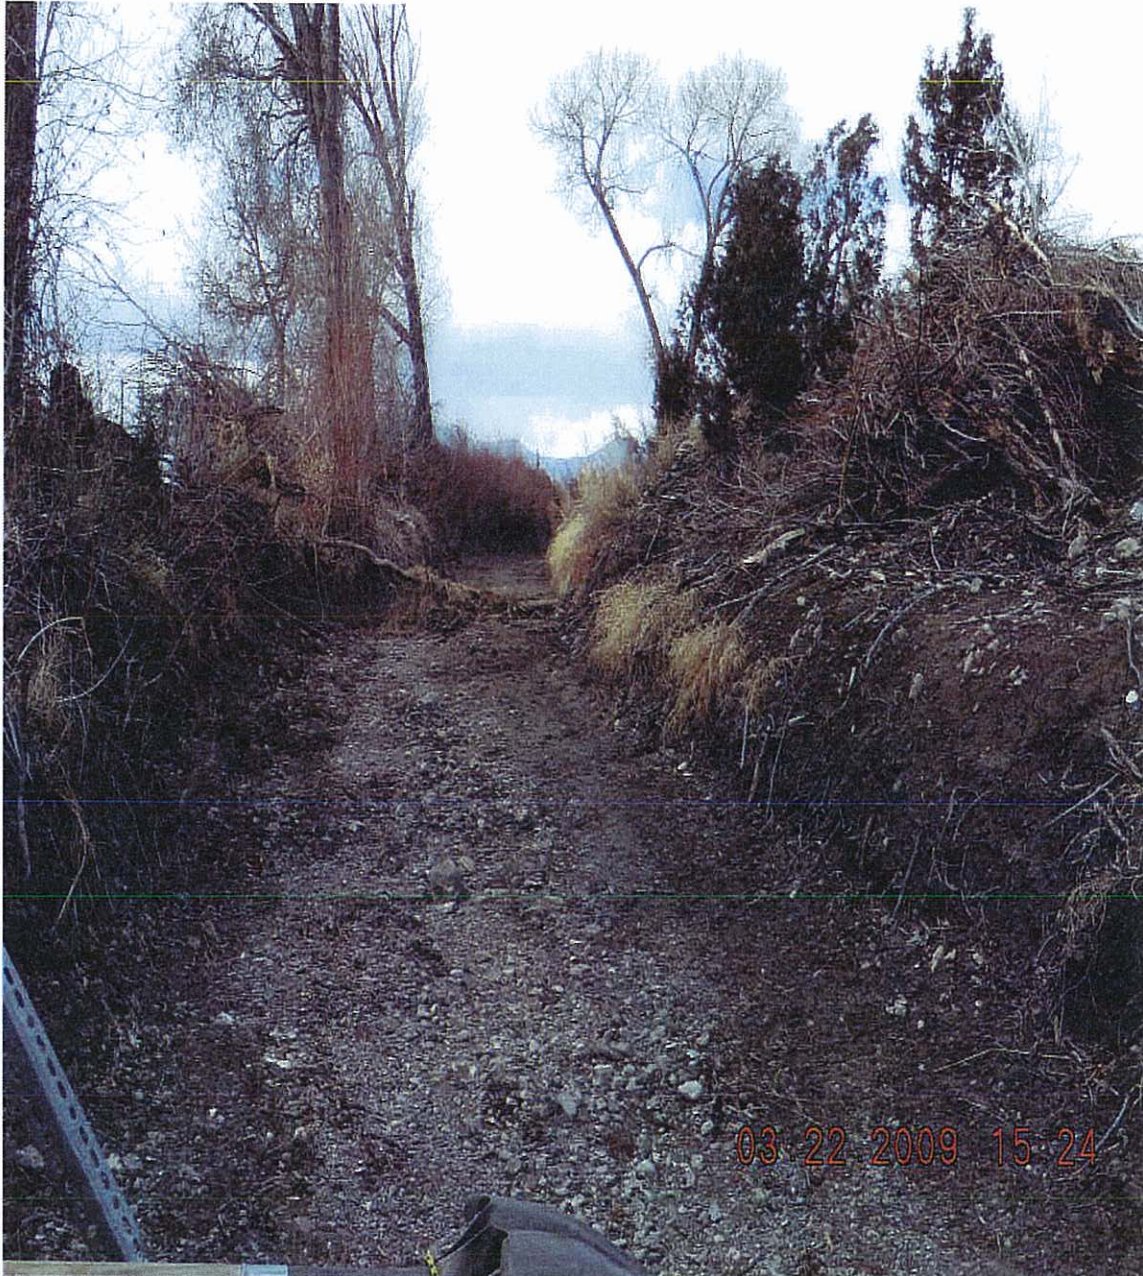
Note fallen tree limbs in canal causing obstruction.

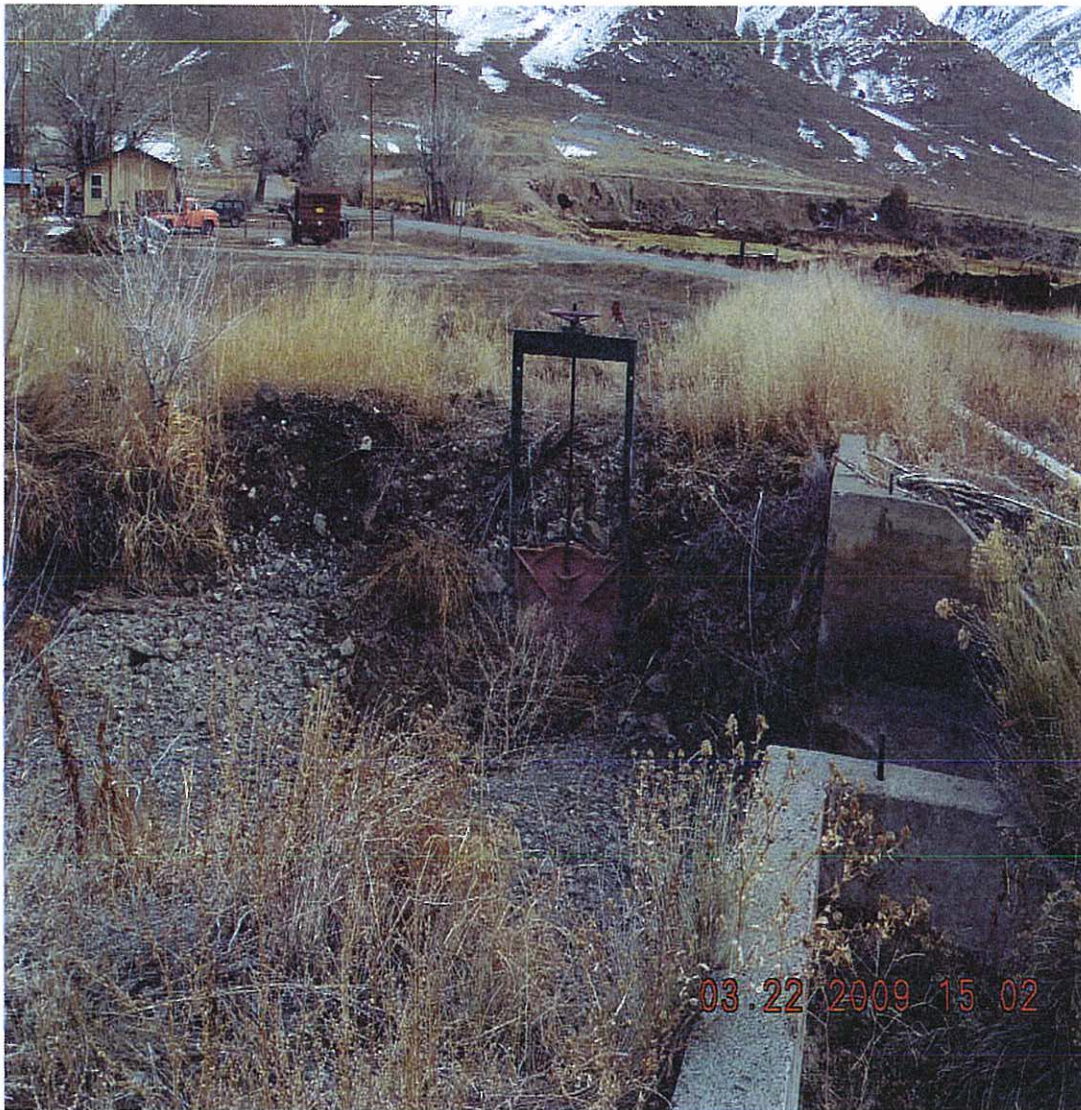
Control gate is adjustable and lockable. No measuring device.

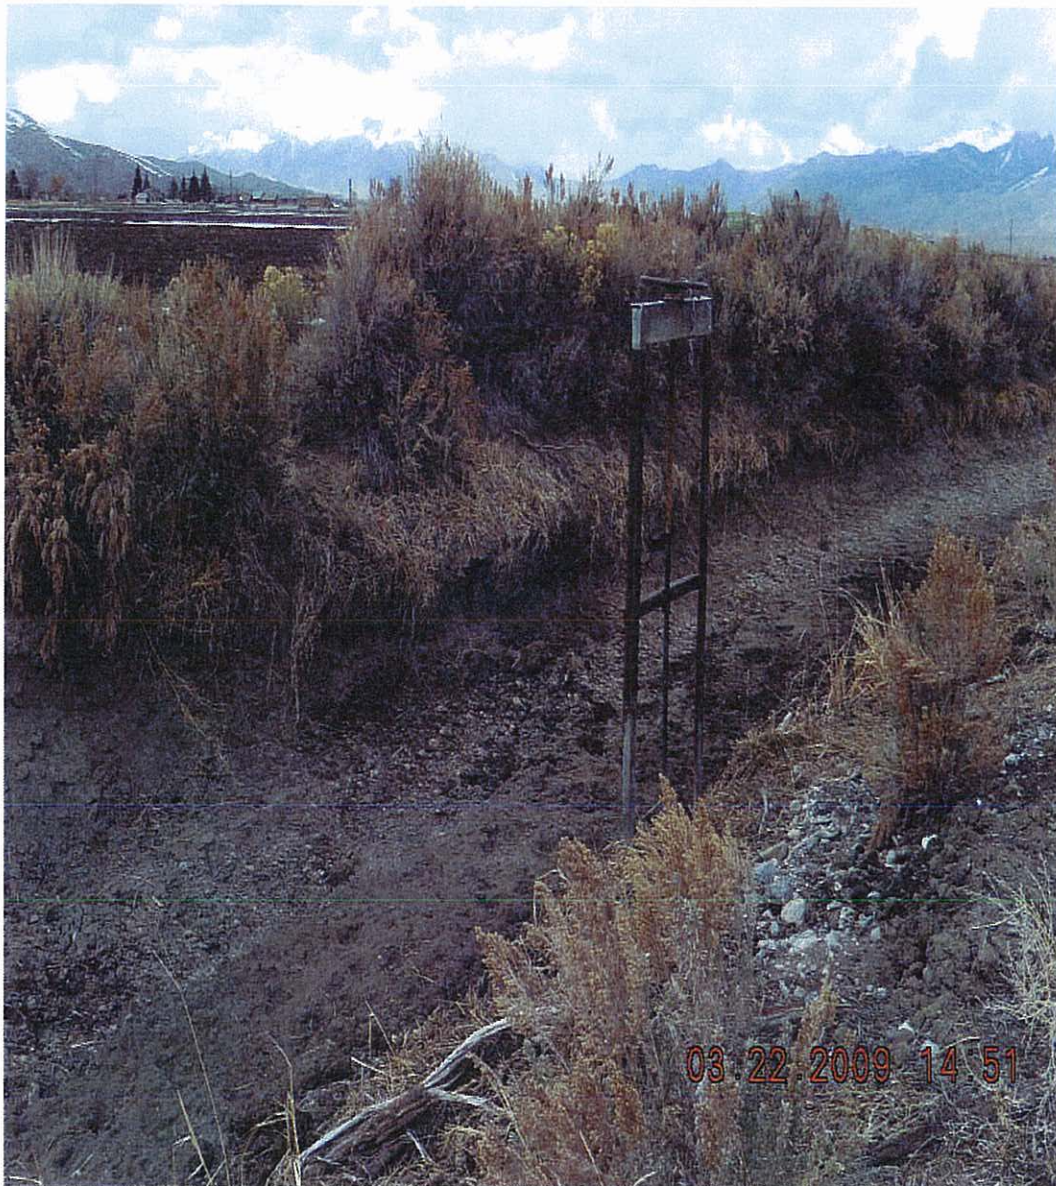
Control gate is adjustable and lockable. No measuring device.

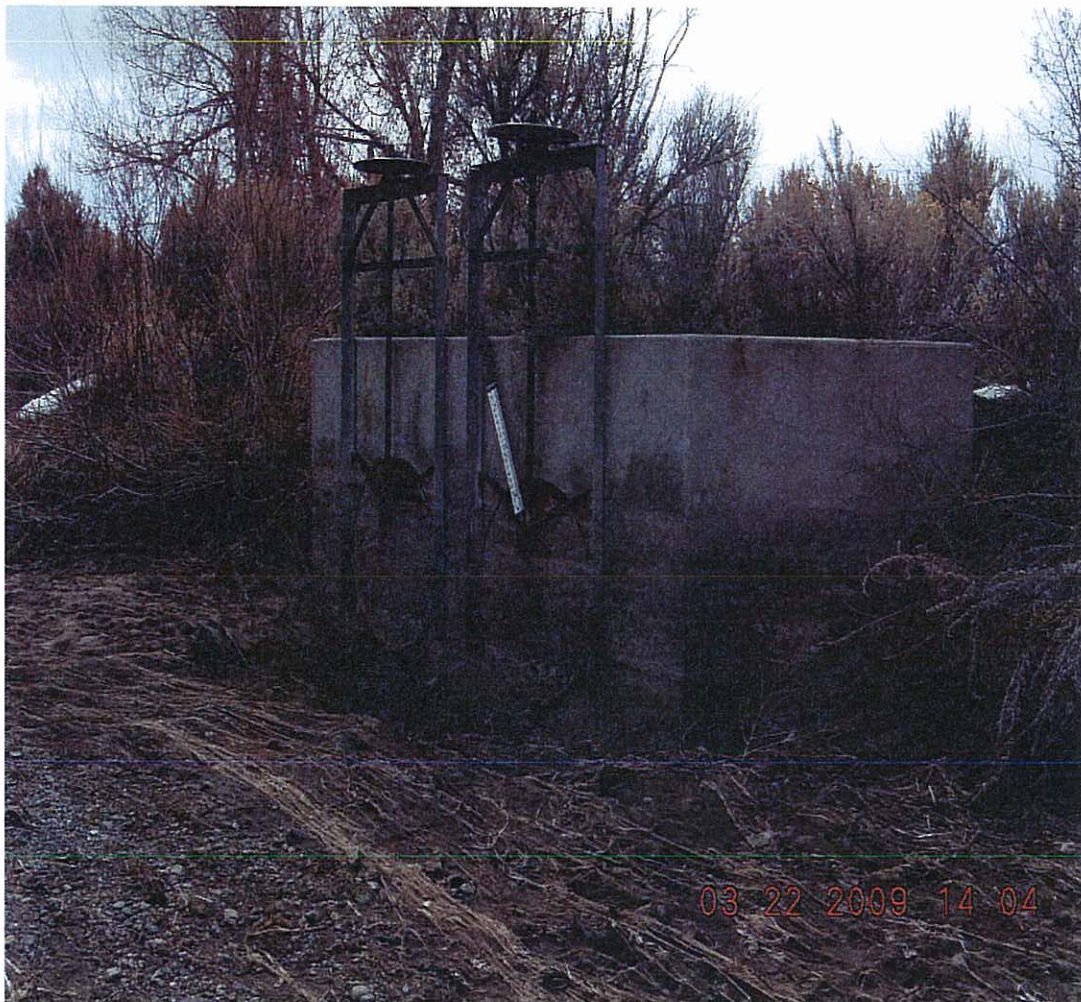
Two (2) control gates into James Creek that are adjustable and lockable. No measuring device.

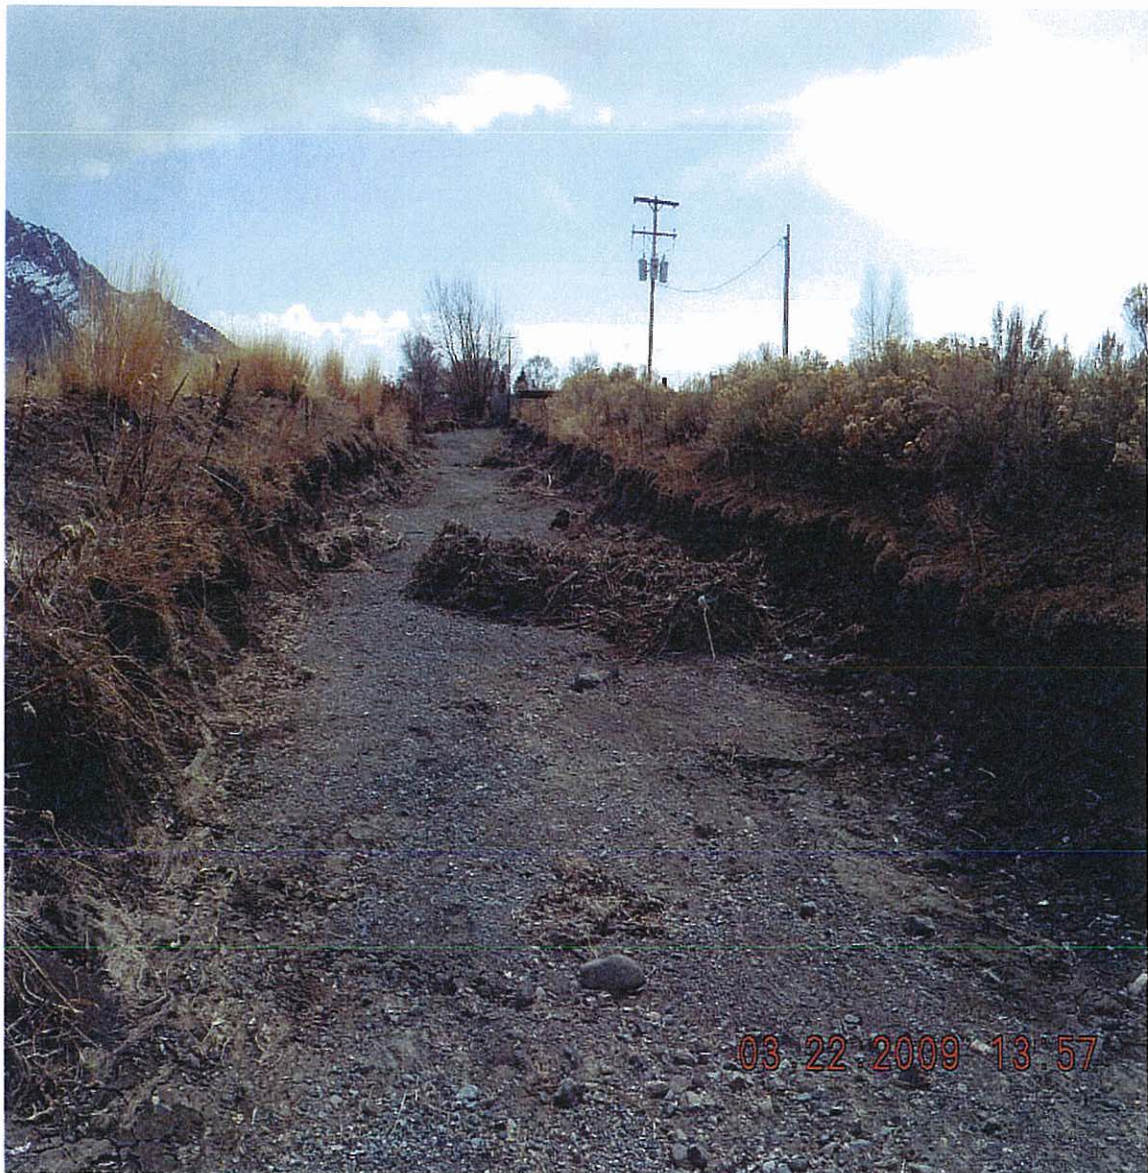
Canal North of Doug Schureman's well. Note the pile of debris in the middle of canal channel causing bank erosion.

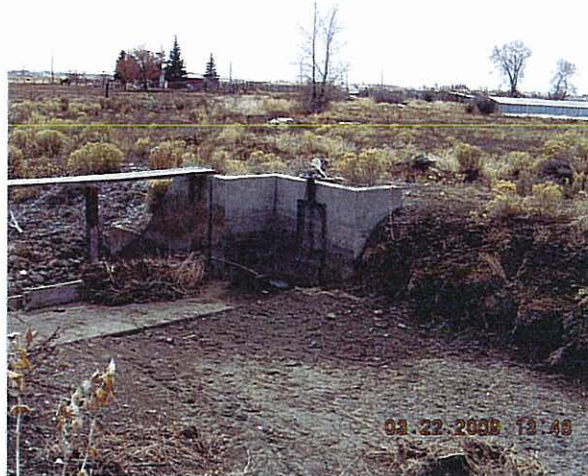
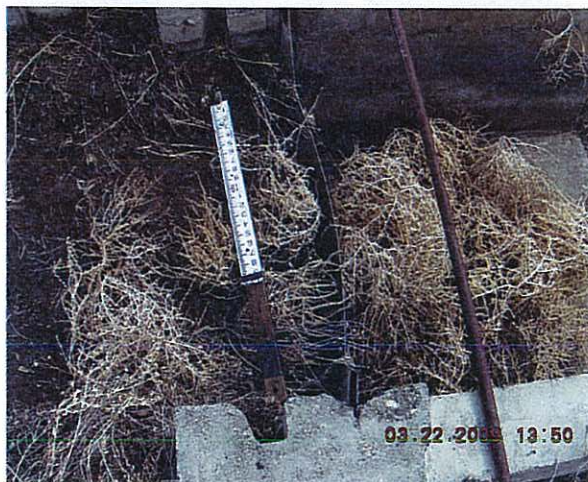
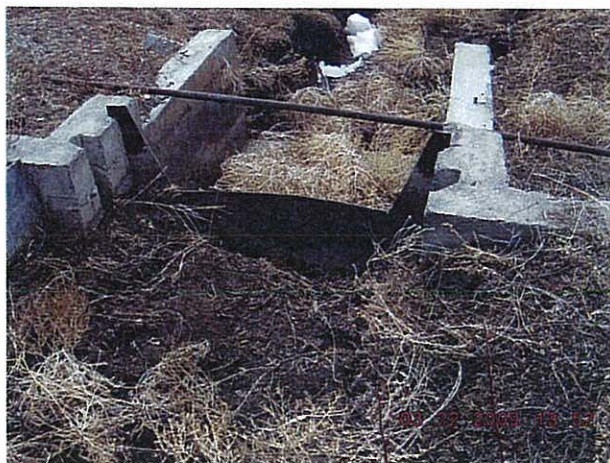
Measuring device needs repair due to bent edge that allows water to go under it.

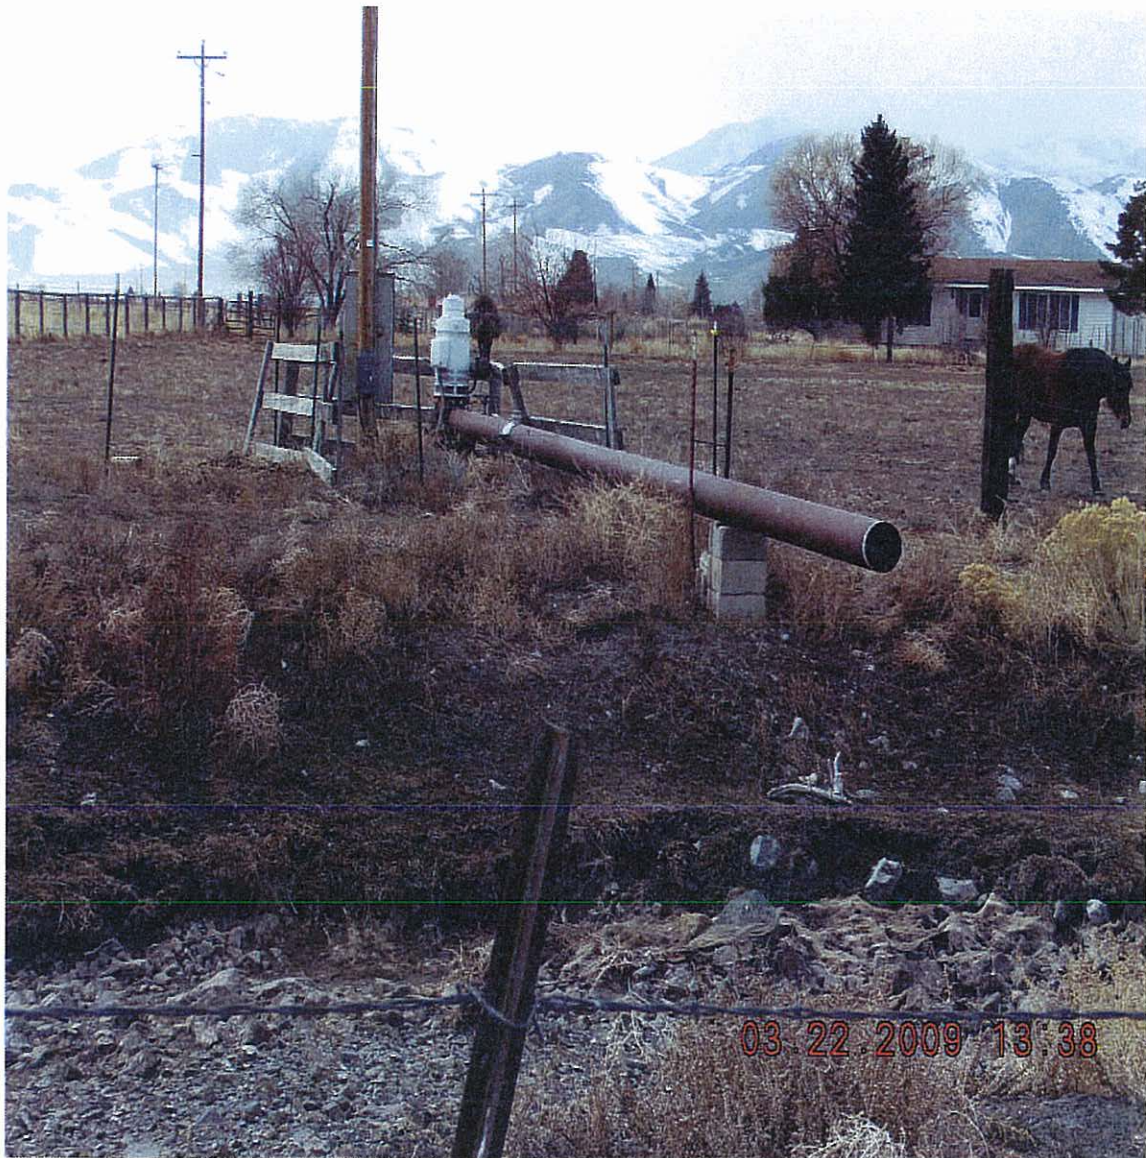
Active well. Inspection could not determine if flow meter works.

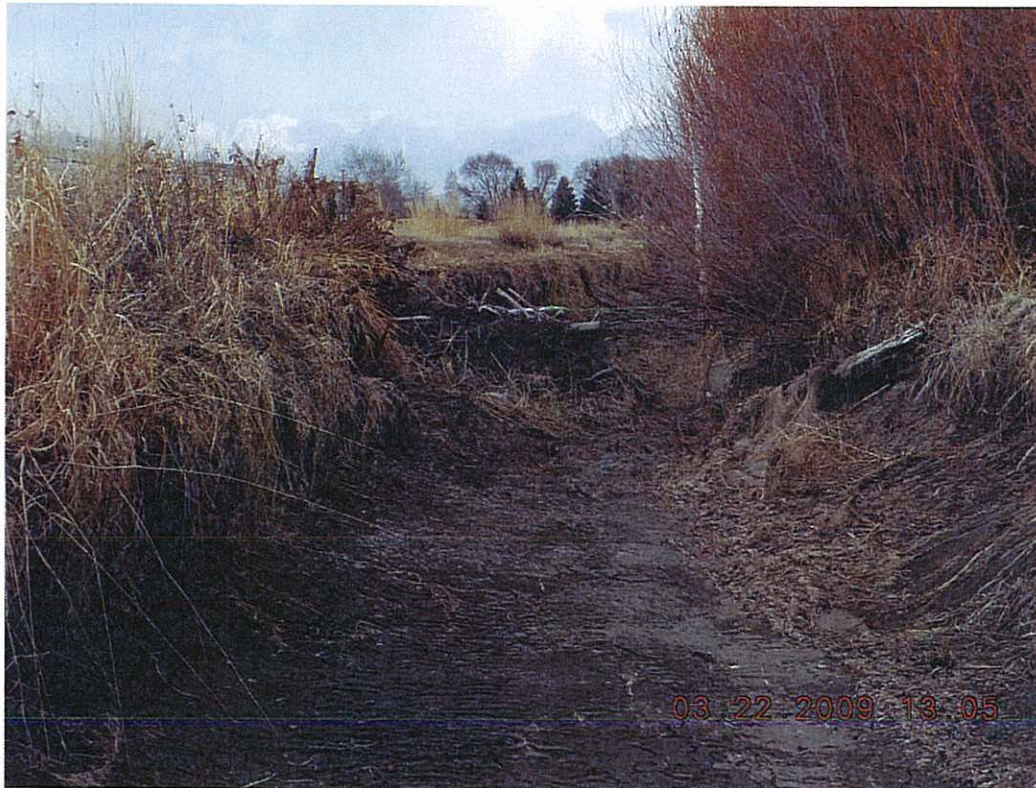
Fence line between Nolan Beard and Mary Lou Felton. Note the huge pile of dirt and debris causing considerable obstruction to canal flows.

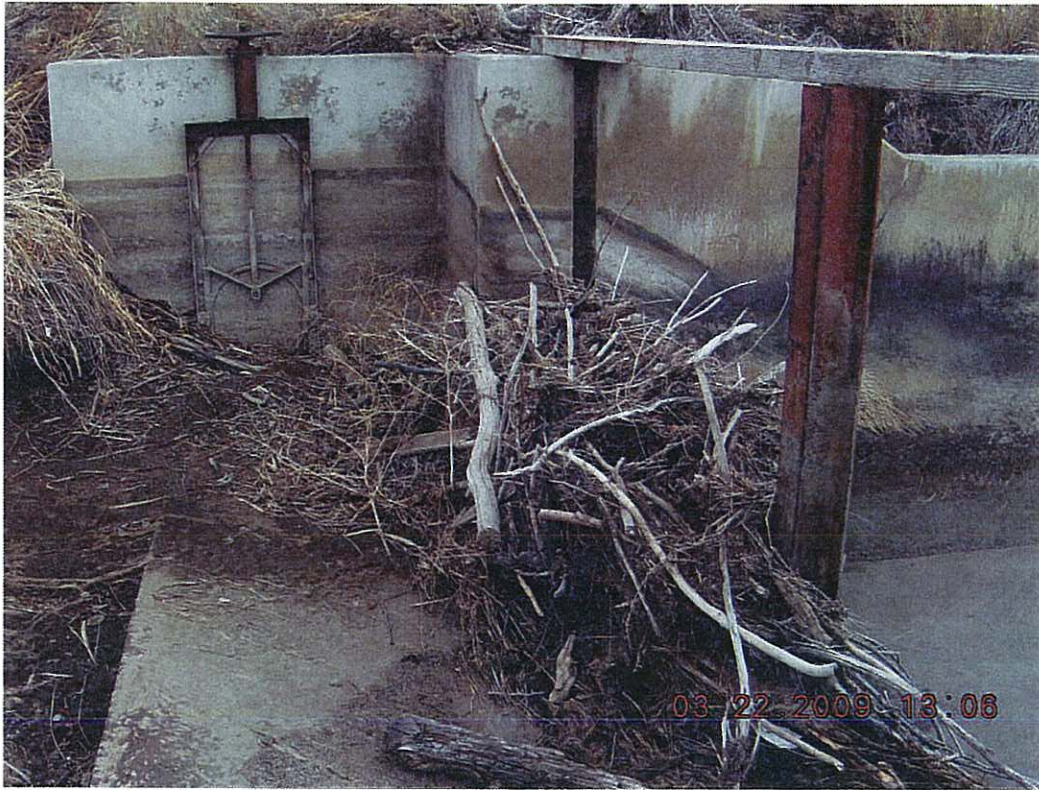
Inactive headgates that are adjustable and lockable. Structure has filled with debris obstructing flows.

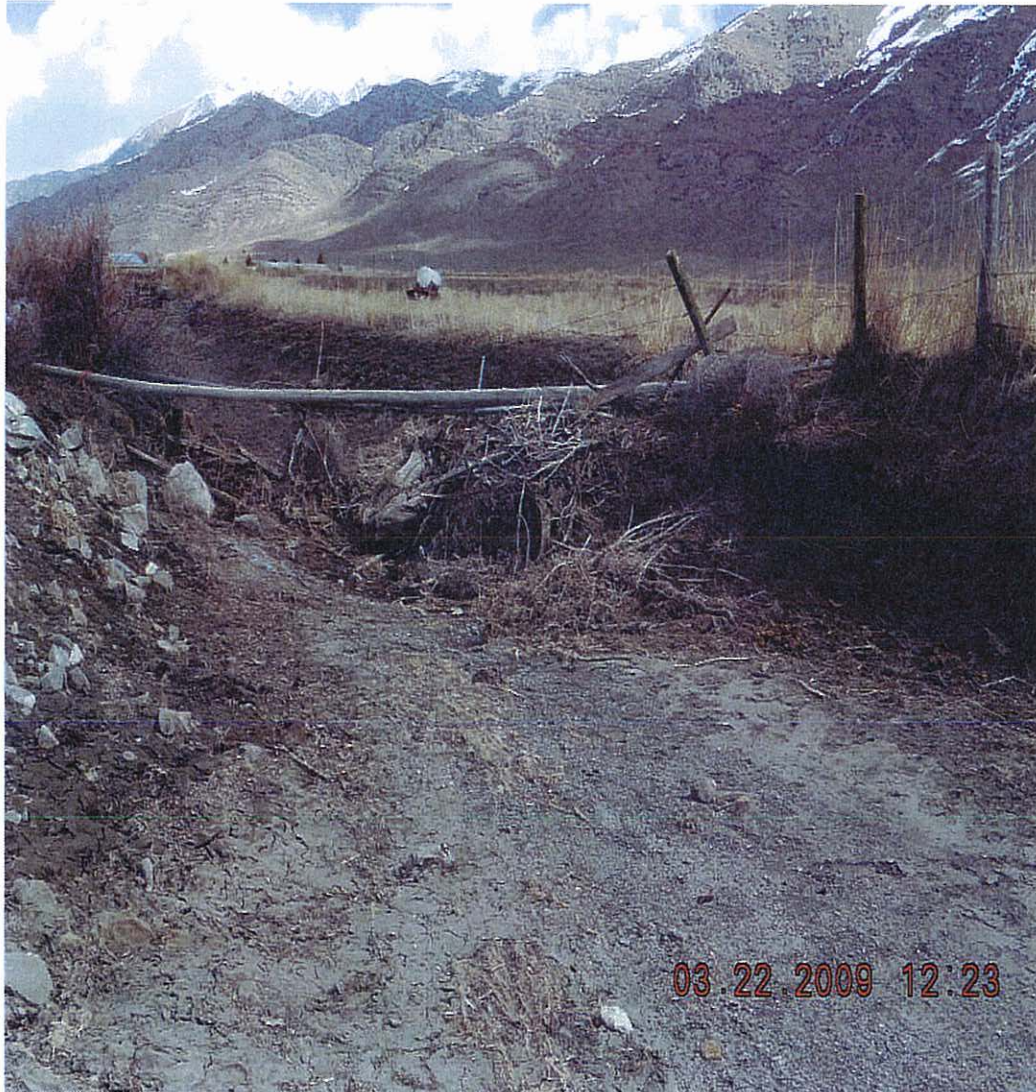
South of Richard Reynold's booster pump. Note the fence crossing the canal and the debris causing an obstruction to flows.

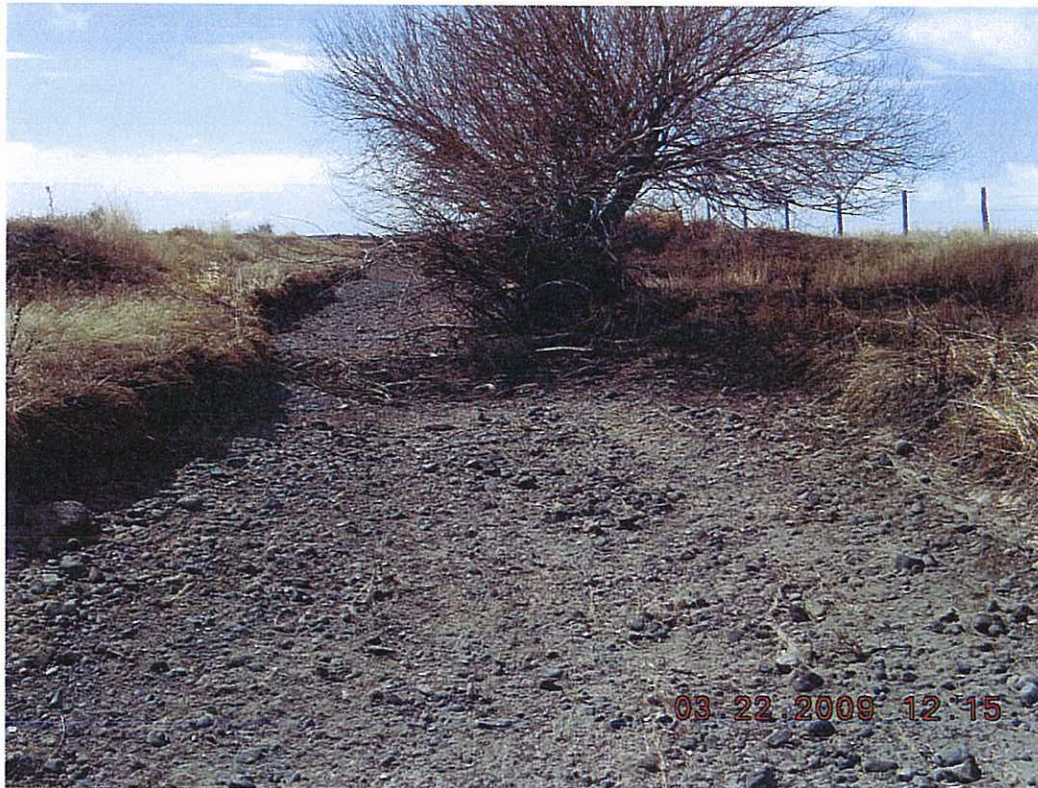
North end of Tony Madsen's property. Tree causing bank erosion and obstructing canal flows.

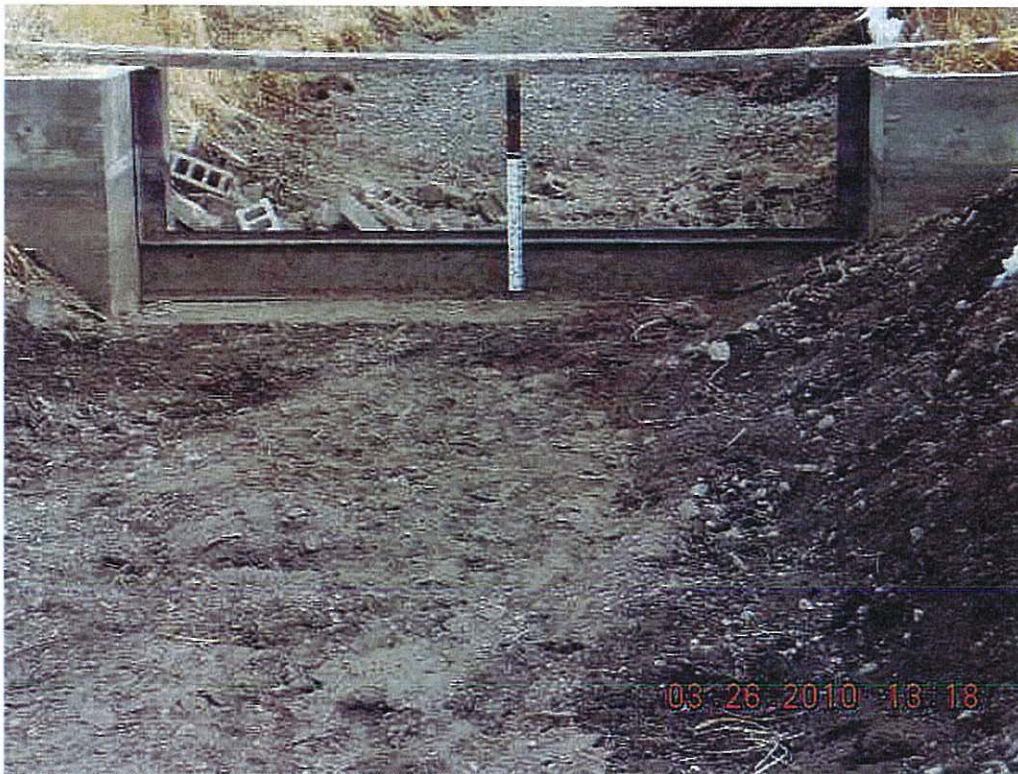
Arco Canal Heading gates are adjustable and lockable. As discussed on the symposium tour, the measuring device is not adequate due to design. There is not enough elevation drop or contraction especially from the bottom and water does not have a straight shot at the weir. A data logger will be installed at this site.

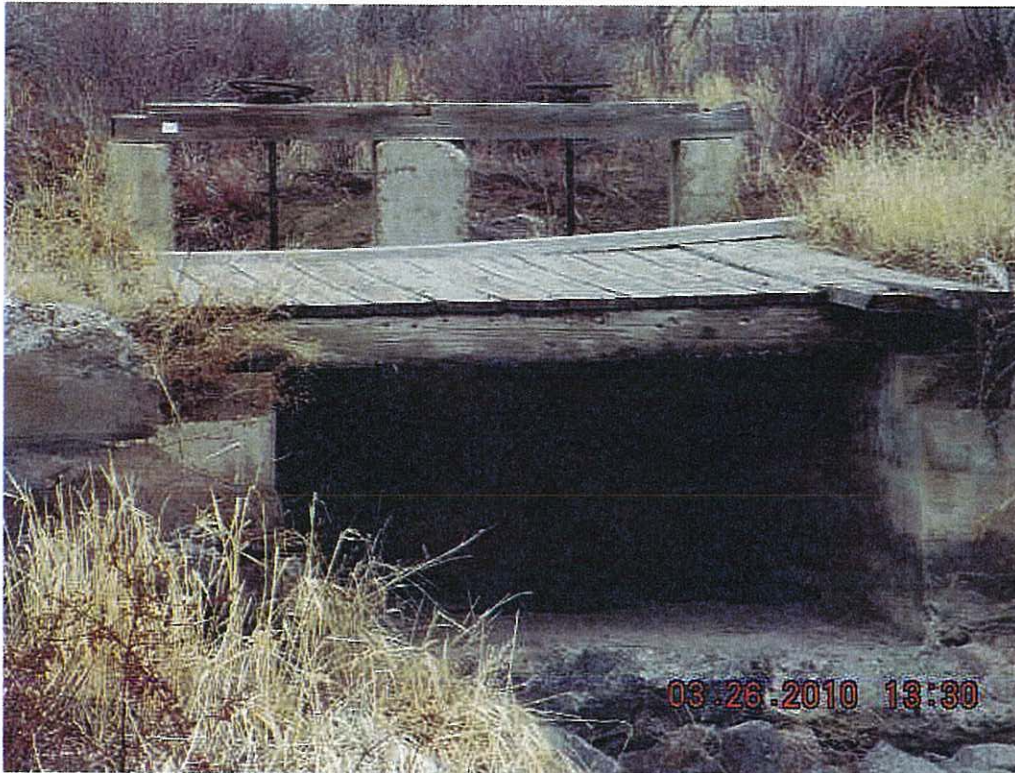
Control device is adjustable and lockable. It also appears that the bottom of the upstream channel is only a few in. lower than the bottom of the gates. The condition of the measuring device is follows:

The measuring device is a 5 ft. Parshall flume. Please note the front to back on East and West sides are nearly level. The East side of the floor is 1.25 in. lower than the West side of the floor. The gauge is 3/100 short and is mounted on the low side.

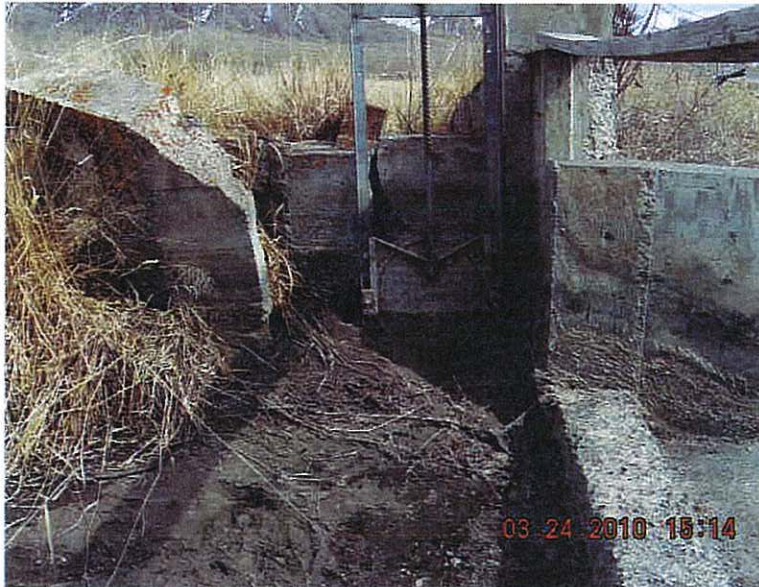
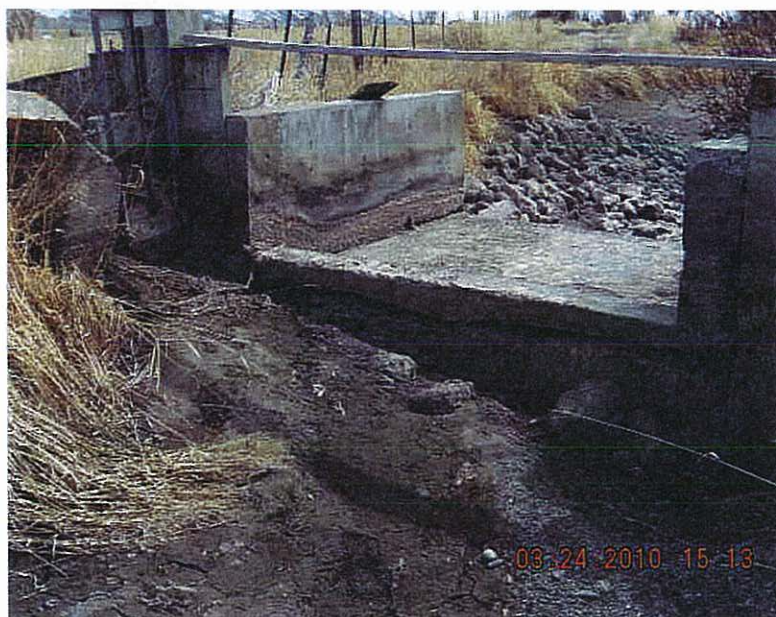
Inactive headgate. The 8 in. lip in the check structure should be removed to reduce water stacking which causes excessive shrink.

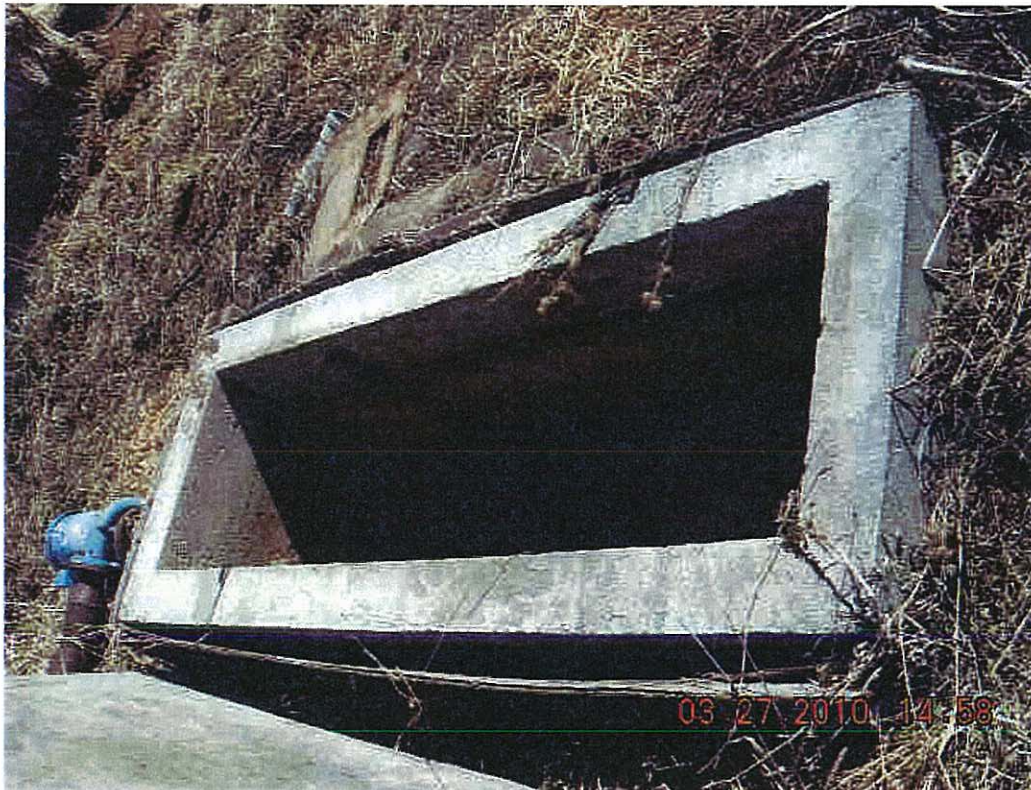
Active station. No adjustable and lockable control. No active measuring device. Submerged orifice plate not installed or used.

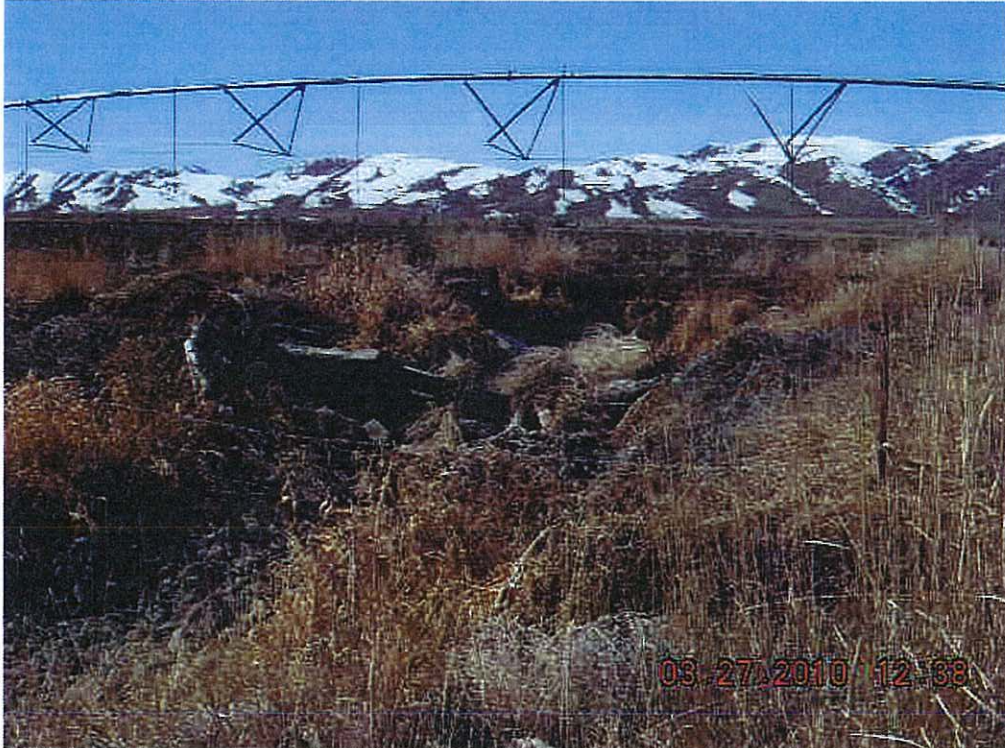
Active headgate. Adjustable and lockable control. 2 ft. Parshall flume. The flume needs to be leveled and vegetation removed prior to being acceptable.

Grass sediments block approach and front end is 1.0 in. high

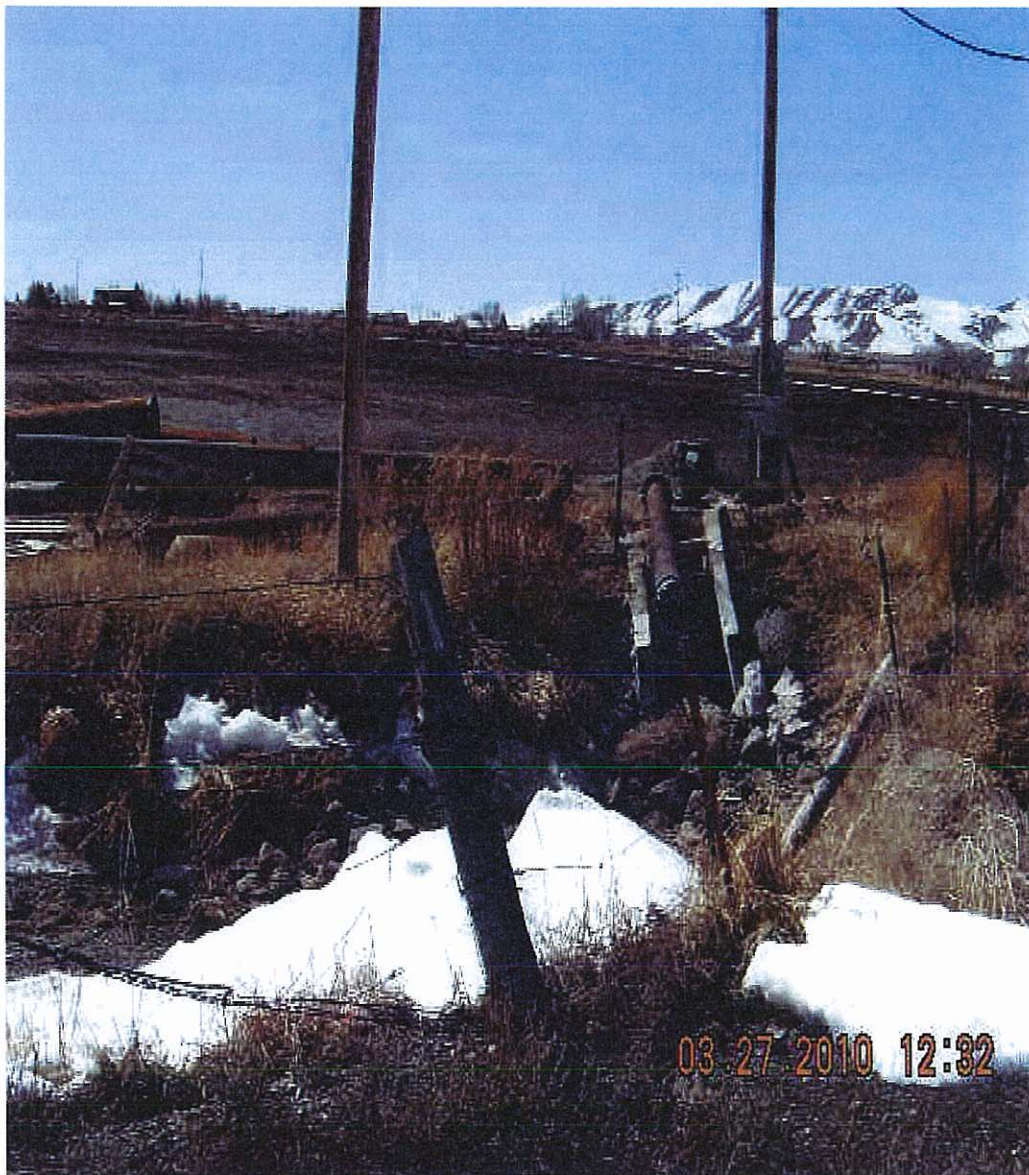
Active well being repaired. The adequacy of the measuring device will have to be determined when repairs are completed, but prior to use.
