RE: Water District 34 Water Measurement Matters.

# **EIM CANAL PRESEASON COMPLIANCE REPORT**

RE: Compliance Report Notification

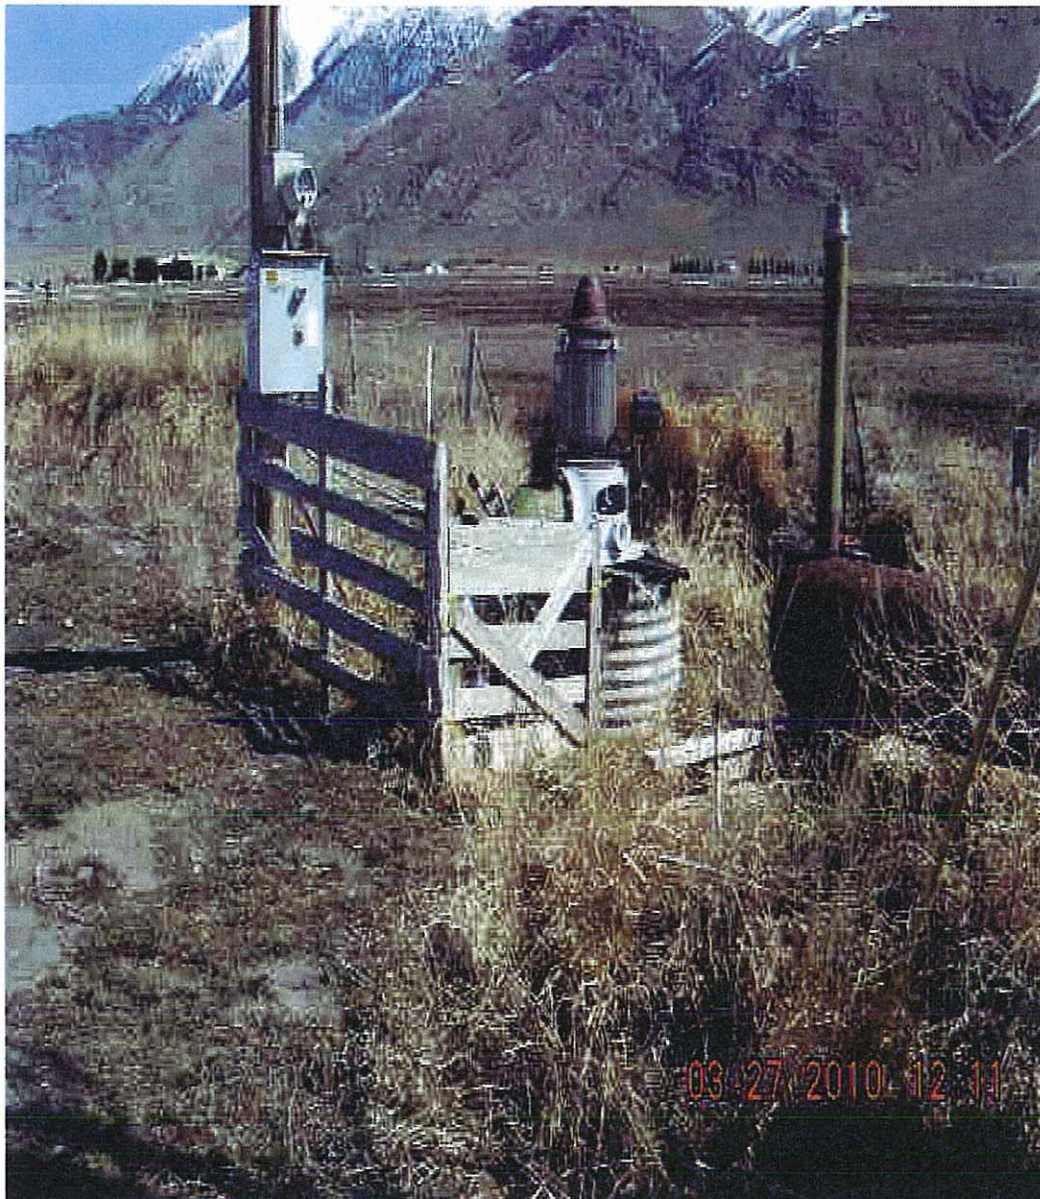
Active station. Magnetic flow meter. No adjustable and lockable control.

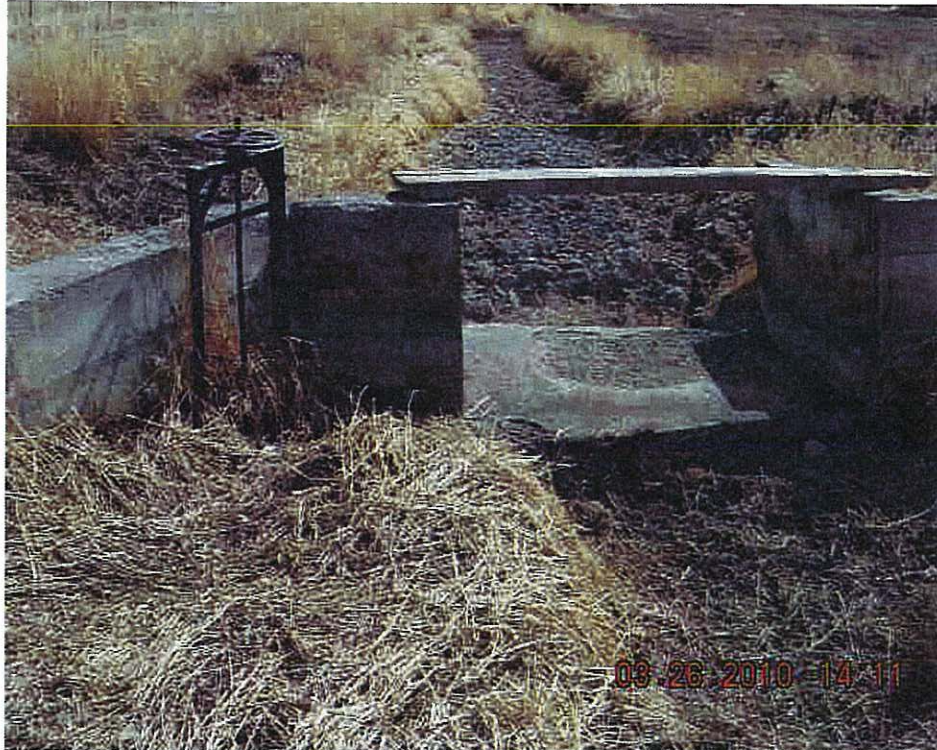
Adjustable and lockable control. Parshall flume does not work because of trash and sediments in approach.

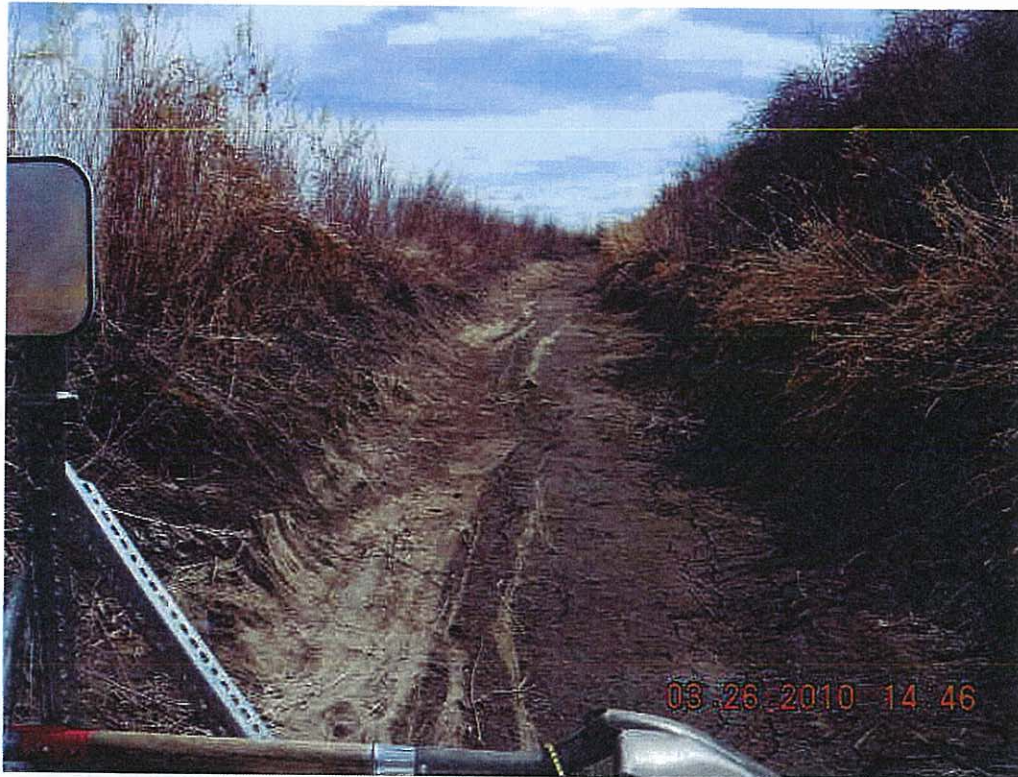
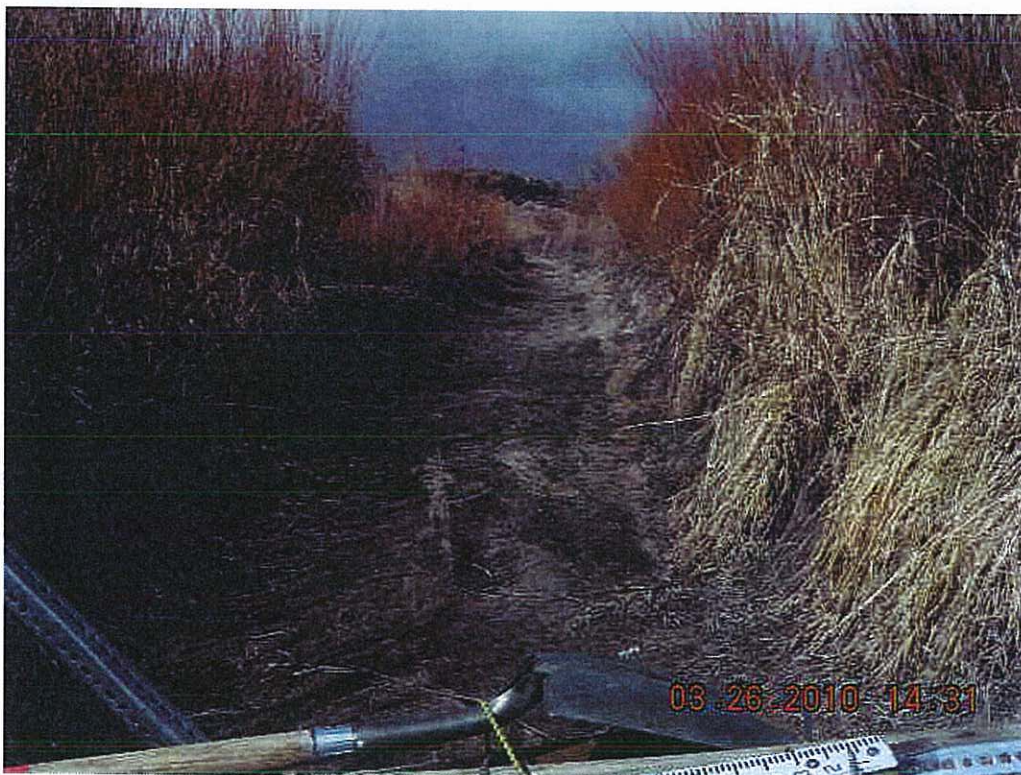
Vegetation on banks needs to be removed or it will cause flow obstruction.

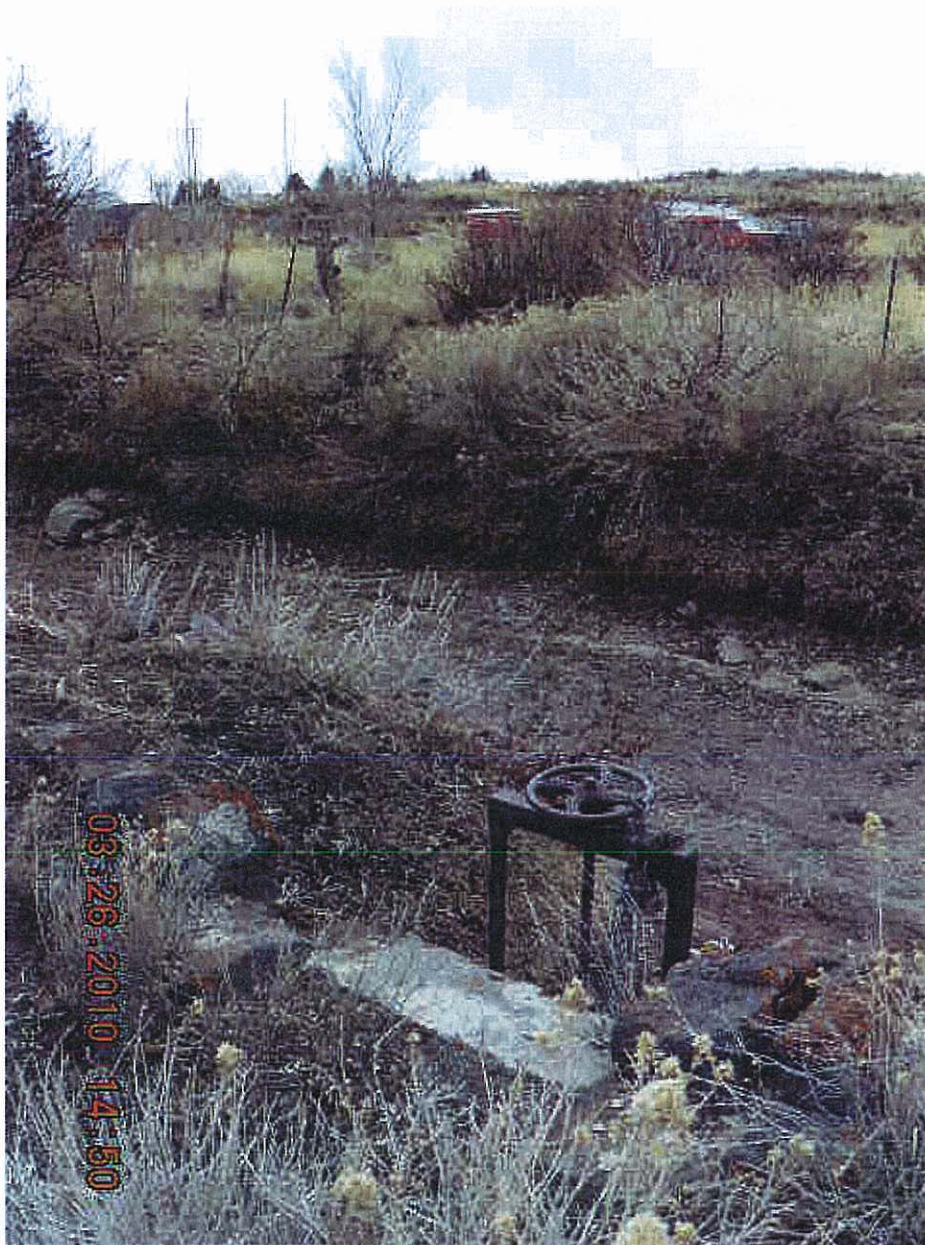
Inactive. Adjustable and lockable control headgate. No measuring device.

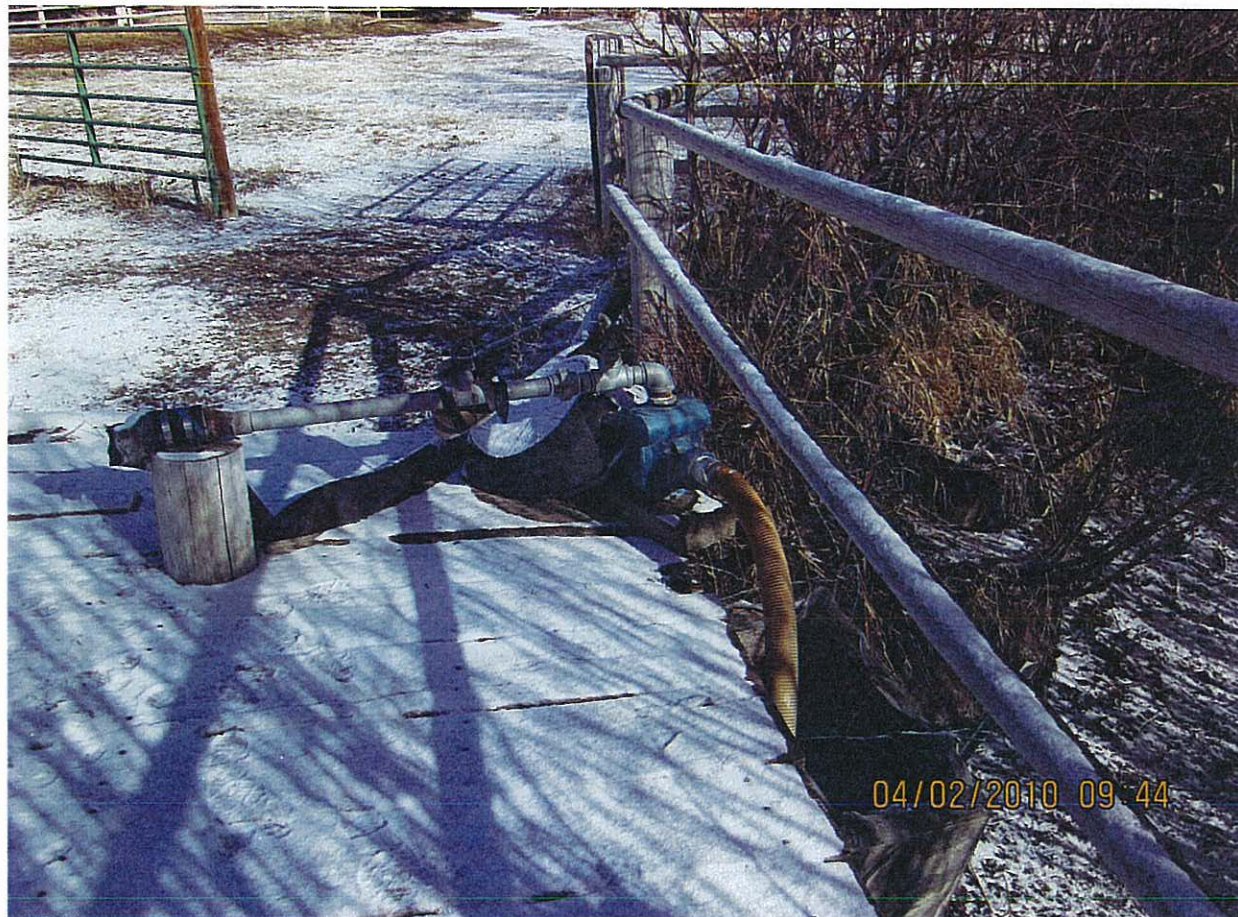
Flow meter exists but is covered with tape. Unknown if the meter is operational.  
No adjustable and lockable control.

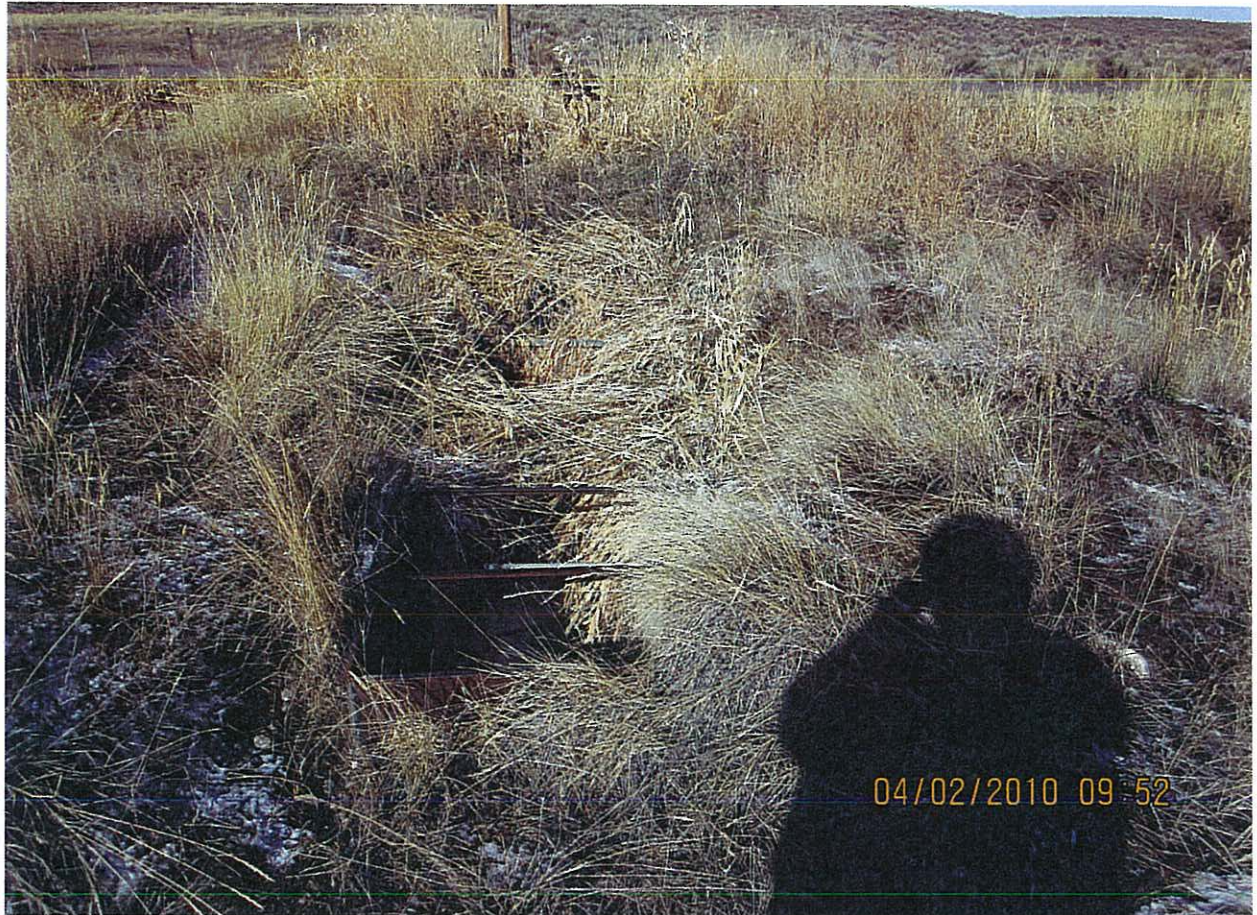
Adjustable and lockable control. 18 in. Parshall flume. Vegetation and trash need to be removed before device will measure accurately.

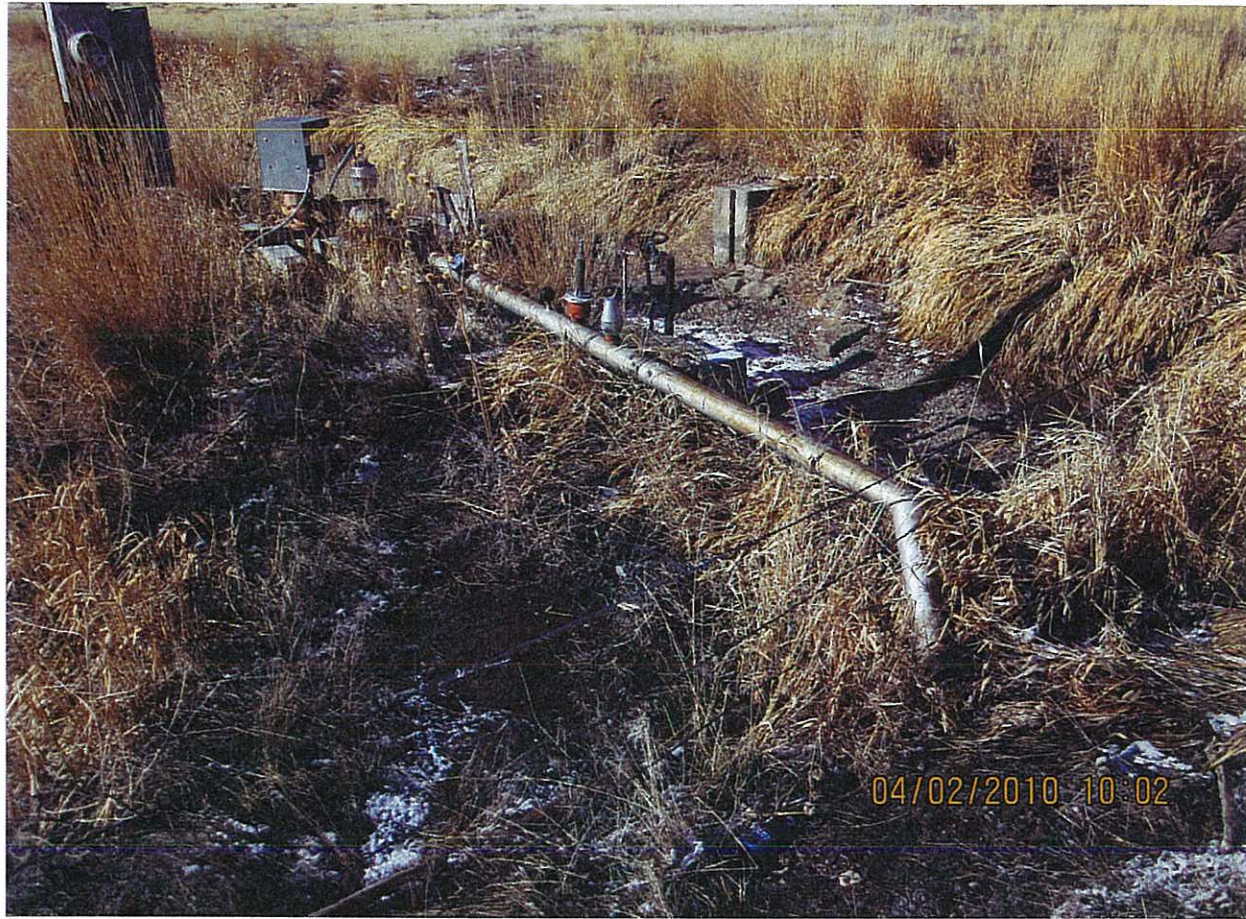
MIC device but it was uncertain if it works. Adjustable control is not lockable.

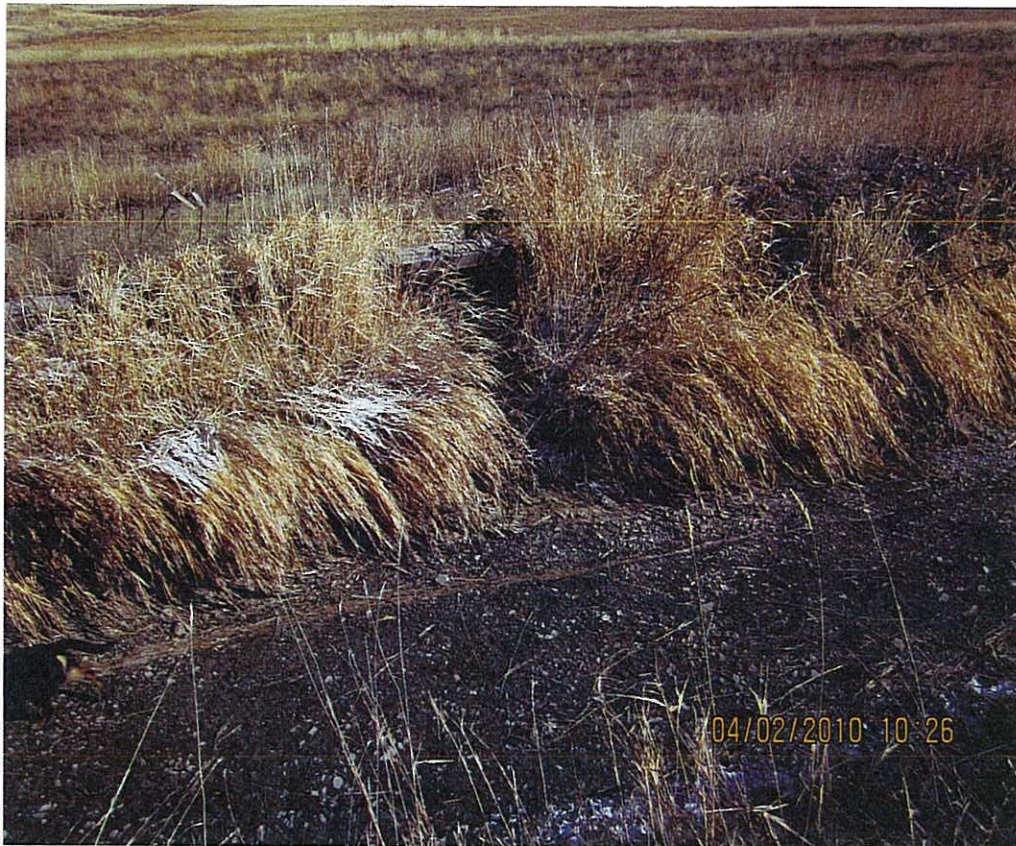
(#5) has been open for an unknown period of time resulting in water loss.

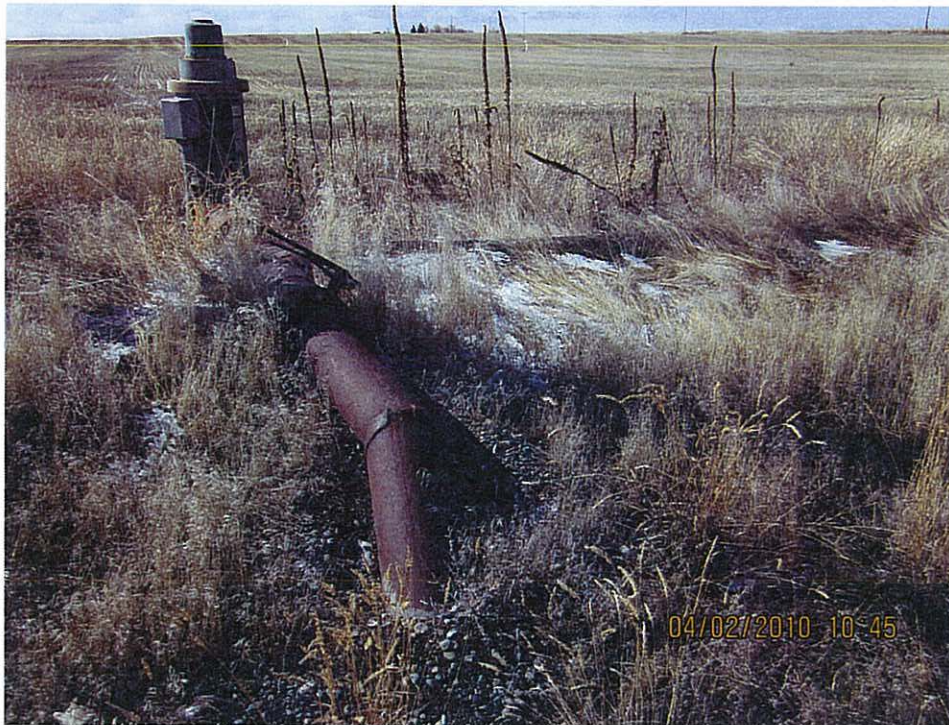
Neither the well water or the surface water from the Munsey Canal are measurable prior to being commingled, but are measured after being commingled. Surface water from the Munsey canal is controllable.

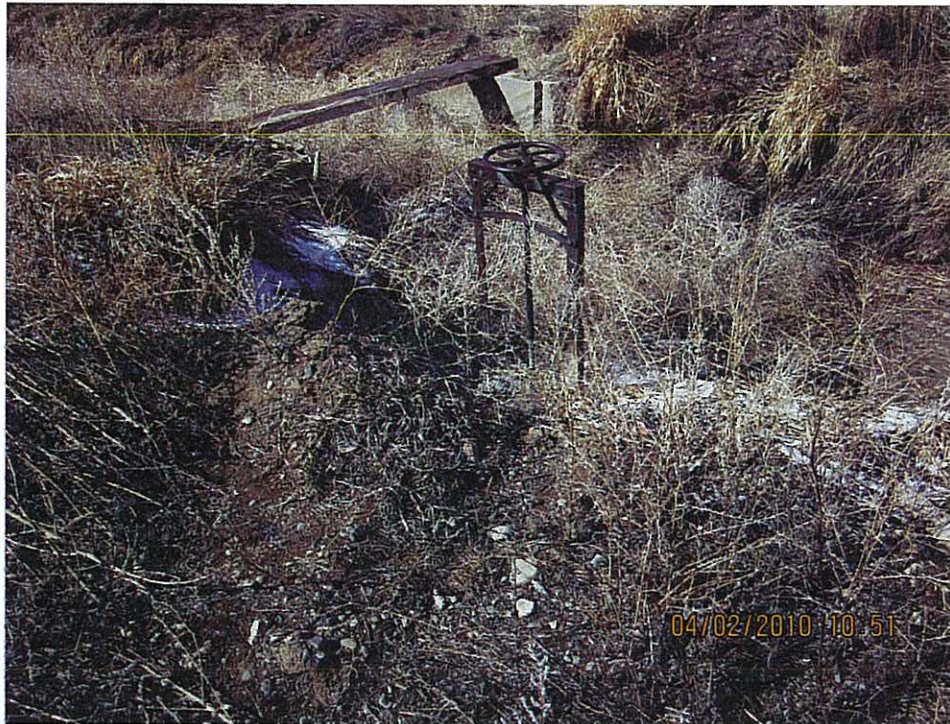
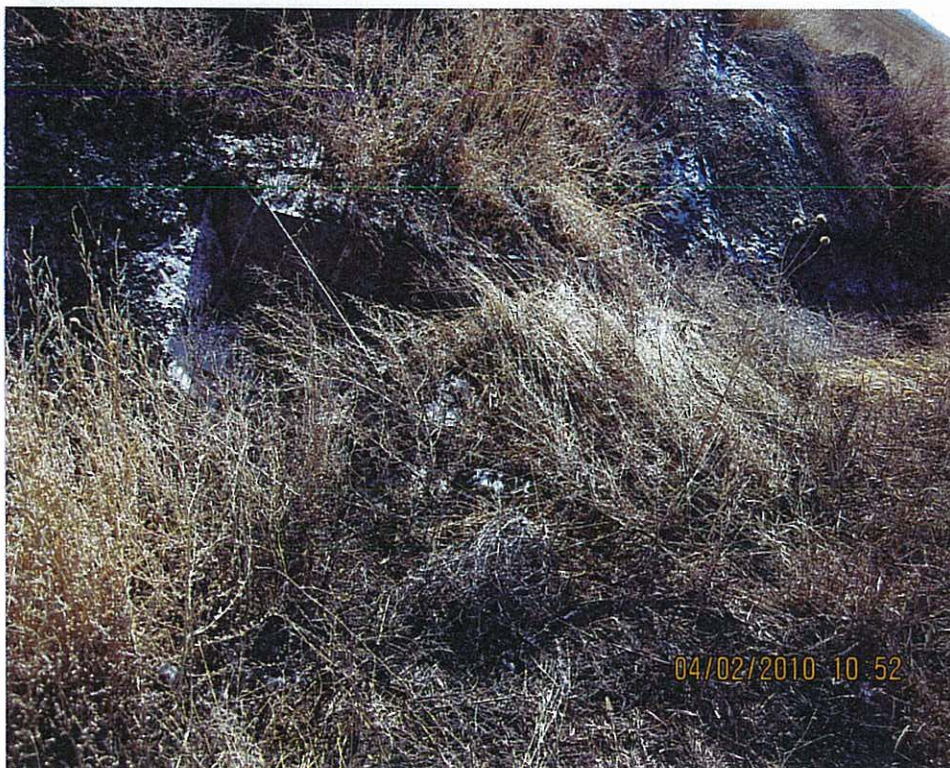
Headgate is adjustable and lockable. 18 in. Parshall flume. Approach to flume needs to be cleaned for accurate measurement.

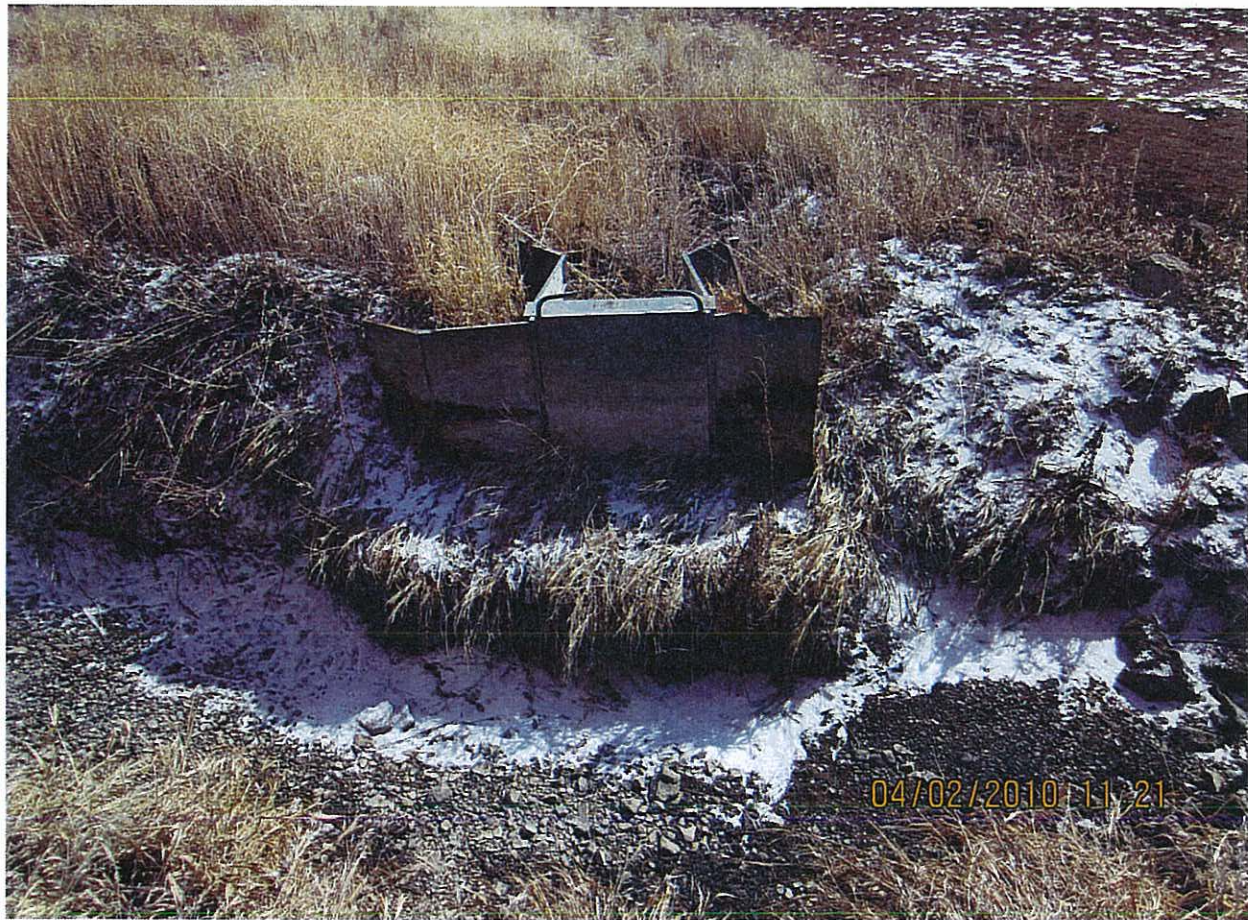
Inactive heading. Not lockable. No measuring device.

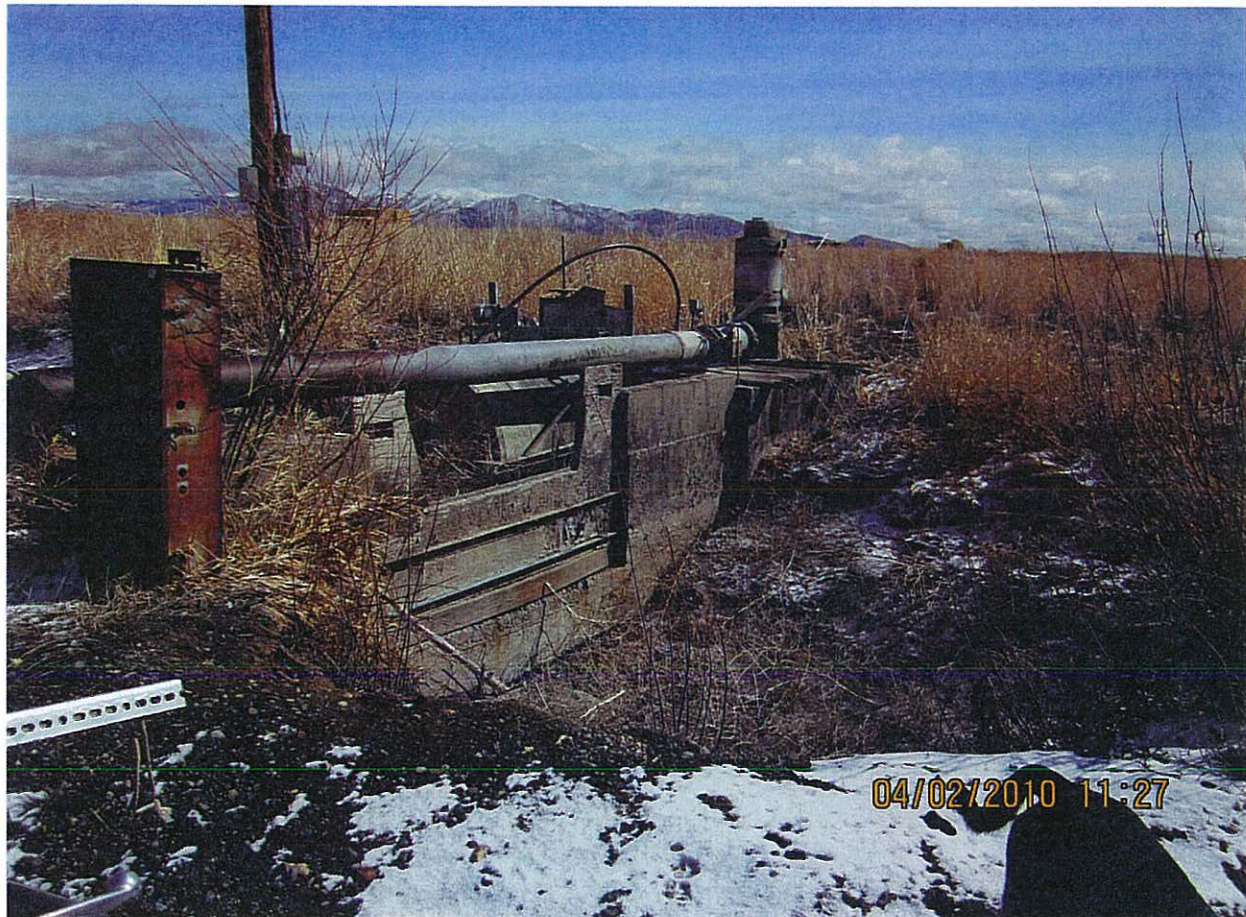
This is also the end of the Munsey Canal. 48 in. Cipolletti is bowed and is not measuring water accurately.

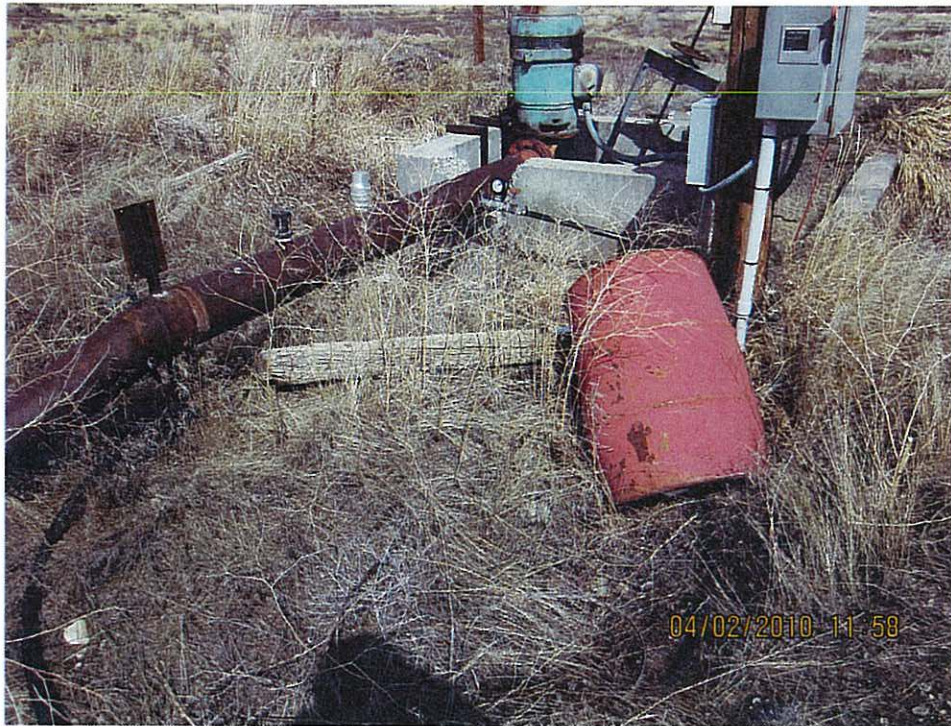
Adjustable and lockable control is located at the pivot point. It could not be determined if the flow meter is operational.

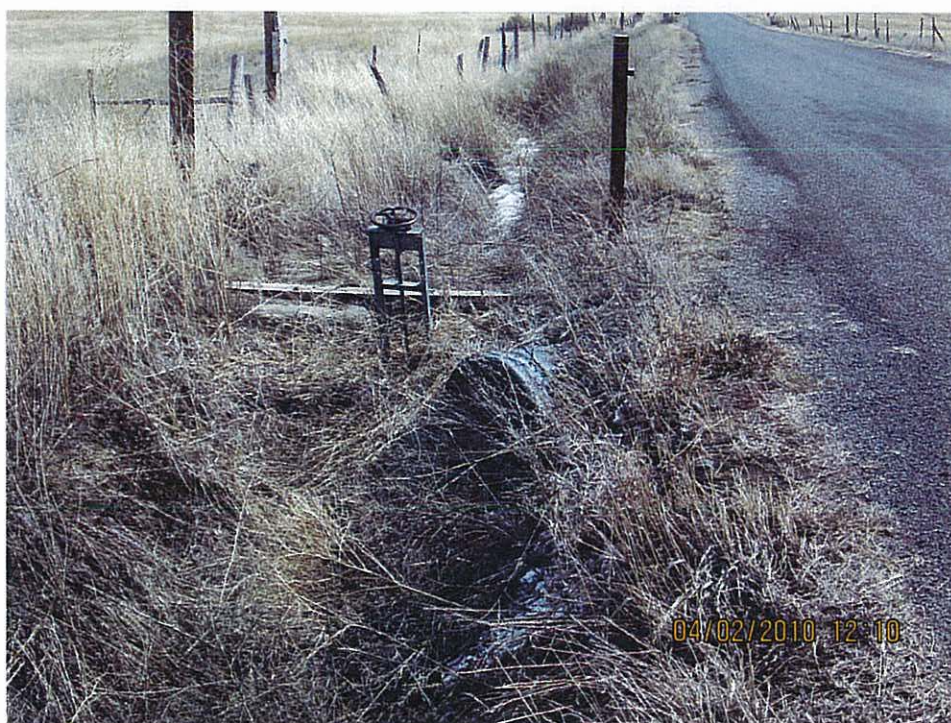
Headgate is adjustable and lockable. 18 in. Parshall flume will require approach cleaning to measure accurately.
