MEMORANDUM

TO: Muldoon Creek Water District (37-O) File

SUBJECT: Investigation of Jim Peterson Property

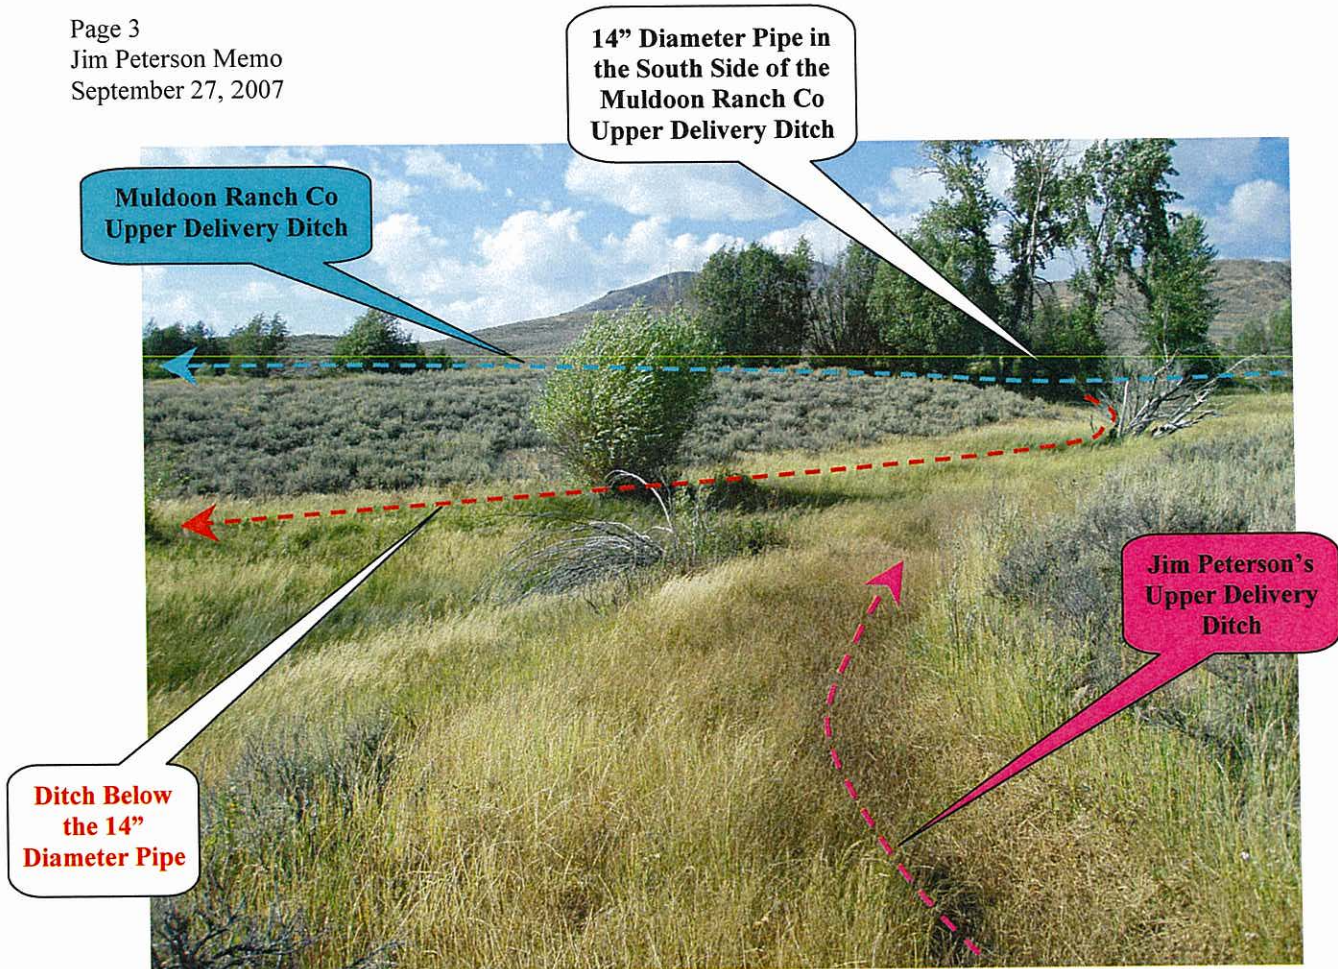
ABOVE: View looking down Jim Peterson's upper diversion ditch towards the area where the 14" diameter pipe in the south side of the Muldoon Ranch Co upper delivery ditch is located. The approximate location of the ditch below the 14" diameter pipe is also indicated. Note the greener grass along the ditch below the 14" diameter pipe compared to the grass along Jim Peterson's upper diversion ditch. The 14" pipe in the south side of the Muldoon Ranch Co upper delivery ditch (shown in view to the left) is located in the trees in the area indicated.

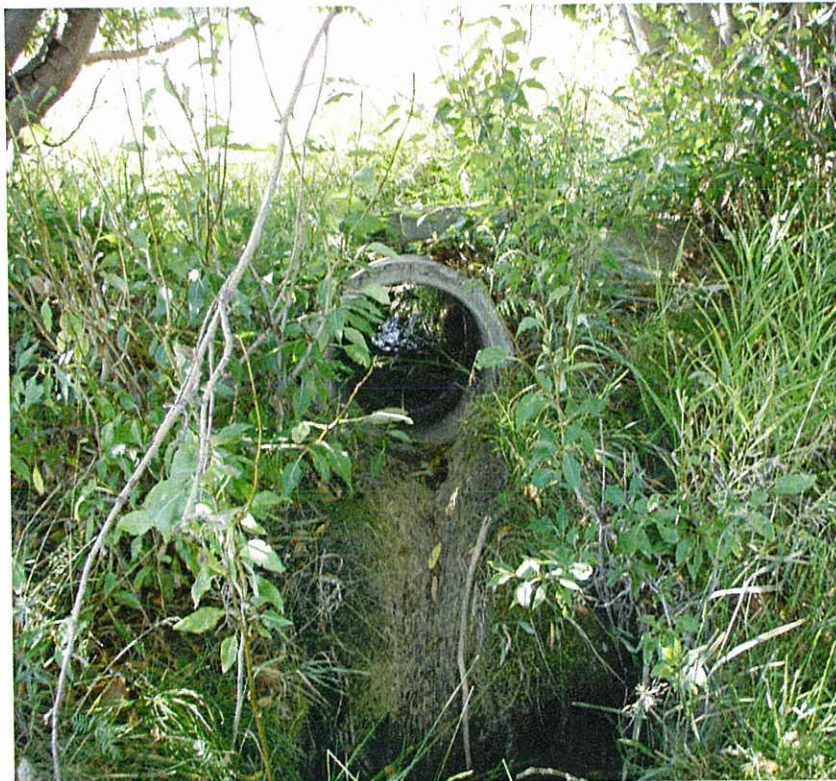
LEFT: View of the downstream end of the 14" diameter pipe in the south side of the Muldoon Ranch Co upper delivery ditch. Note that the upstream slide gate is open, and that water in the Muldoon Ranch Co upper delivery ditch is visible in the background, through the pipe.
