From: Skinner, Corey
Sent: Thursday, September 27, 2007 2:36 PM
To: Luke, Tim
Cc: Merritt, Allen; Cooper, Jeff
Subject: Results of Muldoon Creek Investigation

MEMORANDUM

SUBJECT: Field Visit and Inventory of Diversions

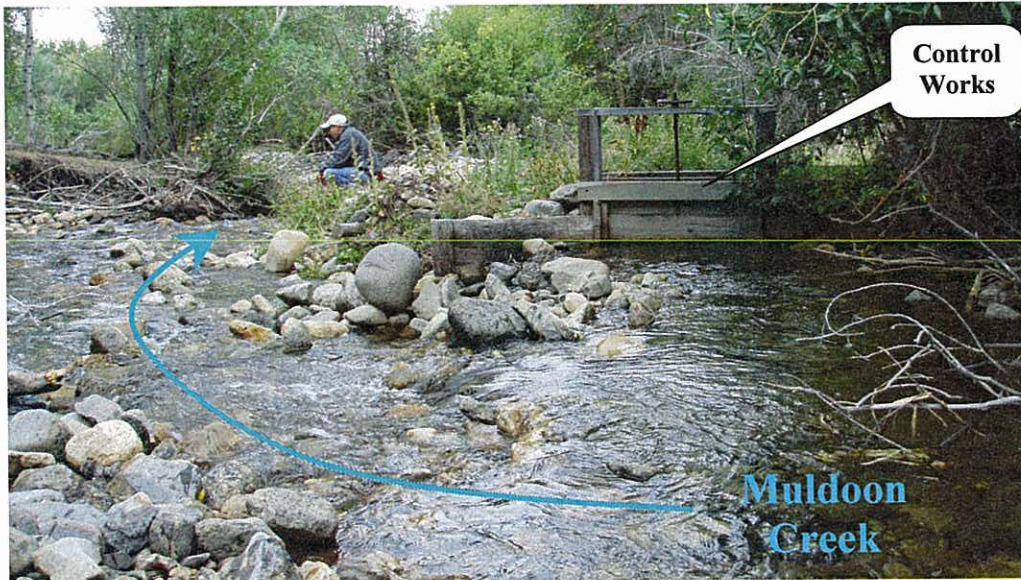
Guy Peterson Diversion

ABOVE: View on 9/5/2007 looking down Muldoon Creek at Guy Peterson's diversion (Site Tag #A0011848) with the control works visible at the head of Guy Peterson's ditch. The control works consist of a wooden gate structure with wooden gate and metal gate stem.

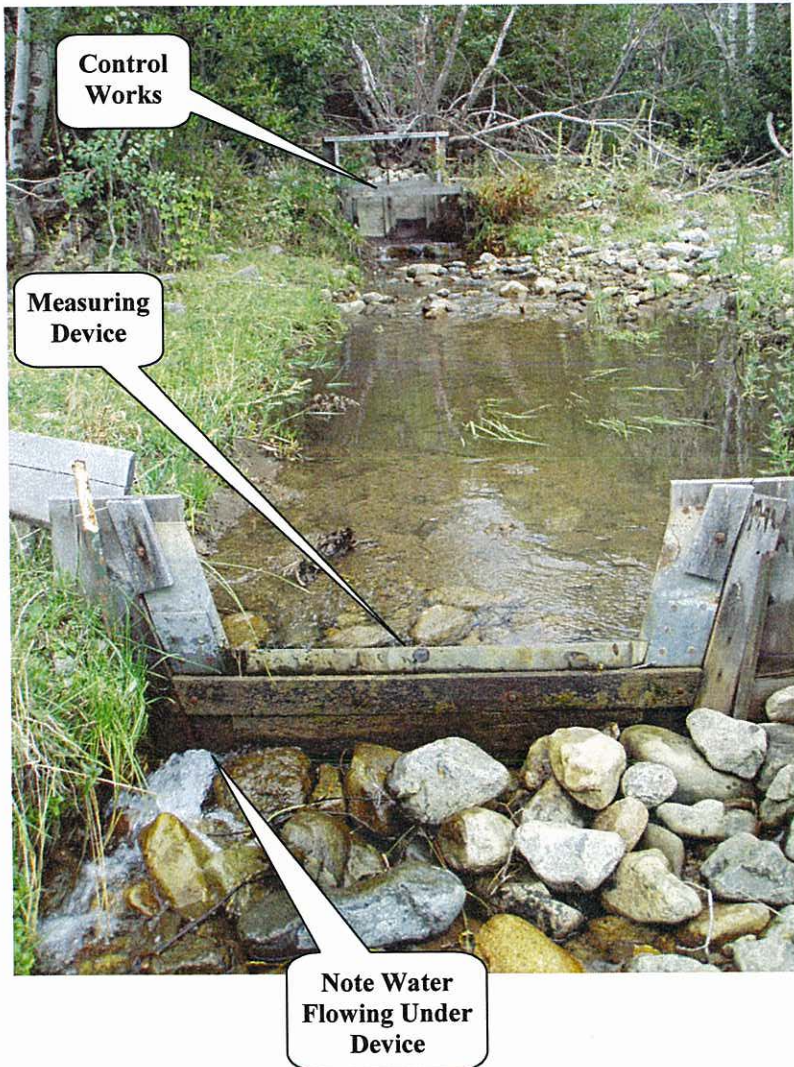
LEFT: View on 9/5/2007 looking up Guy Peterson's ditch through the measuring device towards the control works. Measuring device consists of a 3.0 foot Cipoletti weir (metal blade in wood structure). No staff gage was present for the measuring device. Note the water leaking under the measuring device with no flow over the weir blade on the measuring device. It was also observed that Guy Peterson's ditch(es) have significantly more water flowing through them than what is being diverted at this location. During the middle of the day on September 5th, it was noted that water was flowing over the weir blade at an approximate depth of 2 inches (less than 1.0 cfs total), later that day (when this picture was taken) no water was observed to be flowing over the weir blade. During the middle of the day on September 6th, it was observed that once again water was flowing over the weir blade at an approximate depth of 2 inches (less than 1.0 cfs total).

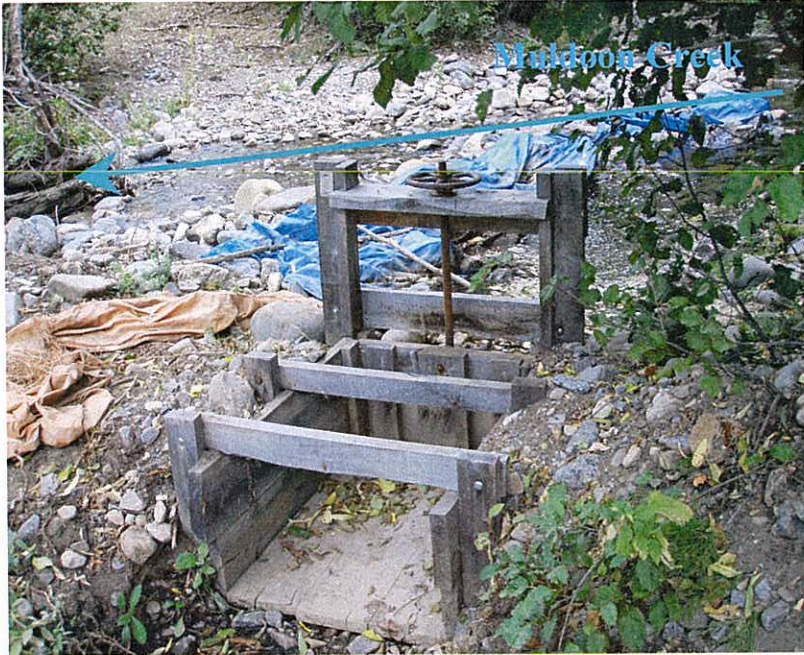
Muldoon Grazing Assoc. Upper Diversion

LEFT: View on 9/5/2007 looking at the Muldoon Grazing Association's upper diversion (Site Tag #A0011847) with the control works visible at the head of the ditch. The control works consist of a wooden gate structure with wooden gate and metal gate stem. Note that no water was being diverted when the picture was taken.

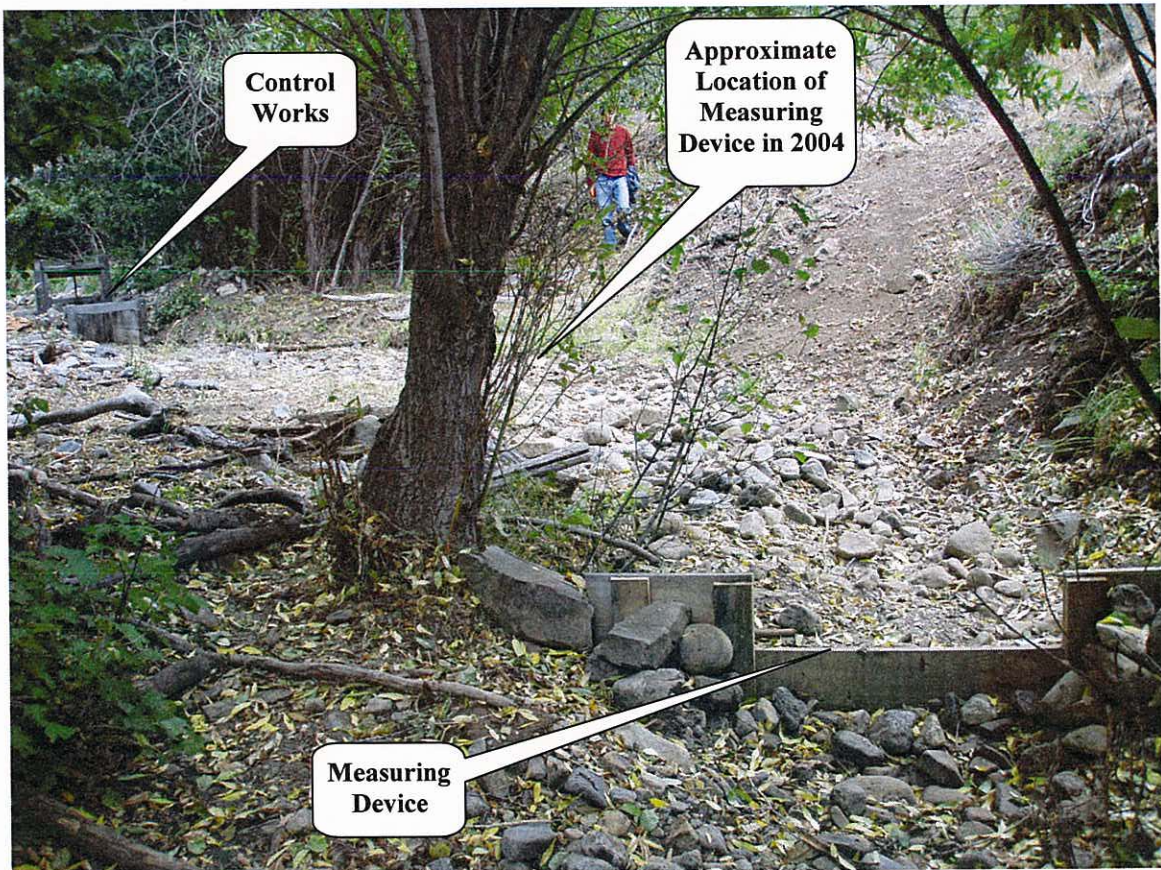
BELOW: View on 9/5/2007 further down the Muldoon Grazing Association's upper diversion ditch showing the location of the measuring device. The measuring device consists of a 3.0-foot rectangular weir. There is no metal blade in the wood structure and I do not recall noting a staff gage being present on the measuring device. Also note that the location of the measuring device has been moved slightly downstream from where it was located during the September 2004 investigation.

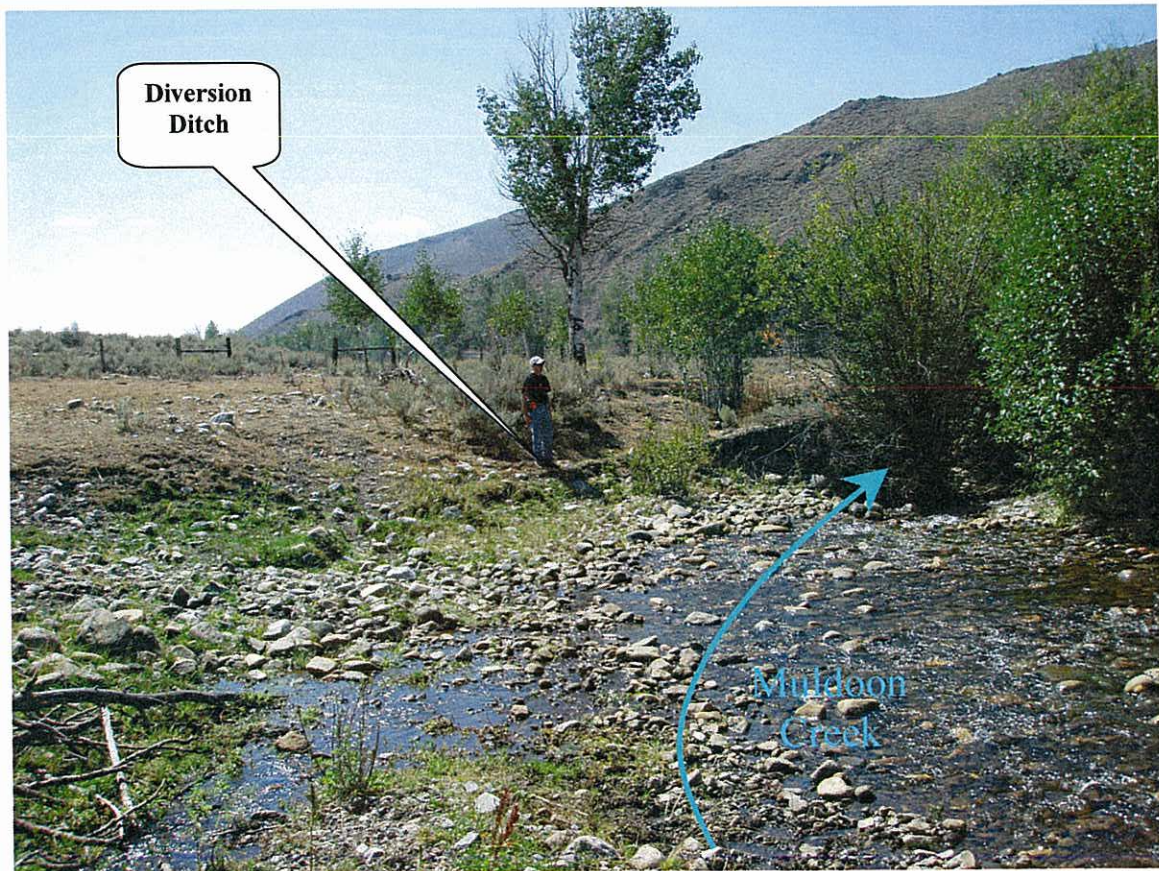
Muldoon Grazing Assoc. Middle Diversion

ABOVE: View on 9/6/2007 looking at the Muldoon Grazing Association's middle diversion. Note the relative height of the ditch in relation to the creek, the lack of control works and measuring device and the general appearance that appears to indicate lack of recent use of this diversion. Sagebrush was growing in the bottom of the ditch indicating lack of recent use of this particular diversion and ditch.

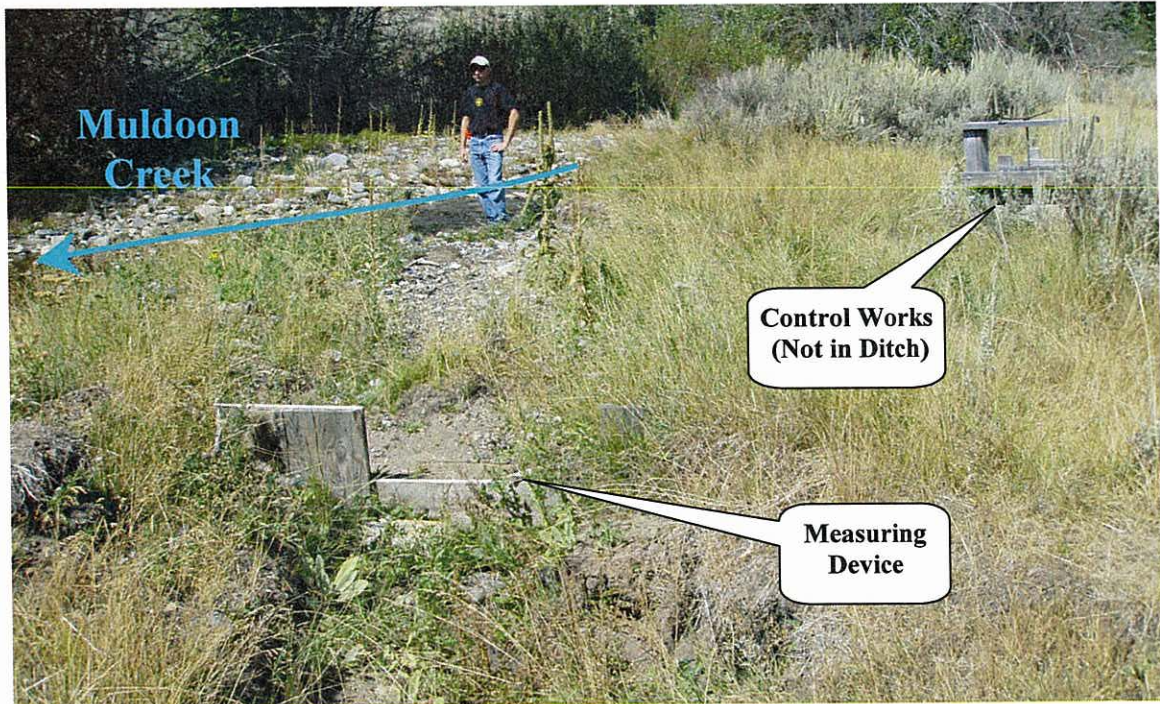
Muldoon Grazing Assoc. Lower Diversion

ABOVE: View on 9/6/2007 looking at the Muldoon Grazing Association's lower diversion (Site Tag #A0011849). Jeff is standing at the head of the diversion ditch. Note that the control works (wooden gate structure with wooden gate and metal gate stem) have been removed from the ditch and the ditch is full of sediment and gravel.

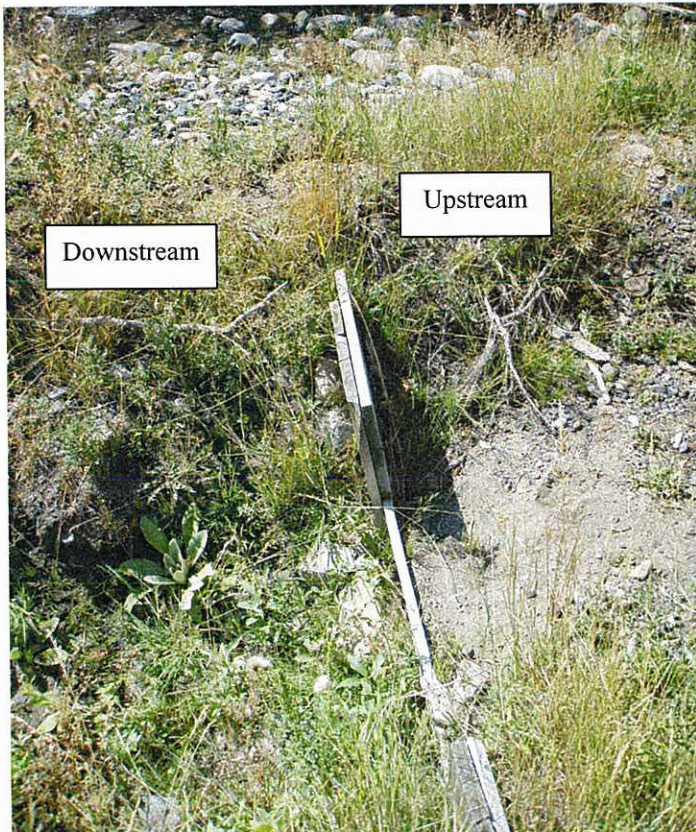
LEFT: View on 9/6/2007 showing the measuring device on the Muldoon Grazing Association's lower diversion ditch. The measuring device consists of a 3.0-foot rectangular weir. Note the sediment and gravel accumulated upstream of the device. No metal weir blade exists in the wood structure and a staff gage is not present.

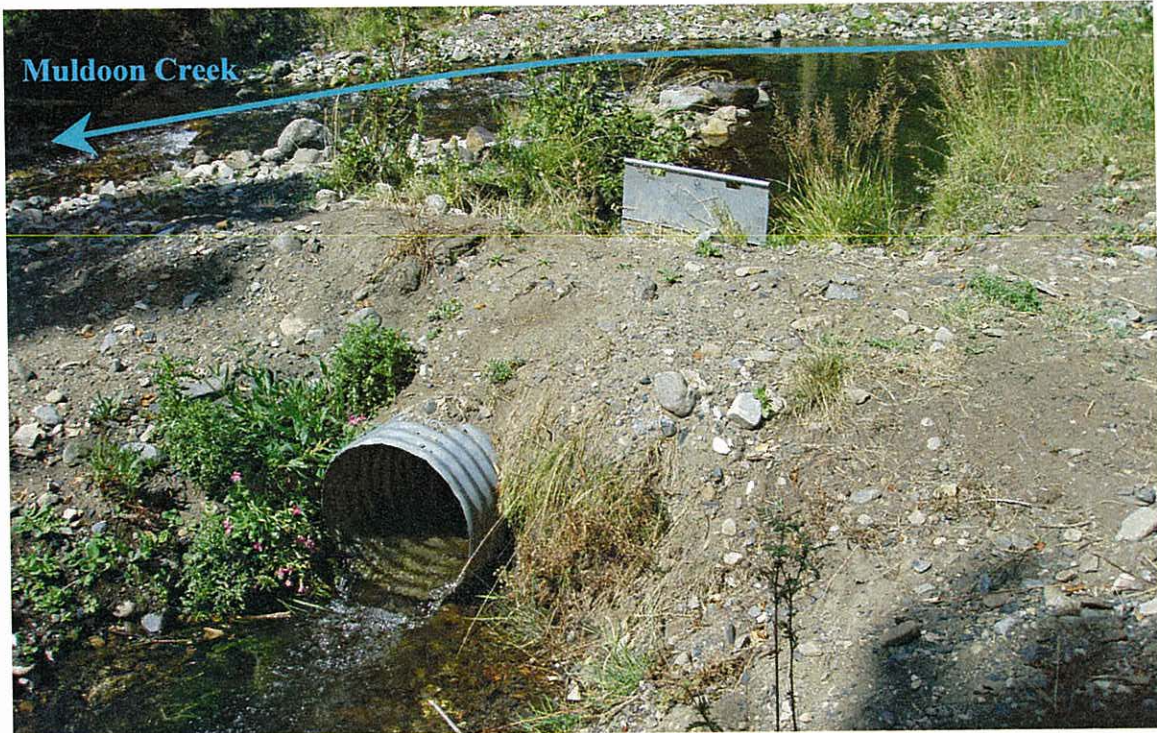
Clark Upper Diversion

ABOVE: View on 9/6/2007 looking at the Clark upper diversion (Site Tag #A0011846) with the control works visible at the head of the ditch. The control works consist of a metal slide gate structure. Holes exist on the edge of the metal slide gate that would allow the gate to be locked in various positions to regulate the flow through the diversion. Note that water was being diverted when the picture was taken.

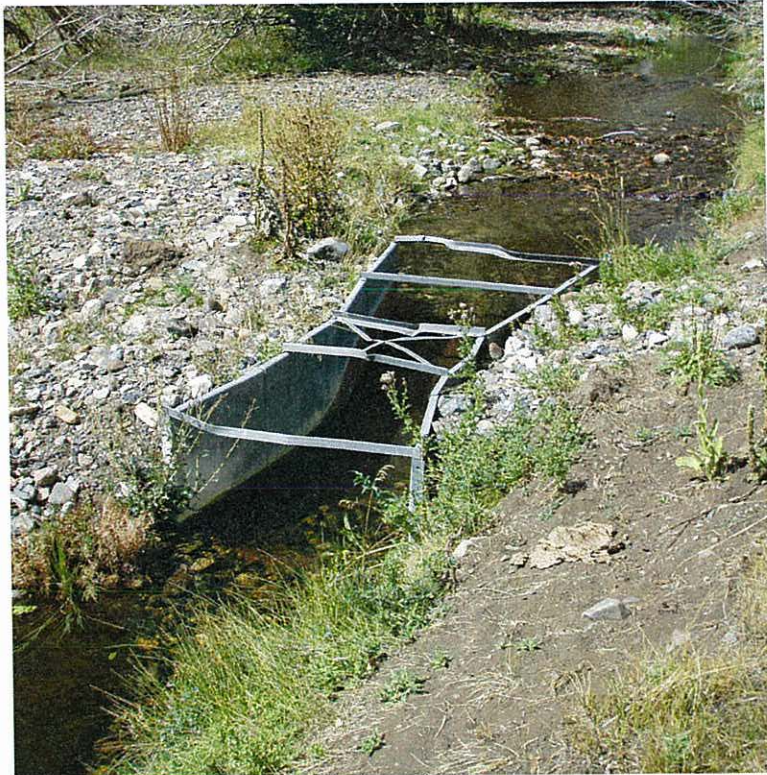
LEFT: View on 9/6/2007 further down the Clark upper diversion ditch showing the measuring device. The measuring device consists of a 2.5-foot Parshall flume. When the picture was taken, the head through the device was 0.31 feet, which would correspond to about 1.60 cfs of flow.

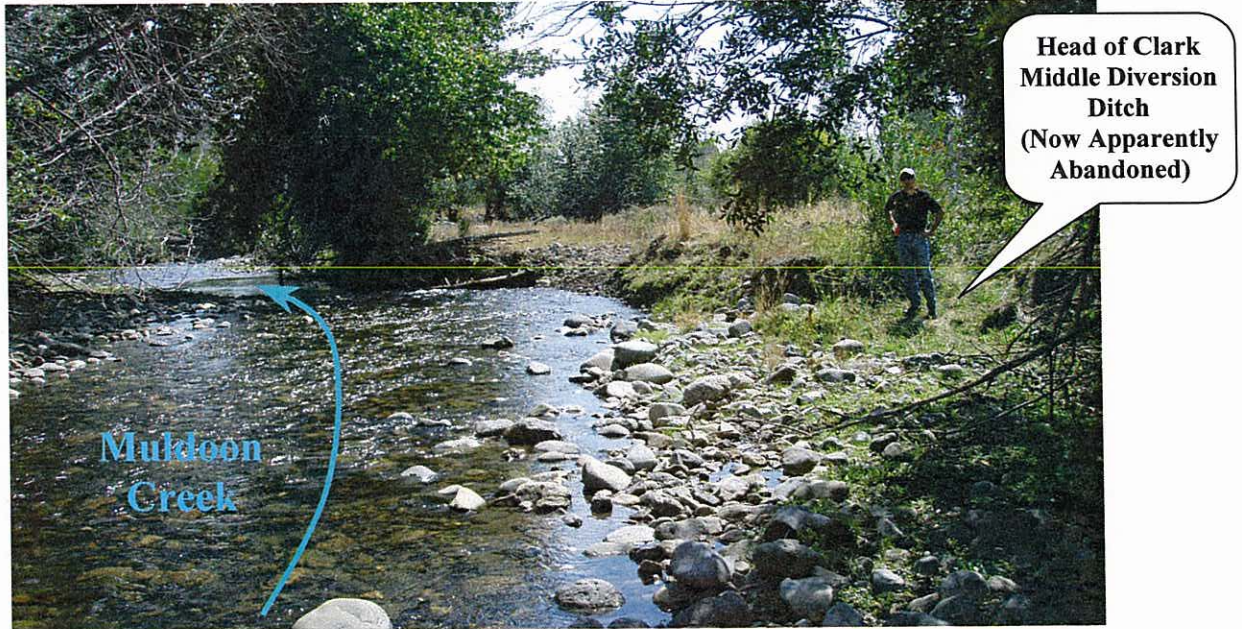
Clark Middle Diversion

ABOVE: View on 9/6/2007 looking down Muldoon Creek with Jeff standing at the head of the Clark middle diversion at the location observed in September 2004. Fill material had been placed in the Clark middle diversion ditch (just downstream of Jeff) essentially blocking off this particular ditch.

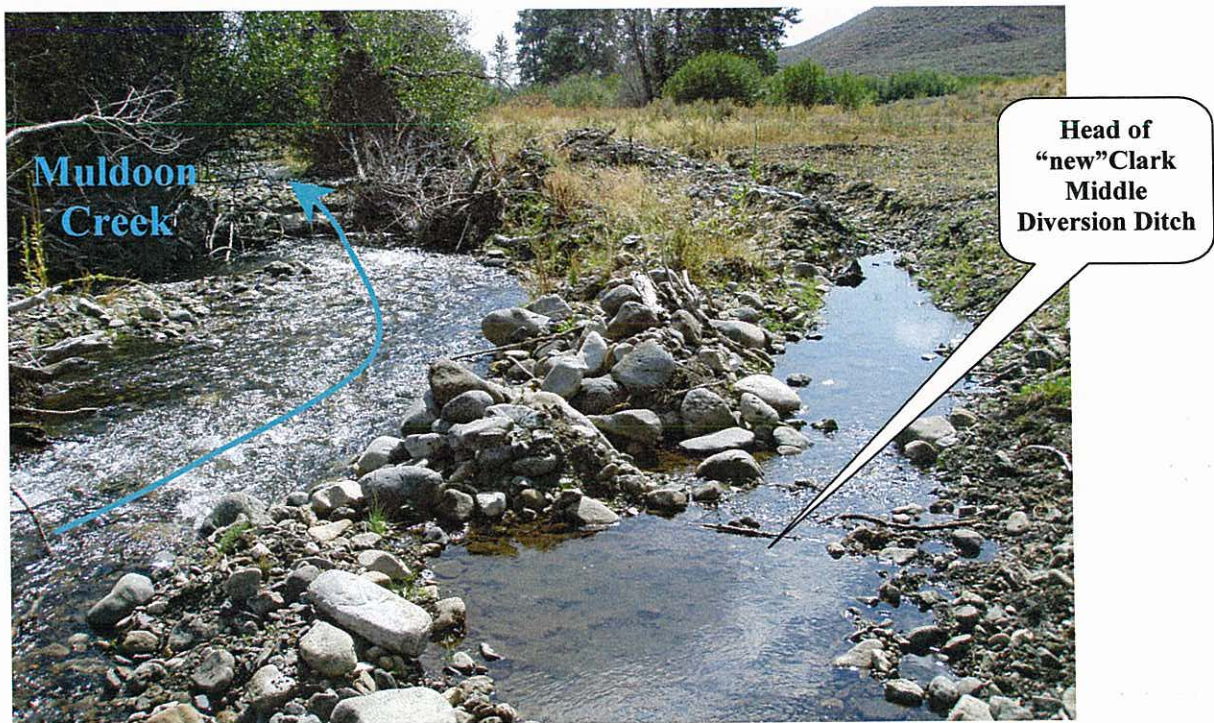
BELOW: View on 9/6/2007 looking down Muldoon Creek approximately 200 feet upstream of the location shown in the view above showing what is now the Clark middle diversion showing diversion ditch on the right (west) side of Muldoon Creek. A metal slide gate structure (control works) is present on the ditch about 200 feet downstream of this location (see photo on next page).

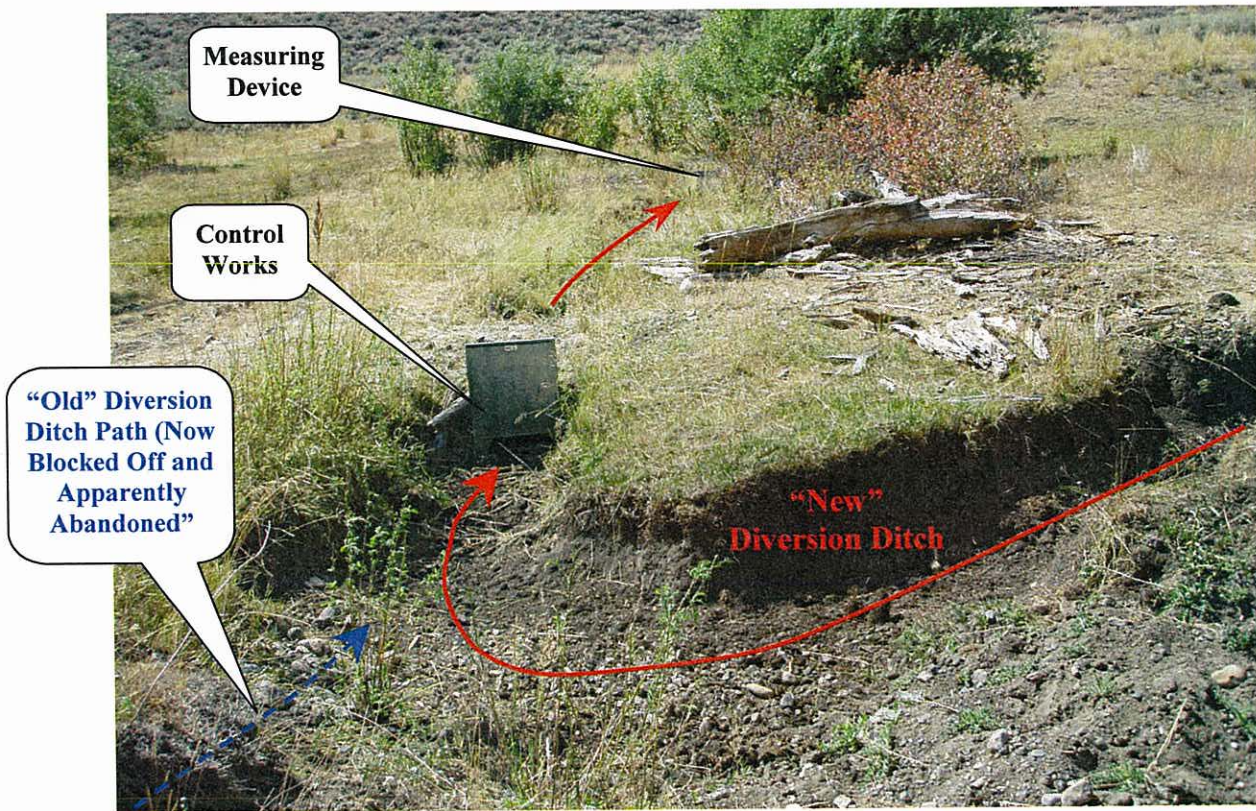
Clark Middle Diversion

ABOVE: View on 9/6/2007 showing the control works (metal slide gate structure) on the Clark middle diversion ditch. This view location is about 200 feet downstream of the head of the “new” Clark middle diversion ditch (2nd view on previous page). Fill material had been placed in the “old” Clark middle diversion ditch upstream of this location essentially blocking off the old ditch so that only water from the “new” diversion can reach the location shown in this view. The approximate location of the measuring device (shown in view below) is indicated. Note that during the September 2004 inspection, no control works or measuring device was present at the Clark middle diversion.

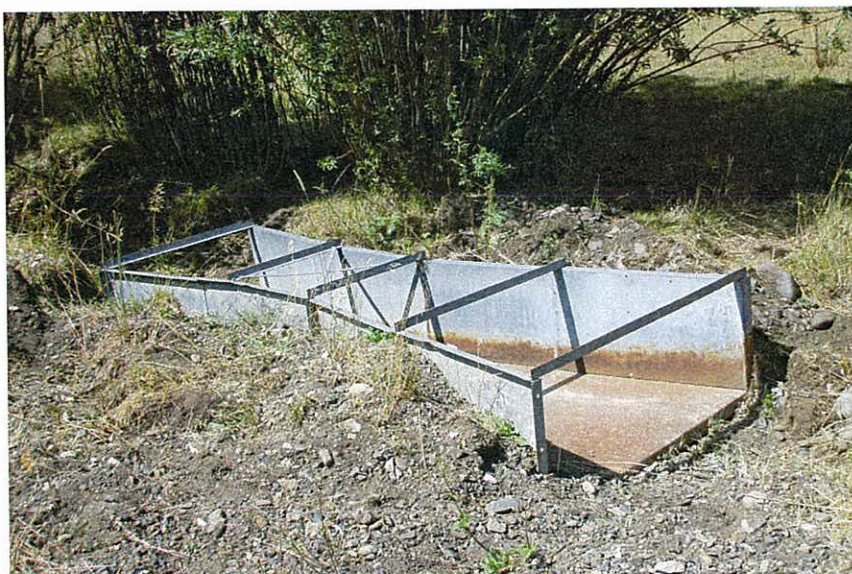
LEFT: View on 9/6/2007 of measuring device (2.0-foot Parshall flume) located on the Clark middle diversion ditch. A staff gauge was located on the device. There may be some concern with the overall installation of this particular device. It appeared that the installation of the flume was not level, with the flume sloping towards the downstream end.

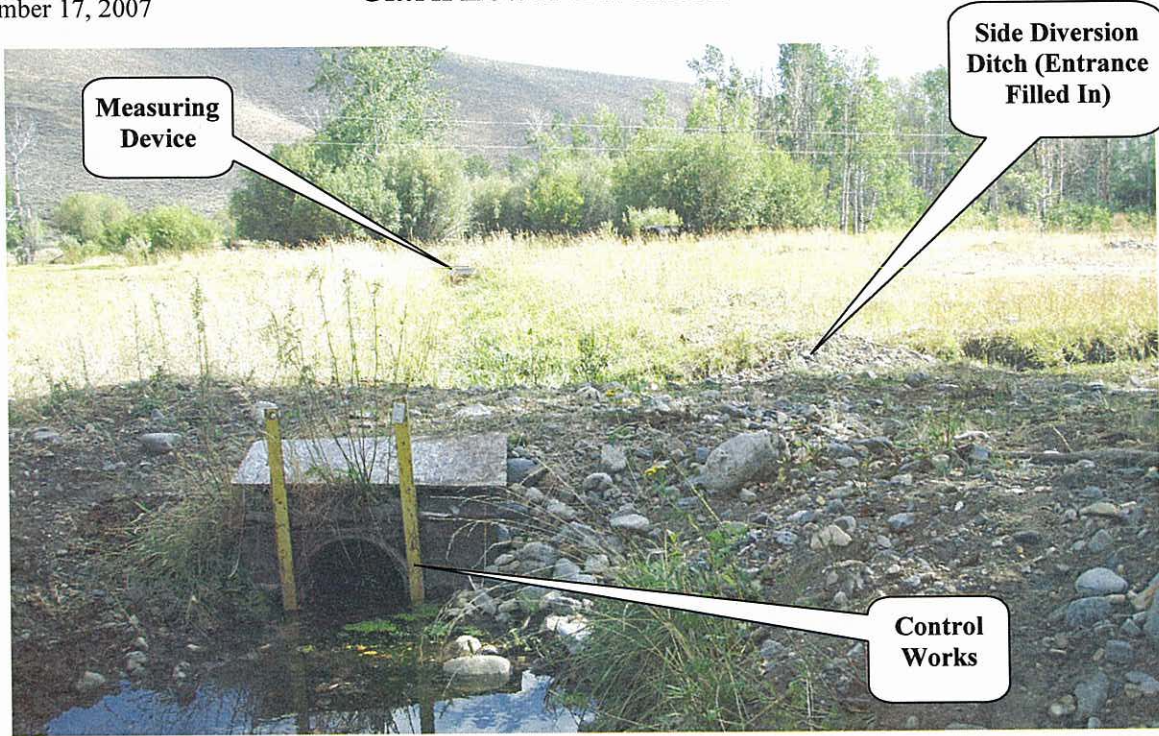
Clark Lower Diversion

ABOVE: View on 9/6/2007 from Muldoon Creek showing the control works on the Clark lower diversion ditch. The control works consist of a buried culvert with a steel headwall and steel posts where a piece of plywood can be slid down to block the culvert entrance. It is debatable whether or not these control works could be locked or adjusted in more than the fully open or fully closed position. The location of the measuring device (shown in view below) is also indicated. During the September 2004 inspection it was noted that a side diversion ditch (location shown) was located upstream of the measuring device, but this ditch has now been blocked off with fill material. Note that the location shown in this view is directly across the stream from the Muldoon Ranch Co upper diversion shown on the next page.

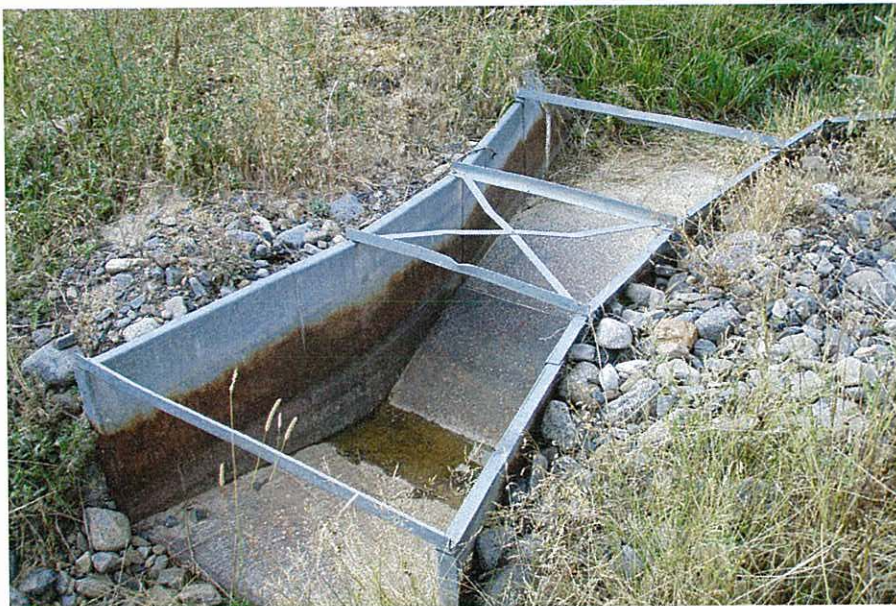
LEFT: View on 9/6/2007 of measuring device (2.5-foot Parshall flume) located on the Clark lower diversion ditch. A staff gauge was located on the device. It appears that the installation condition has improved since the September 2004 inspection (see photo in 9/23/2004 memo).

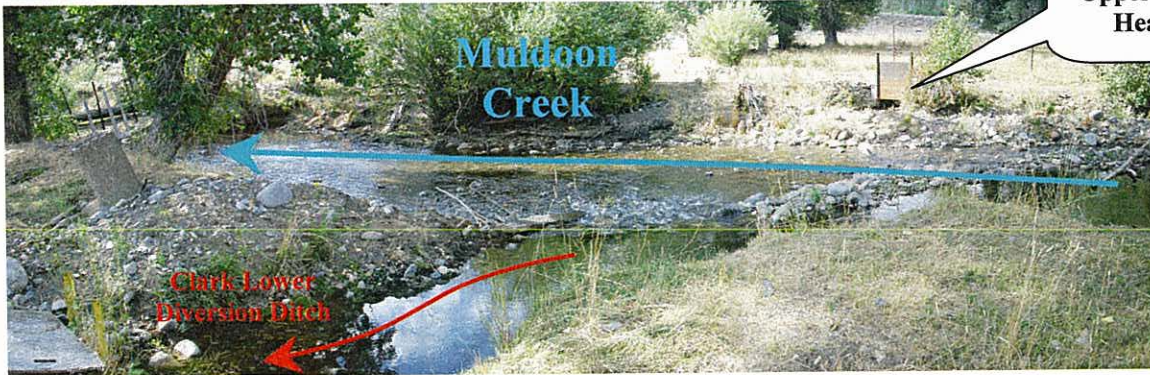
Muldoon Ranch Co Upper Diversion

ABOVE: View on 9/6/2007 looking across the Clark lower diversion ditch and Muldoon Creek with the Muldoon Ranch Co upper diversion control works (steel head gate) visible in the background across the creek.

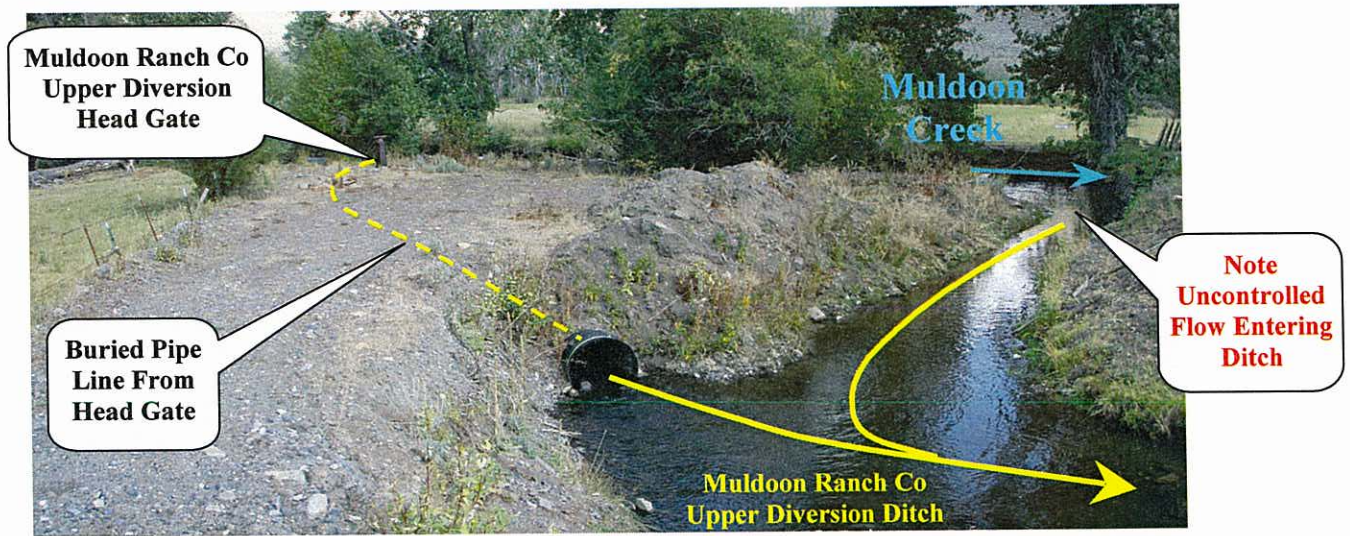
BELOW: View on 9/6/2007 looking up the Muldoon Ranch Co upper diversion ditch (Site Tag #A0011841) showing the location of the pipe discharge from the diversion control works (steel head gate) and showing uncontrolled channel conveying water into the Muldoon Ranch Co upper diversion ditch.

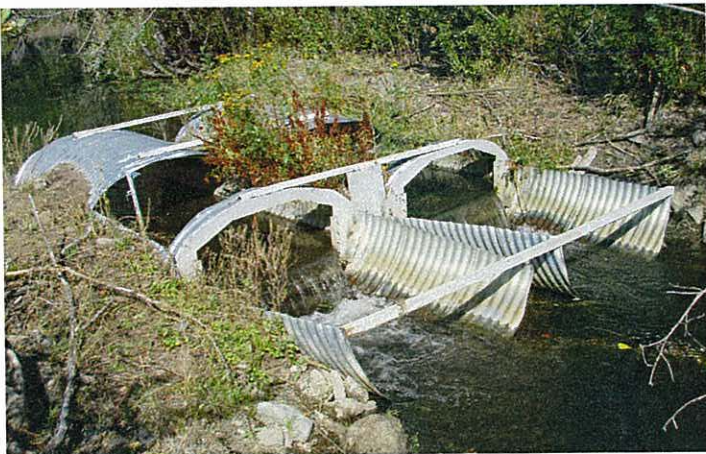
LEFT: View on 9/6/2007 of the measuring device on the Muldoon Ranch Co upper diversion ditch. The measuring device consists of 42-inch rectangular weirs placed in parallel. When the picture was taken, the head through the device was 0.30 feet, which would correspond to about 3.78 cfs of flow.

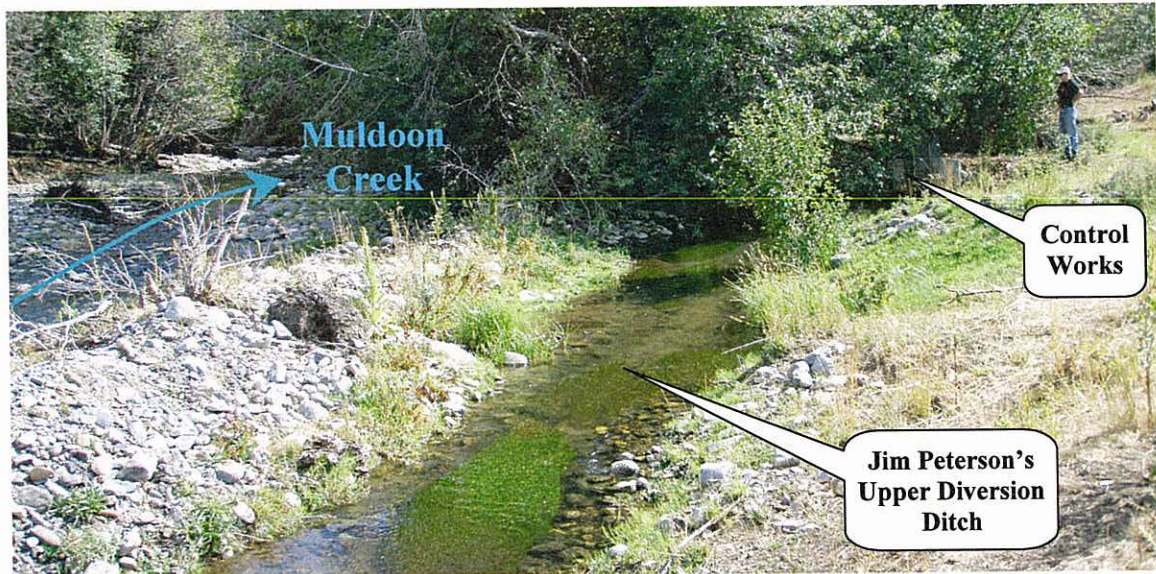
Jim Peterson Upper Diversion

ABOVE: View on 9/6/2007 looking down the head of Jim Peterson's upper diversion ditch (Site Tag #A0011842) with the location of the control works indicated.

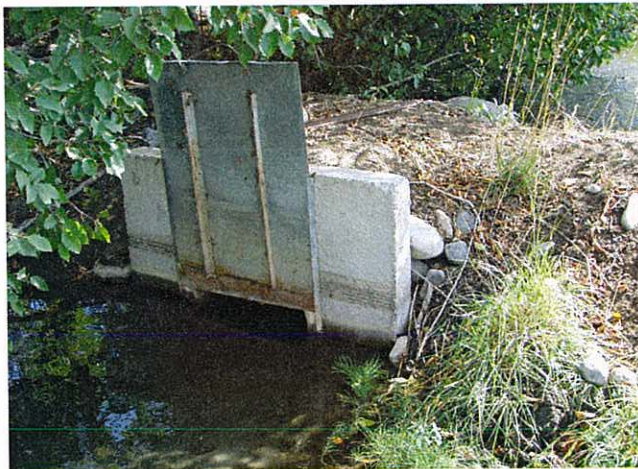
LEFT: View on 9/6/2007 of control works on Jim Peterson's upper diversion ditch. The control works consist of a metal slide gate structure. It is debatable whether or not these control works could be locked or adjusted in any position other than the fully open or fully closed position.

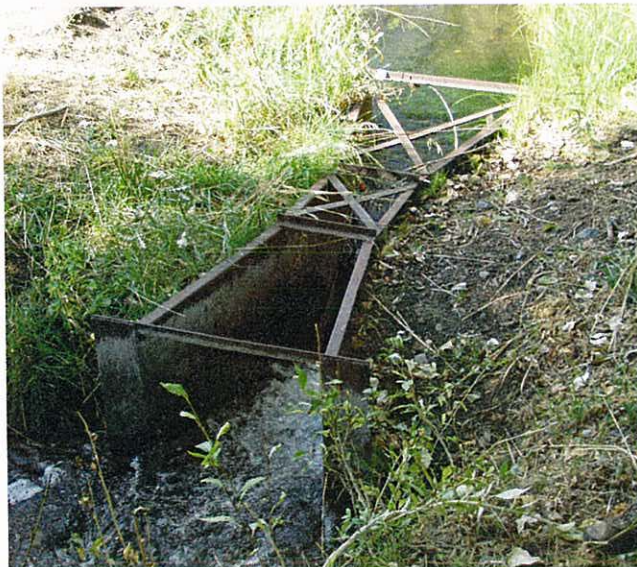
LEFT: View on 9/6/2007 of the measuring device (1.0-foot Parshall flume) located on Jim Peterson's upper diversion ditch. When the picture was taken, the head through the device was 0.90 feet, which would correspond to about 3.35 cfs of flow.

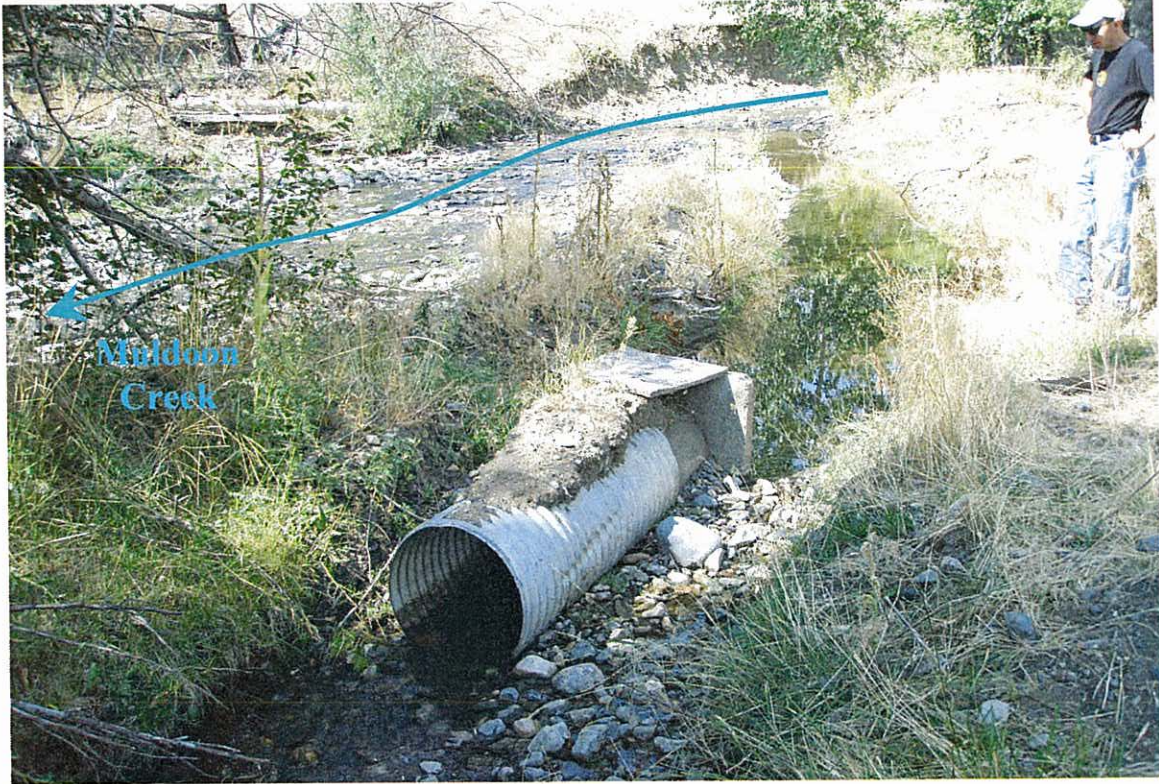
Jim Peterson Lower Diversion

ABOVE: View on 9/6/2007 of control works on Jim Peterson's lower diversion ditch (Site Tag #A0011843). Note that the control works have washed out and no longer regulate flow in the ditch. Prior to washing out, the control works consisted of a buried culvert with a concrete headwall where a piece of plywood could be slid down to block the culvert entrance. It is debatable whether or not these control works could be locked or adjusted in more than the fully open or fully closed position.

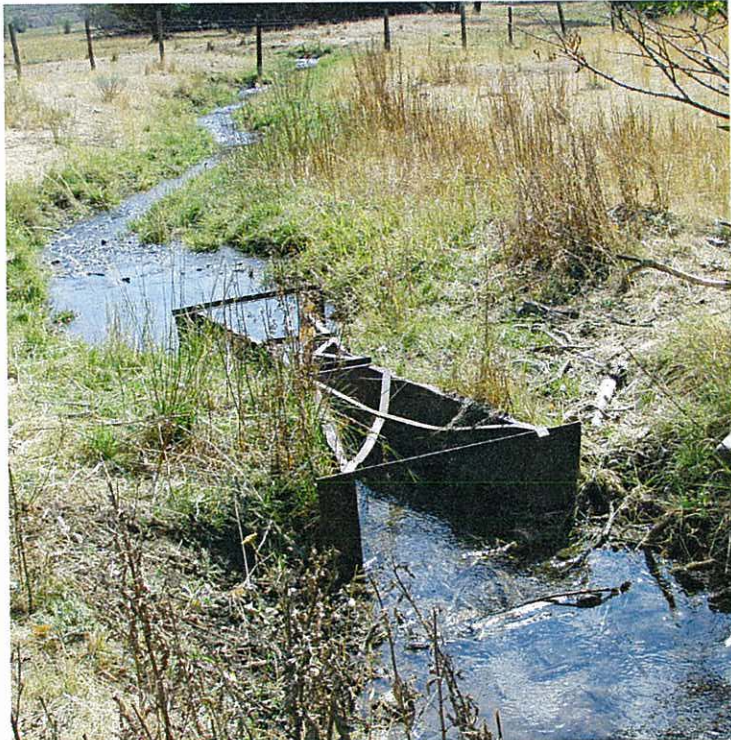
LEFT: View on 9/6/2007 further down Jim Peterson's lower diversion ditch showing measuring device (1.0-foot Parshall flume). When the picture was taken, the head through the device was 0.62 feet, which would correspond to about 1.88 cfs of flow.

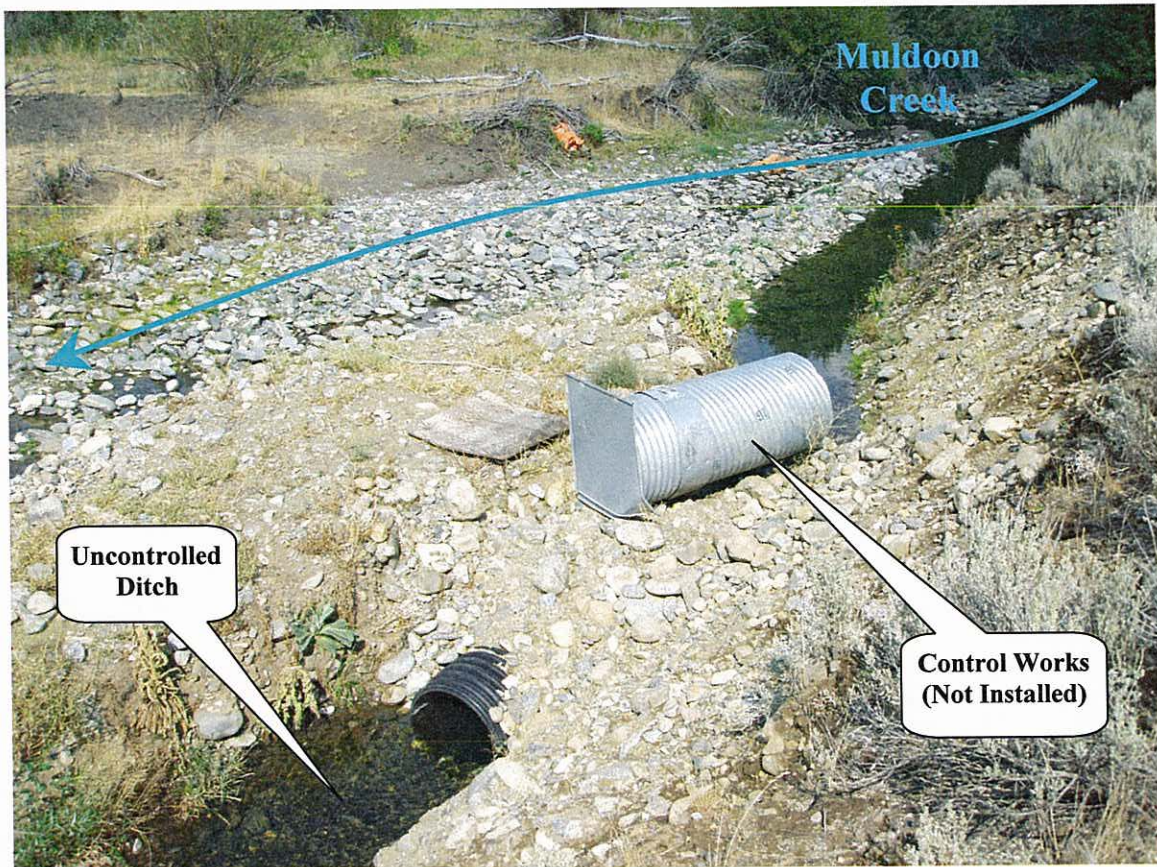
Muldoon Ranch Co Middle Diversion

ABOVE: View on 9/6/2007 of the Muldoon Ranch Co middle diversion. Note that the control works (culvert with metal slide gate) are not installed and the diversion consists of an open, uncontrolled ditch, flowing through an open, uncontrolled pipe.

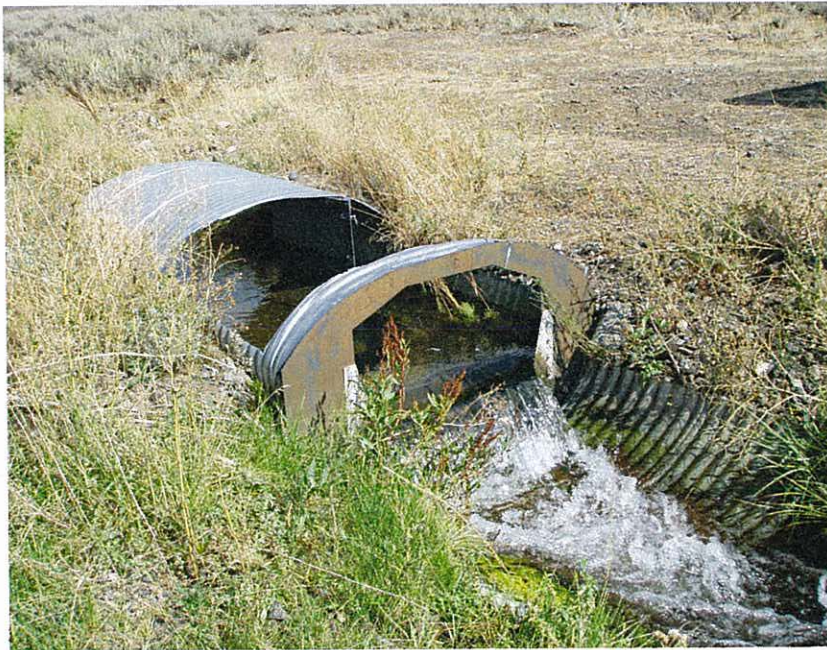
LEFT: View on 9/6/2007 further down the Muldoon Ranch Co middle diversion ditch showing measuring device (2.5-foot Cipoletti weir). When the picture was taken, the head through the device was 0.39 feet, which would correspond to about 2.05 cfs of flow. Note that this measuring device is located approximately 0.20 mile downstream of the diversion.

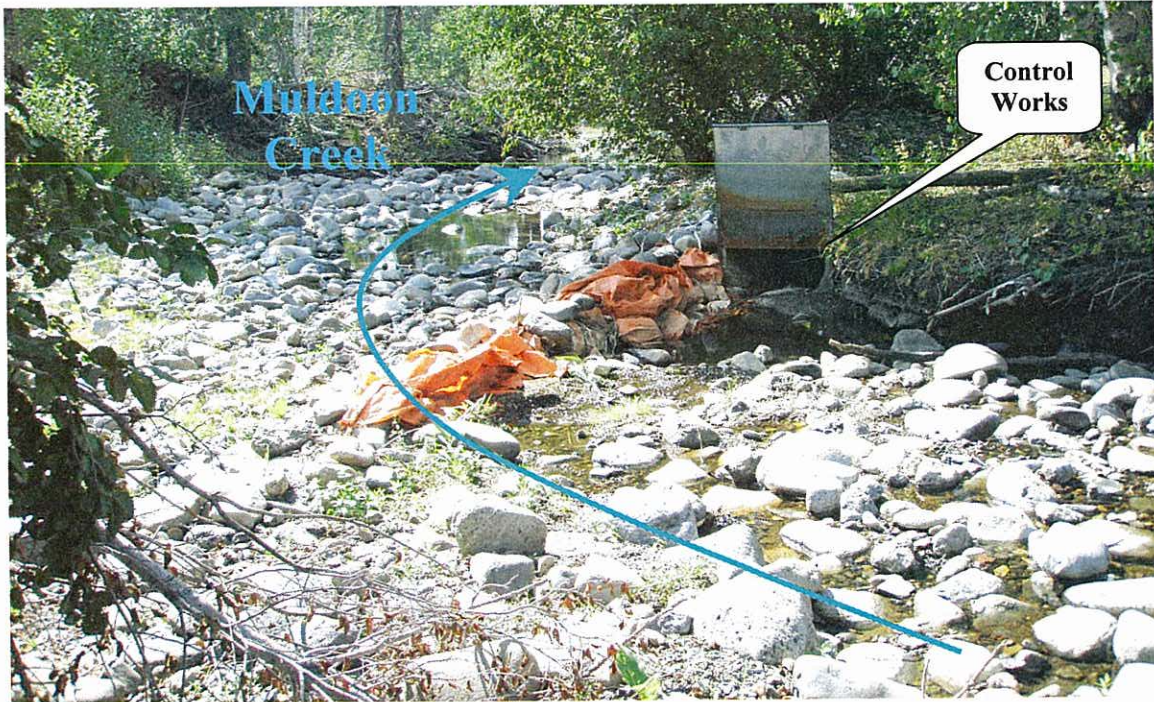
Muldoon Ranch Co Lower Diversion

ABOVE: View on 9/6/2007 looking down Muldoon Creek at the Muldoon Ranch Co lower diversion (Site Tag #A0011845). The control works consist of a metal slide gate structure.

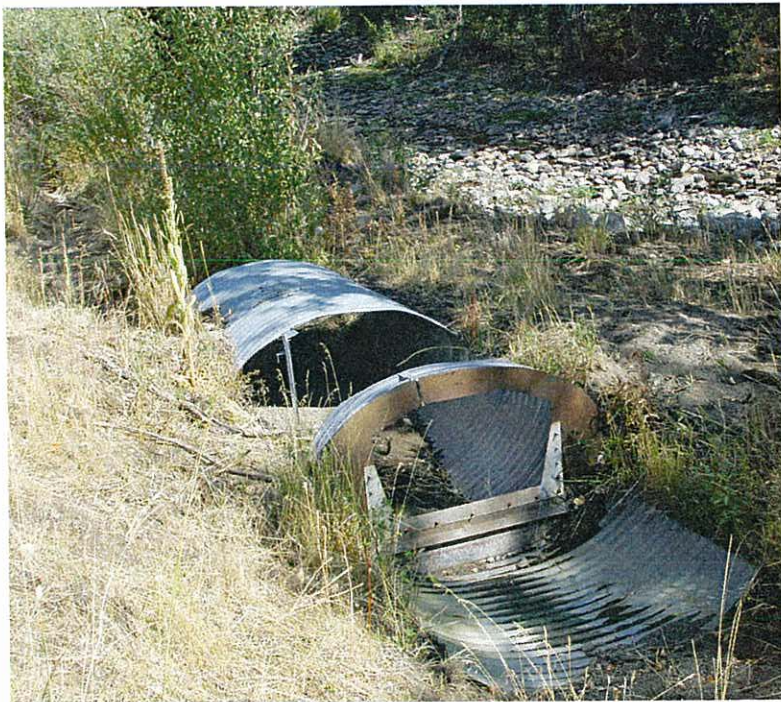
LEFT: View on 9/6/2007 further down the Muldoon Ranch Co lower diversion ditch showing measuring device (2.5-foot Cipoletti weir). When the picture was taken, no flow was being diverted through this diversion (the entire creek was being diverted into the Muldoon Ranch Co middle diversion ditch).
