## **IDWR FIELD EXAMINATION OF CFPRBA WATER RIGHT CLAIM**

**Claim Identification Number:** 97-2000

**Examination Location:** 445 Shaw Rd, Priest River, 83856

**Purpose of Visit:** Verify Point of Diversion location

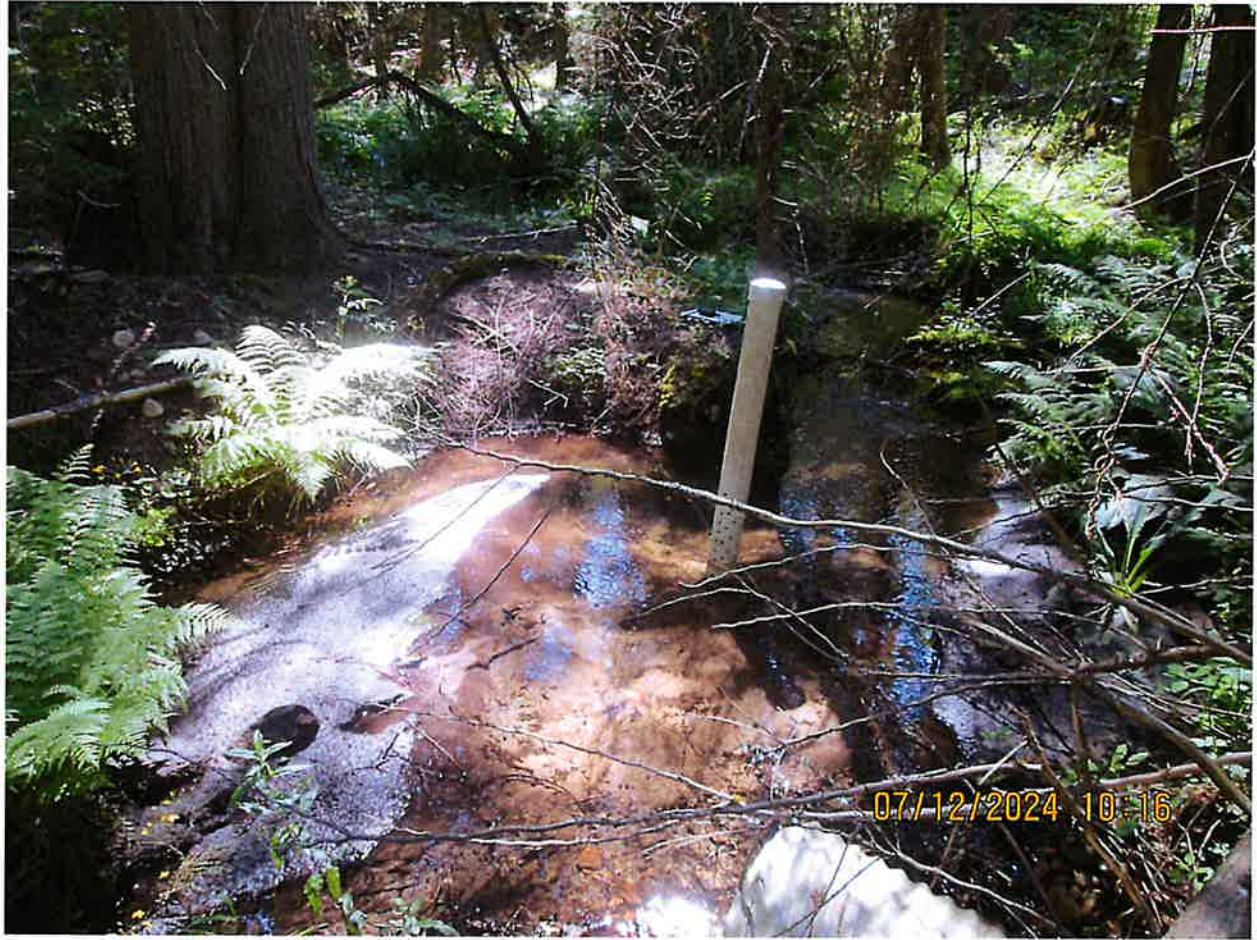
Alder creek is not impounded by this point of diversion, and water is allowed to freely flow past the perforated intake pipe, through an aluminum culvert, and then to continue in its natural channel. Heavy tree cover made recording an accurate GPS location take slightly

Photo 1: showing wide spot in Alder Creek with perforated intake pipe and aluminum culvert allowing water to flow past POD.

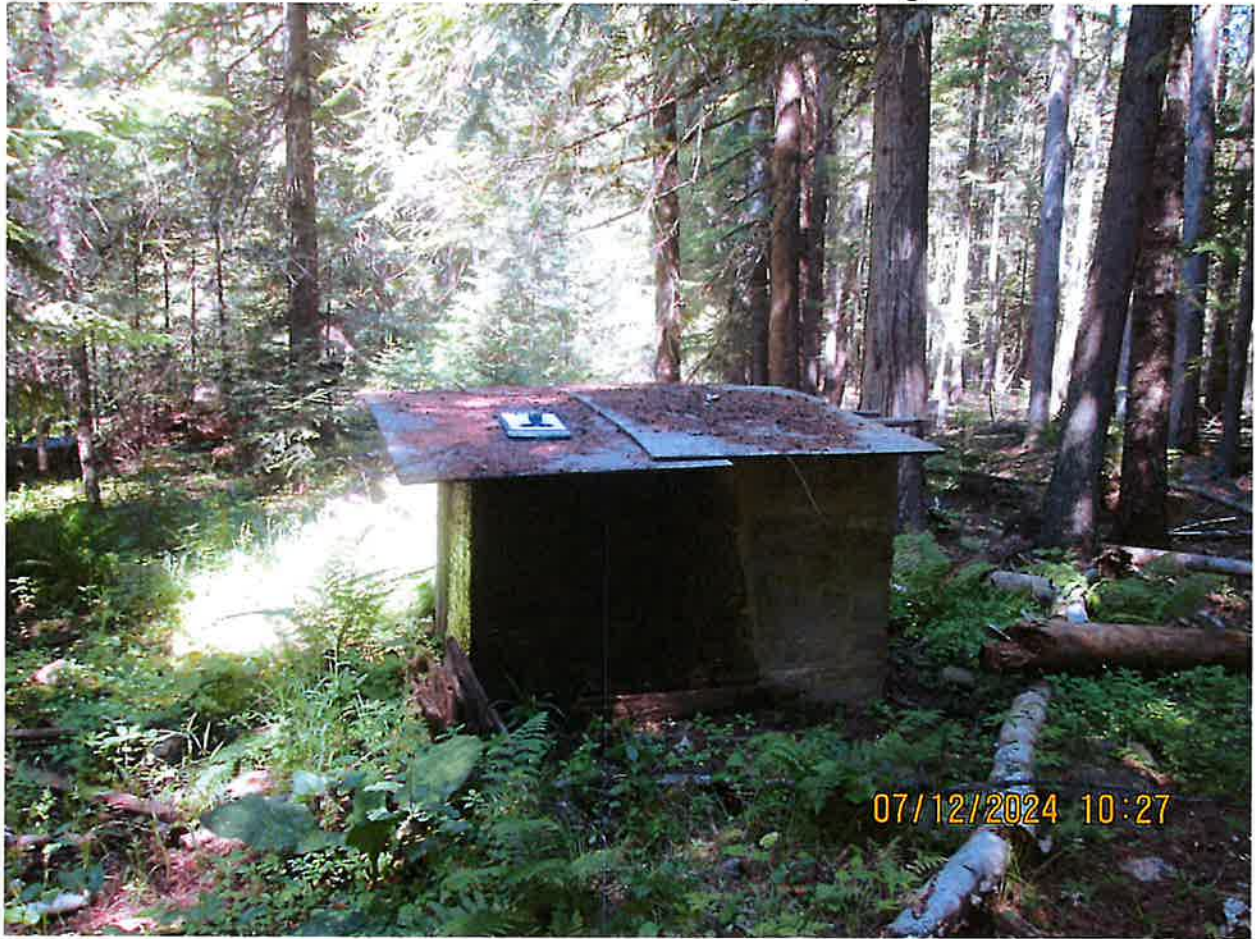
Photo 2: concrete cistern holding water before gravity feeding to residence.
