# FIELD EXAMINATION OF PRBA WATER RIGHT CLAIM

**Claim Identification Number:** 87-10601, 87-10602

**Date of Examination:** 7/17/2024

**Examination Location:** 1480 Uniontown Rd, Genesee, ID 83832

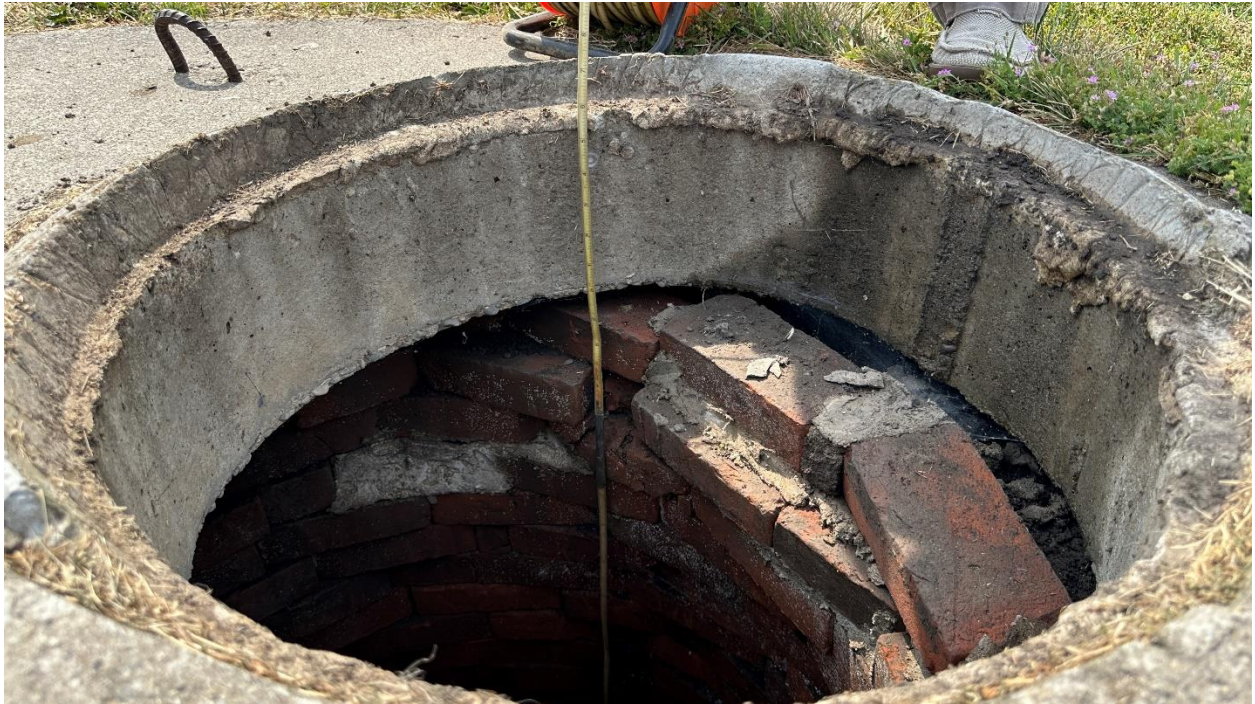
Photo 2: Measuring static water level of well.

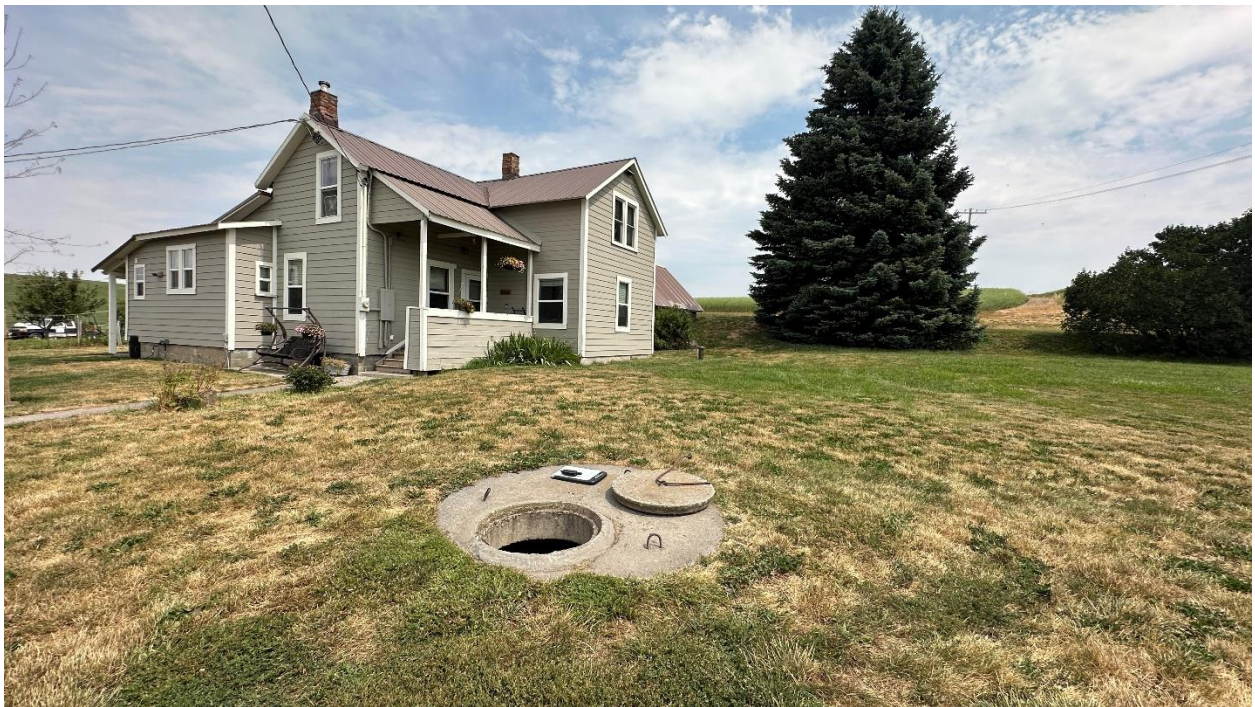
Photo 3: Location of well in relation to home.

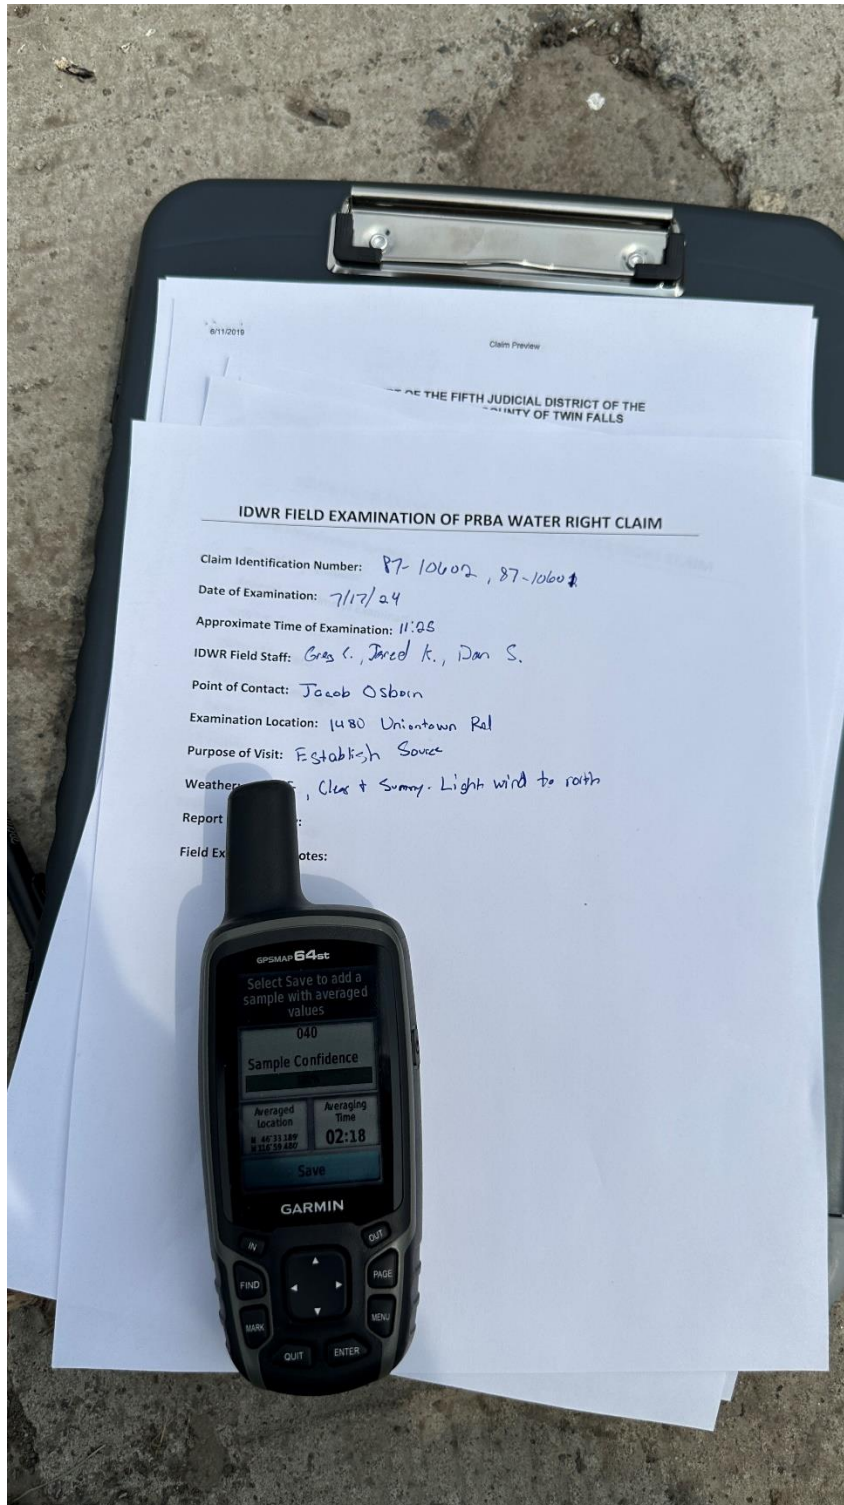
Photo 4: GPS coordinates for POD (87-10601).

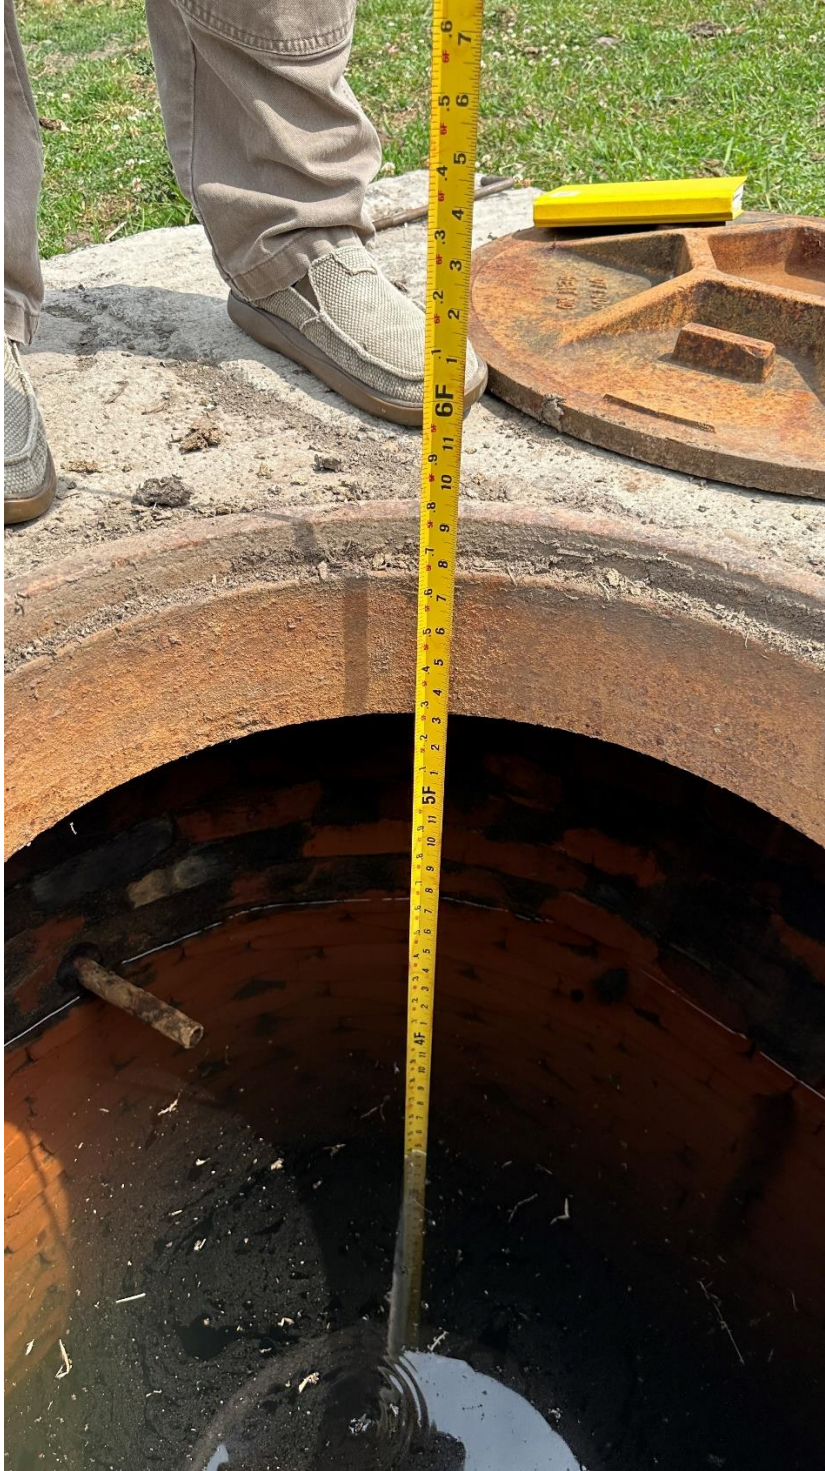
Photo 5: Measuring depth of well.

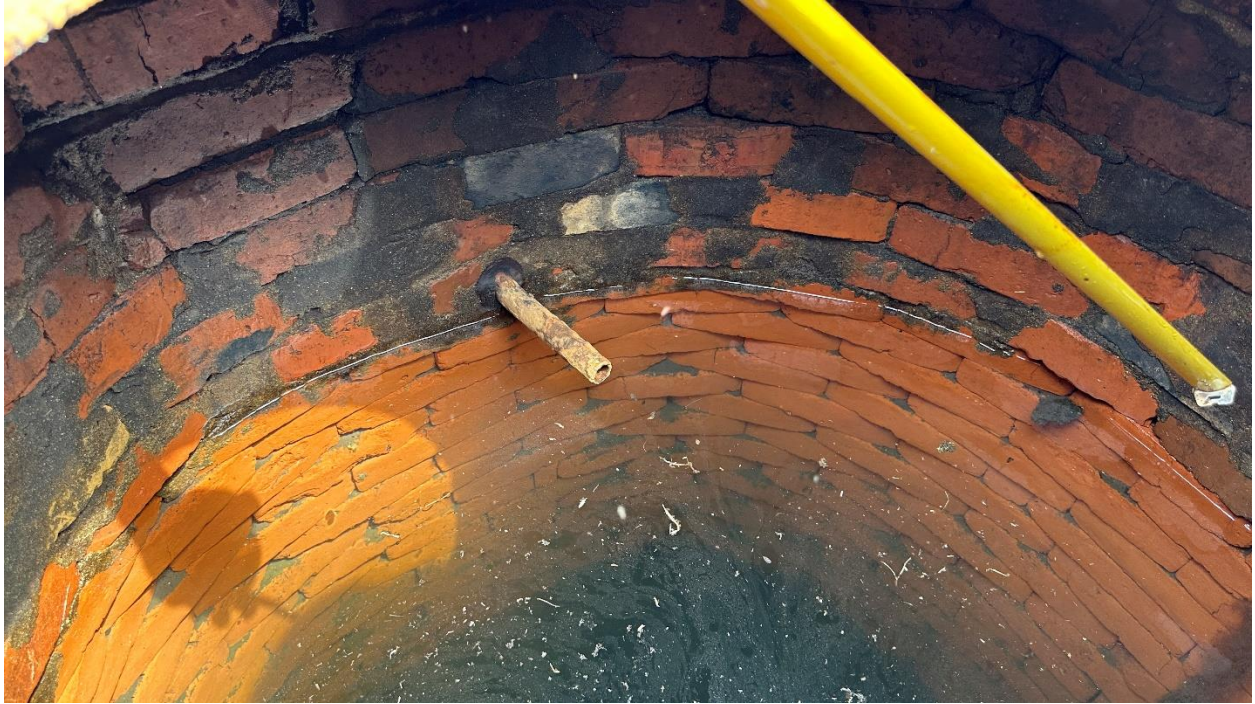
Photo 6: Interior of well.

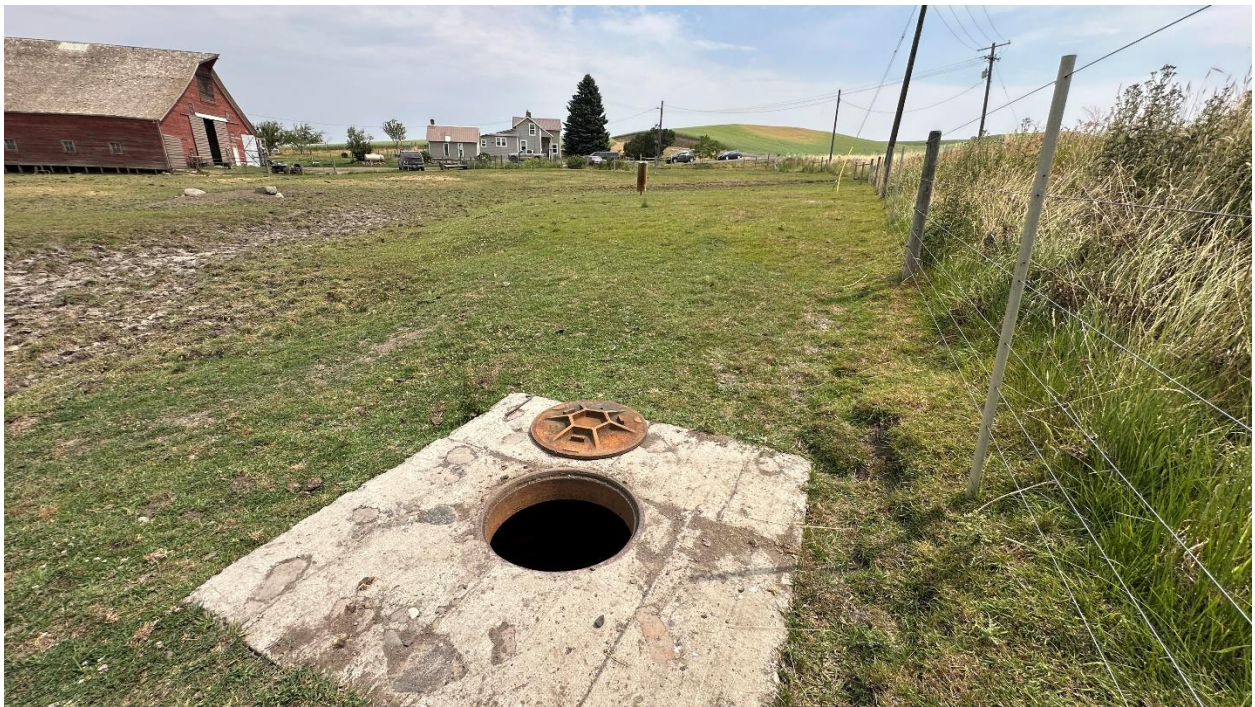
Photo 7: Location of well in relation to the home and barn.
