STATE OF IDAHO  
DEPARTMENT OF WATER RESOURCES  
**BENEFICIAL USE FIELD REPORT**

**Permit No:** 63-34335  
**Exam Date:** 01/23/2025

Water Right No. 63-34335

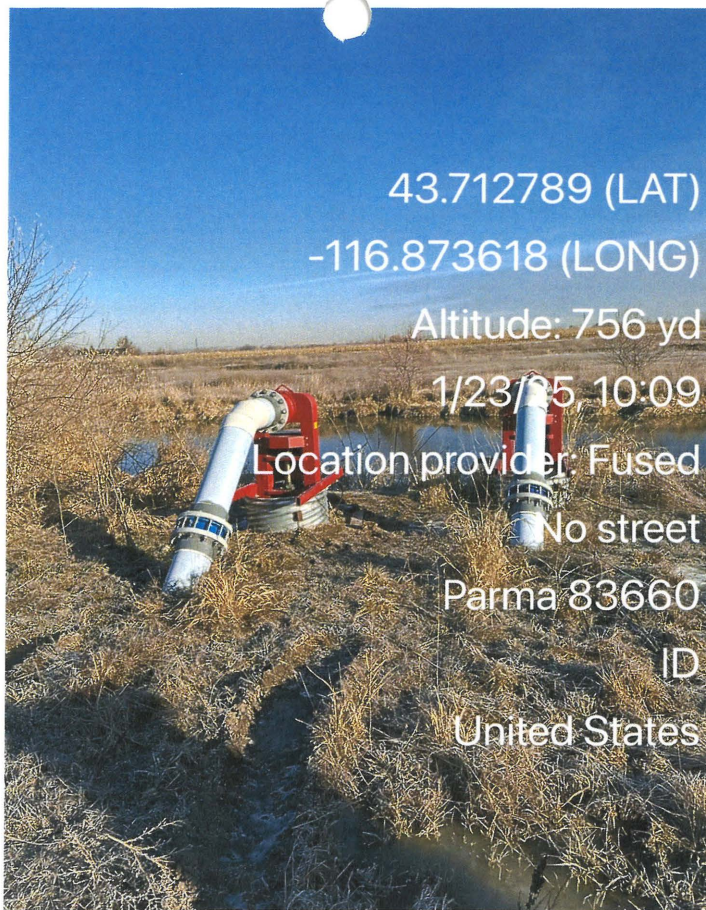
Fig. 1 – Location of POD Located in the SENE QQ by the Dixie Slough. View looking N.

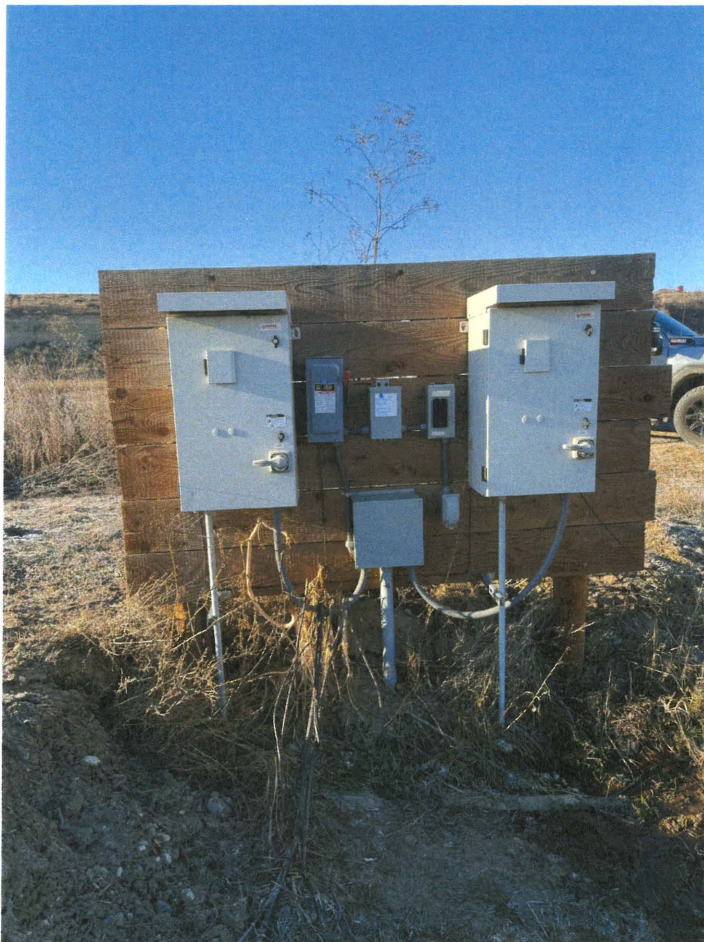
Fig. 2 – Location of control box for the pumps for POD. View looking E.

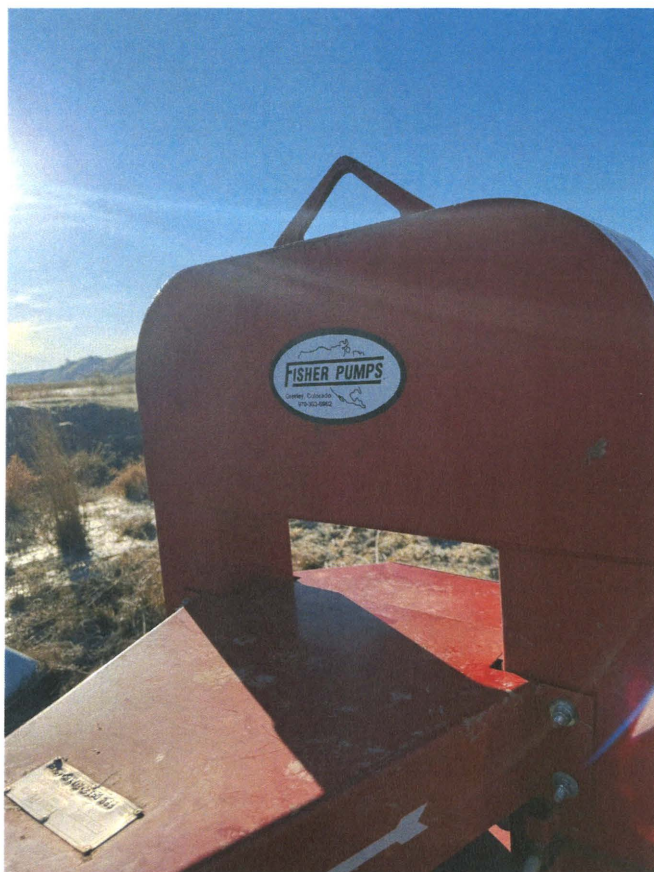
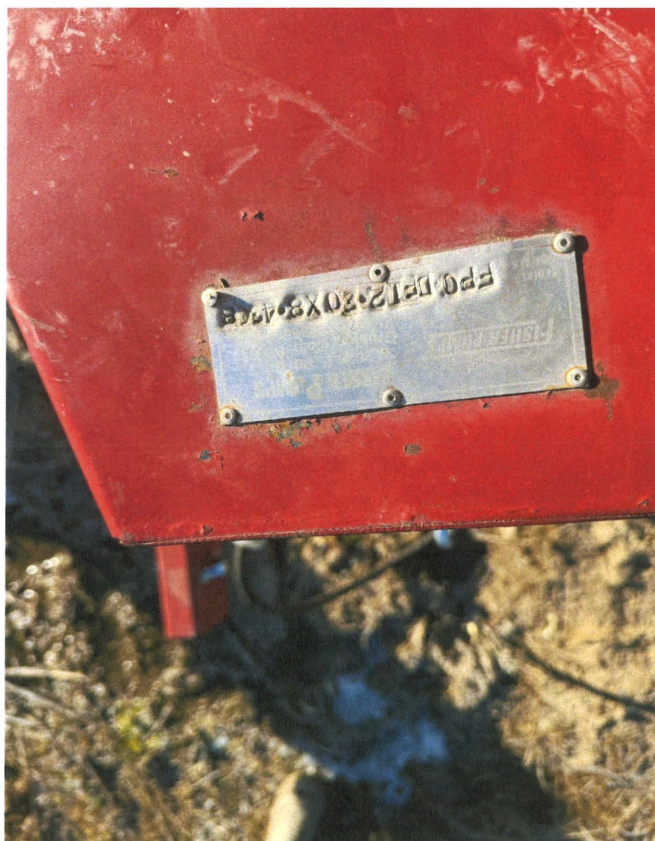
Fig. 3 & 4 – Pump make and model.

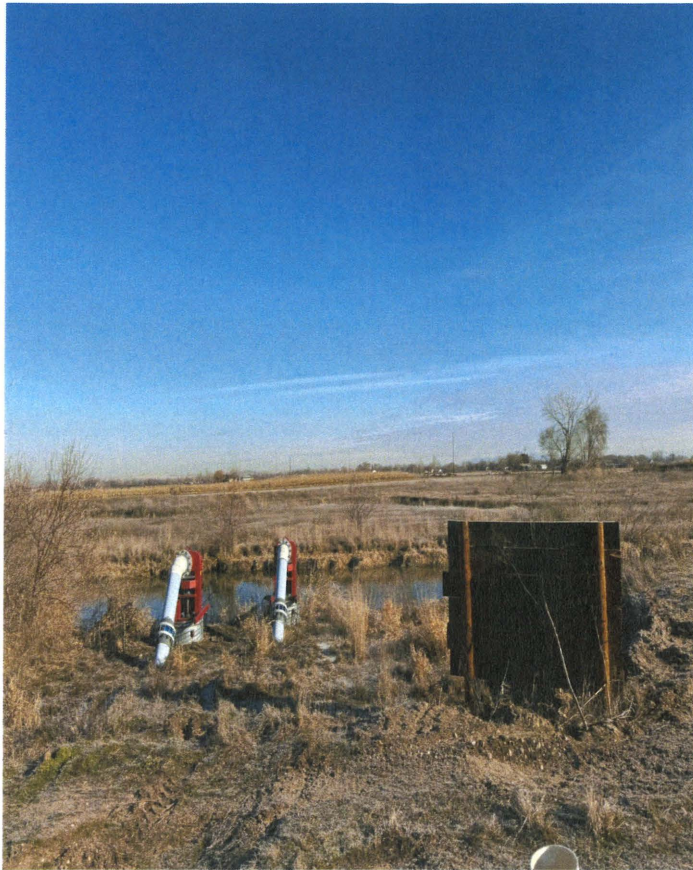
Fig. 7 – Whole POD system view looking N.

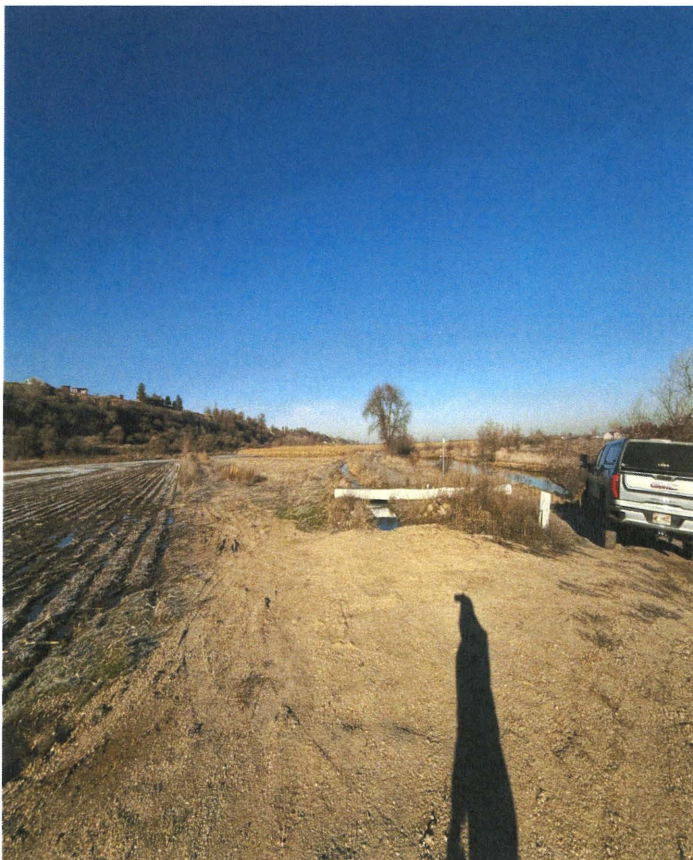
Fig. 8 – PVC pipe leaving POD to ditch in the SE area of the POU. View looking W.

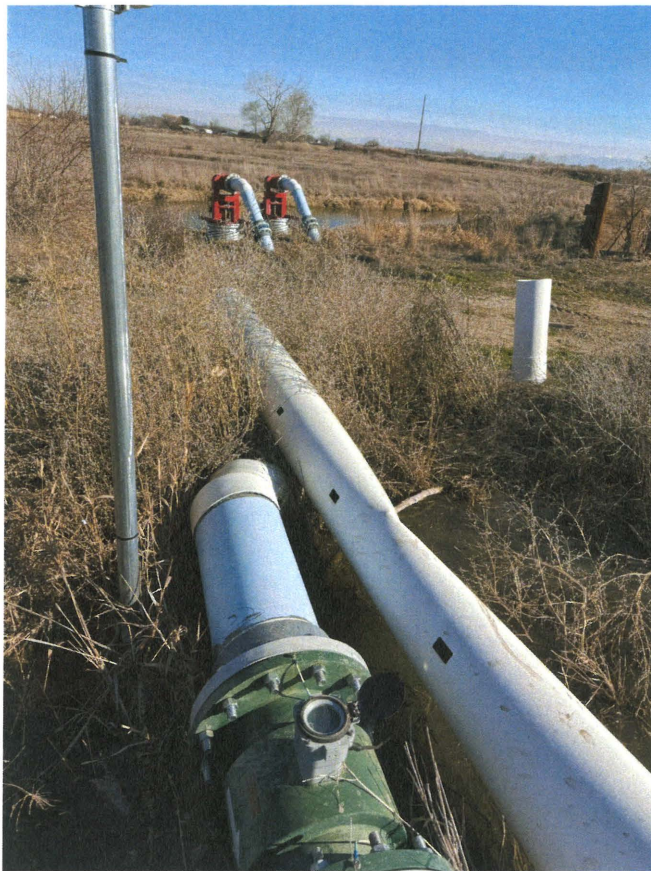
Fig. 9 – Close up of the PVC pipe leaving the POD with a meter attached. View looking N.

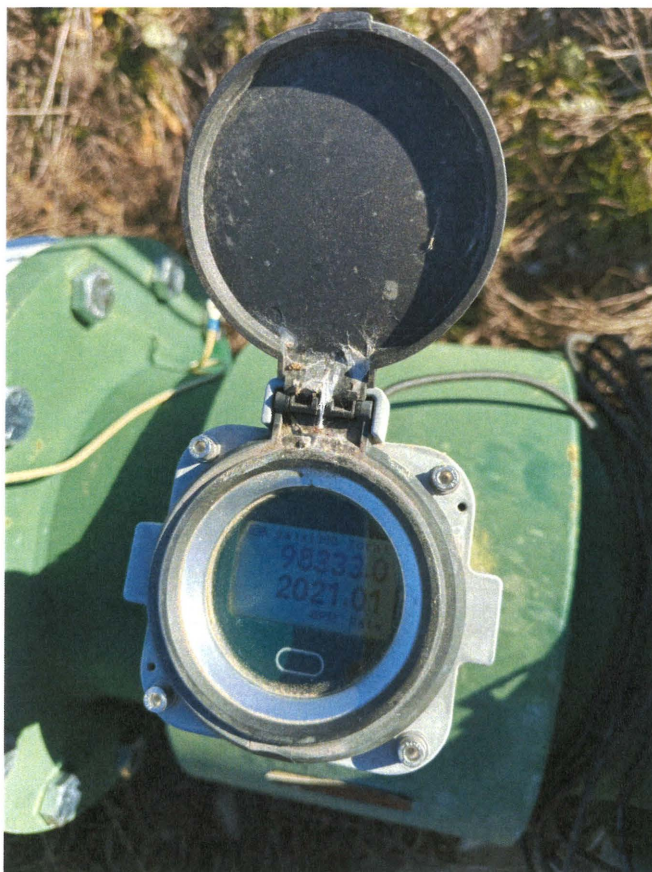
Fig. 10 – Meter reading after water had been flowing for over 2.5 hours.

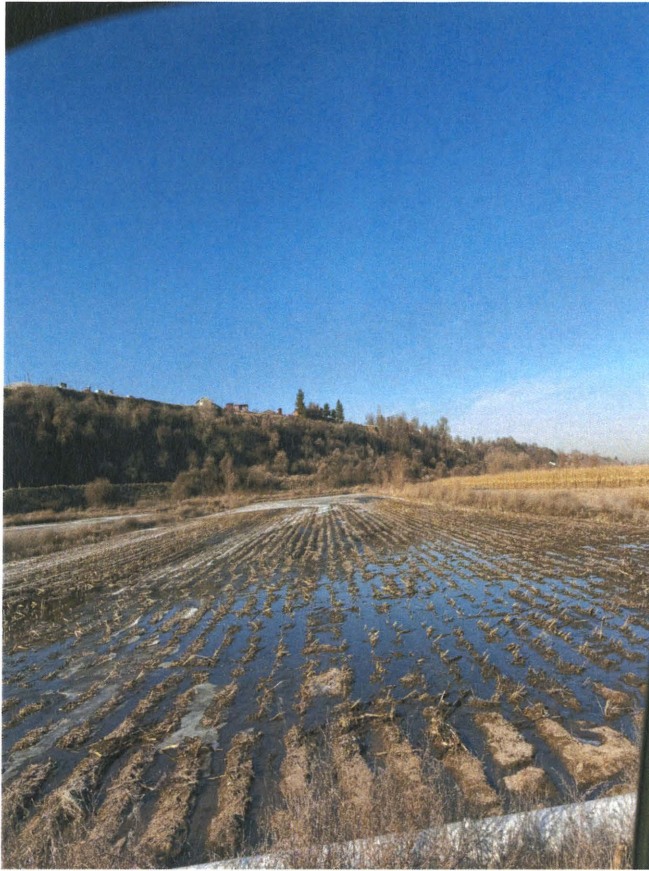
Fig. 11 – Flooding in the NESE QQ of the POU. View W.

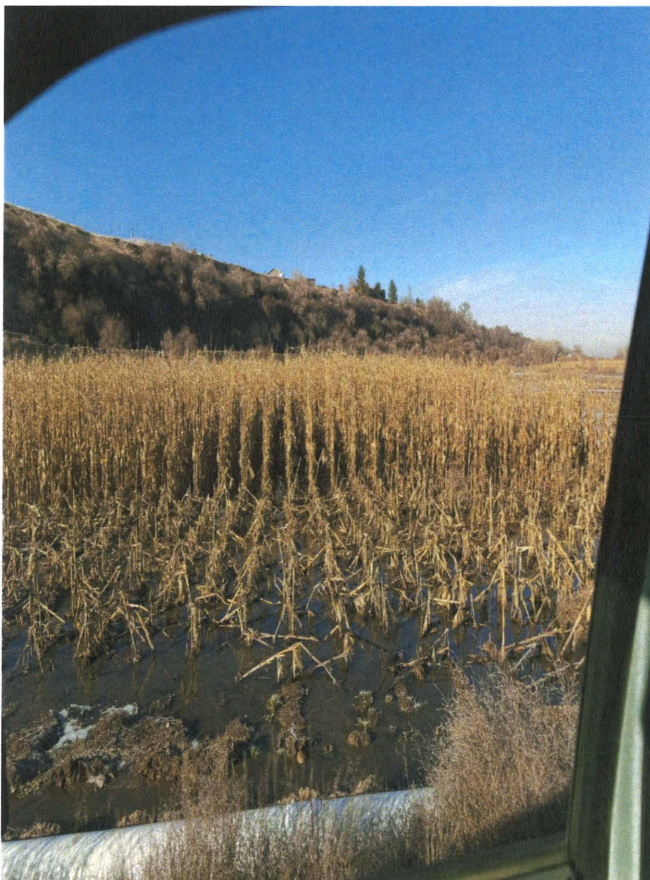
Fig. 12 –Flooding in the NESE QQ of the POU. View looking W.

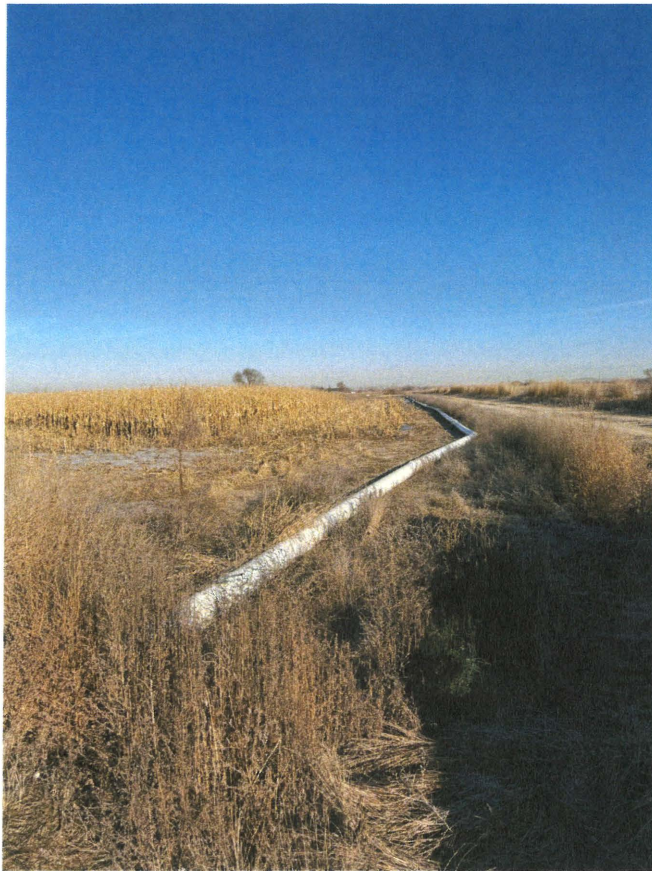
Fig. 13 – Field flooding system PVC pipe that follows the POU south in the NESE QQ.

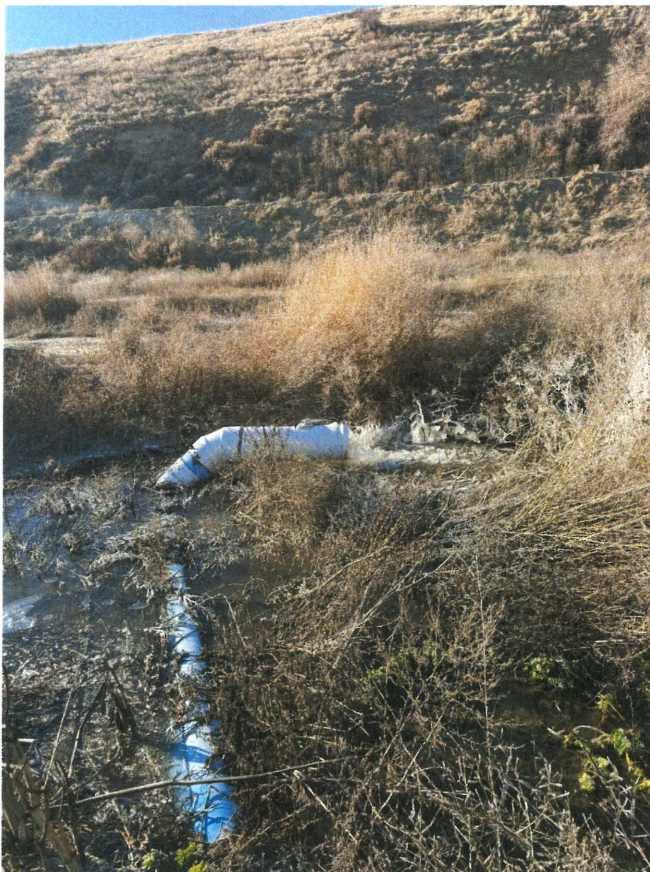
Fig. 14 – Same PVC pipe pictured above but at the end of the line where the water is flowing into the field.

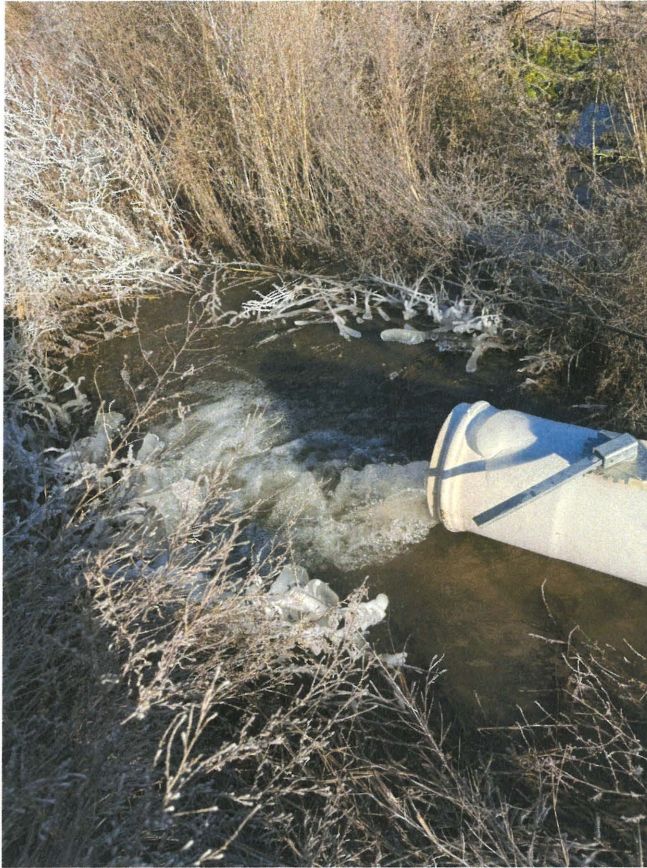
Fig. 15 – Discharge of water to flood the POU in the NESE QQ of the POU.

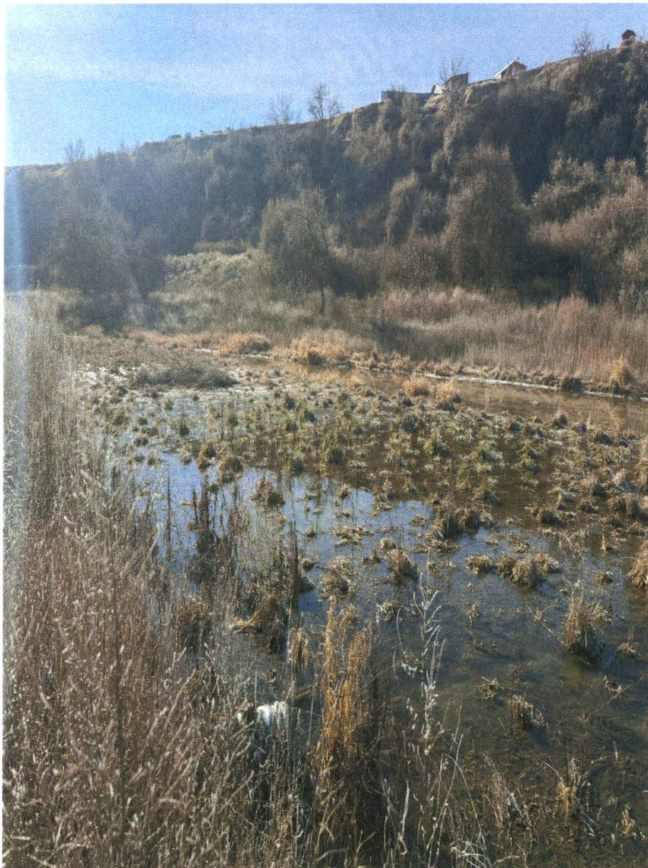
Fig. 16 – More field flooding on the west side of the NESE QQ of the POU. View looking NW.

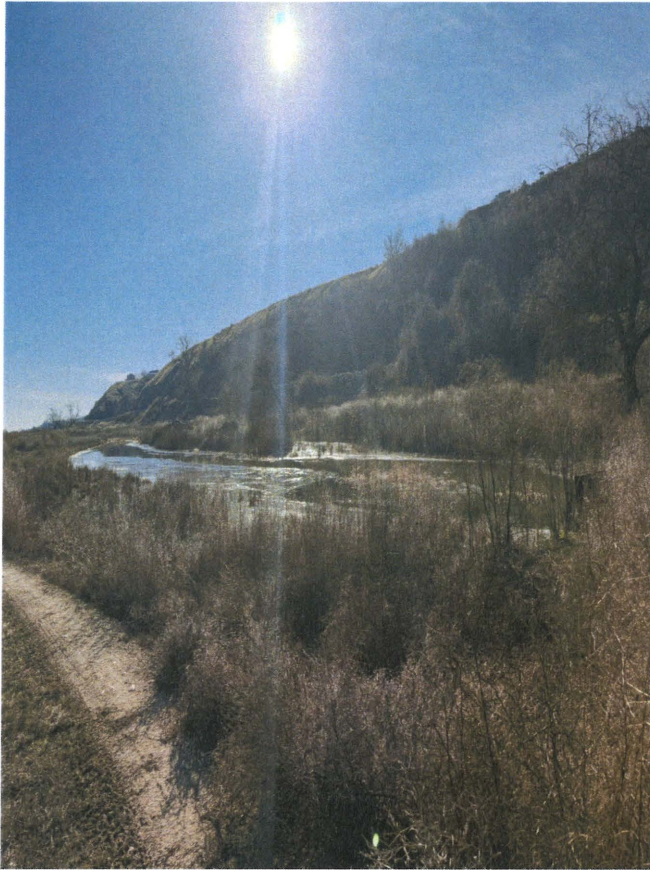
Fig. 17 – More field flooding on the west side of the NESE QQ of the POU. View looking NE.

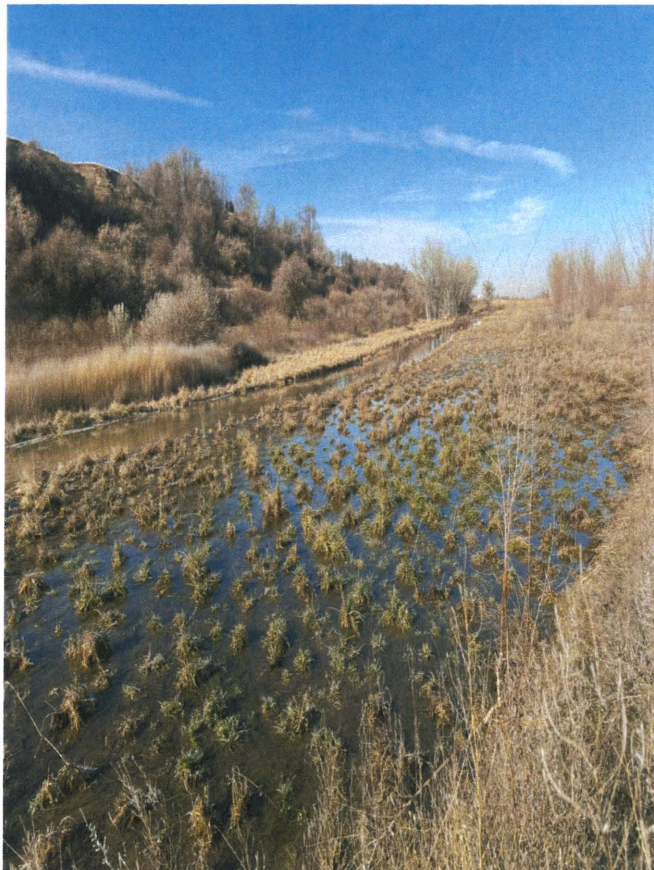
Fig. 18 – More field flooding on the south side of the SWNE QQ of the POU. View looking SE.

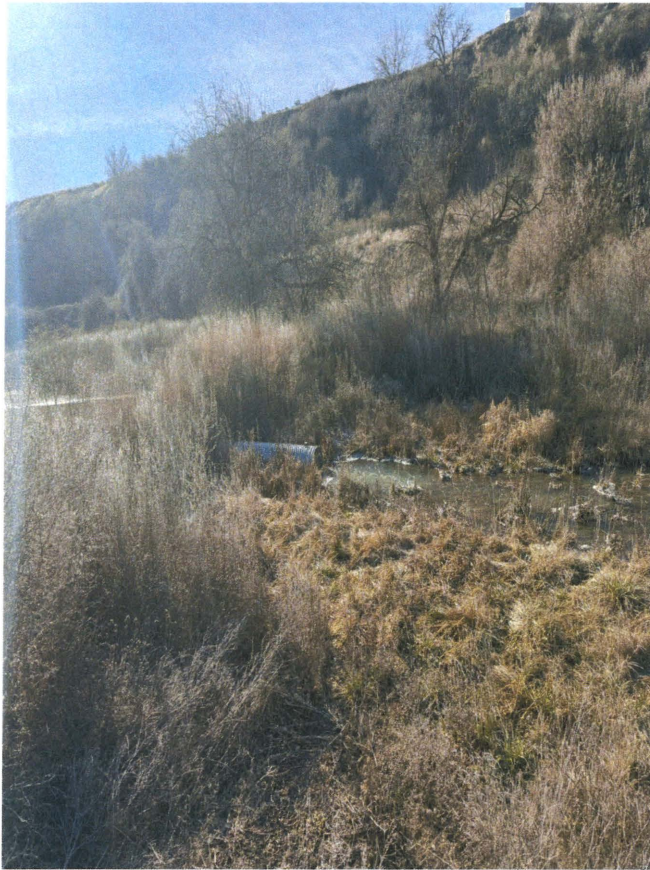
Fig. 19 – Discharge of water to flood the POU in the SWNE QQ of the POU. View looking S.

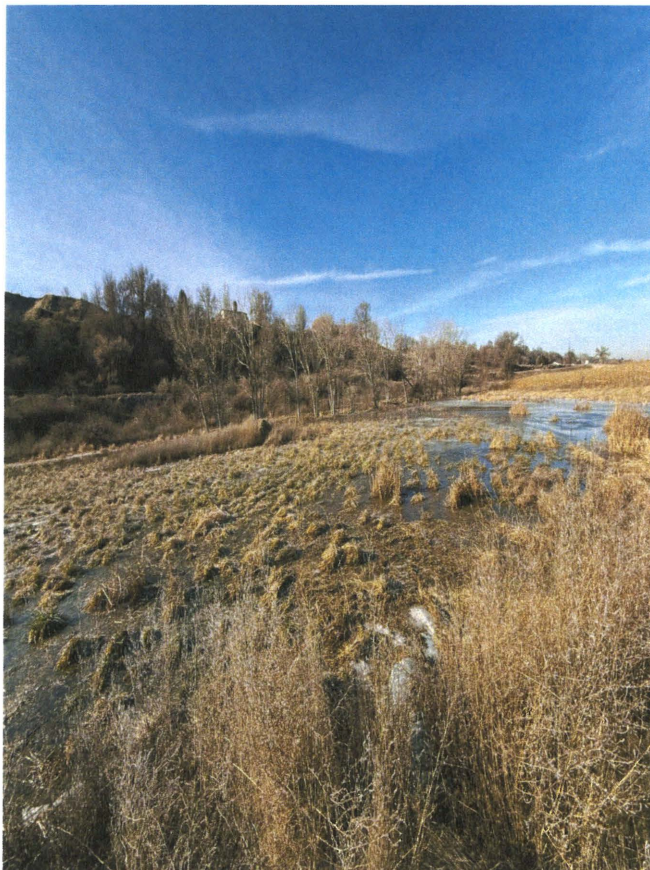
Fig. 20 – More field flooding on the south side of the SWNE QQ of the POU. View looking NW.

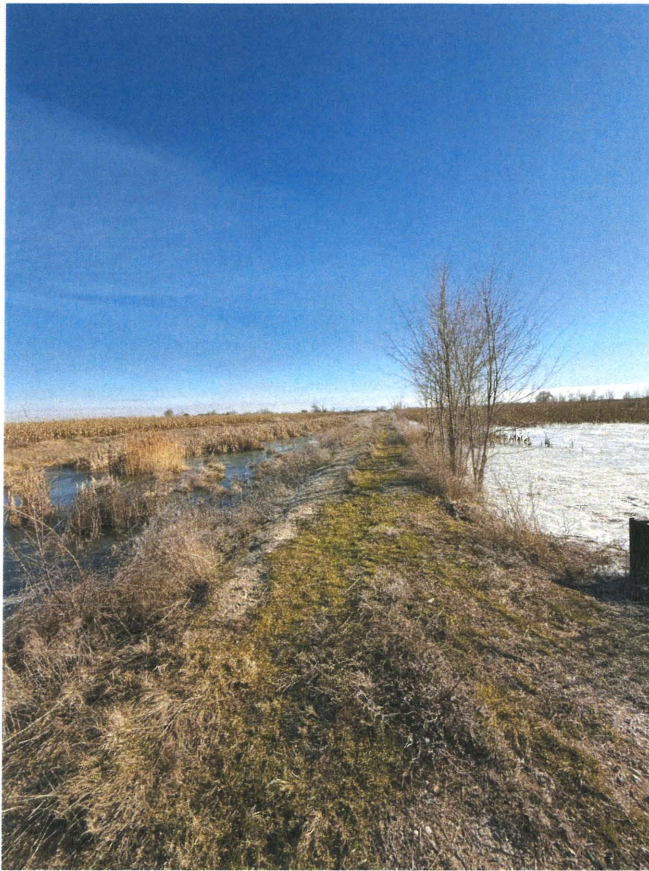
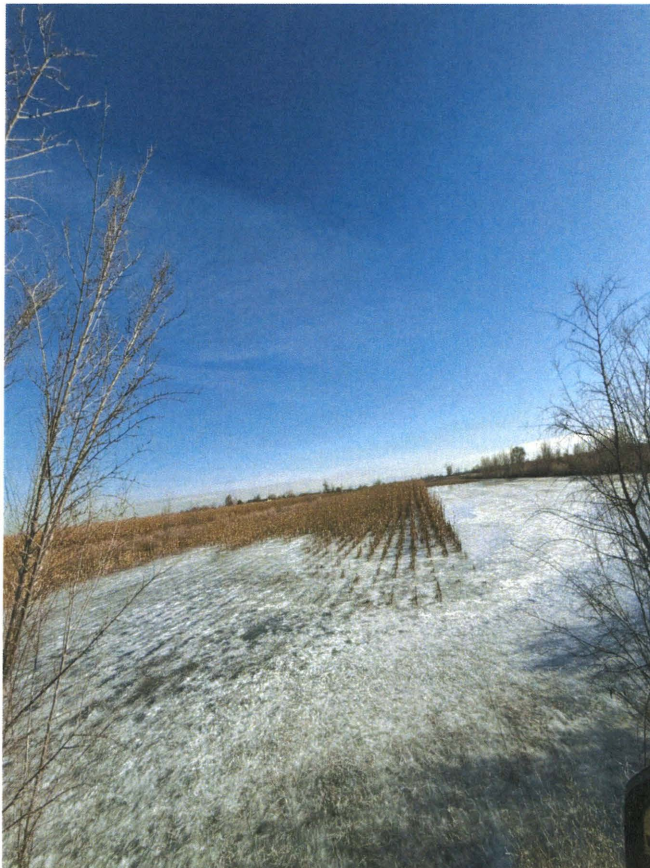
Fig. 21 & 22 – View of the field flooding in the SWNE and SENE QQ of the POU. This field runs east to west View looking E.

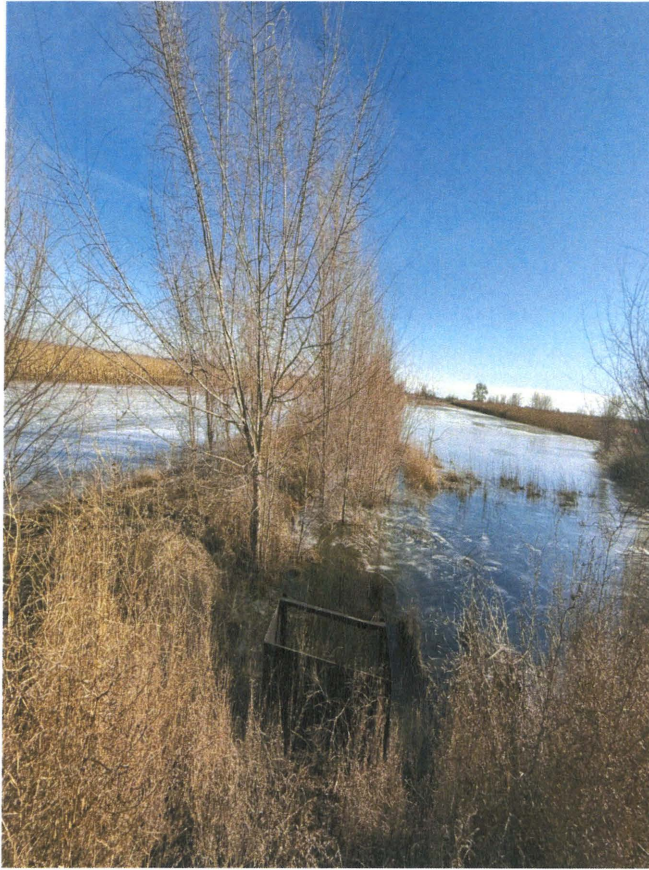
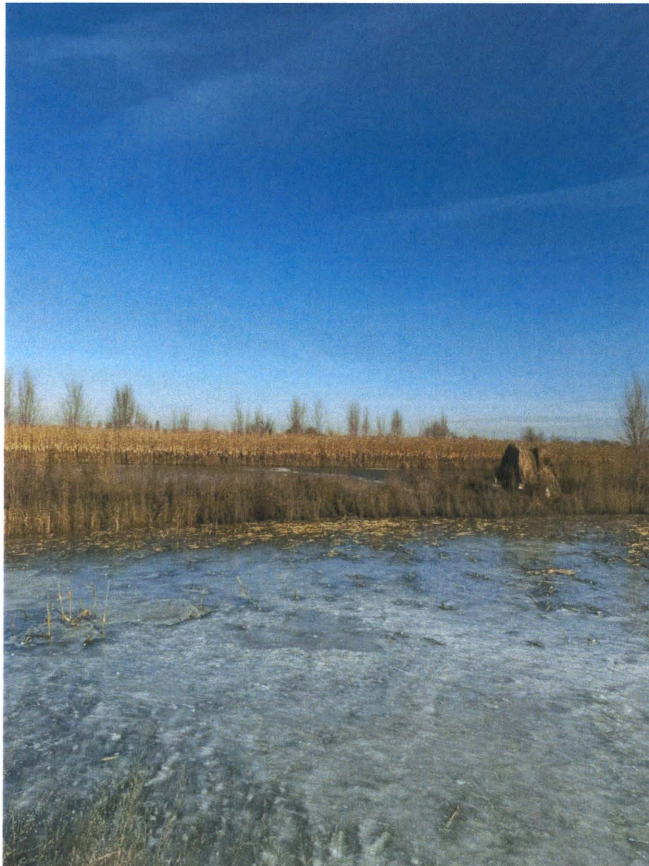
Fig. 23 & 24 – View of the field flooding in the SWNE and SENE QQ of the POU. This field runs east to west  
View looking E in image 23 and N in image 24.

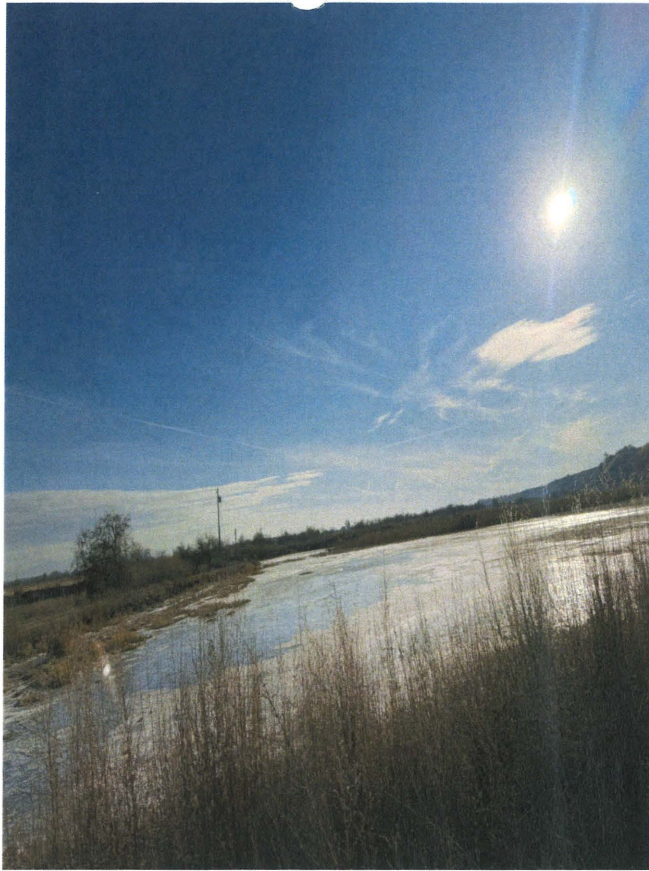
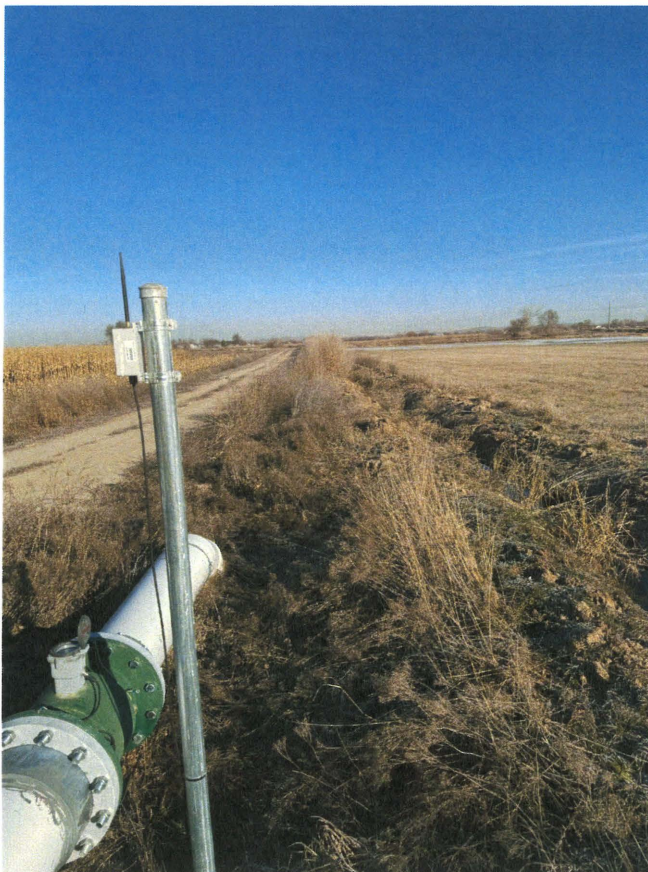
Fig. 25 & 26 View of the field flooding in the far east of NESEQQ of the POU. This field run north to south View looking N.

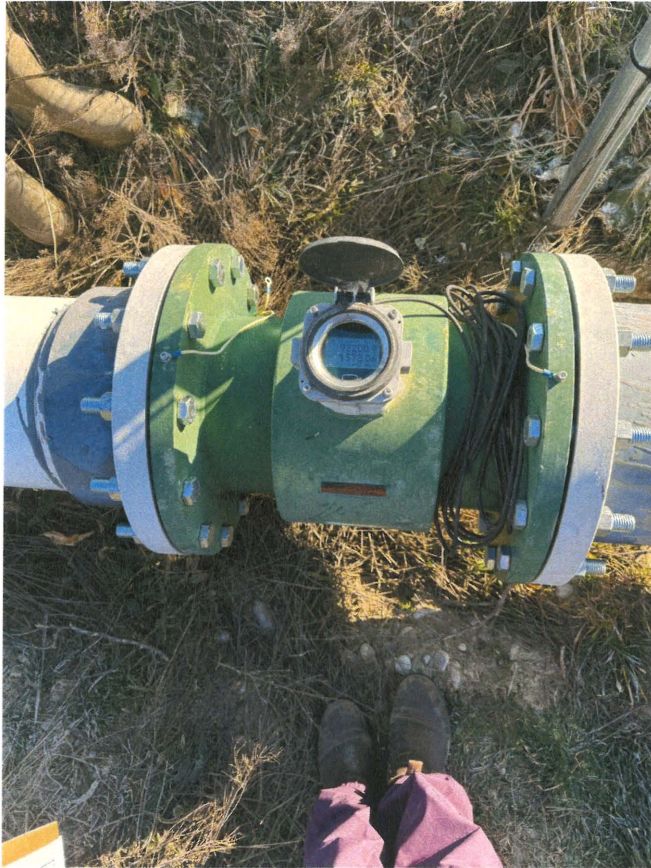
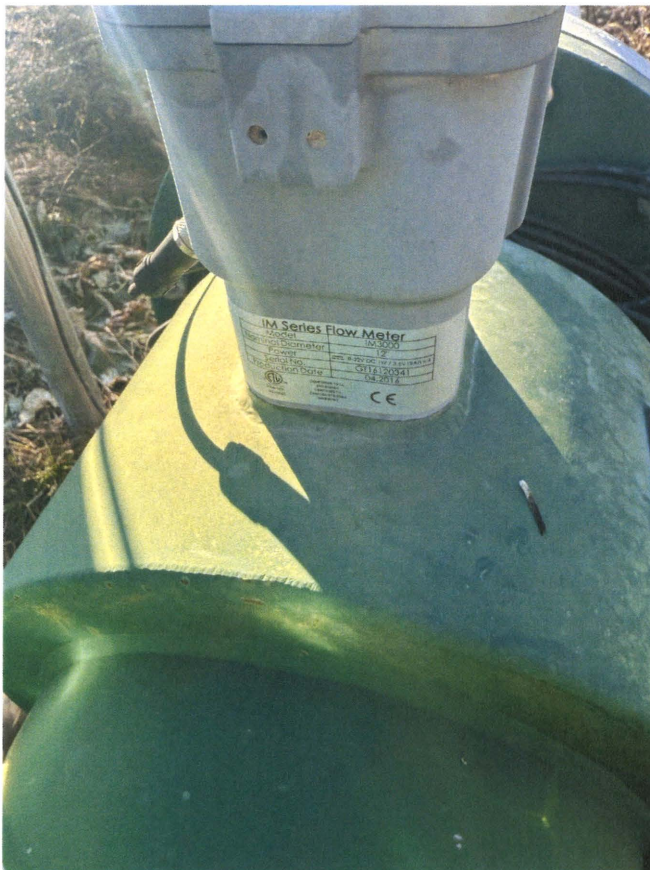
Fig. 27 & 28 – Second meter in system located in the field that runs north and south in the NESE QQ.

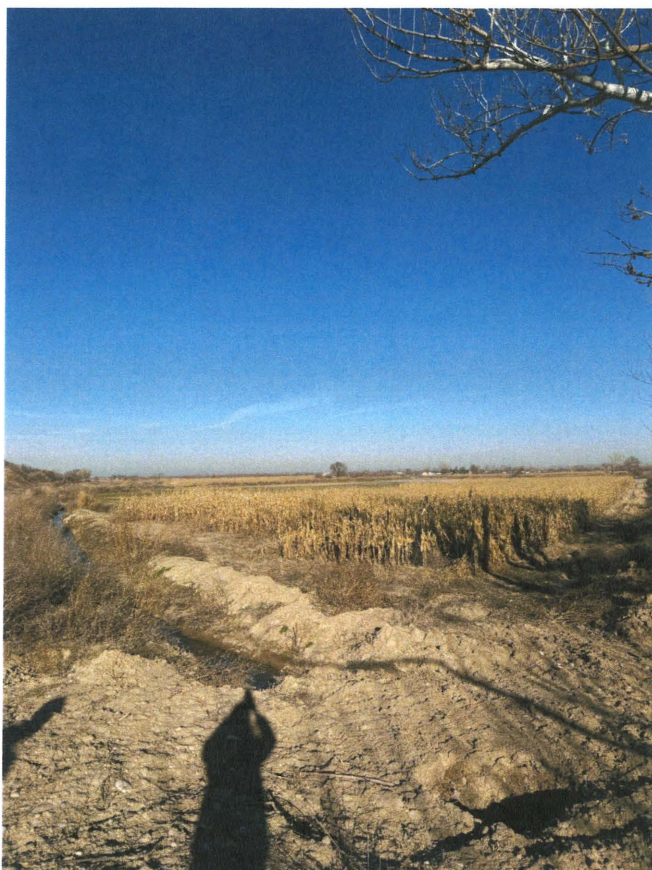
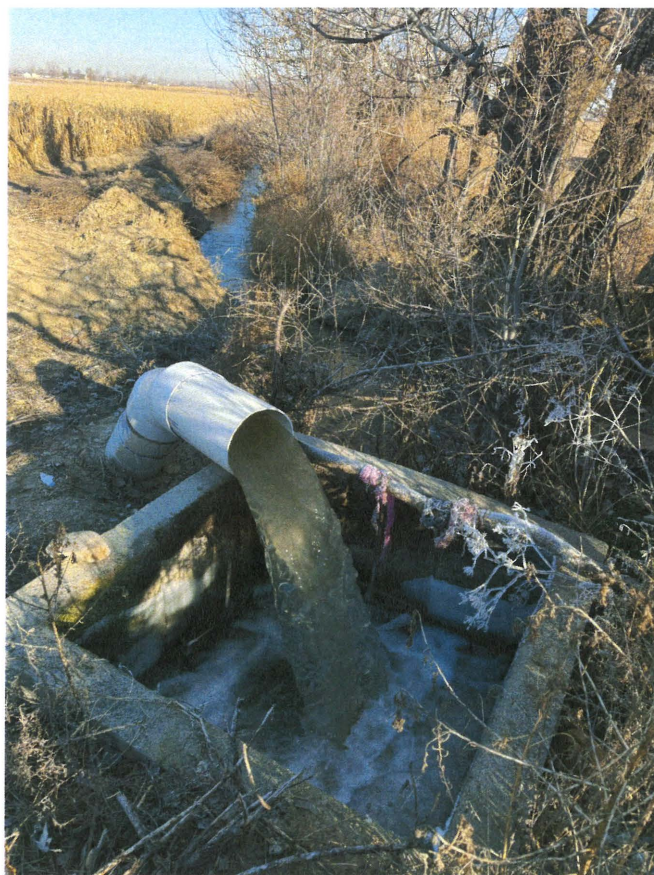
Fig. 29 &30 – Corner of ditch system that sends water north to the field in the SENE QQ.

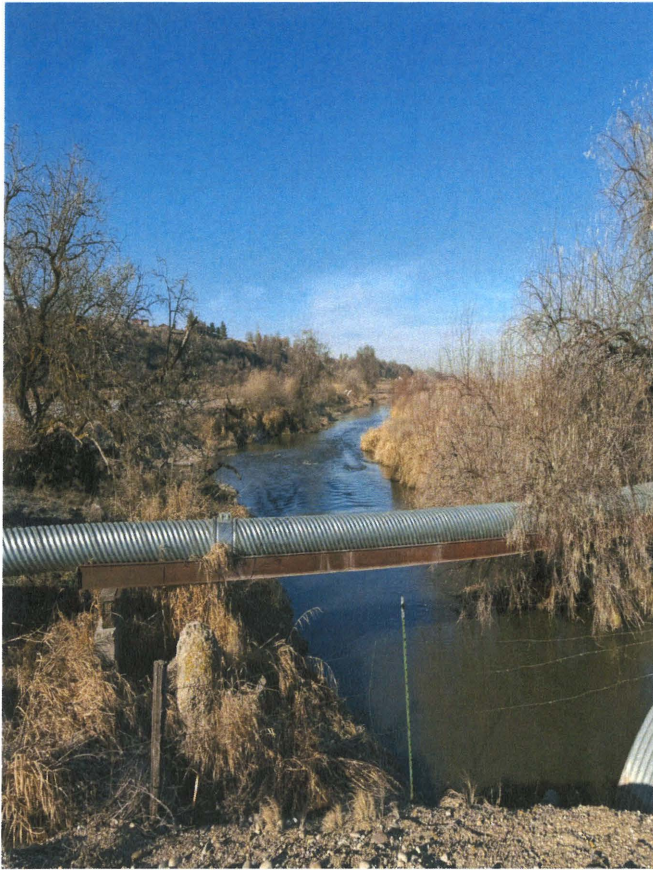
Fig. 29 – Conveyance system running north from NESE QQ over the Dixie Slough. View looking W.

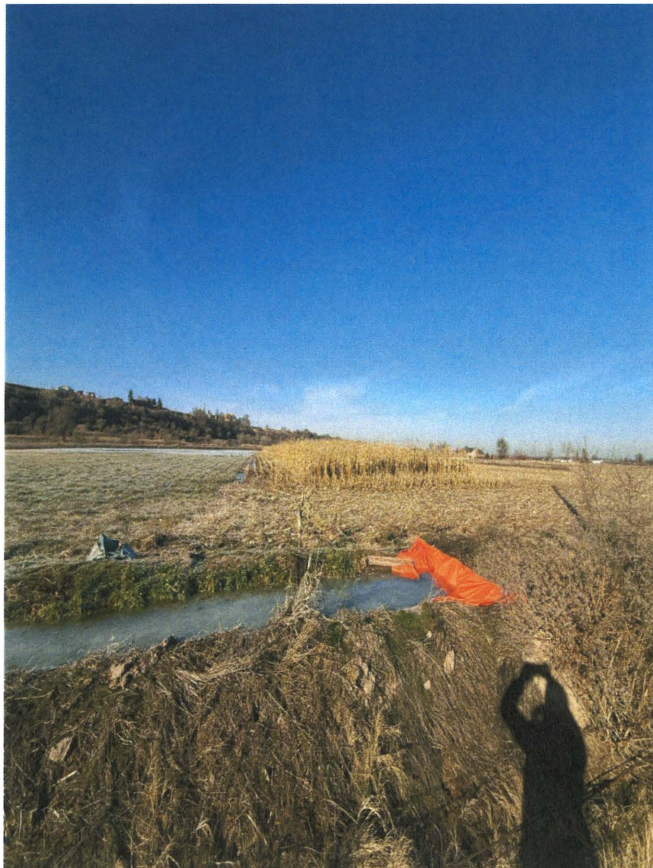
Fig. 30– Open channel conveyance system ending in the SENE QQ. View looking W.

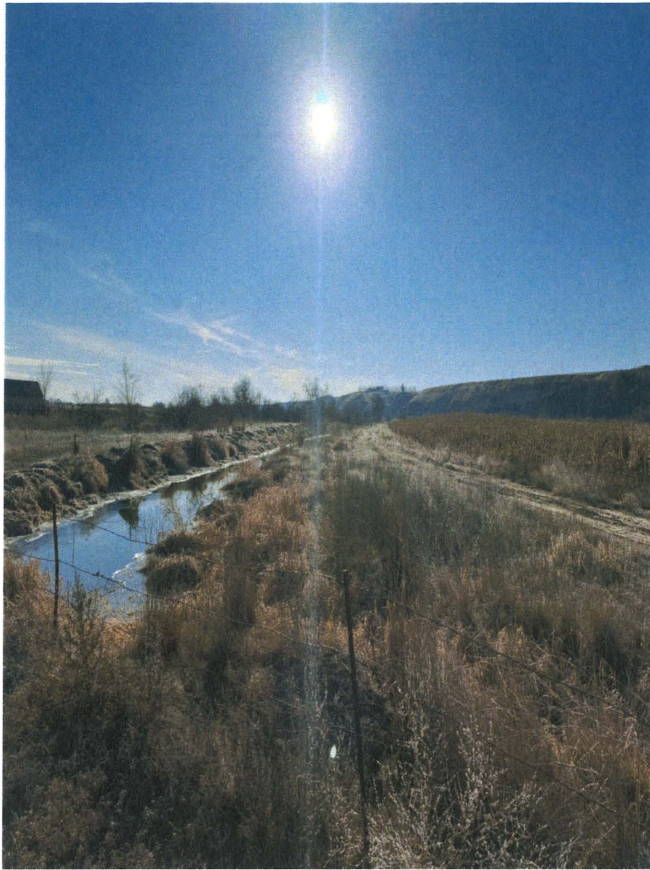
Fig. 31 – Open channel conveyance system running south in the SWNE QQ of the POU. POU undeveloped on the right side of the picture. View looking S.

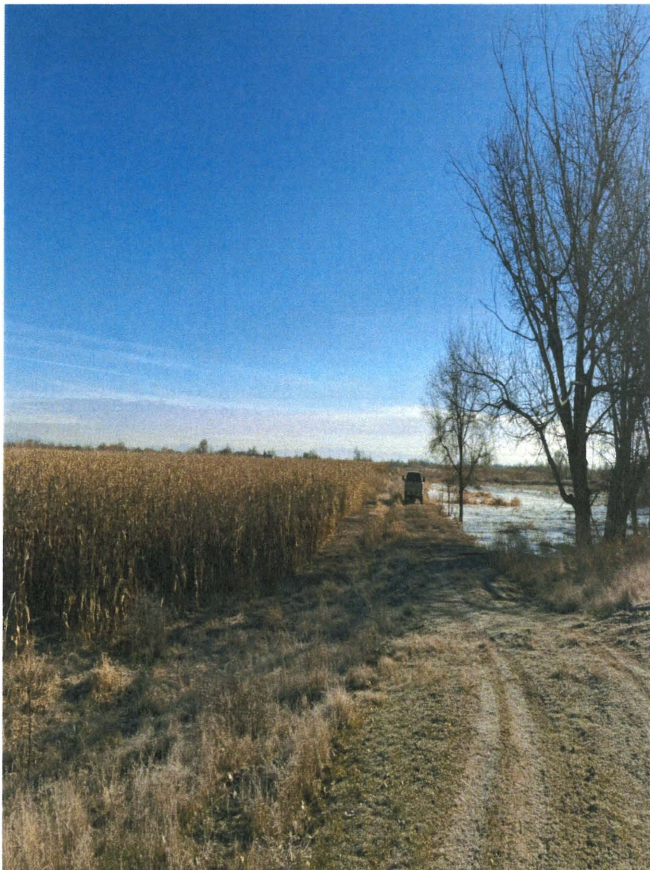
Fig. 32 – Flooding to the right of picture but no developed acres on the left of POU in the SWNE QQ. View looking E.

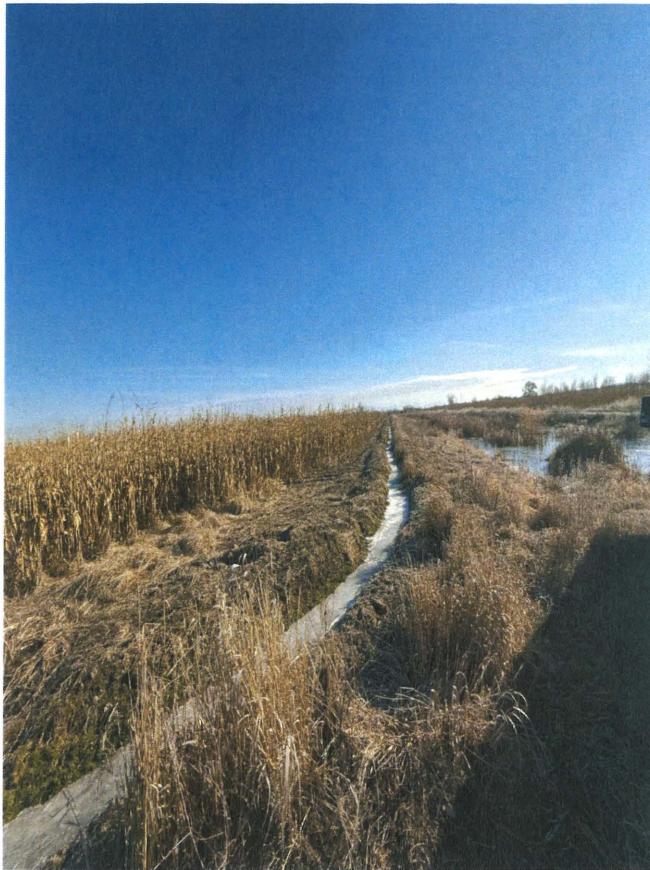
Fig. 33 – Flooding developed POU in the SWNE QQ. View looking E.

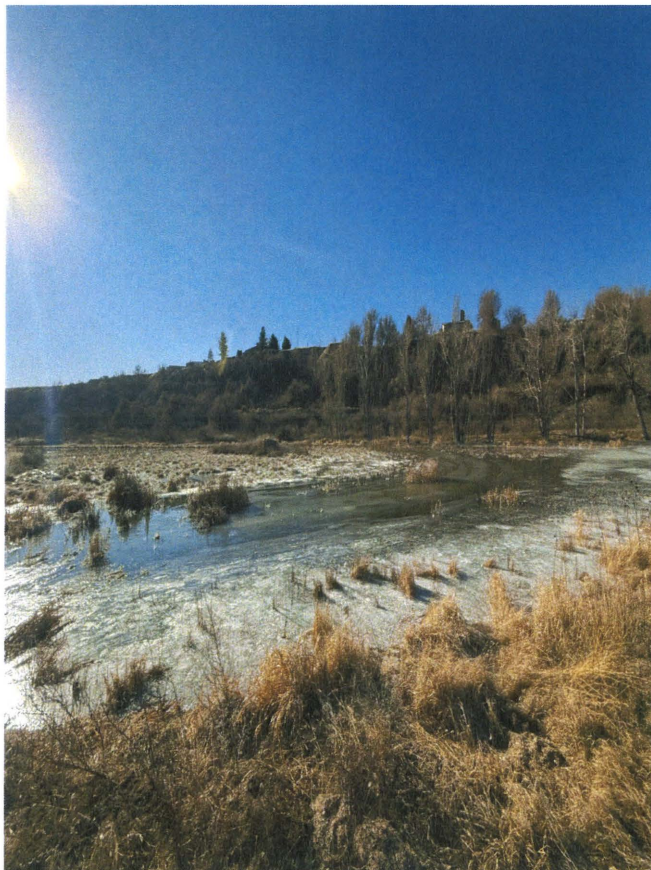
Fig. 34 – Field flooding developed in the SWNE QQ. View looking SW.

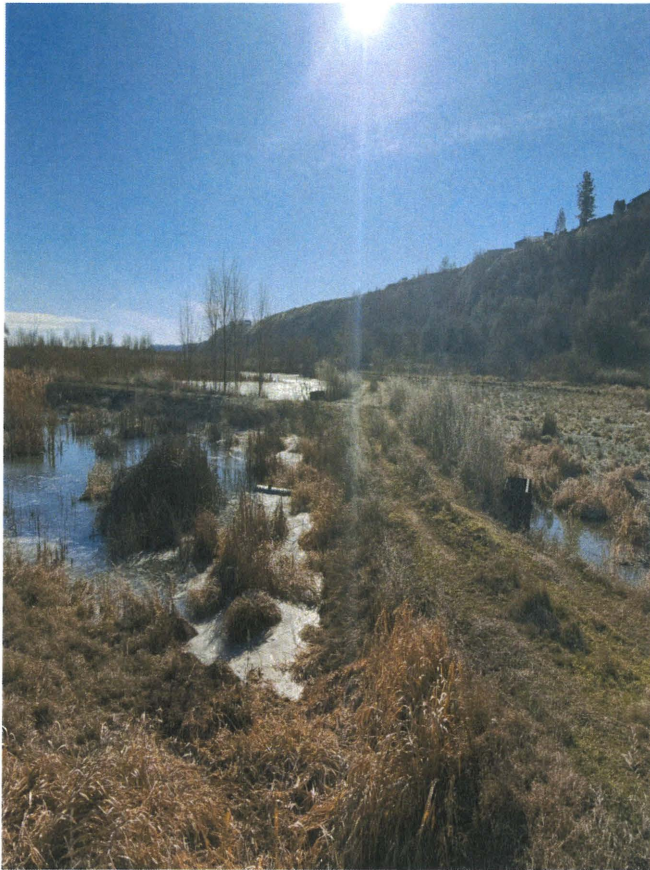
Fig. 35 – Field flooding developed in the SWNE QQ. View looking SE.

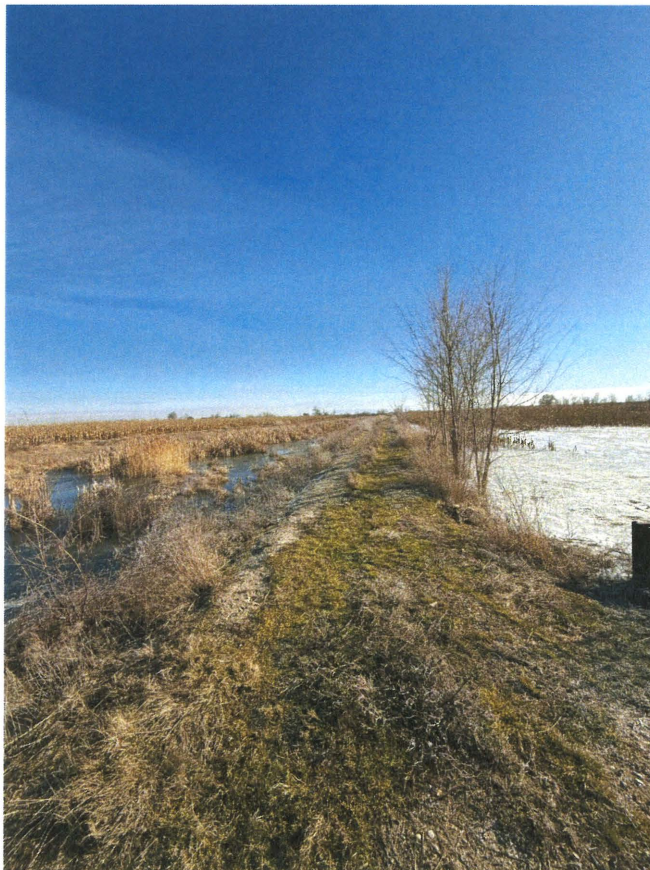
Fig. 36 – Field flooding developed in the SENE QQ. View looking E.
