IDWR Adjudication Claims Investigation

## Claim Investigation Field Report

WR # 11-991A

WR # 11-8234

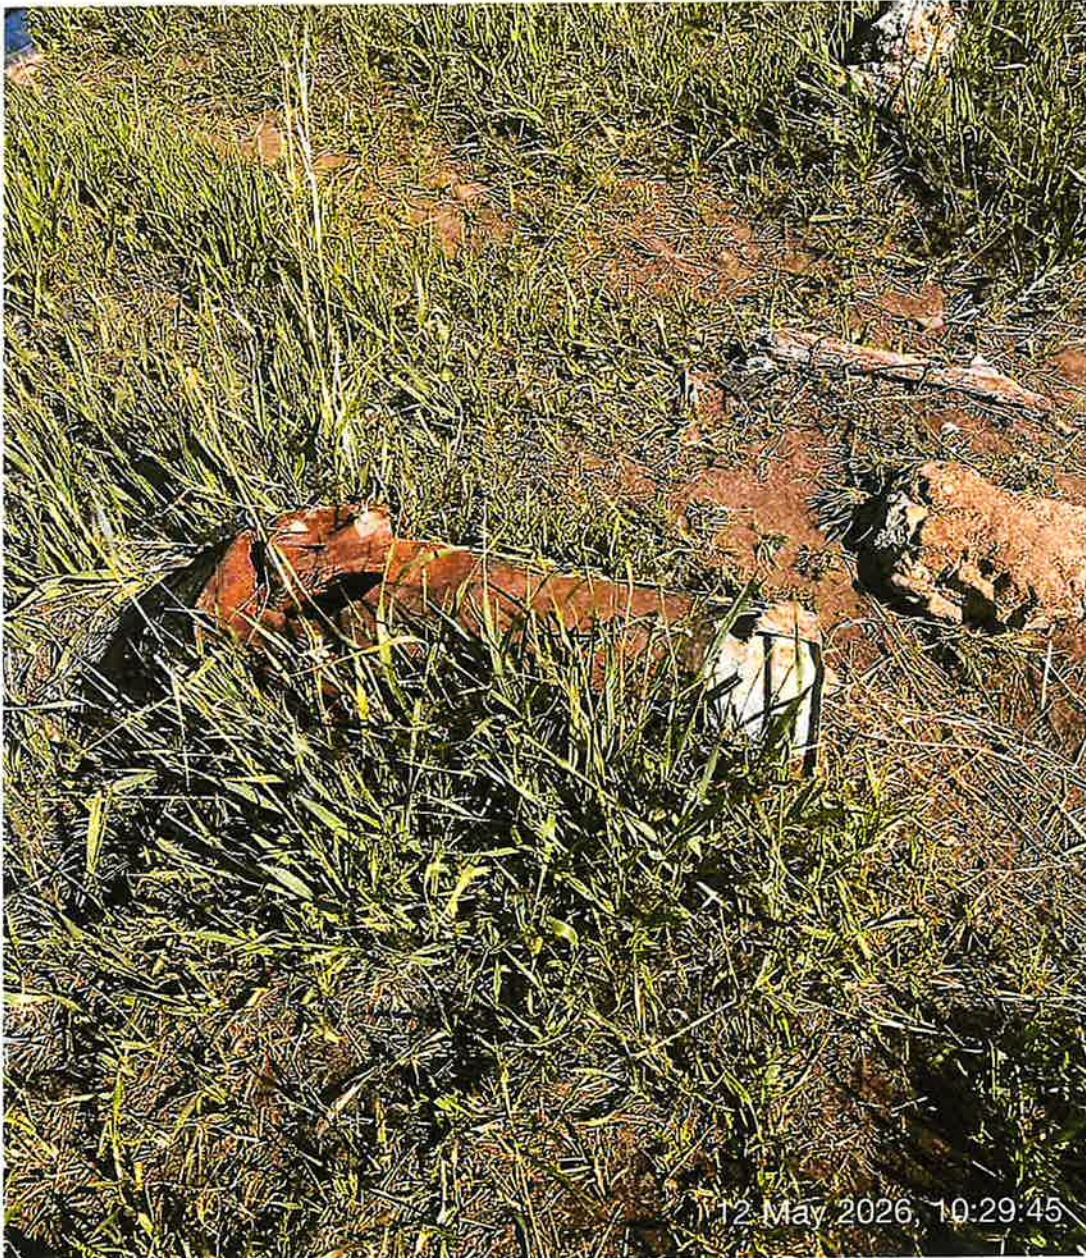
Pipe emerges at top of hill, and would direct water into handlines. Pipe was rusted out and unusable at time of site visit.

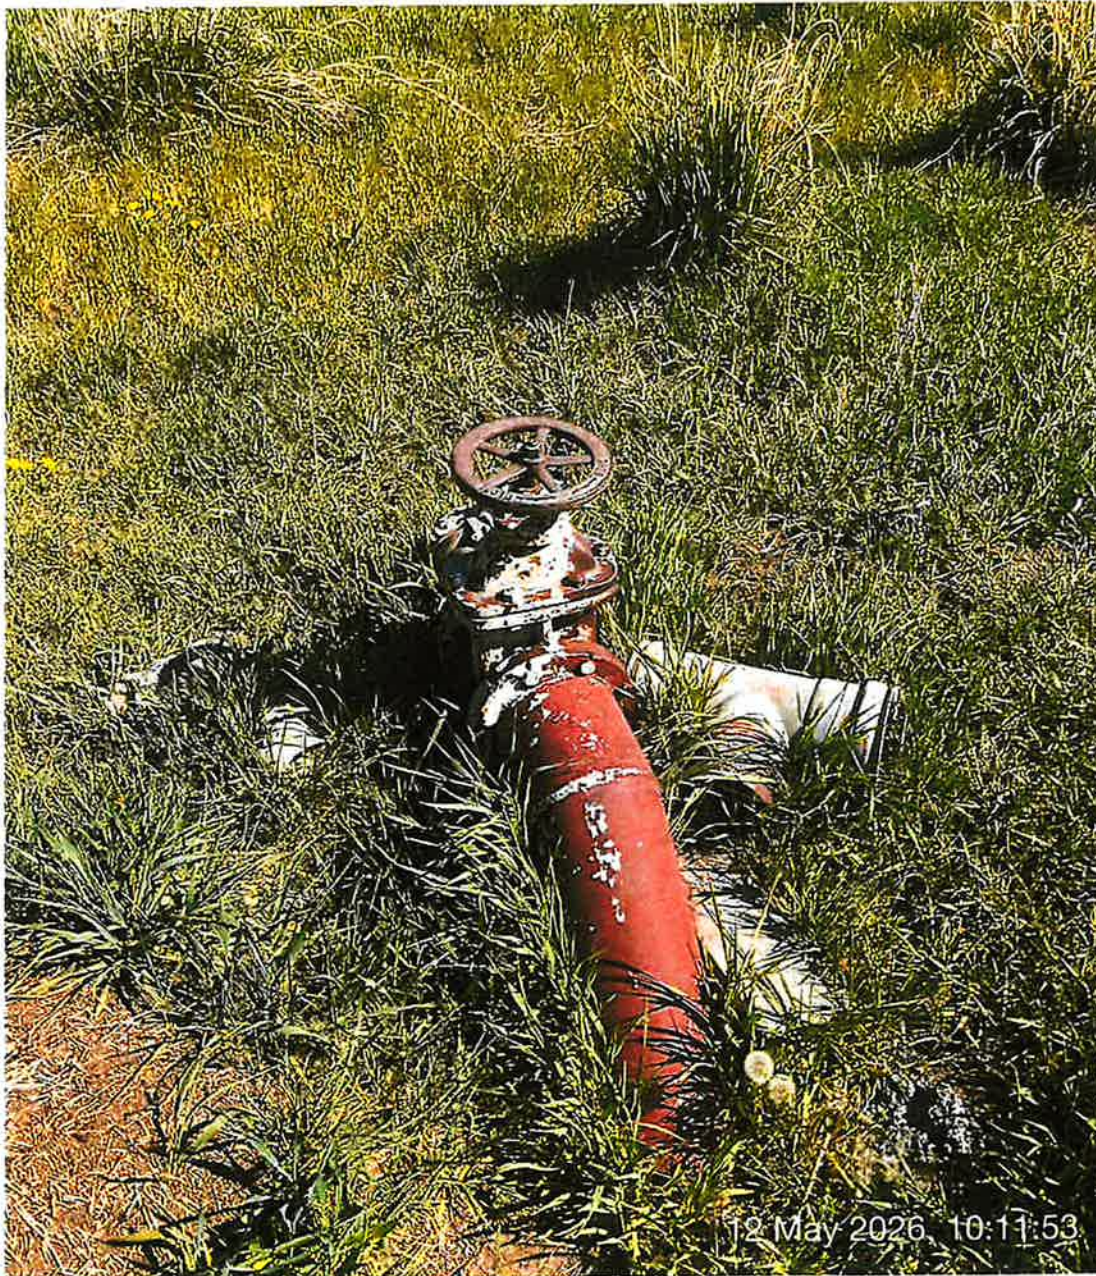
Another valve emerges from the north buried pipe. Place of use was not included in the claim.

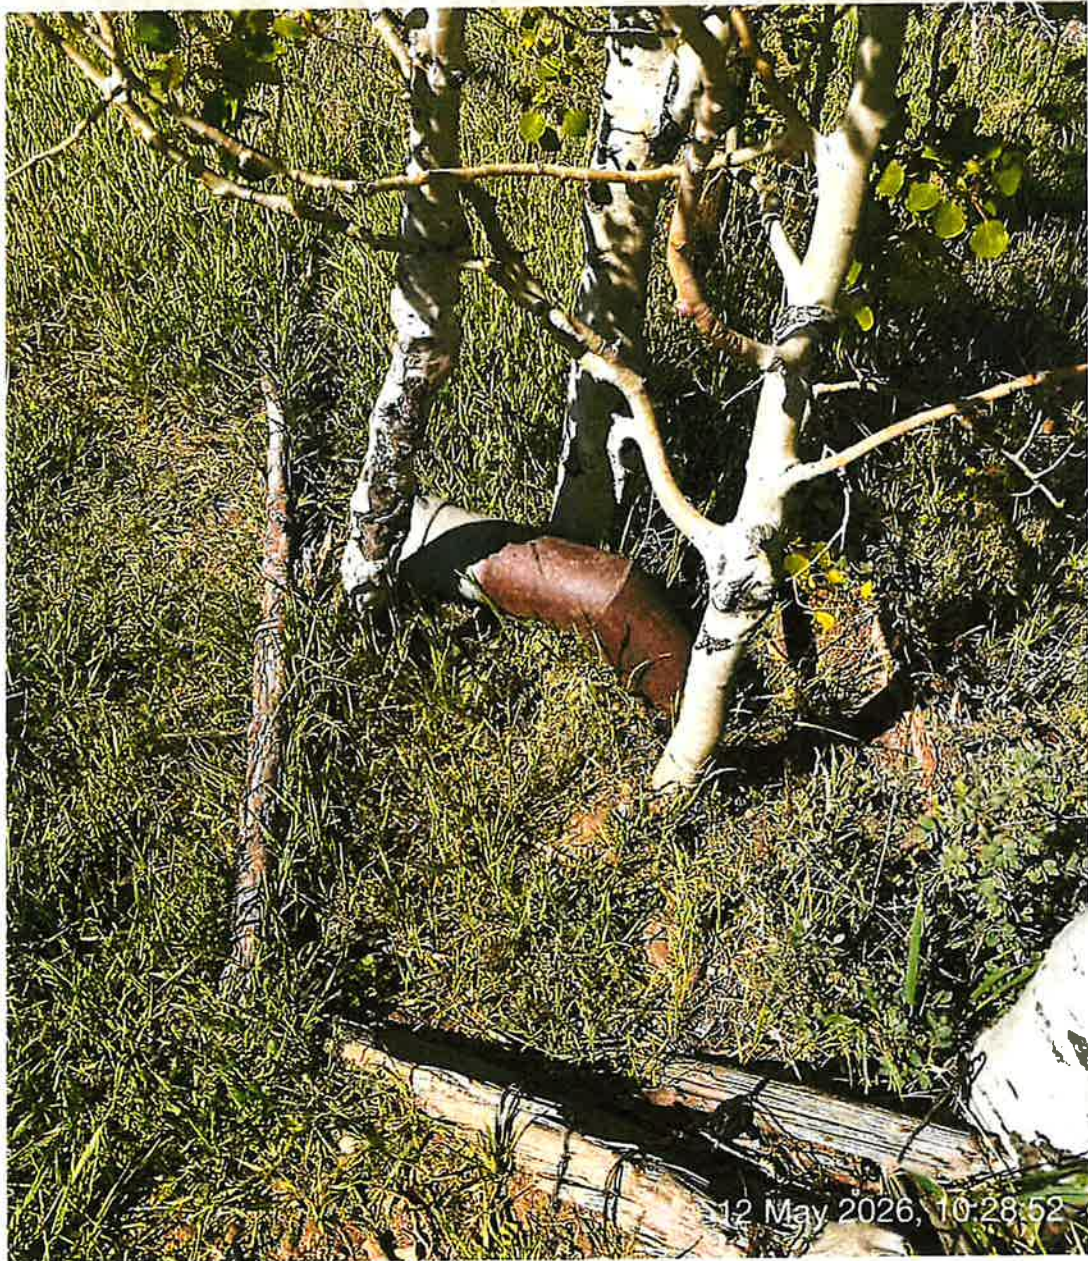
4" surfaced pipe opening that would direct water to handlines.

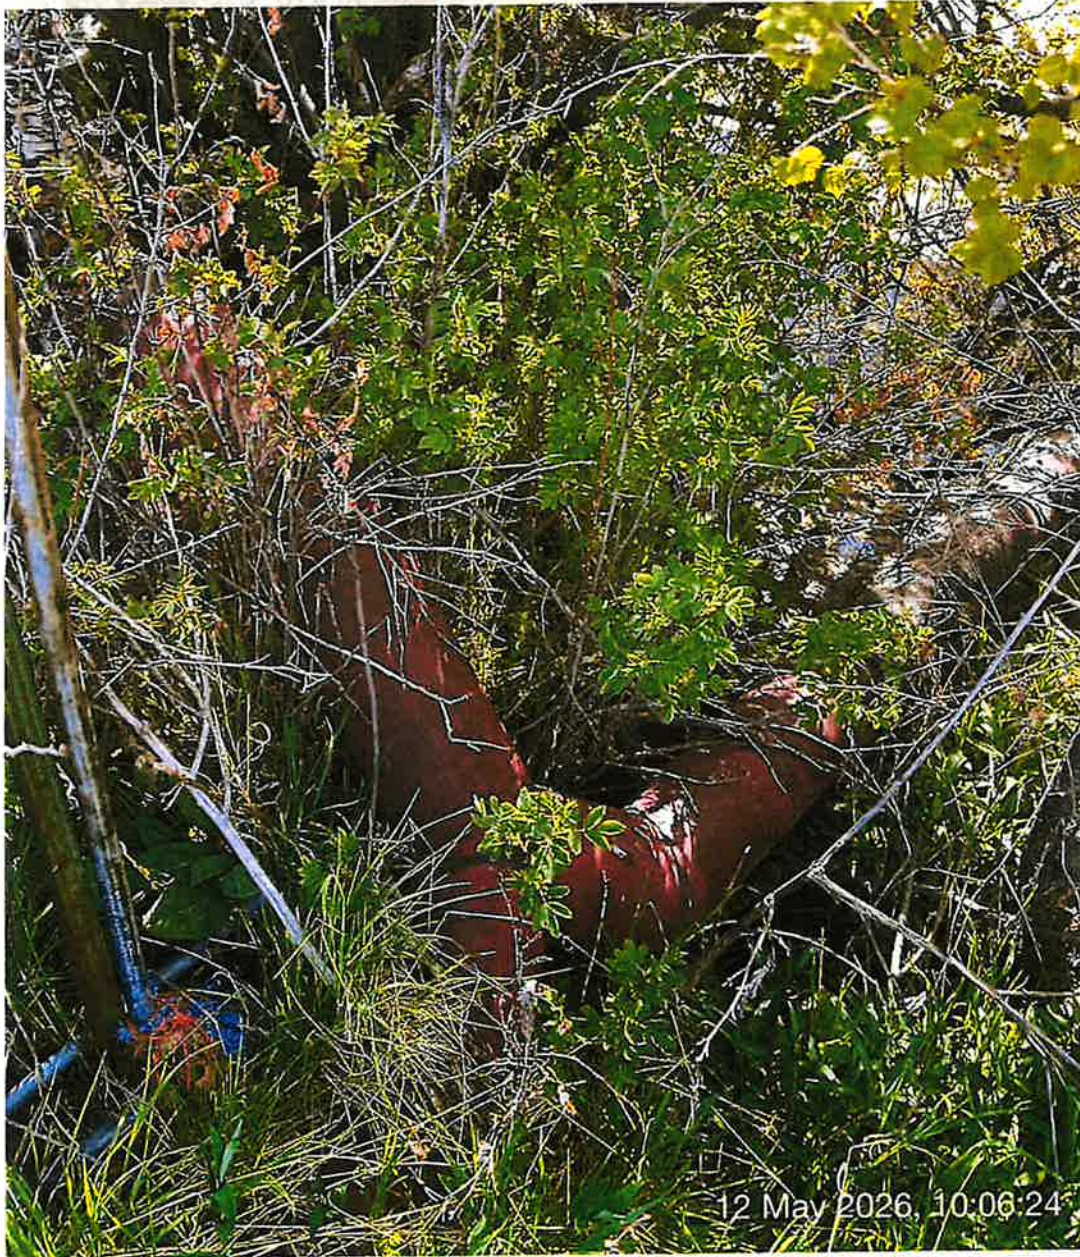
Pipe near the point of diversion splits flow. The 6" pipe pictured on the right directs flow across the creek. The pipe is buried and surfaces at the two openings at the top of the hill.

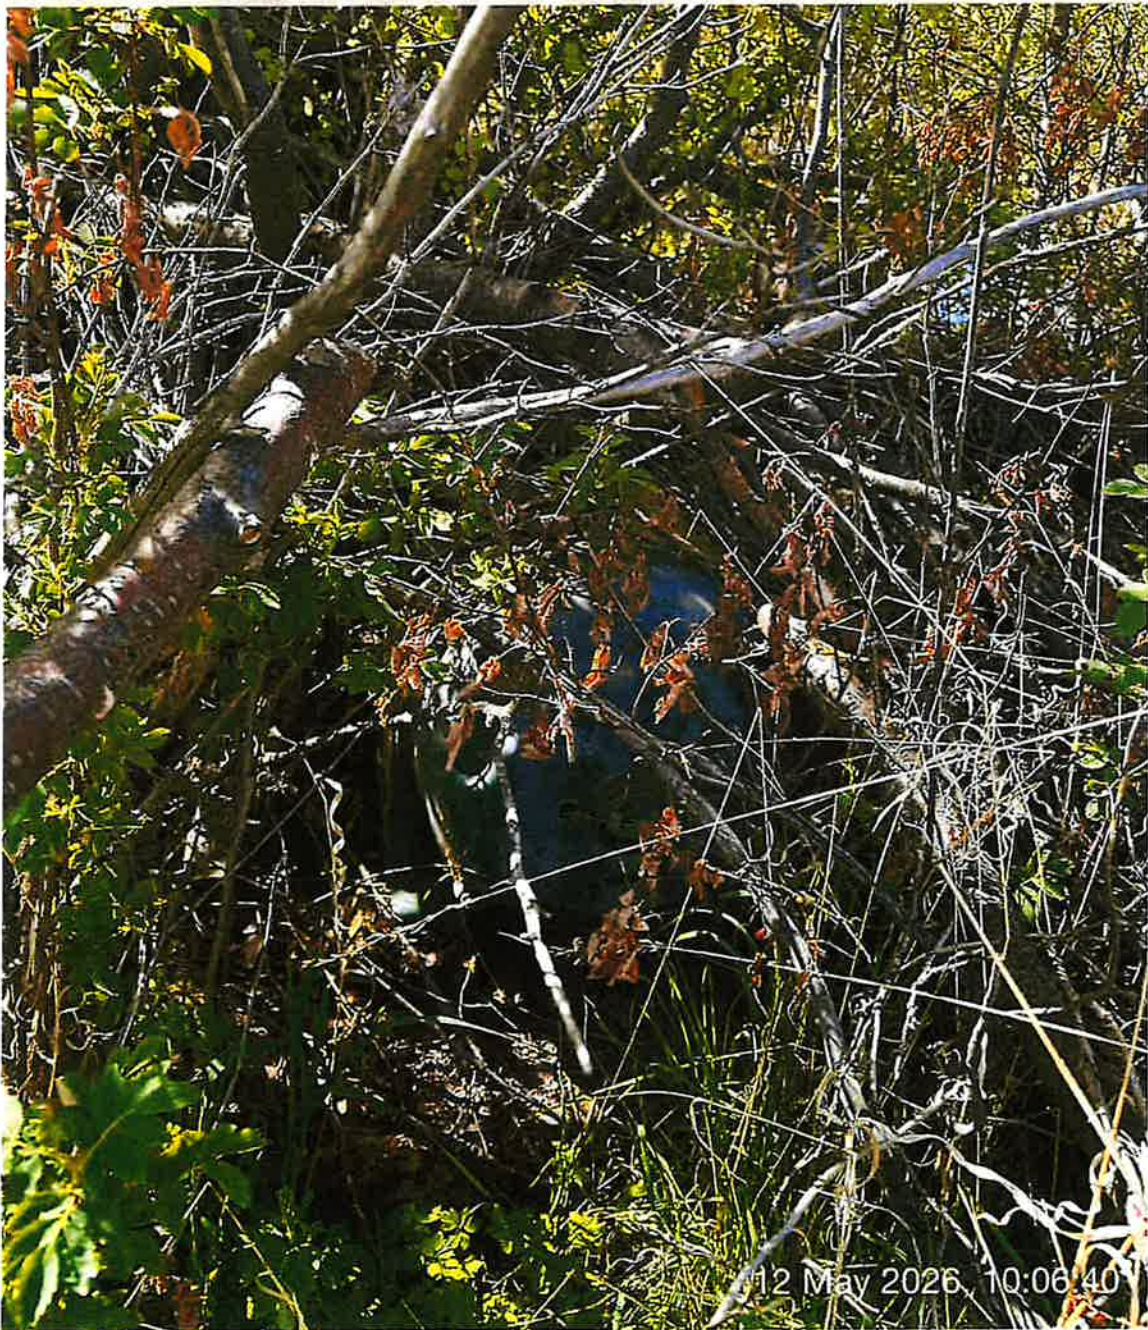
Mary took me to a pump located near the concrete headgate on the north streambank of Formation Springs. The elevation of the pump is 6160 feet. The pump was surrounded by dense vegetation so I could not approach it to determine whether the pump was connected to any pipes. The pump was not running and was not connected to power. Several feet away from the pump, I saw a pipe (8-10") emerging from the vegetation that split into two pipes. One pipe goes north underground and the other pipe splits south and crosses over the stream. From what was visible through the vegetation, the pump, power meter, and pipe were all in poor condition. There was heavy rust, broken glass, and cracks and holes in the pipe. I was unable to determine the horsepower of the pump and Mary did not give me an estimate of the pump horsepower.

Irrigation pump. Very old condition, inactive, not currently functional. Buried in trees. Pump characteristics unknown.

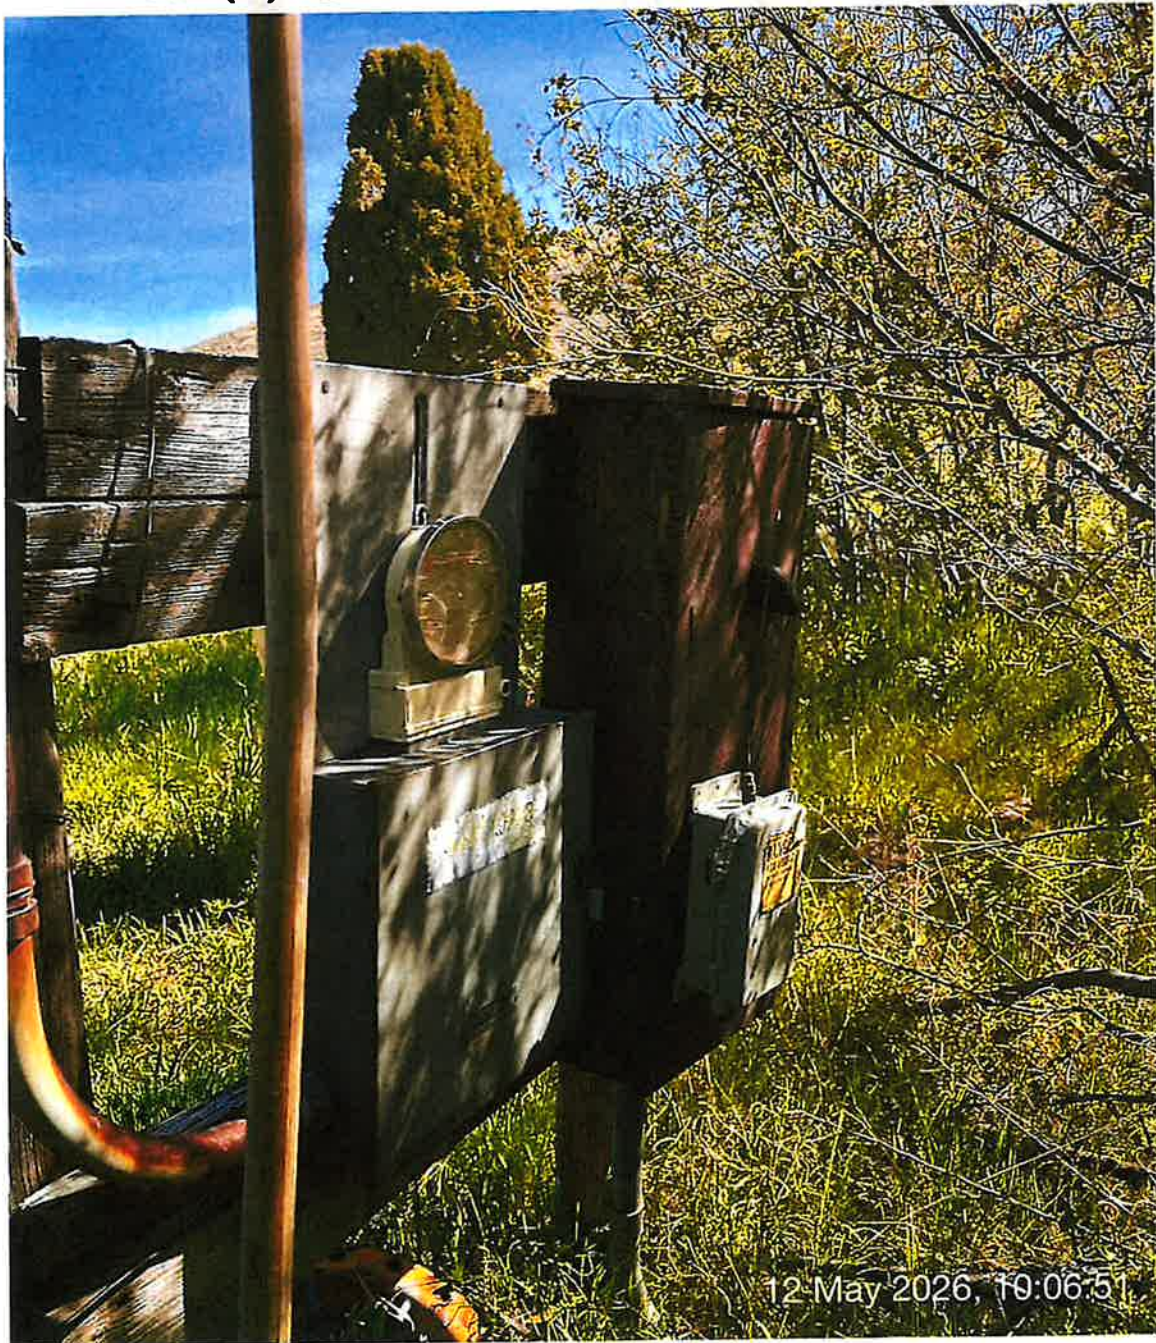
Power panel to pump. Not functional in 2026.

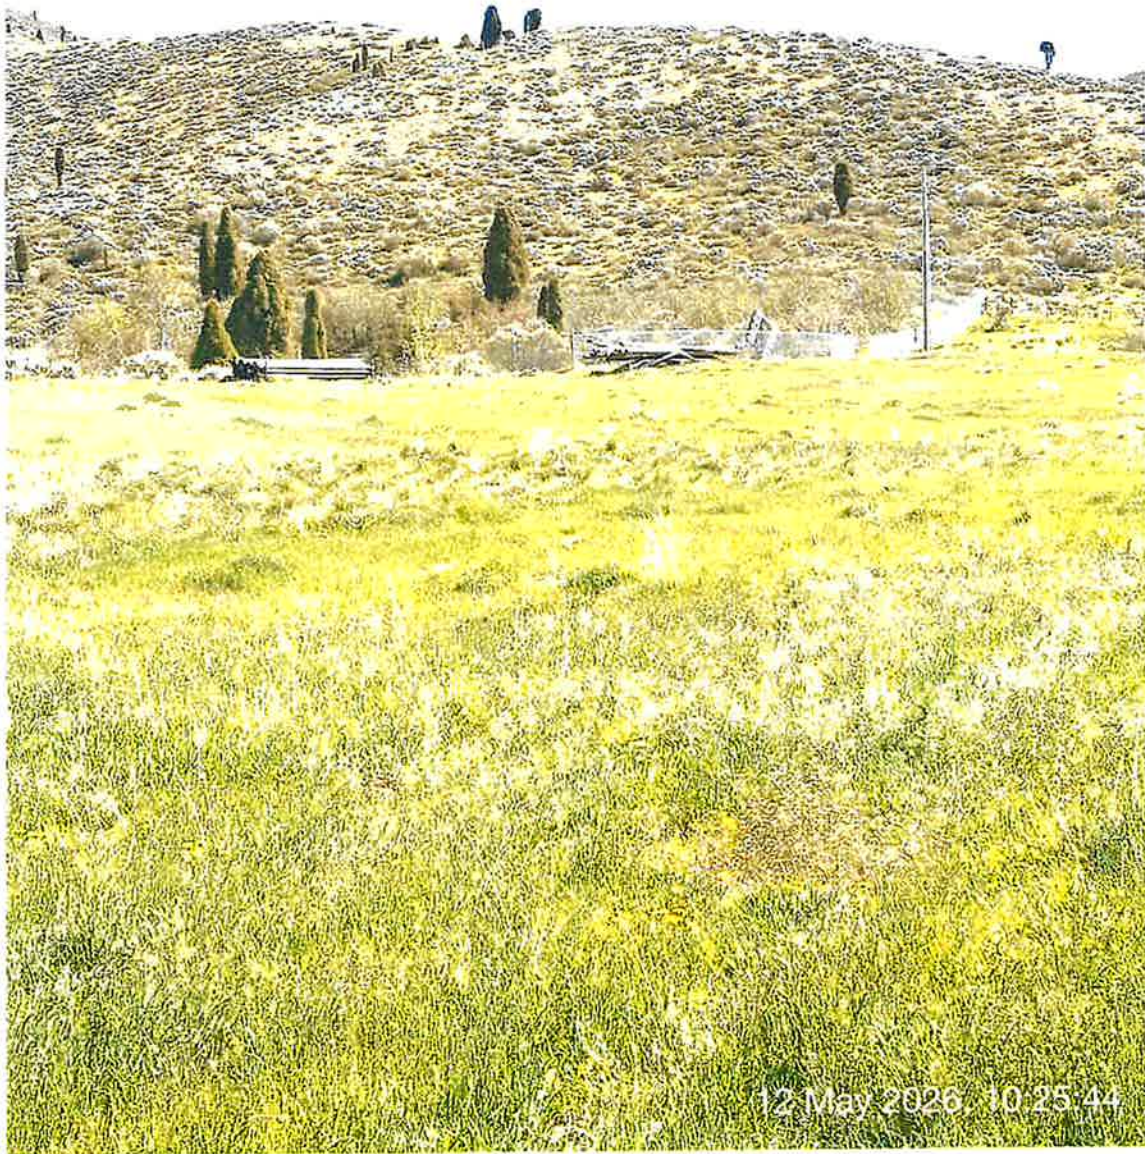
Other remarks: I asked Mary where the portable mainlines were. She showed me a pile of fifty 30' pipes lying on the ground to the south of Formation Springs. This pile of pipes is visible in this exact location, unmoved, in every available Google Earth aerial photo since 09/2010.

50 30' x 4" aluminum handline pipes

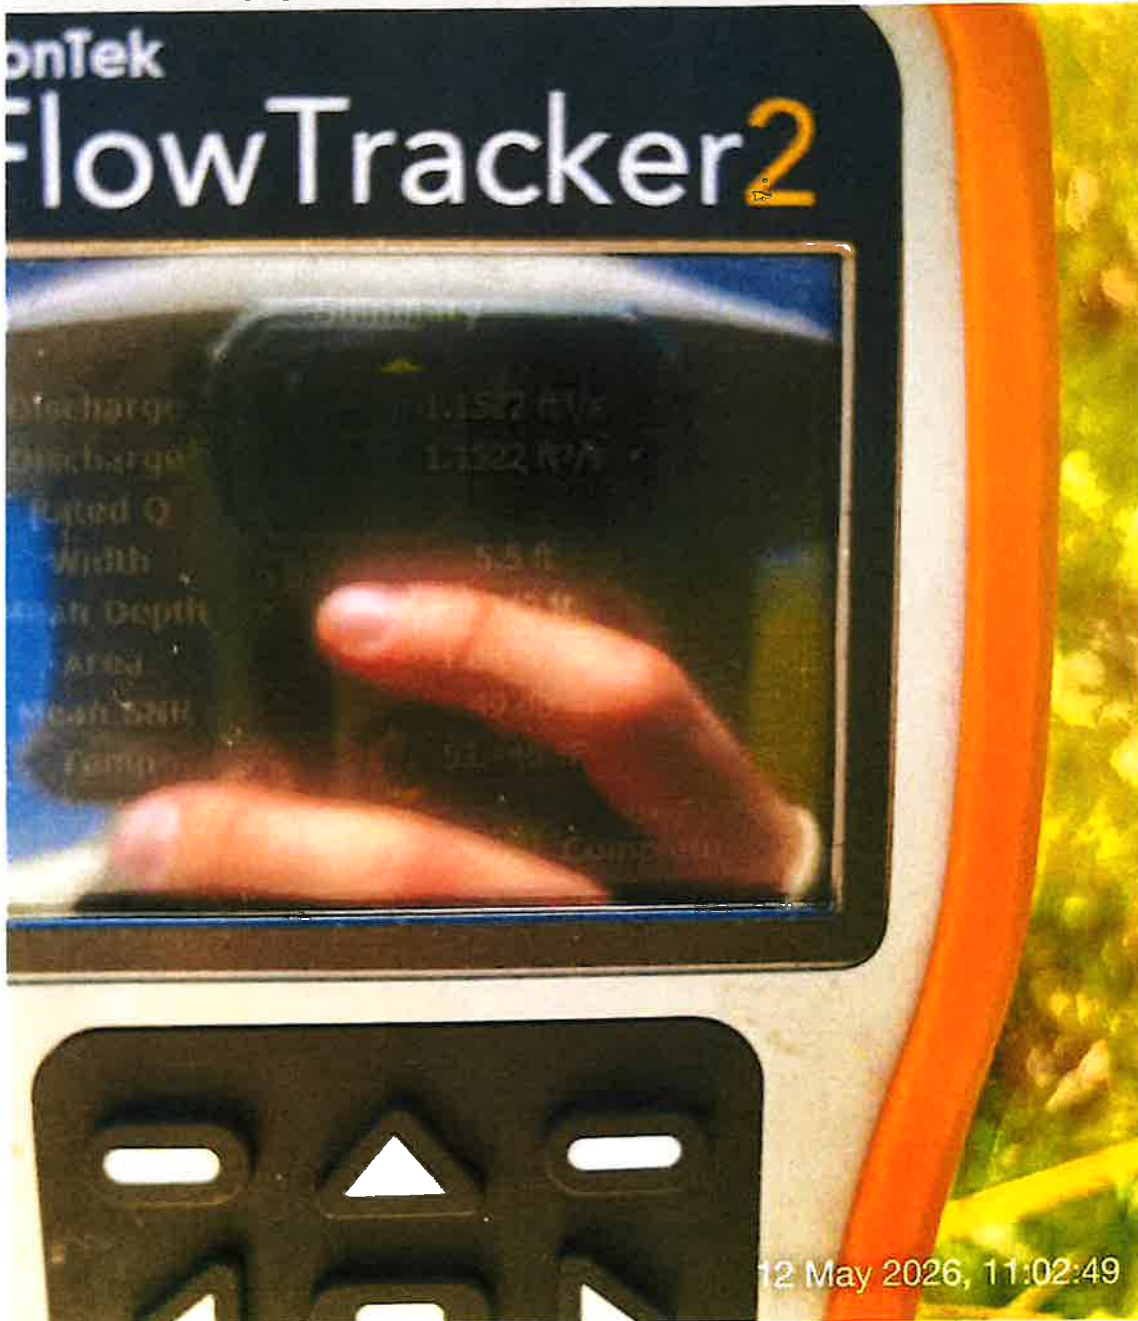
Jensen Ditch flow measurement 1.15 cfs.

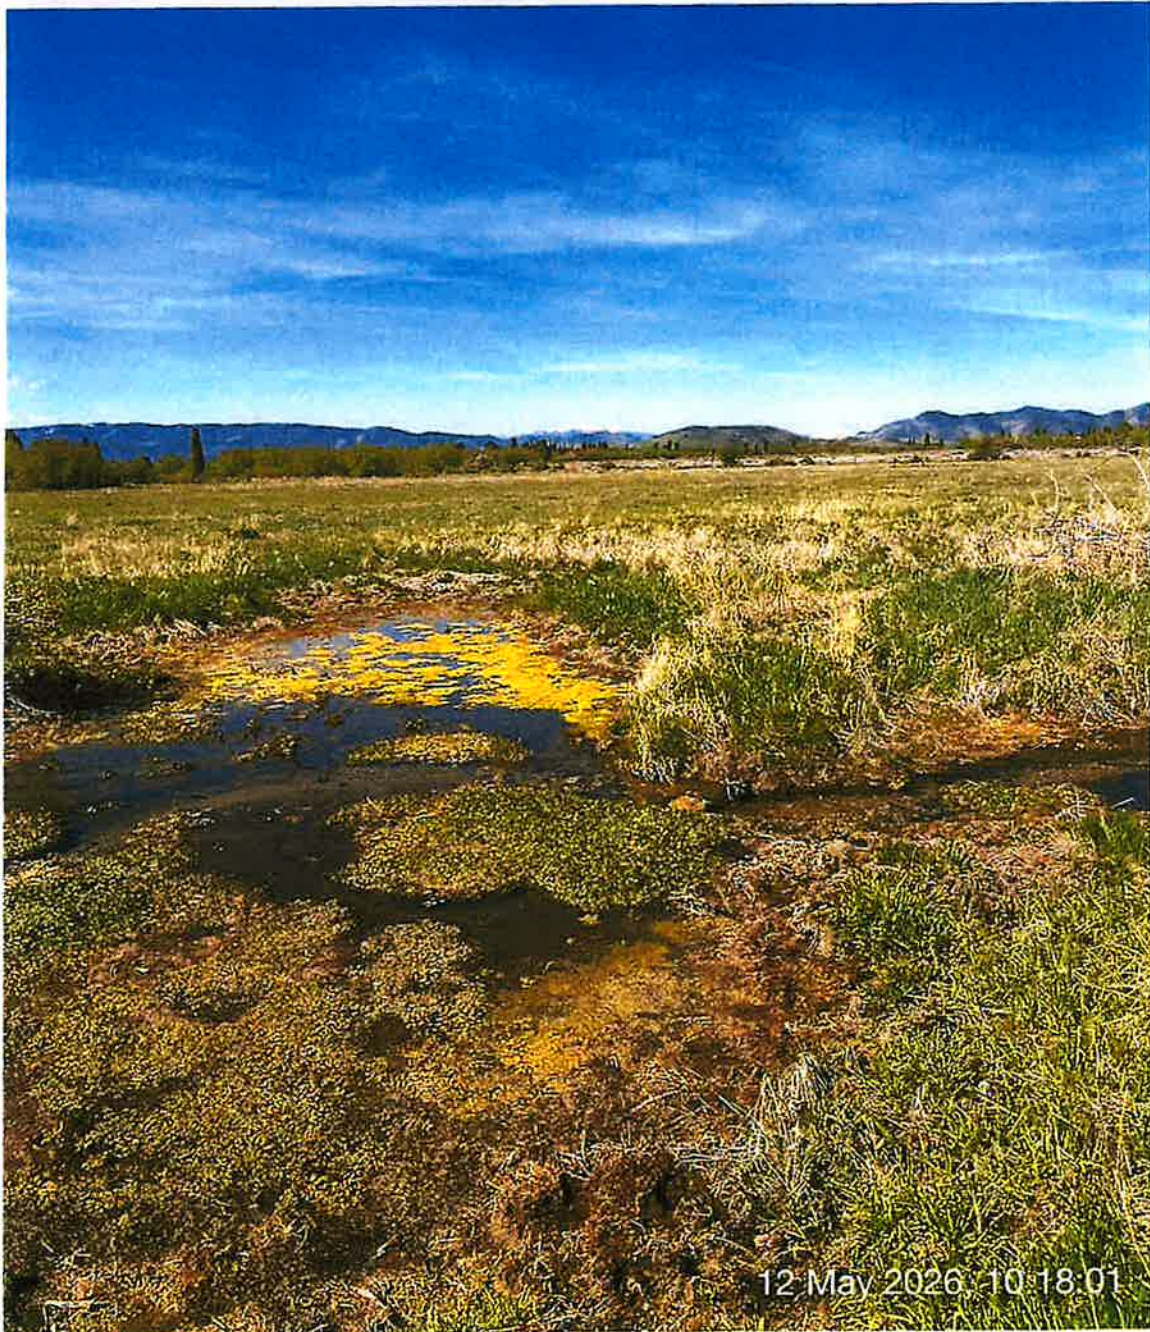
Flood irrigation from the ditch at the place of use.
