# IDWR Claim Investigation Field Report

## WR # 11-995D/11-4323

Christian Stewart – Water Resource Agent

6/5/2026

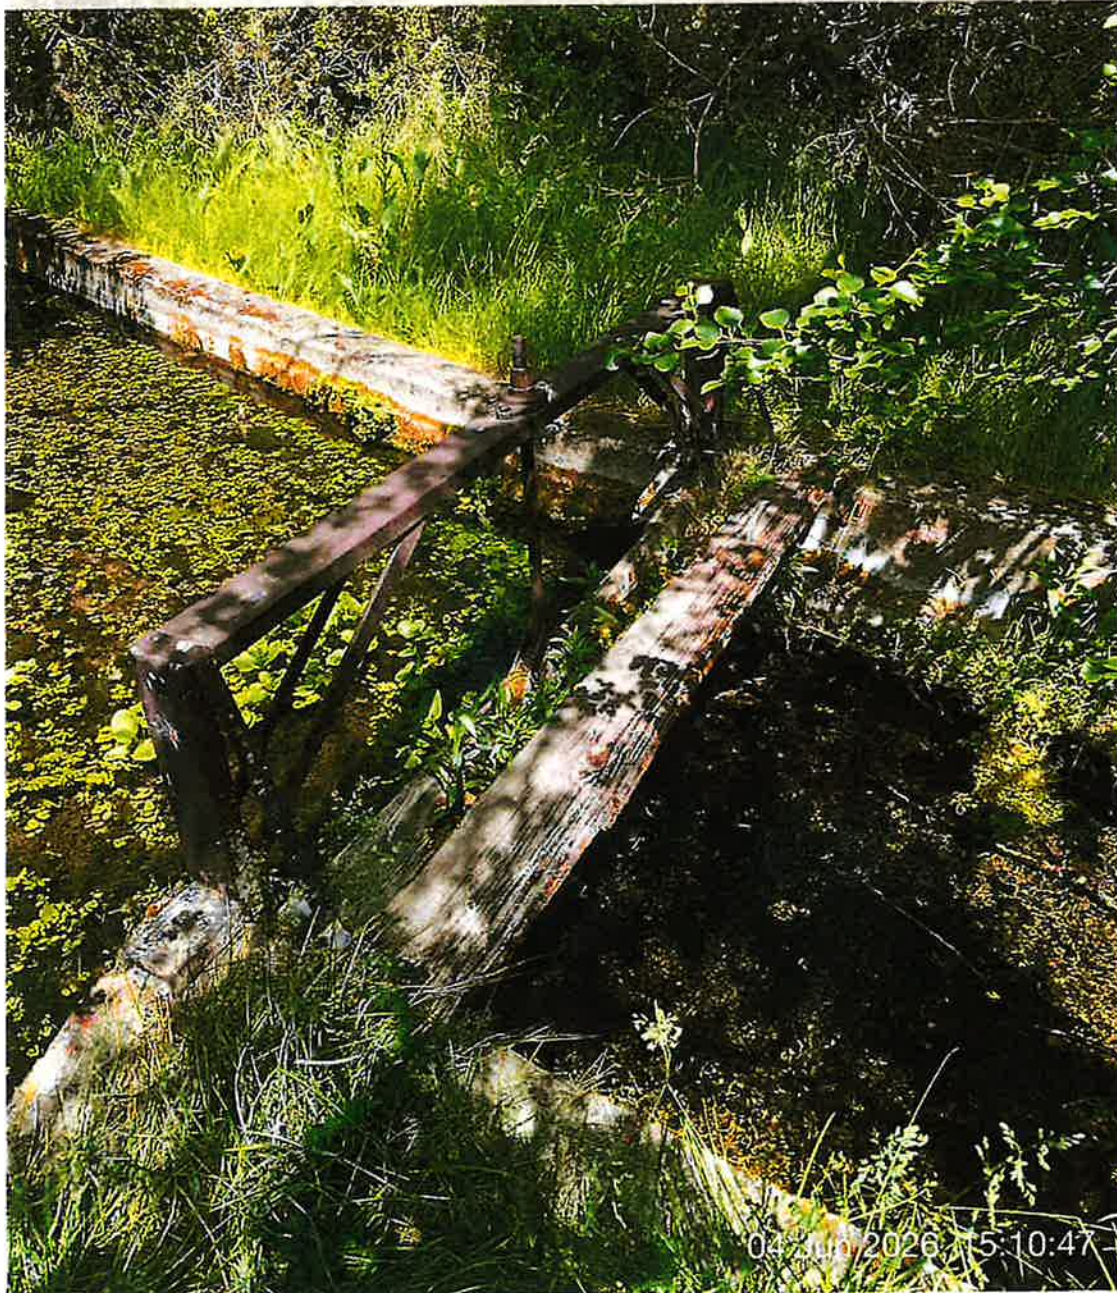
At the point of diversion, there was one headgate diverting water into the Davis ditch and another that diverted water into a channel where the water sinks. The Davis headgate is located at the furthest downstream part of the Formation Springs stream channel. The headgate was mostly shut, much more water could theoretically be diverted at the headgate.

Partially open headgate at the point of diversion. Dimensions are 5ft wide x ~2ft deep. Headgate was only open an inch or two at the bottom.

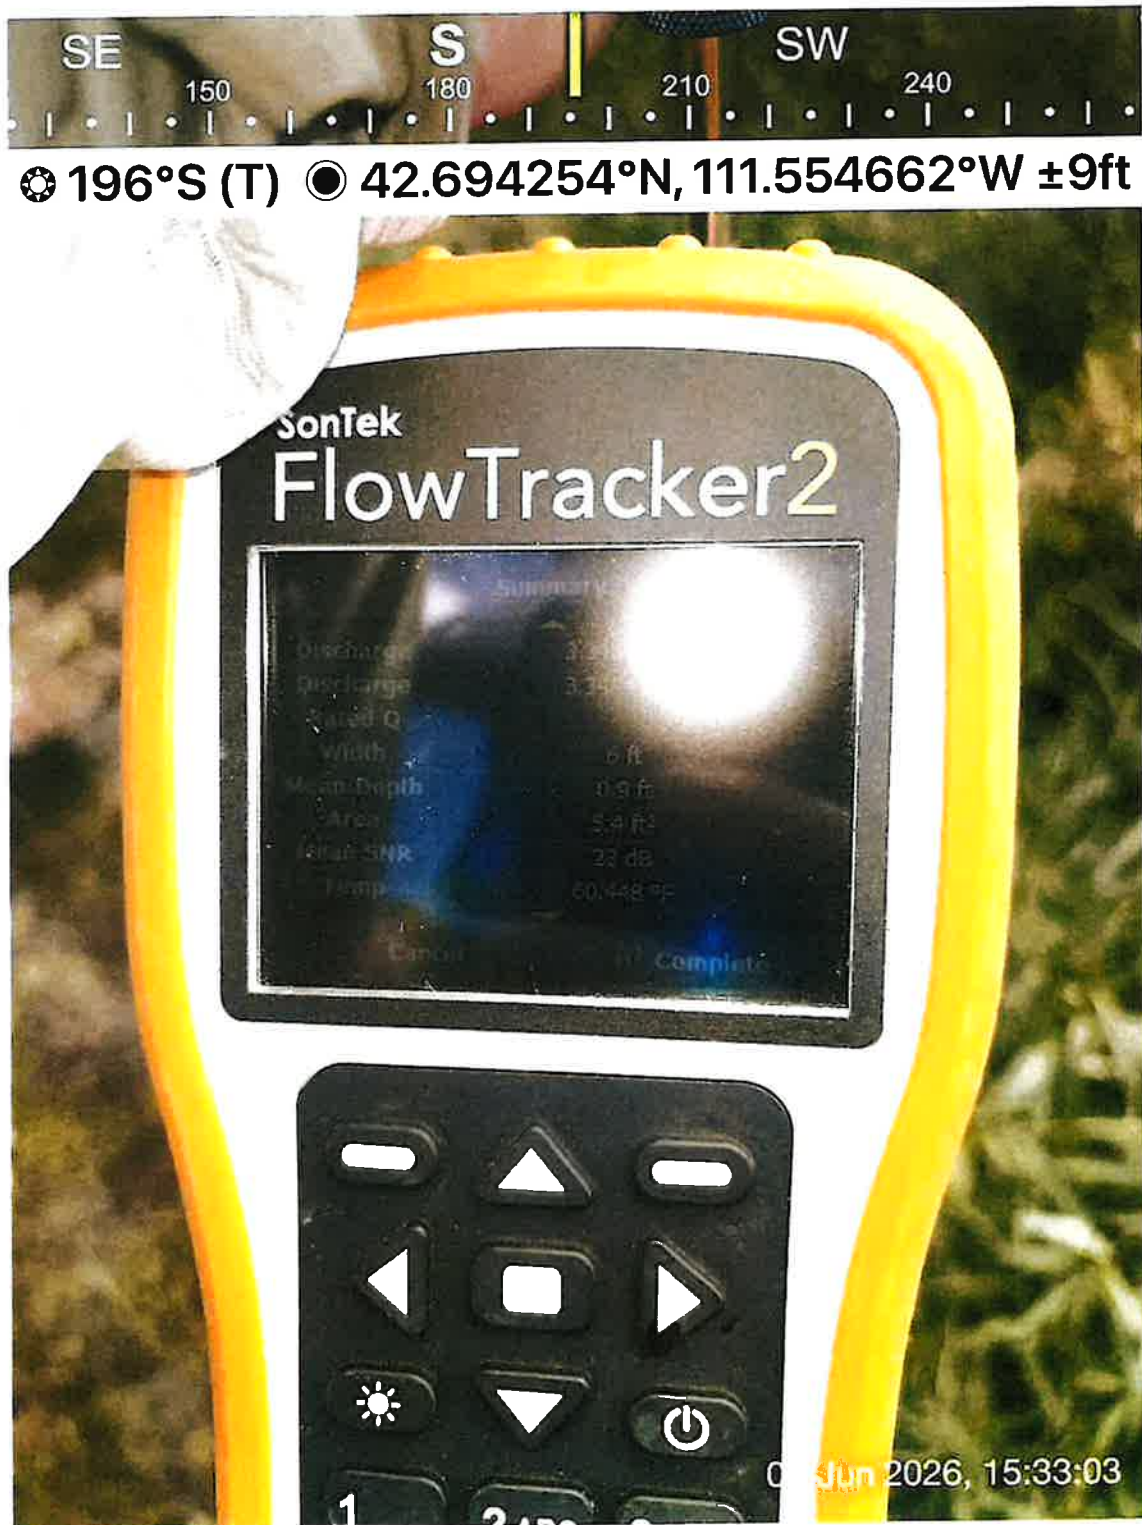
I measured 3.34 cfs at a location ~150ft downstream of the point of diversion using a Sontek Flowtracker2. This measurement necessarily included additional inflows from the overbank flooding that was occurring around the headgate and flowing into the Davis ditch. The ditch was at capacity. Any additional inflows would overtop the ditch beyond how much it was already overtopping in several areas.

Flow measurement 3.34 cfs taken at the walking path bridge

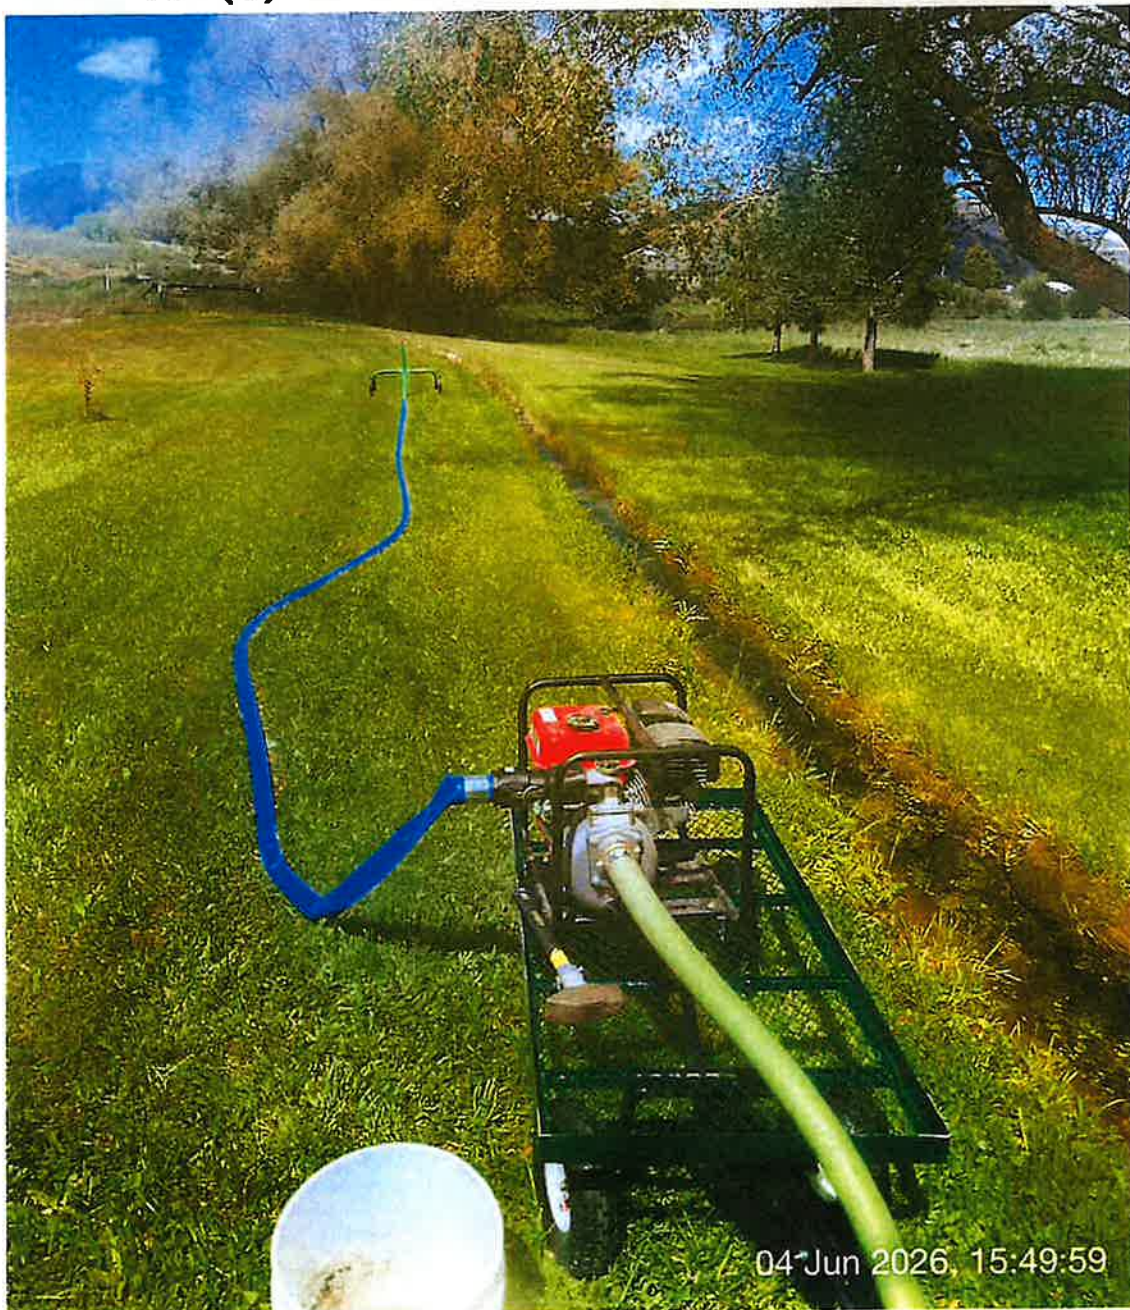
Portable irrigation pump diverting from the ditch

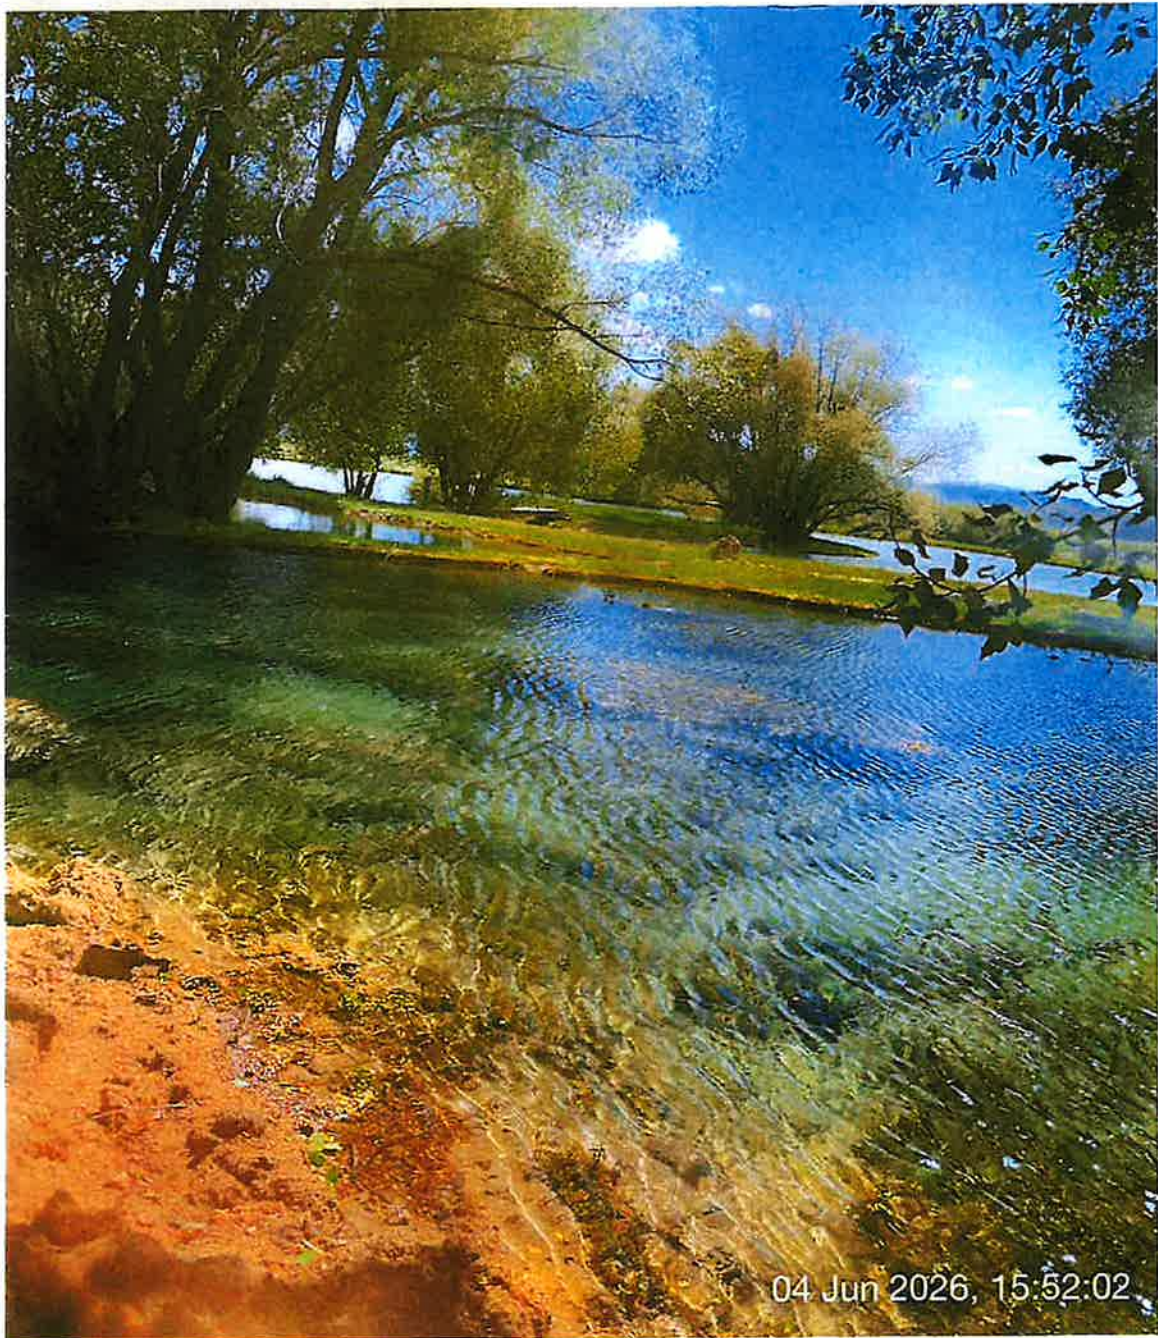
Pond with two other ponds visible in the background
