IDAHO DEPARTMENT OF  
**WATER RESOURCES**

**BRBA FIELD EXAMINATION REPORT**

**Claim Number:** 11-2041 B

**Exam Date:** 7/28/2026

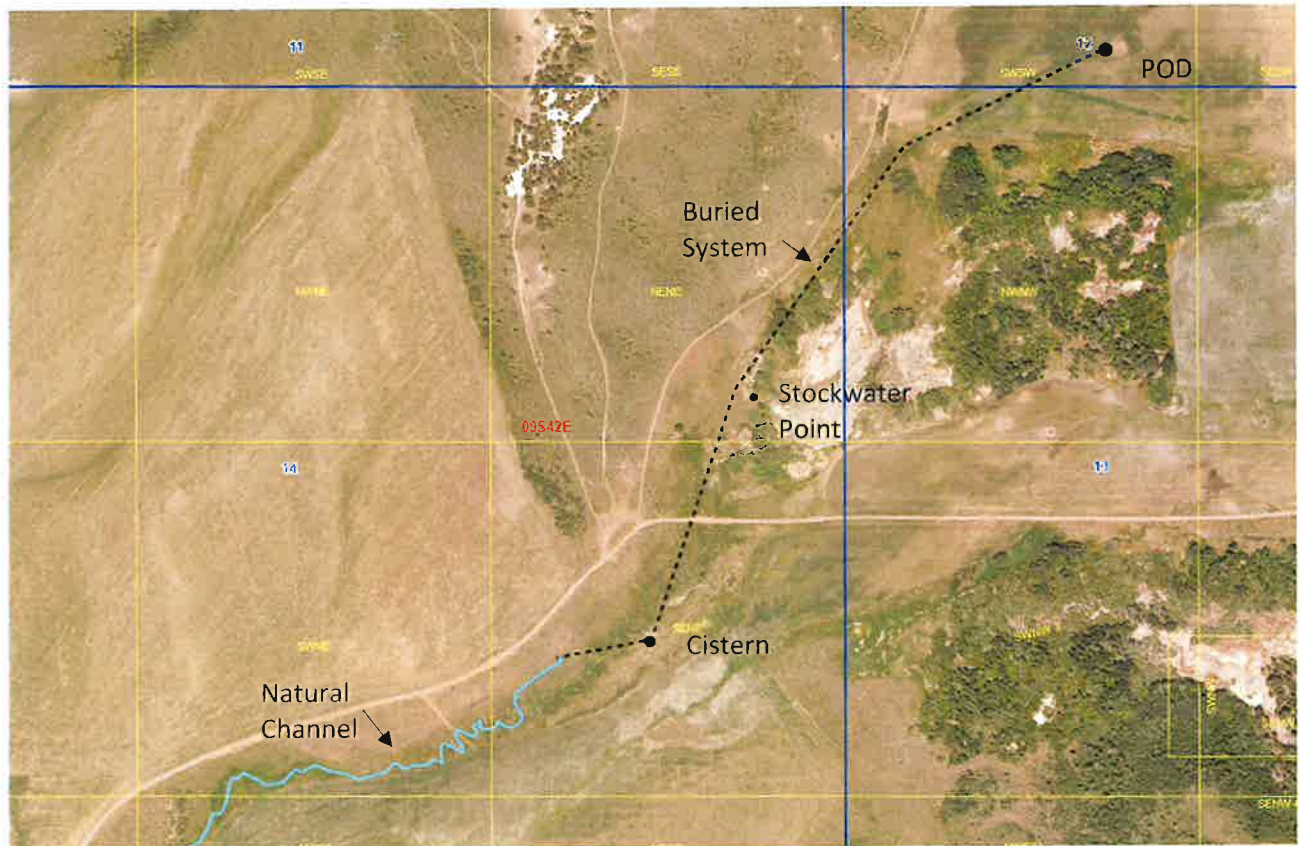
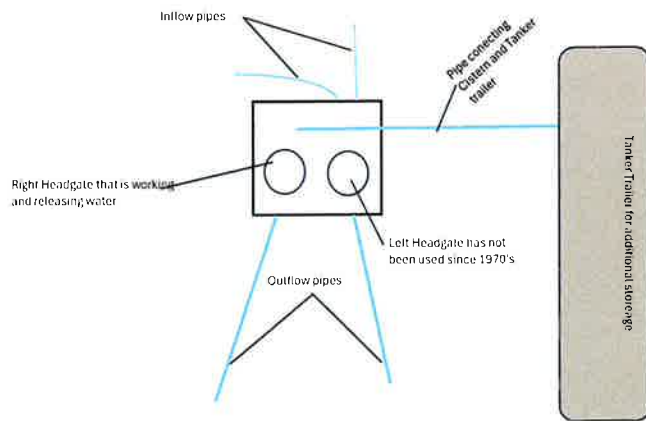
The map above shows the system as explained by claimant during field exam. The dashed line is a buried system that directs the water from the POD towards the cistern then to the natural channel identified on the NHD layer. The Cistern is a passthrough and does not act as a storage facility currently due to the storage tank not functional.

The diagram to the left shows the diversion works of the cistern system as observed and explained during field exam.

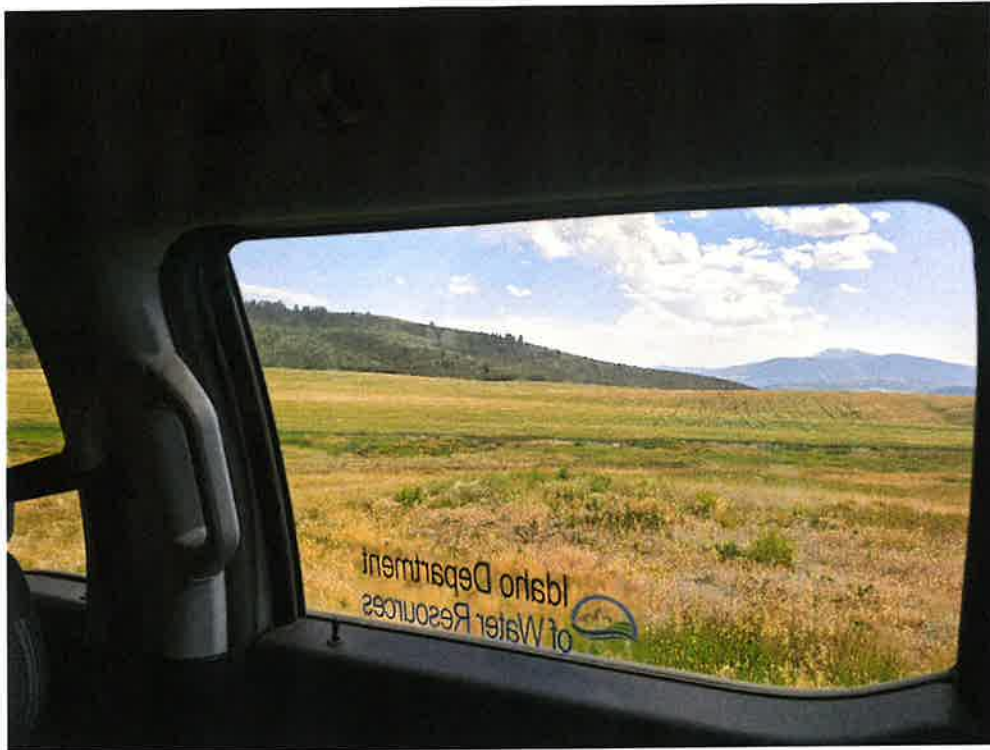
*Figure 1: Initial view of POU when driving into claim.*

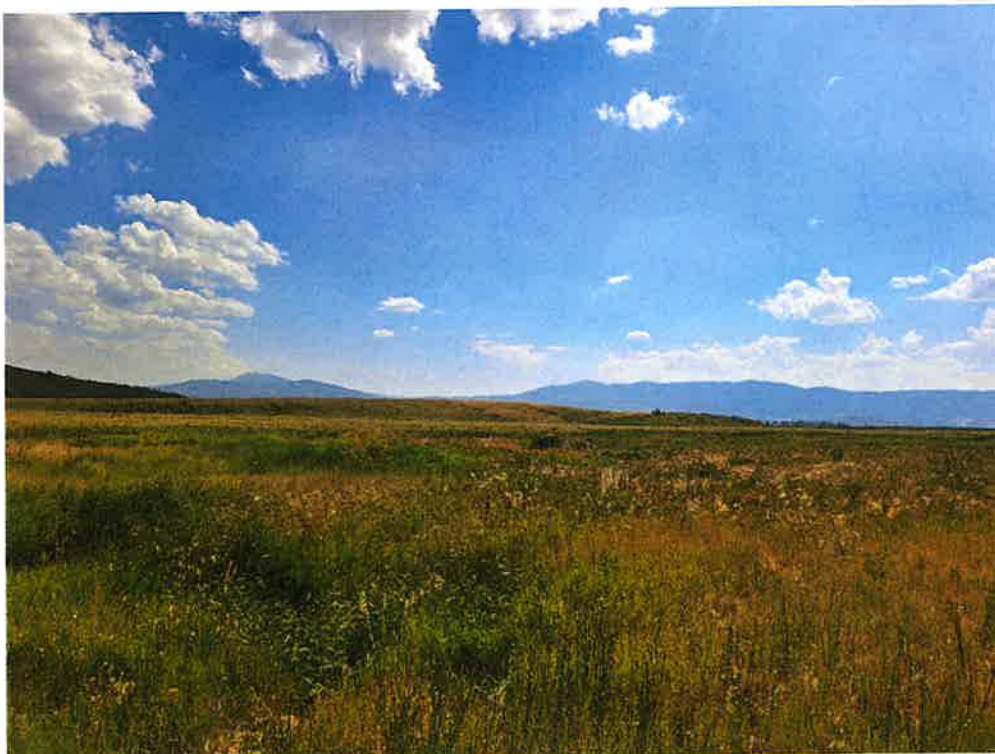
*Figure 2 POU at the midpoint near the culvert*

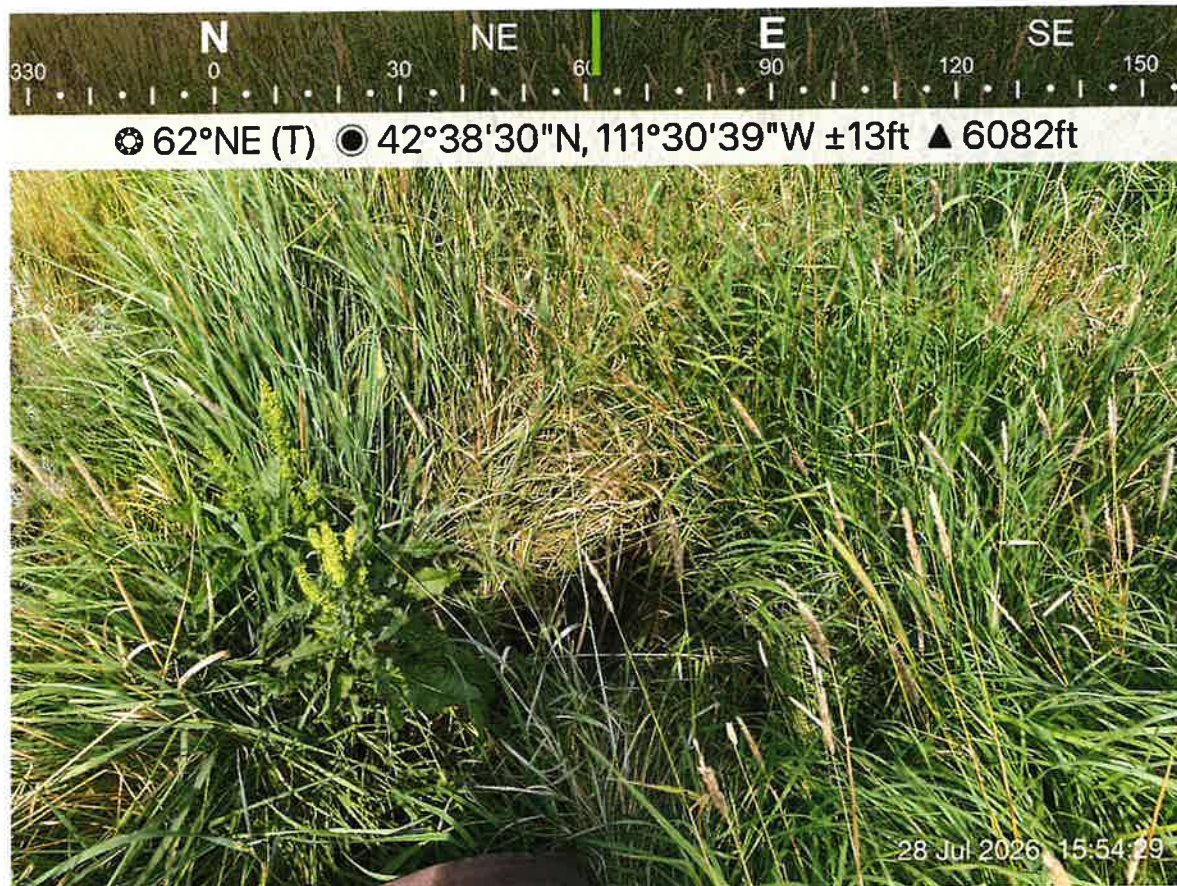
Figure 3 Stream channel claimant claimed irrigation use occurs from entering culvert midway in the claimed POU.

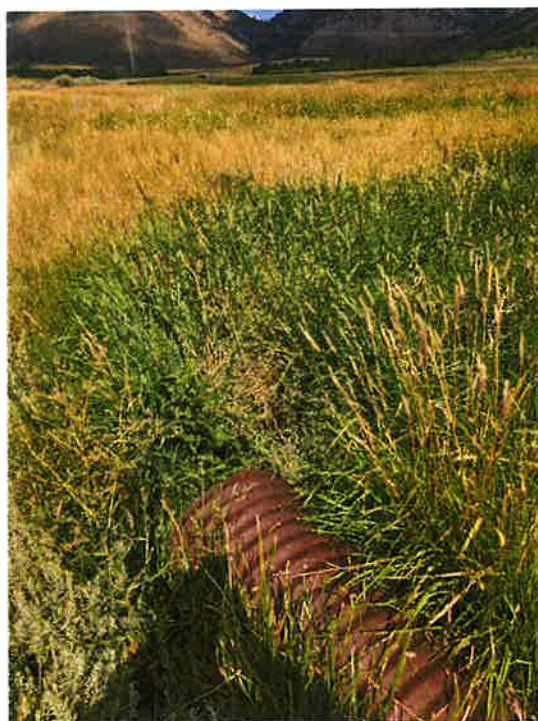
Figure 4 Culvert at the midpoint of the POU.

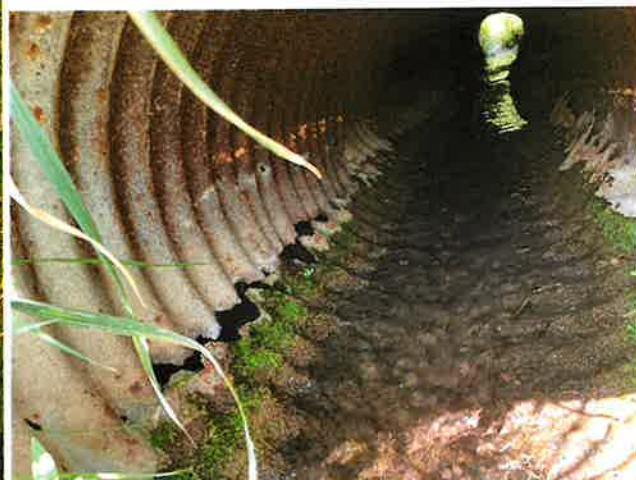
Figure 5 Interior of the culvert and large structural crack.

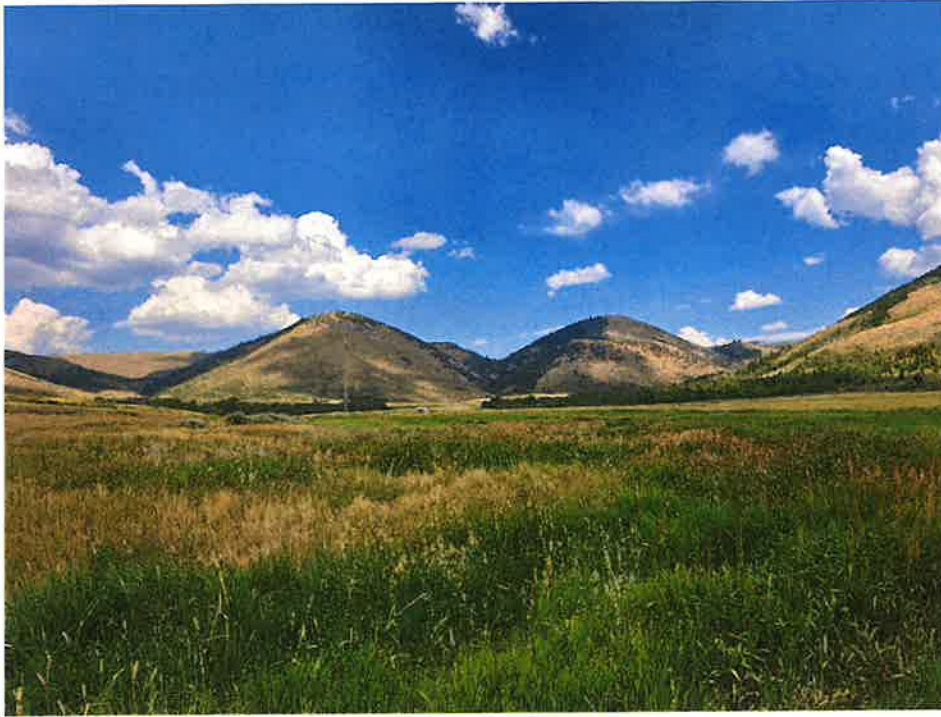
Figure 5 From the midpoint of POU looking towards the upper section of the POU where the cistern and storage tank is located.

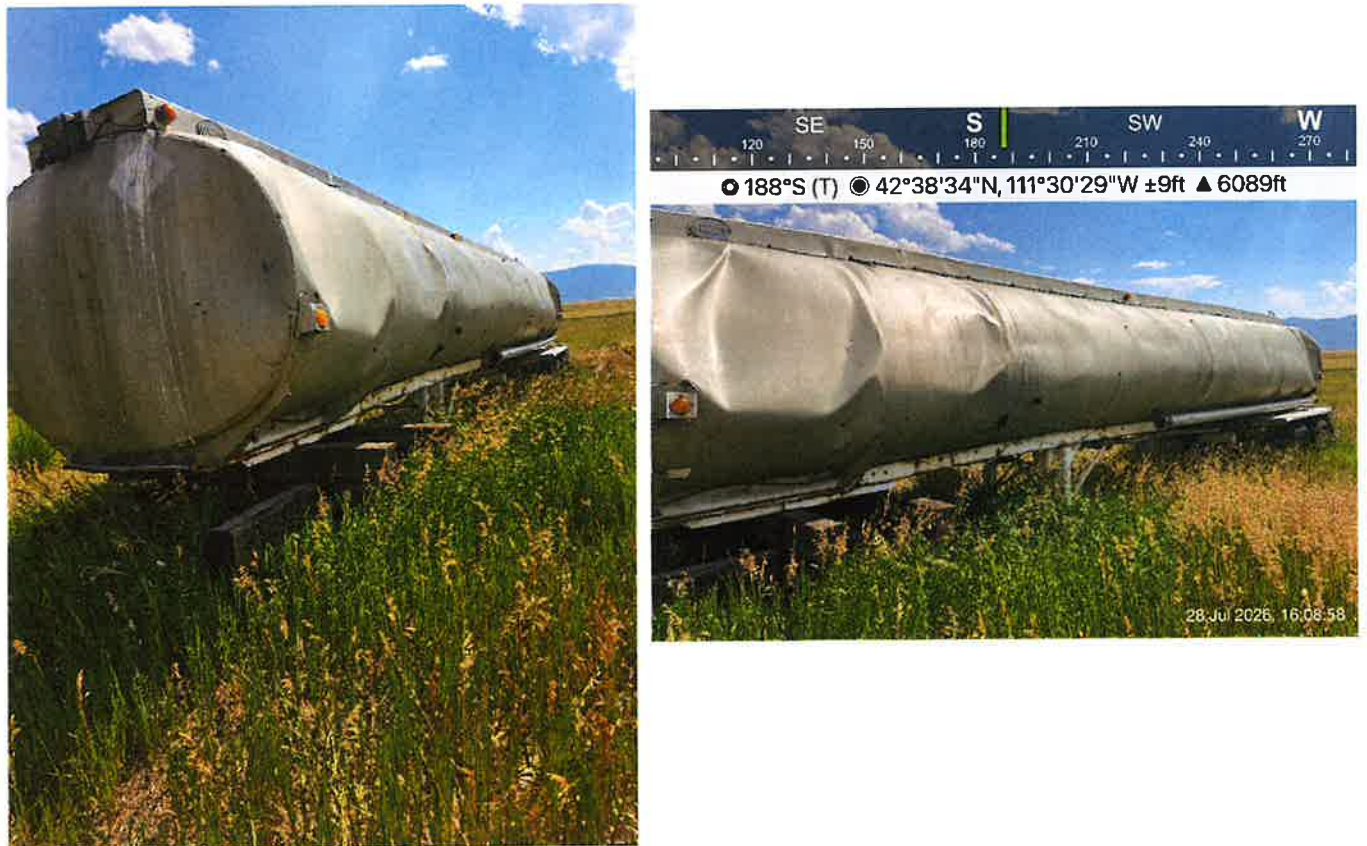
Figure 6 & 7.5 Storage tank for cistern. Not currently in use due to target practice evidence.

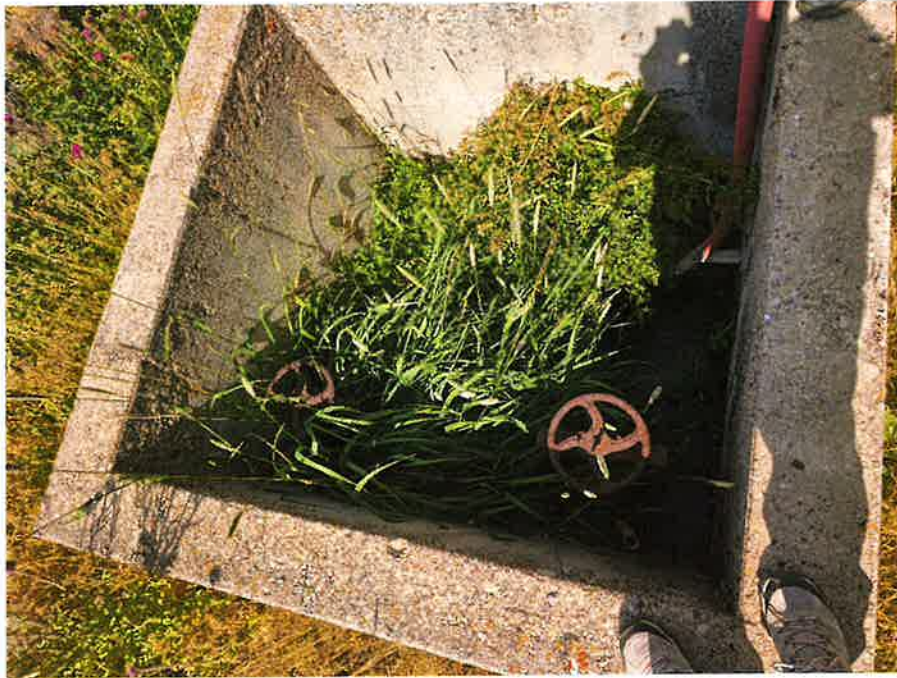
The next area Mr. Barker showed us was the cistern. He uses only the north gate of the cistern. The south gate remains closed (nonfunctional), and he is not aware of the outlet location. Tracing the outlet of the active portion shows it is approximately 350 feet (measured via Google Earth) from the cistern and discharges directly into the natural channel. A 1–2 inch PVC pipe with a banjo valve is installed in the cistern and connects to the adjacent tanker trailer, though the trailer has been unused for several years due to bullet damage. Historically, the trailer was filled from the cistern and used to support irrigation. The inlet pipe diameter into the cistern is unknown to the claimant, but they stated they were in the process of replacing broken tiles from the POD to the cistern.

*Figure 7 Cistern inner works includes two head gates and a PVC line that connects the storage tank to the cistern.*

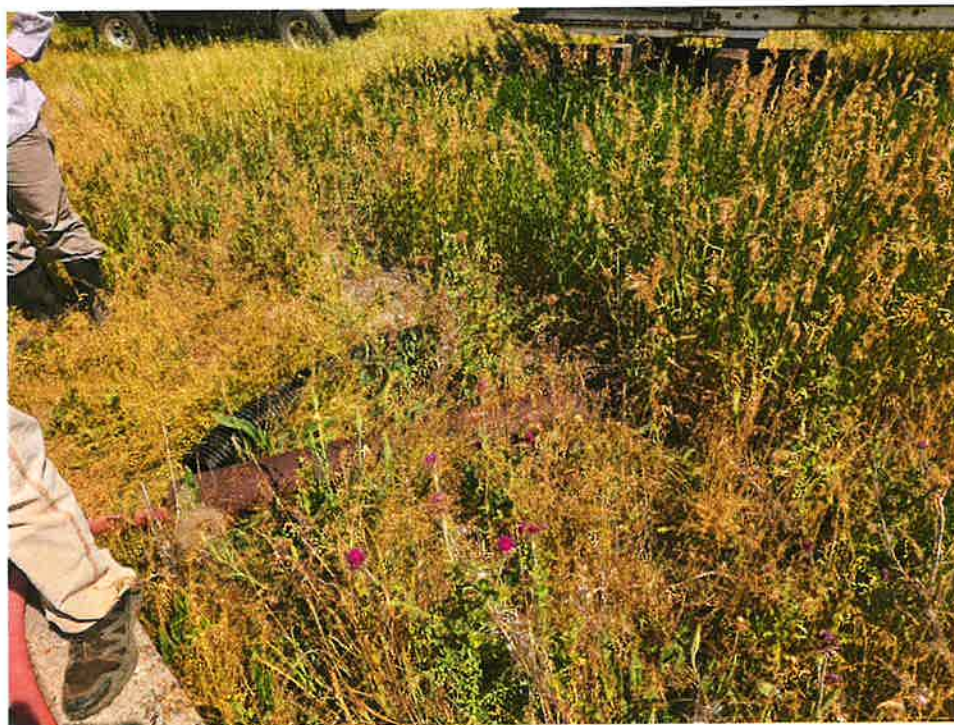
*Figure 8 Cistern inlet lines.*

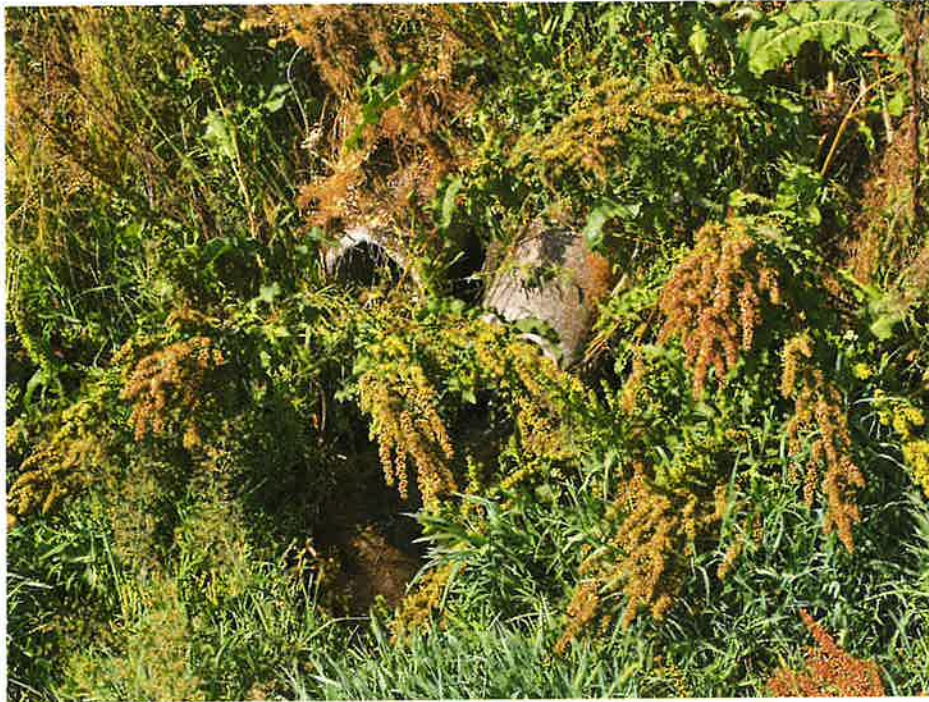
*Figure 9 Outlet for the right head gate that feeds into the active stream channel. On the right side is the active release point.*

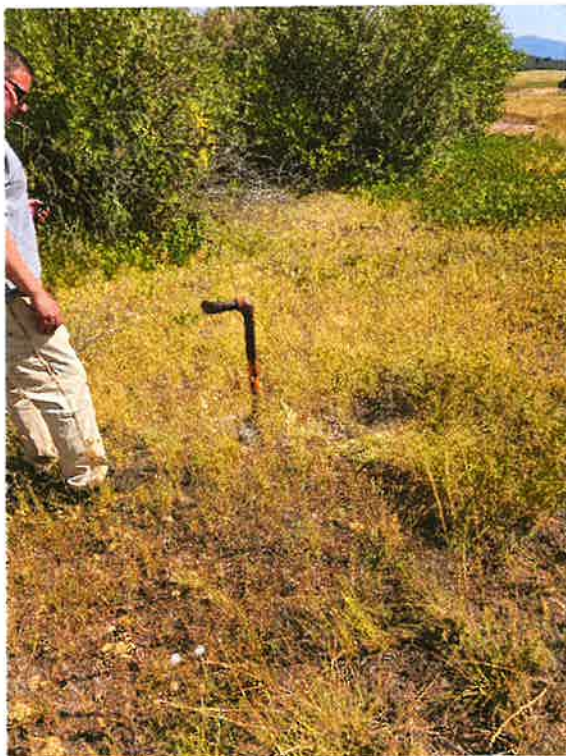
*Figure 11 Identified POD during office visit was found to have been part of the old mine desulfurization process and later stock water use point.*

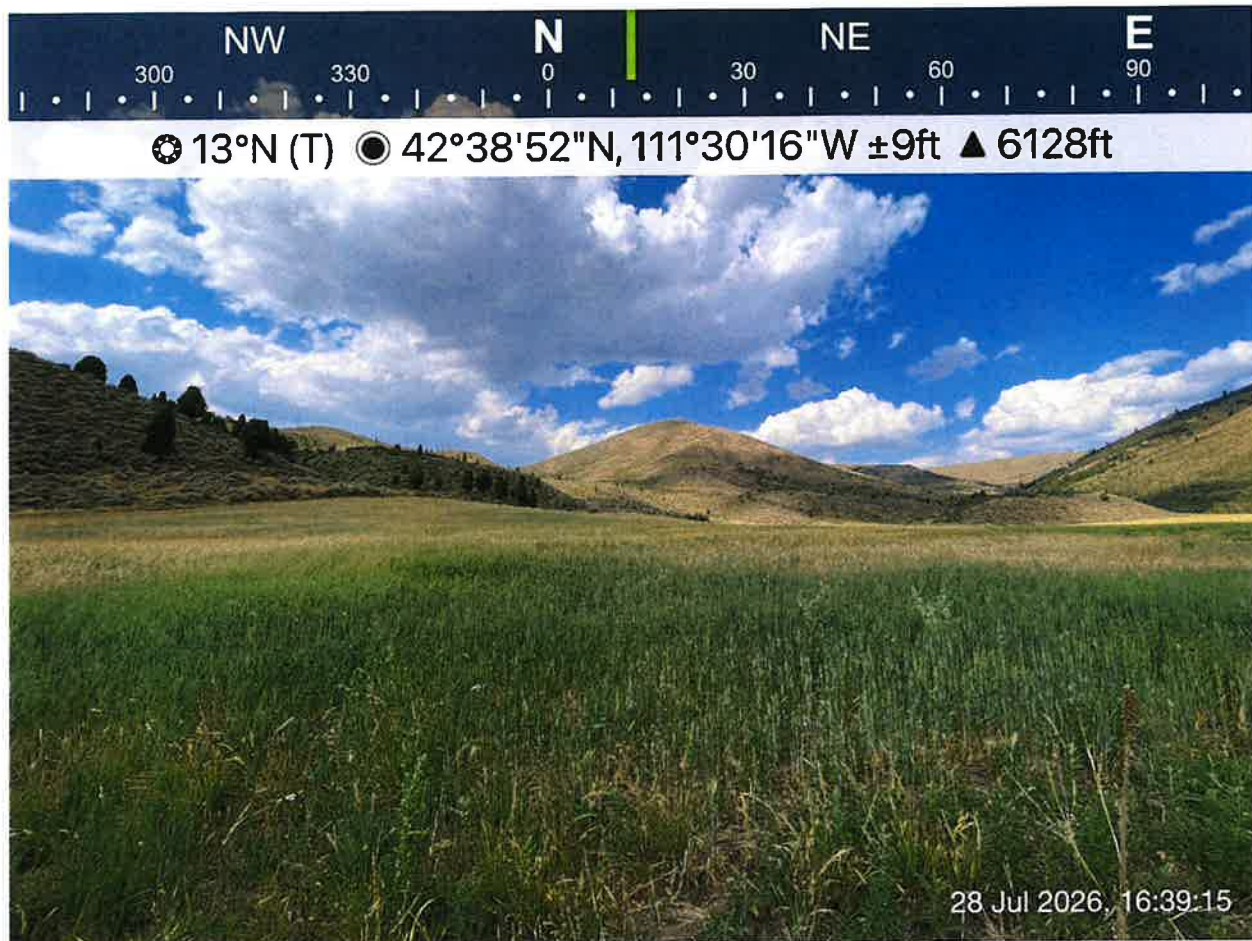
The POD identified during the in-office visit was found to be a pipe historically used for mining and more recently for stockwater. The actual POD location is approximately 1,500 feet northwest (measured via Google Earth) and is noted on the hand-marked map in Section 12. Mr. Barker mentioned he believes he located the secondary POD referenced in the original license somewhere in Section 13, but this was not observed during our visit. From the POD to the cistern, the elevation has a slope of about 5.3°, or 30–40 feet.

Figure 12 Actual POD was found to be under a field located in the SWSW section 12 just NW of the previously identified POD location.

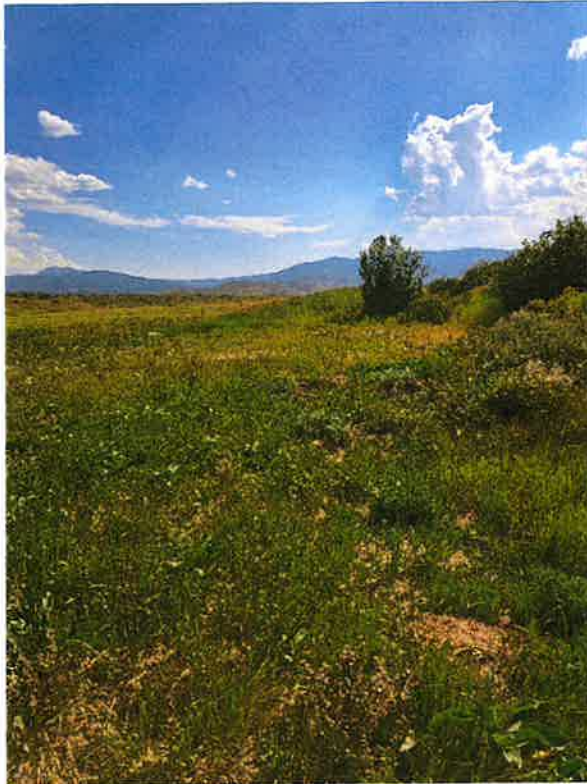
Figure 13 remains of the historical dam that was removed in 1970.

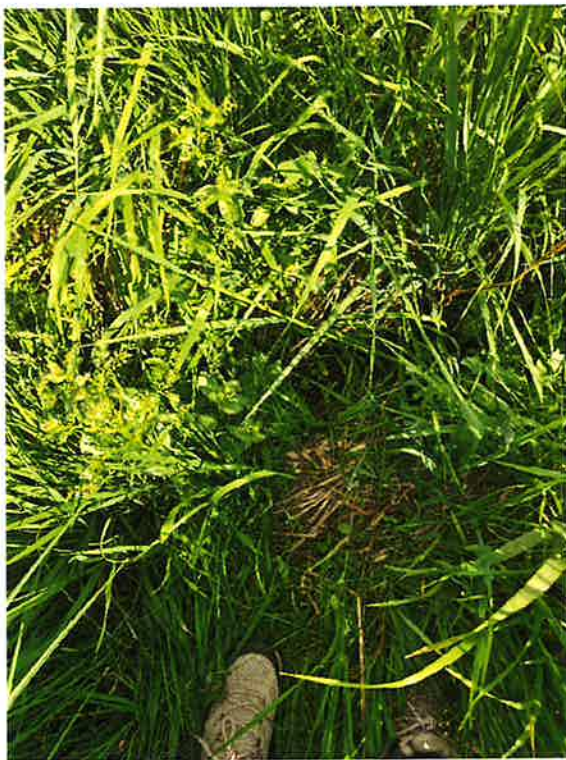
Mr. Barker also pointed out the historical dam location and indicated this as the area where flood irrigation traditionally occurred. When we walked to the remains of the dam, the channel soil appeared dark, indicating recent moisture, but no water was present. Water was present at the culvert, but somewhere between that point and the dam it dispersed. The distance from the culvert to the dam is

Figure 14 Stream channel near the historical dam was found to have been recently wet but no present water was found in channel.

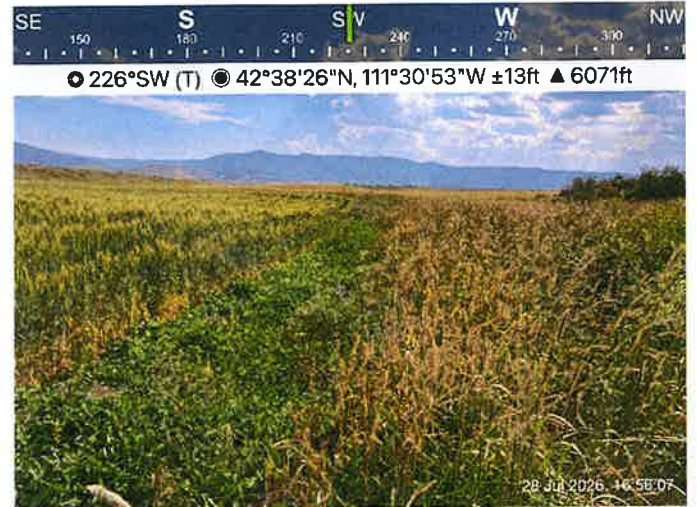
Figure 13.5a Historical dam from 1970 to the right field to the left and stream channel through the center.

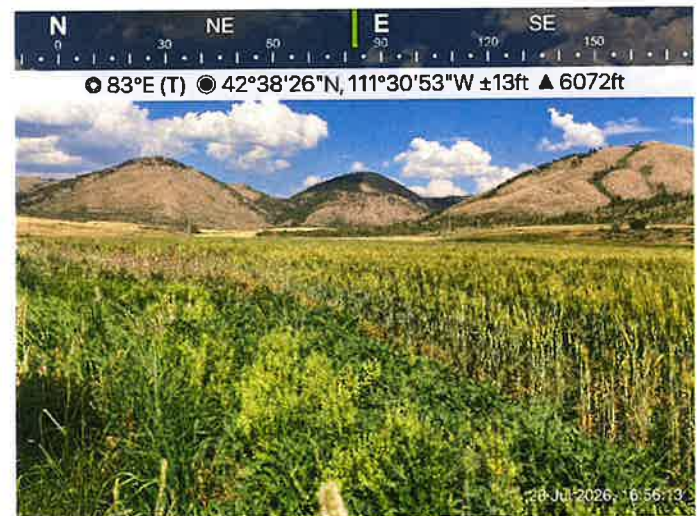
Figure 13.5b Historical dam from 1970 to the right field to the left and stream channel through the center.
