IDAHO DEPARTMENT OF  
**WATER RESOURCES**

**BRBA FIELD EXAMINATION REPORT**

11-2079, 11-4054 and 11-4055

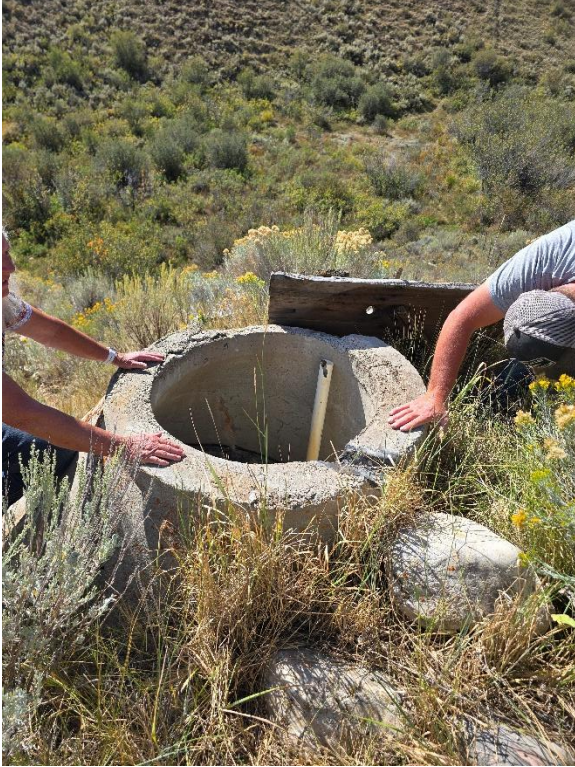
*Figure 1: Cistern located up about ½ mile into Red Pine Hollow.*

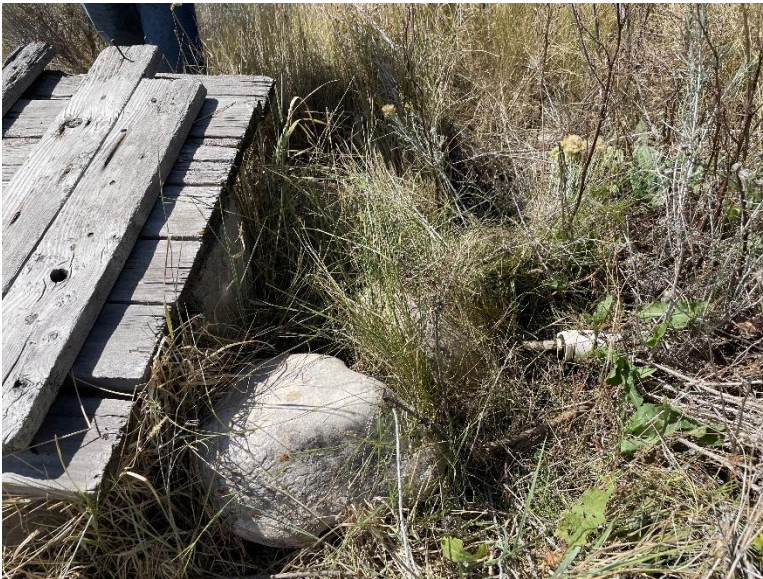
We then walked an additional 0.26 miles (measured by Esri ArcGIS Pro) to the cistern. An inlet pipe entering from the west was observed, supplying collected water to the cistern. When the rubber end was removed, water was observed trickling out of the pipe. Adjacent stock troughs were present, and Rigby confirmed stock use at these locations. A hose connected to the base of the cistern appeared to be used for filling the troughs. To the east, a rock-lined spillway was visible, directing overflow back to the creek channel below. GPS coordinates were collected for the cistern.

*Figure 2: Cistern with wooden lid and inlet PVC pipe visibly protruding from the ground with a connecting hose into the cistern.*

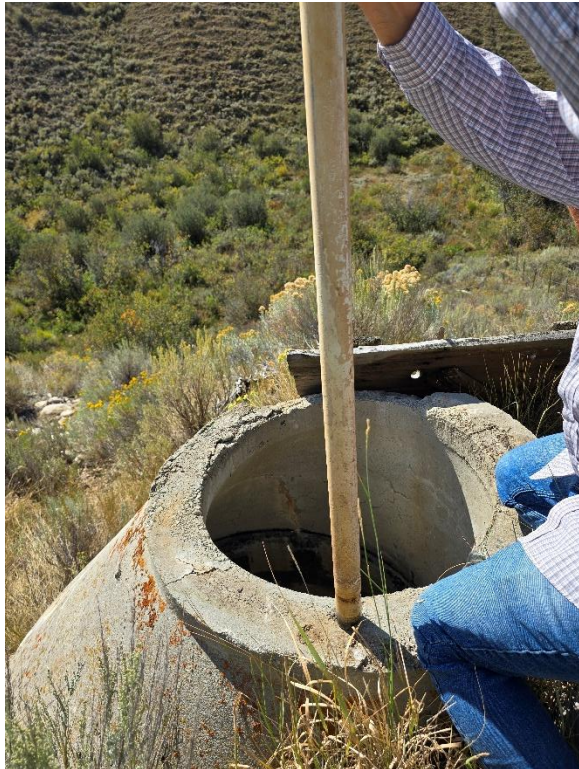
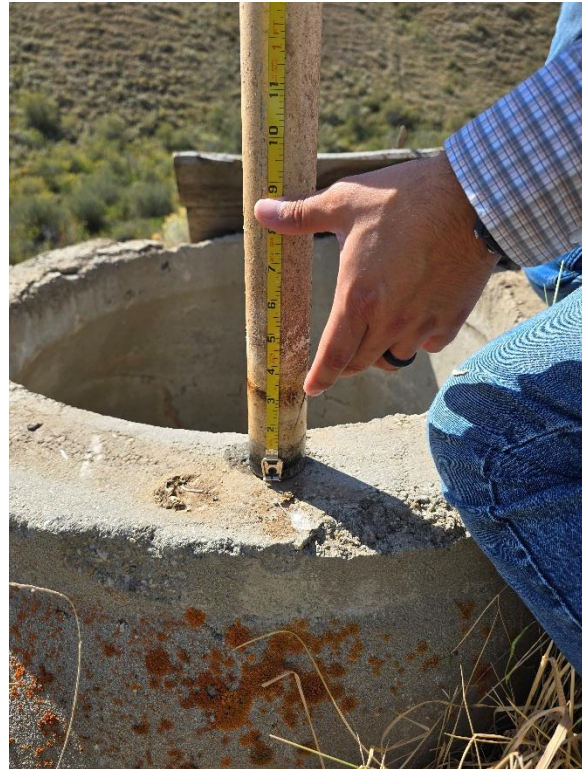
road leading to the second homestead. In years with exceptional snowpack, flow may extend to the end of the property and has historically washed out the main road, though this is infrequent. Regarding the spring, he noted that the cistern and trough have not filled in recent years, likely due to a break or clog in the line; he plans to investigate the issue.

*Figure 3 & 4: PVC pipe from inside of the cistern was removed to evaluate the water level inside the cistern. Current water level at the time of field exam in 3" deep.*

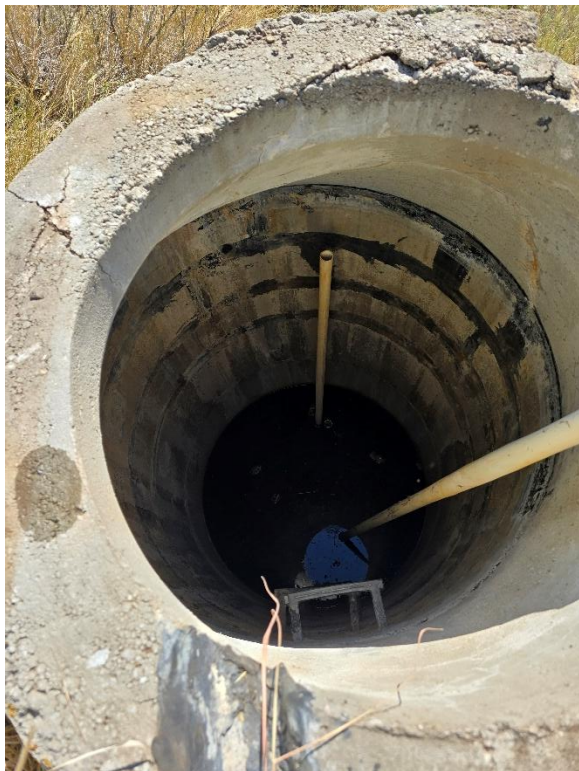
*Figure 5: Interior of cistern.*

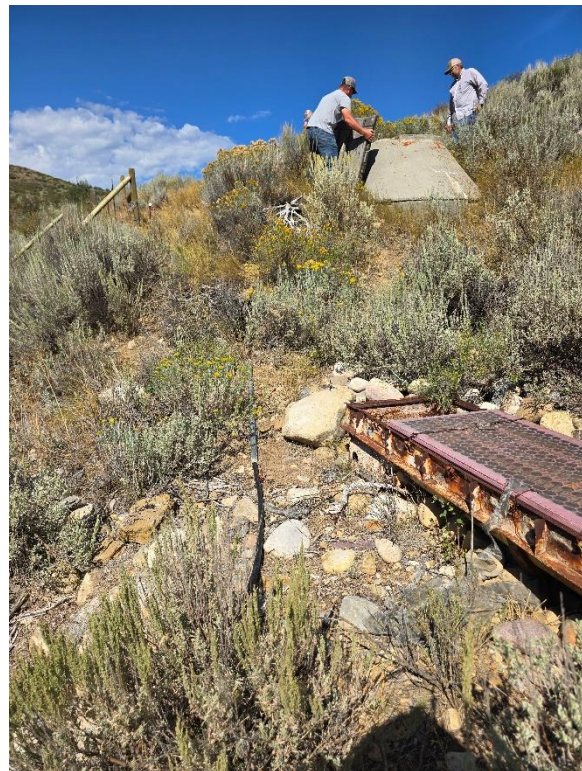
*Figure 6: Black hose connected to the cistern and reaches stock troughs below the cistern.*

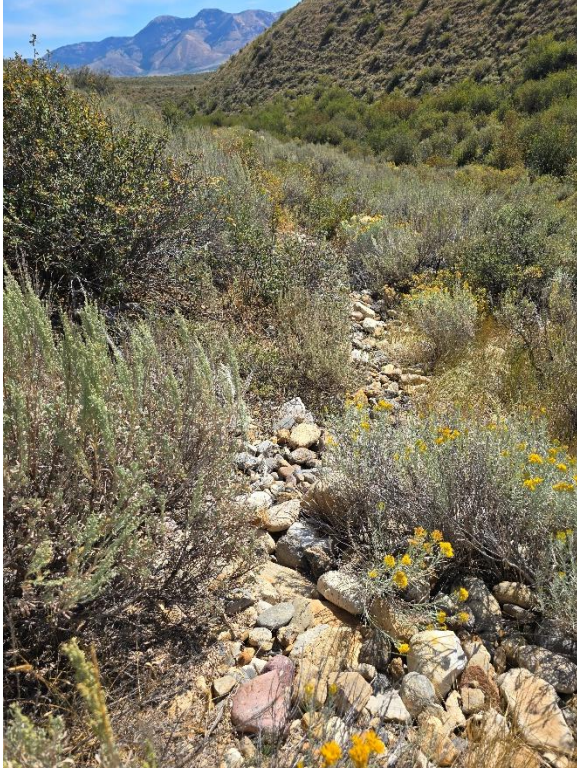
*Figure 7: Overflow path from troughs leading back to Red Pine Hollow Creek.*

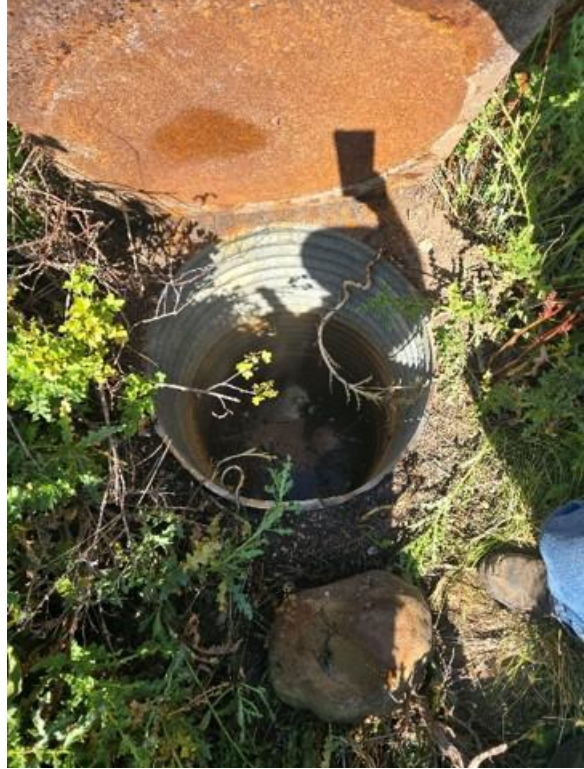
From the cistern, we continued another 0.03 miles (measured by Esri ArcGIS Pro) to the actual POD. This POD consists of a recessed vertical metal culvert covered by a metal lid. Due to standing water, inlet and outlet points could not be confirmed. GPS coordinates were collected for this POD as well.

*Figure 8: Actual POD used to collect water. Unable to see inlet and outlets due to current water inside collection container.*

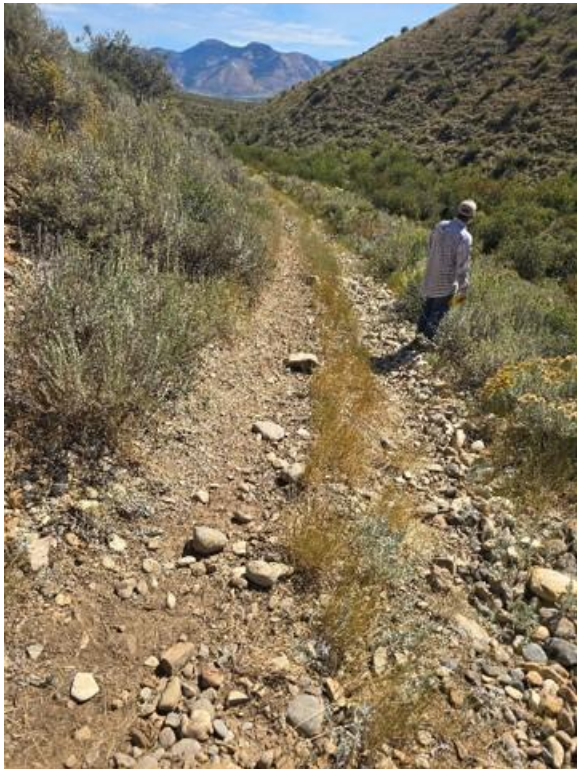
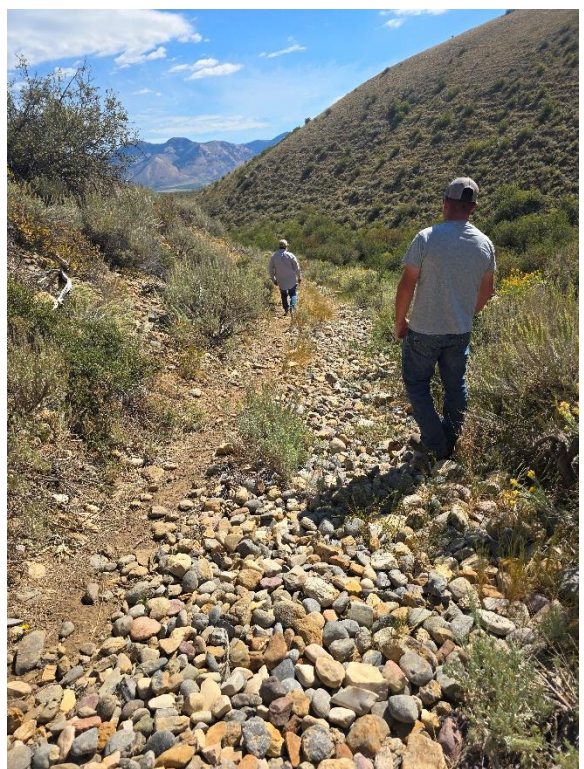
During the return to the fields, a rock-lined depression was observed along the south side of the road resembling a possible ditch. When questioned, Jaren stated that water is piped underground from the cistern to the trough rather than conveyed in an open channel.

*Figure 9 & 10: Roadway leading from the POD to the claimed POU shows a distinct depression on the right side that is filled with rocks. Possible runoff system. Under this area is where the diversion works is buried leading towards claimed POU.*

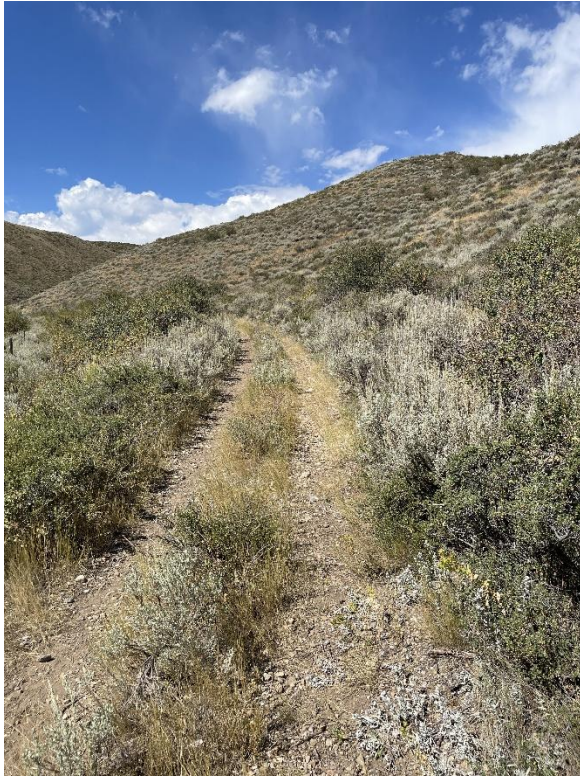
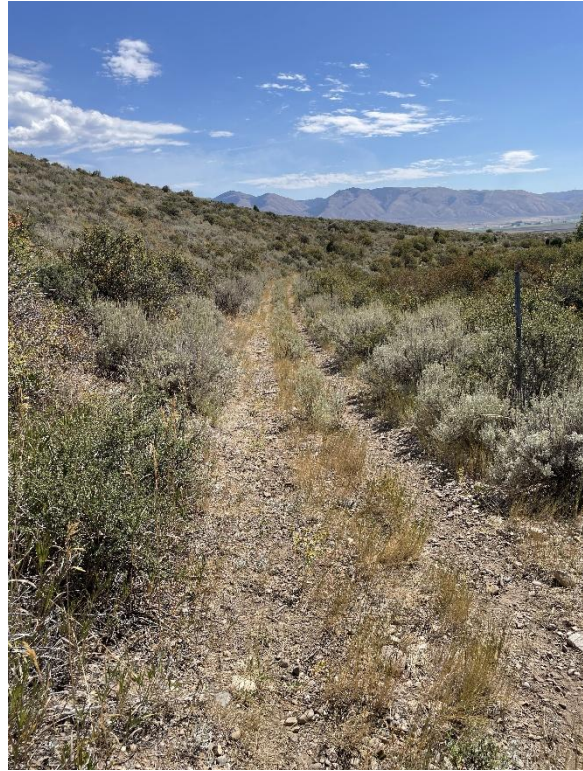
The actual POD is located approximately 0.5 miles (measured by Esri ArcGIS Pro) up the canyon on the right side of the roadway. According to measurements obtained through Google Earth, the slope from the POD to the stockwater trough averages 3.5° (6.12% grade), and from the trough to the homestead averages 2.4° (4.19% grade). These slopes would allow adequate flow by gravity. However, no historic or present-day ditch systems were observed between the POD and the POU's. Given the absence of conveyance channels, diversion structures, and the nature of the terrain, there is insufficient evidence to recommend irrigation use.

Figure 11 & 12: Shows the slop of the path leading towards the POU from the cistern.

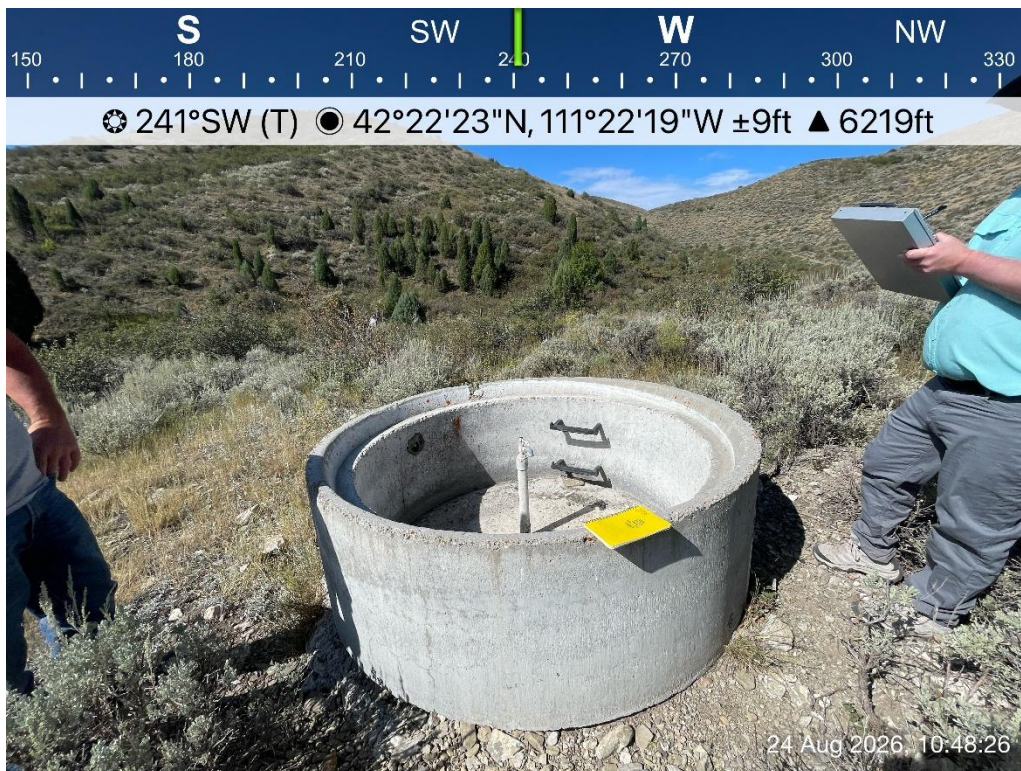
At the Rigby Homestead, we walked approximately 0.23 miles (measured by Esri ArcGIS Pro) along the dirt road to the initially claimed stockwater trough. Jaren informed us that this concrete trough was installed around 1977. The original piped system from the homestead supplied the trough and in 1985, a line from the trough to a hydrant on the homestead was installed to reestablish the historical connection.

Figure 13: Cement stockwater trough.

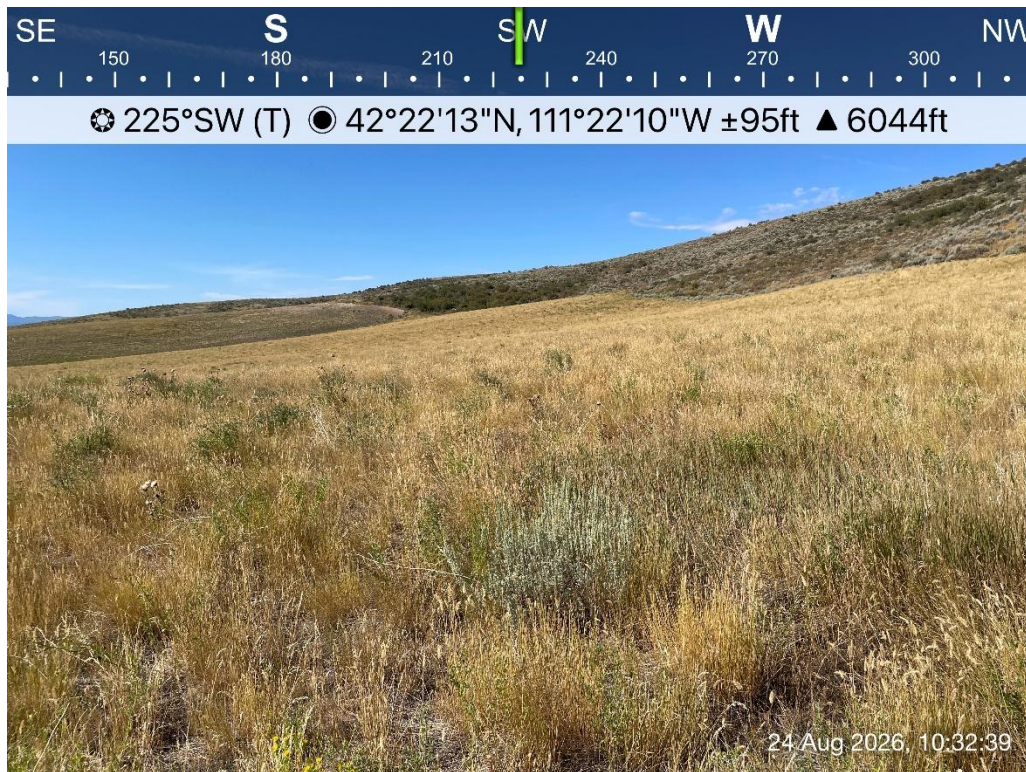
Figure 14: 11-4054 POU from the Rigby homestead looking Southwest.

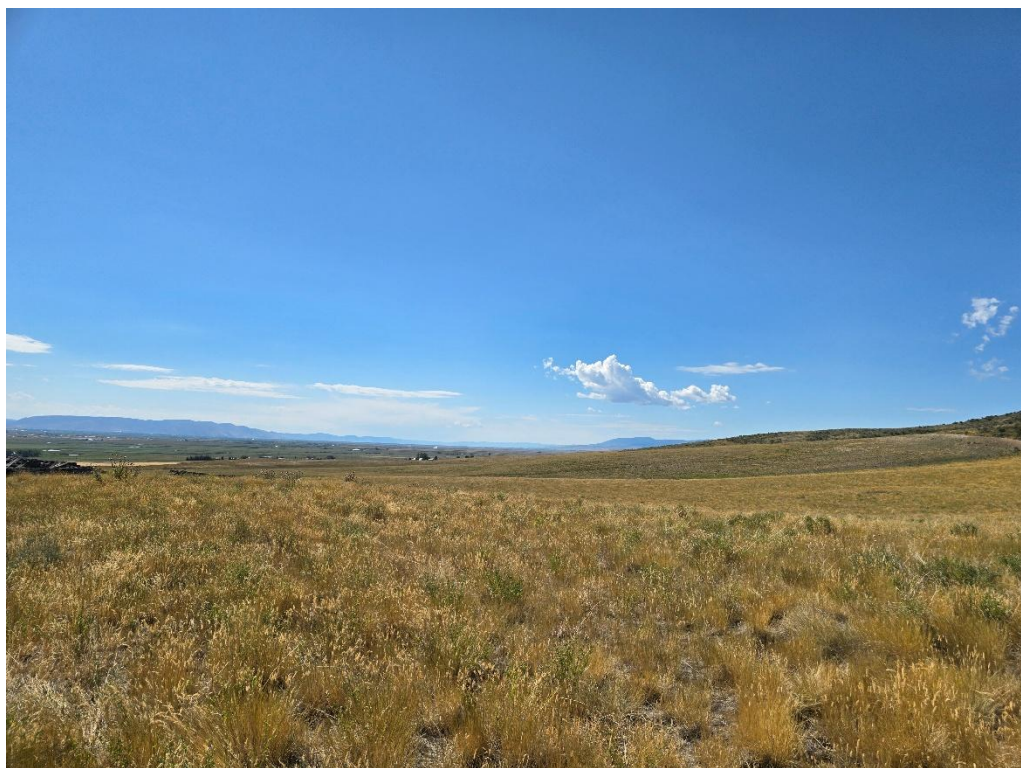
Figure 15: 11-4054 POU from the Rigby homestead looking South.

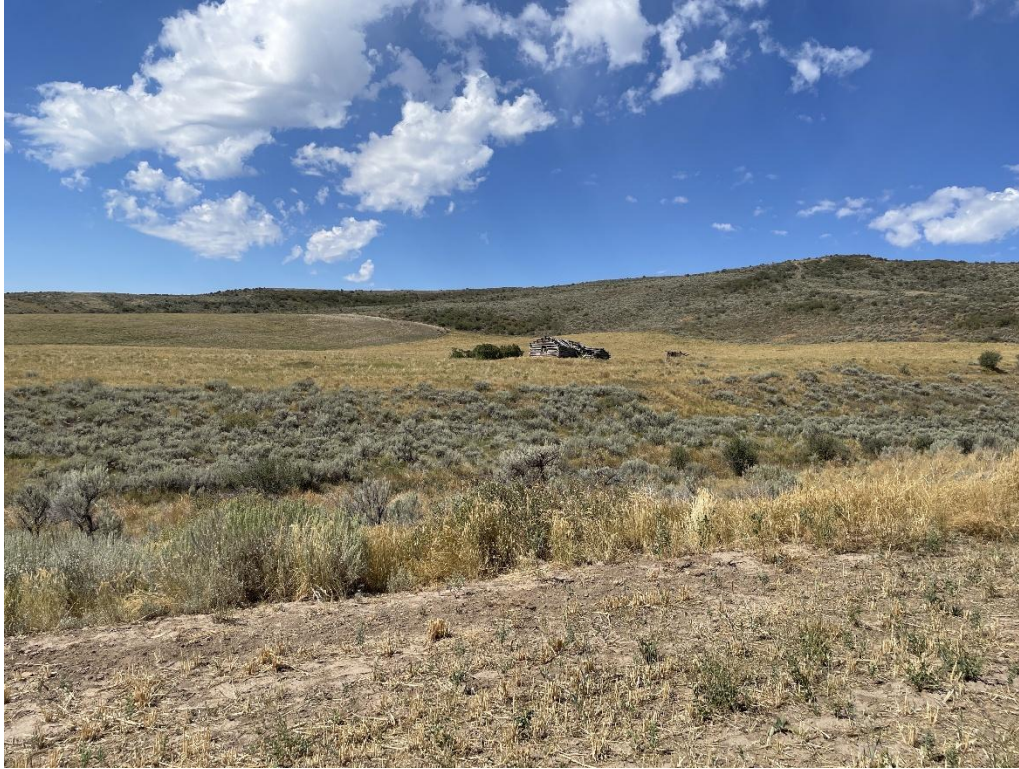
*Figure 16: 11-4054 POU featuring the Rigby homestead.*

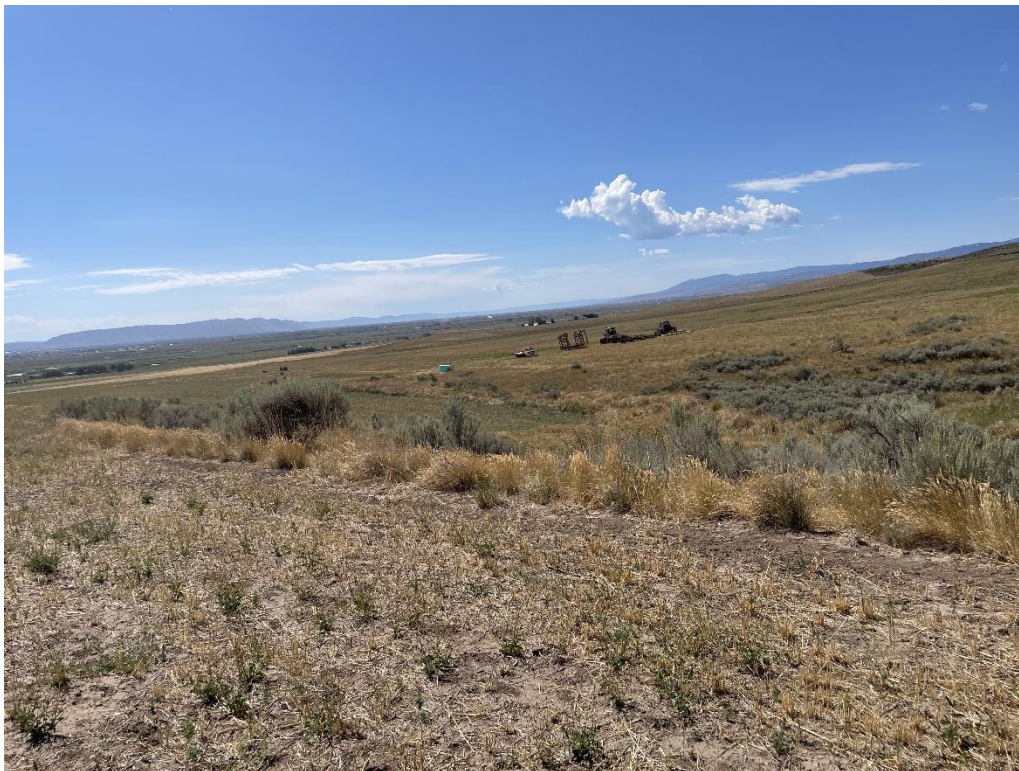
*Figure 17: 11-4055 view of the POU Southwest facing.*

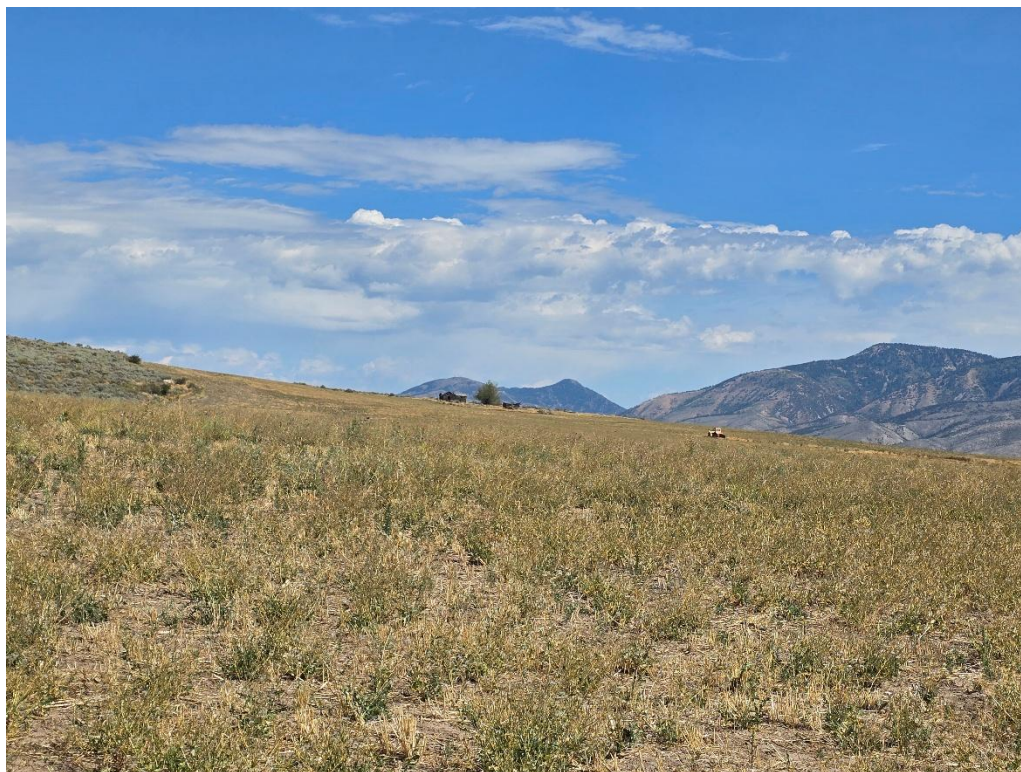
Figure 18: 11-4055 view of the POU Northeast facing.

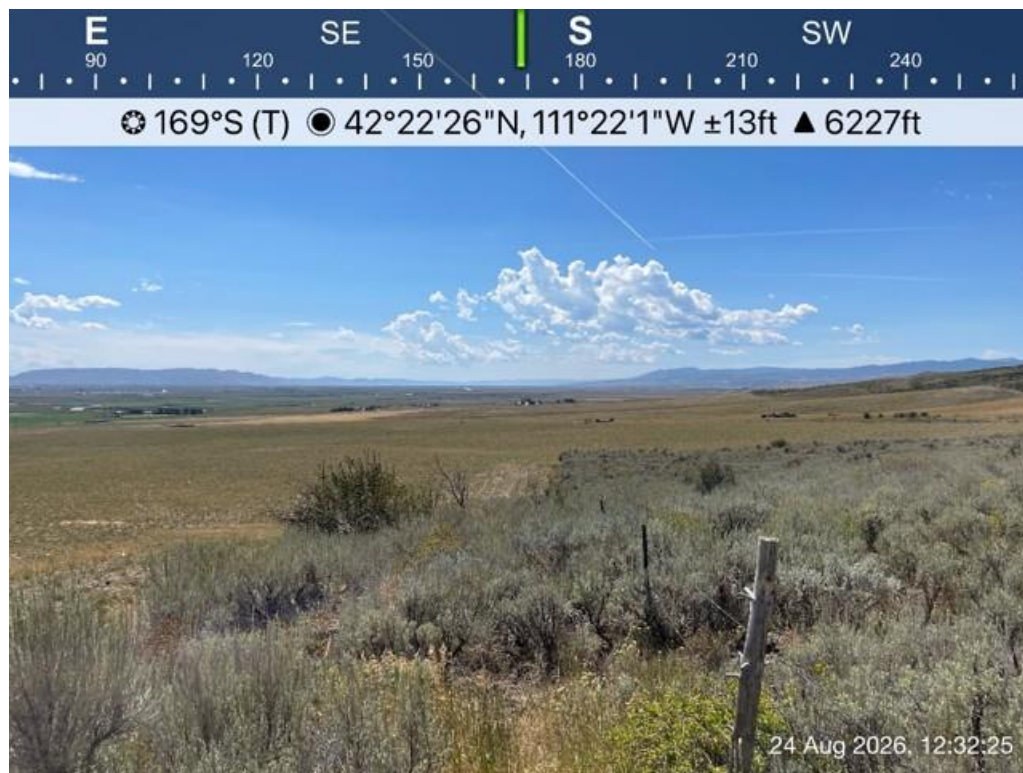
Figure 19: 11-4055 view of the POU South facing.

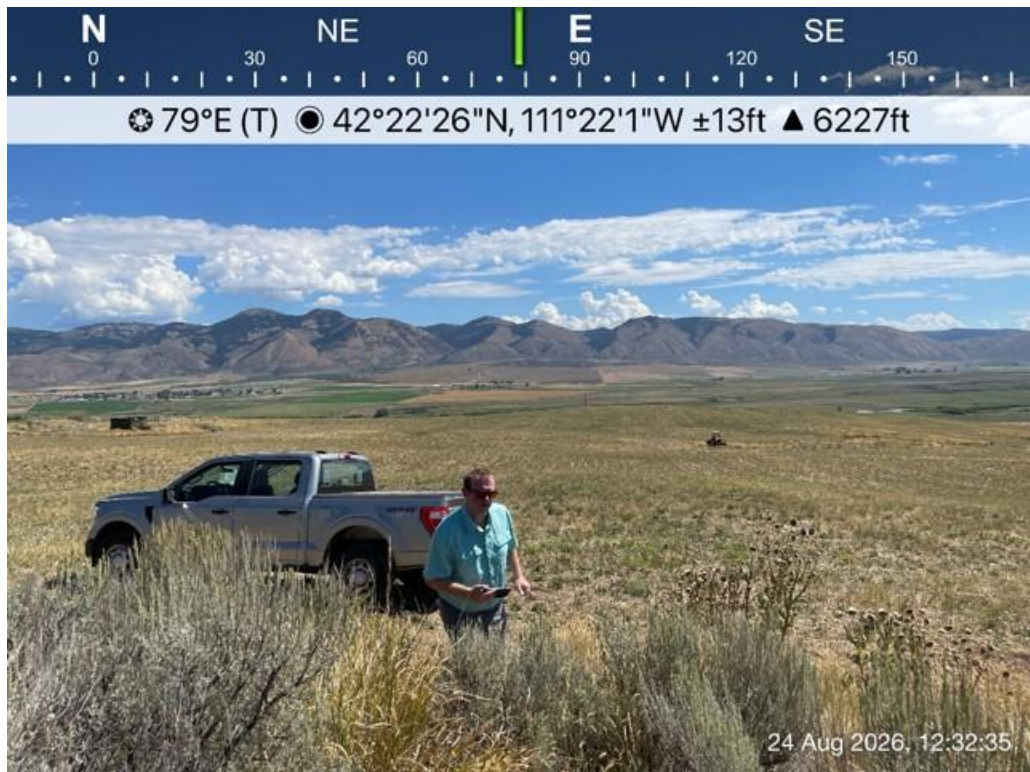
Figure 20: 11-4055 view of the POU East facing looking over the NWNW lot1 QQ.

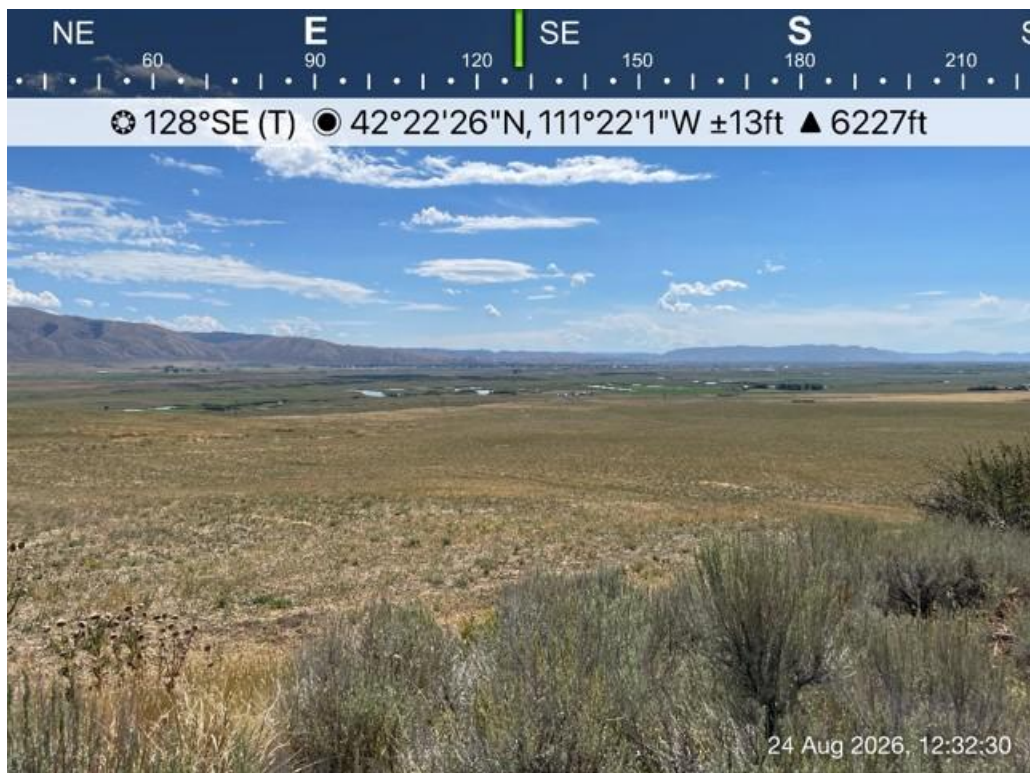
During the drive out, LiDAR imagery suggested a potential historical ditch within the SWNW Lot 2 QQ. Upon physical inspection, the feature appeared to be only a natural swale rather than a constructed ditch.

Figure 21: 11-4055 view of the POU Southeast facing looking over the SWNW lot2 QQ.

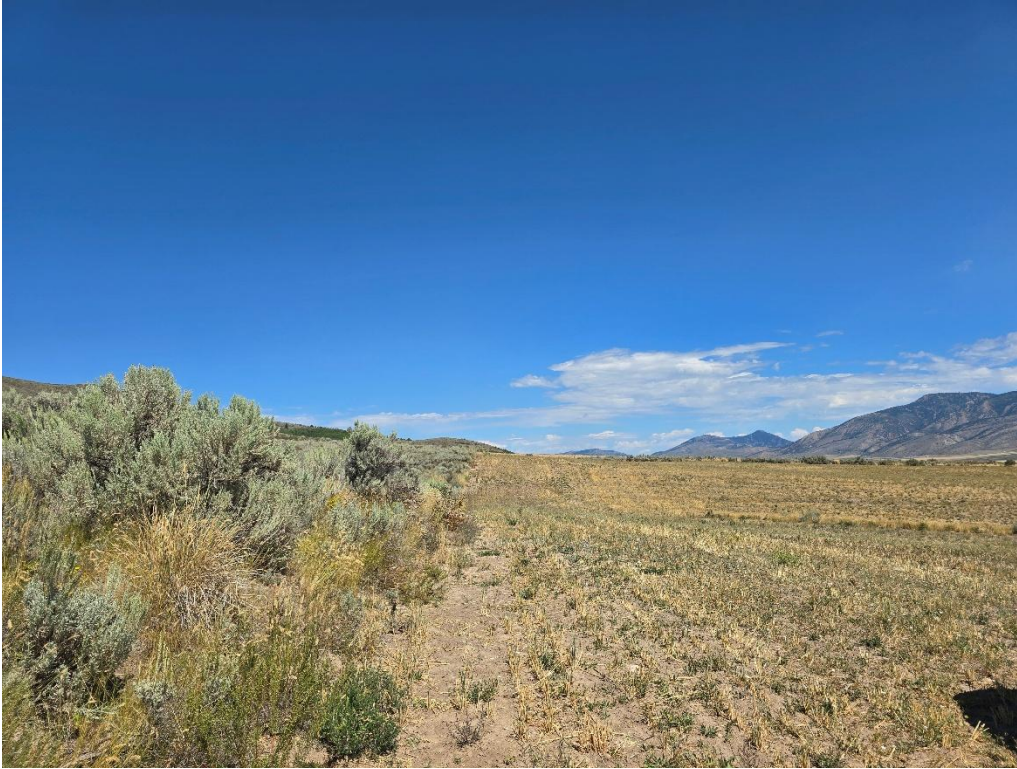
*Figure 22: 11-2079 & 11-4054 view of the overlapping POU in the SWSW lot 4 QQ.*

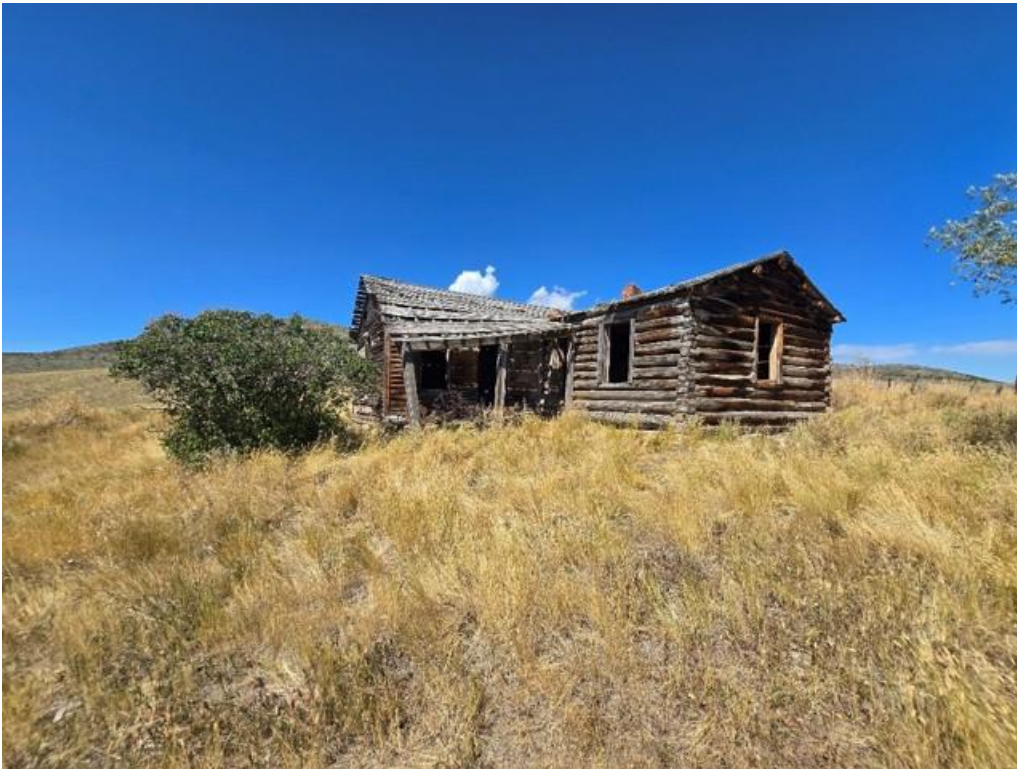
*Figure 23: 11-2079 Domestic structure.*

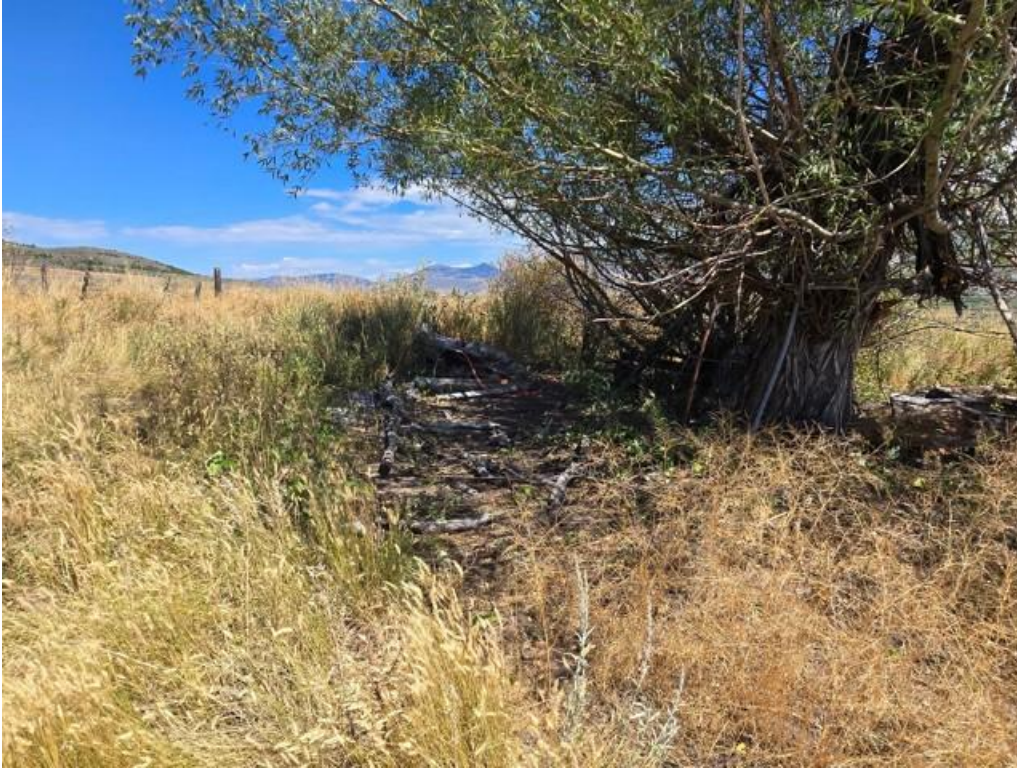
*Figure 24: 11-2079 Diversion inlet for stockwater located next to willow tree.*

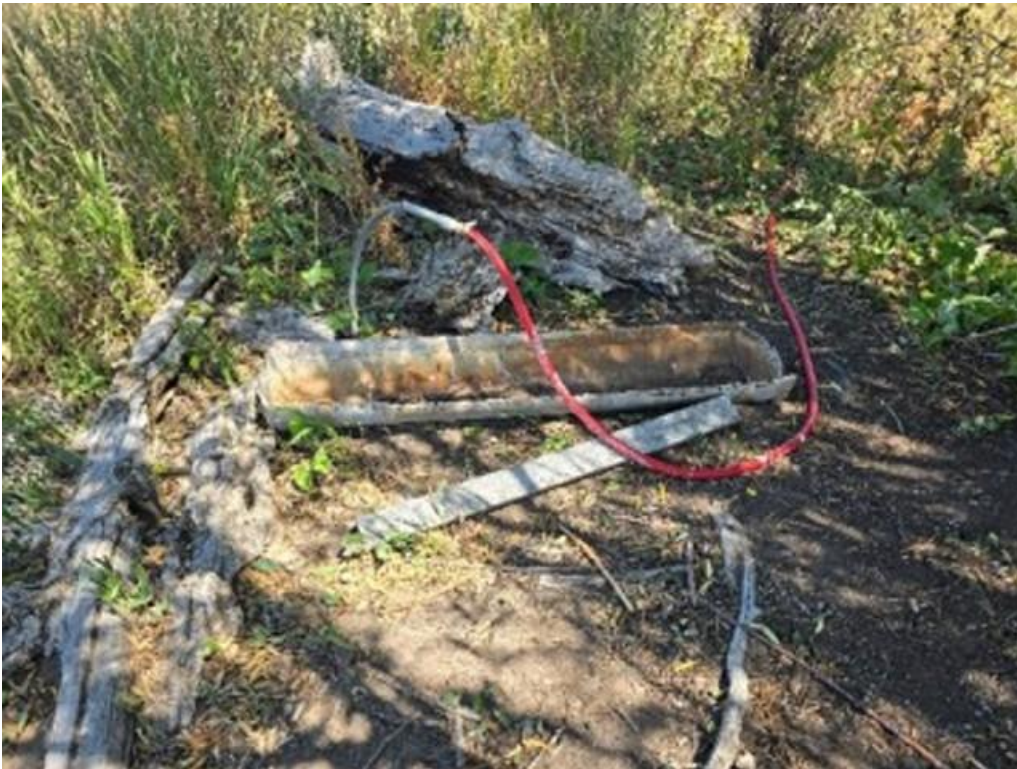
*Figure 25: 11-2079 Diversion system with stock trough and hose leading towards stock area.*

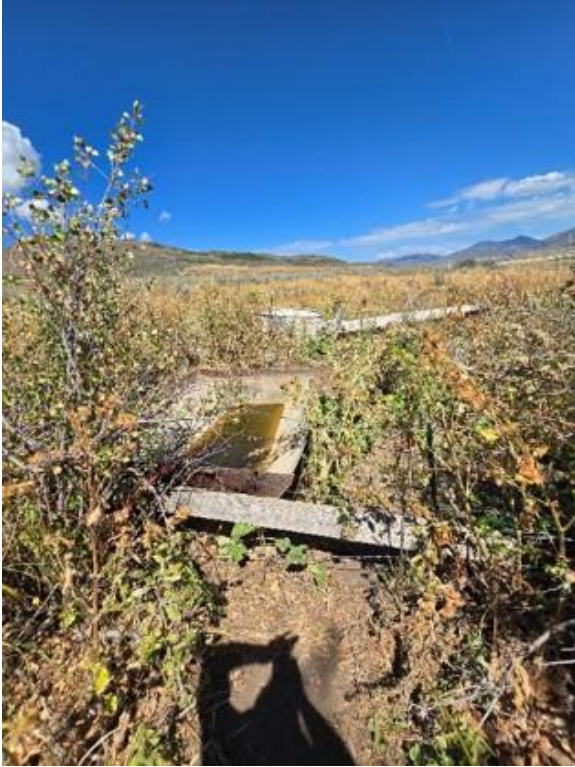
*Figure 26: 11-2079 Stock troughs in stock area behind domestic structure.*

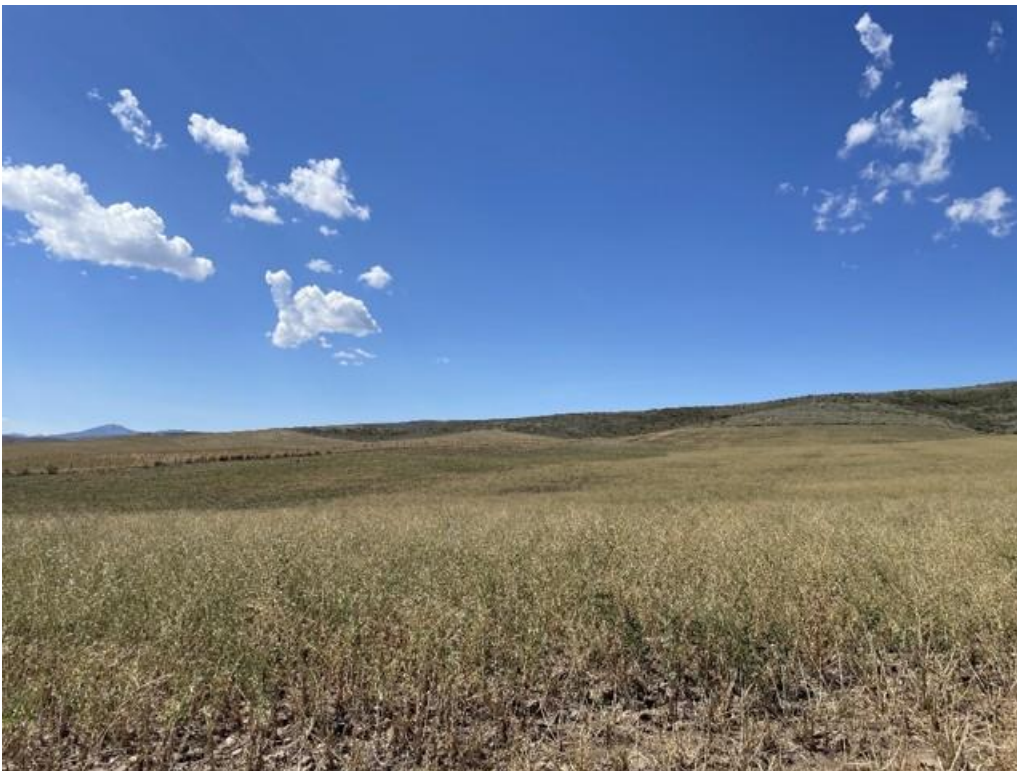
*Figure 27: 11-4055 view of the POU West facing looking over the SENE QQ.*
