IDAHO DEPARTMENT OF  
**WATER RESOURCES**

**BRBA FIELD EXAMINATION REPORT**

**Claim Number:** 11-7583

**Exam Location:** Northern half of 12S 43E 35 NWSE.

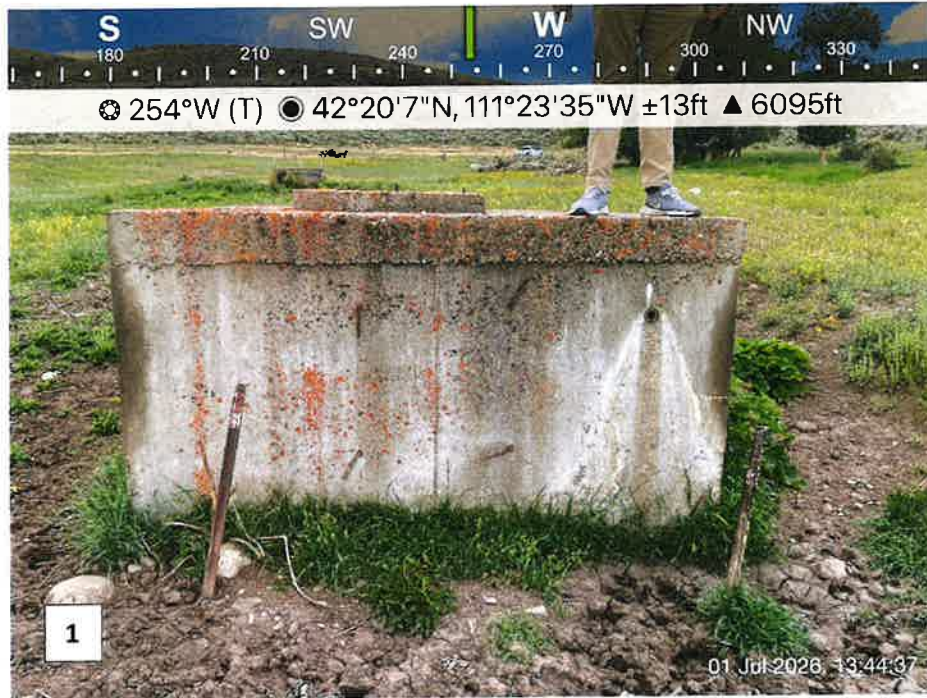
Starting at the above-ground concrete cistern (Photo 1), it was clear that the system had not been in use recently. There was no water present in the system (Photo 2), and it was unclear how water was put to use in the past. The open channel downstream of the cistern was dry (Photo 3).

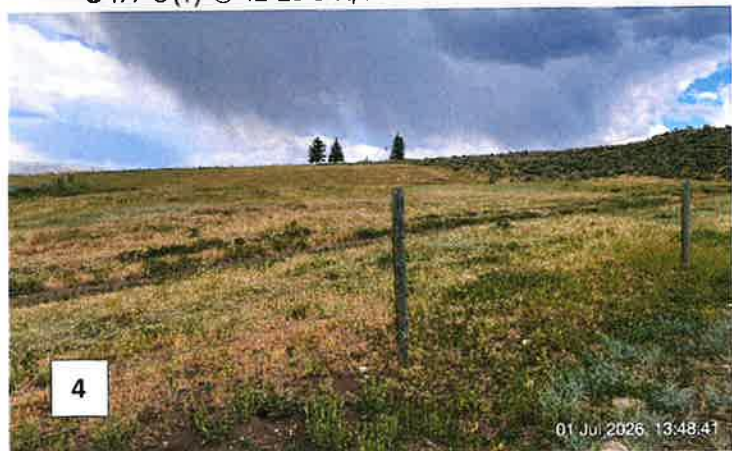
☉ 177°S (T) ☉ 42°20'6"N, 111°23'34"W ±13ft ▲ 6103ft

The land Southeast of the cistern is the claimed POU. Looking South, this land is hilly and slopes upward from North to South (Photo 4). Looking Southeast, the land slopes downward from West to East (Photo 5). Looking Northeast, the land flattens out and slopes downward gently from West to East (Photo 6). The claimed POU would be difficult to impossible to irrigate with the system as described and understood.

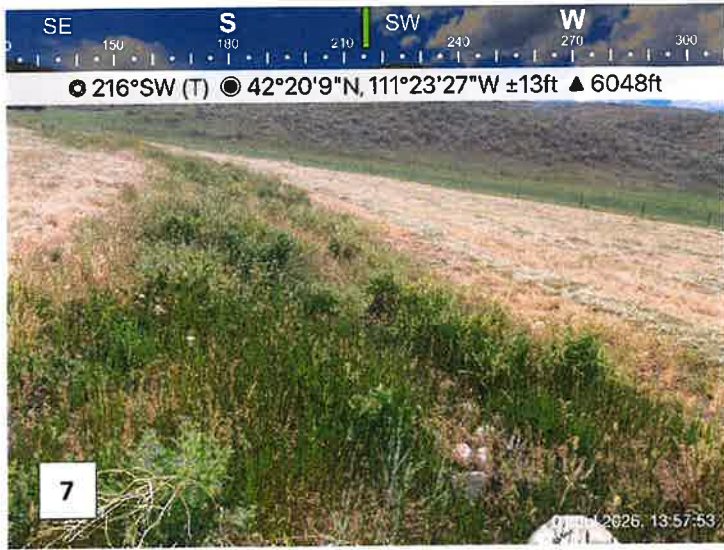
The last set of photos were taken in the field where the channel crosses through. This area is not within the claimed POU. The photos were upslope (Photo 7), downslope (Photo 8), and of unused wheel line parts (Photo 9).
