IDAHO DEPARTMENT OF  
**WATER RESOURCES**

**BRBA FIELD EXAMINATION REPORT**

**Claim Number:** 11-4110,  
11-8117

**Exam Date:** 07/29/2026

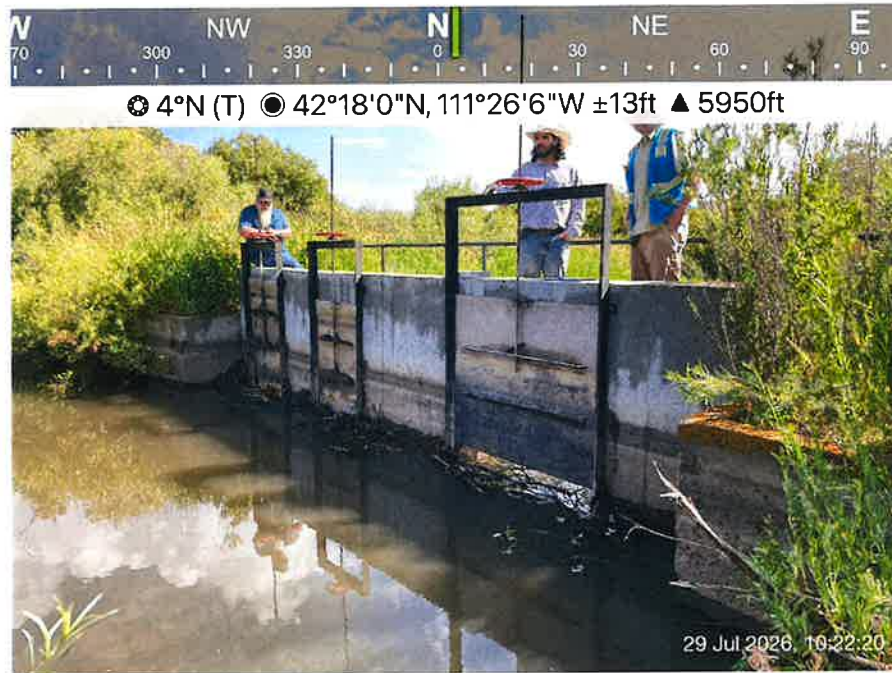
*Photo 1 POD*

First, we went to see the POD, (Photo 1). From the dam we could clearly see the remnants of the old dam, (Photo 2). This new diversion dam was installed in 2016 to replace the old dam, (Photo 3). From the dam you can also see an old channel that has been overgrown, (Photo 4), the water still goes through this channel when backed up, but water mainly goes around it to the west.

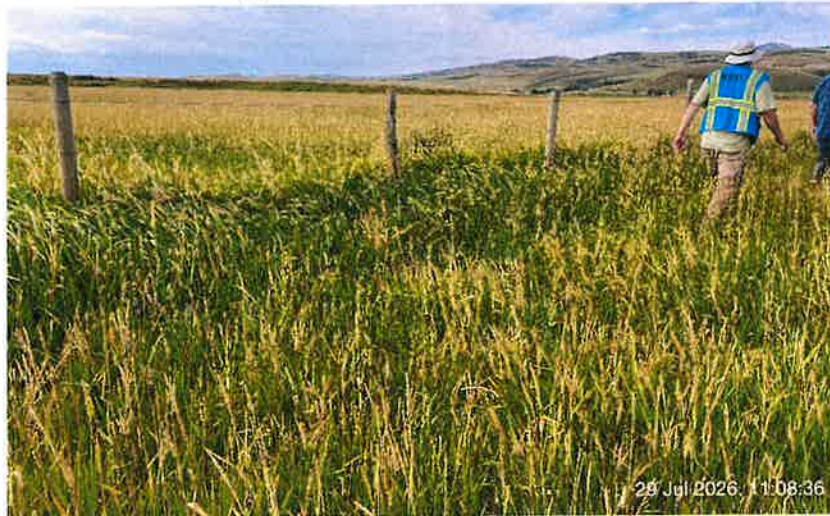
*Photo 5 Check dam*

From the POD we went to see the POU for 11-8117. Dylan showed us where check dams are in place to spread the water, (Photo 5). The east fenceline is raised to act as a berm and spread the water. Then, we went to see where the pump is located for the sprinklers, (Photo 6). The pump area has been dug out and bermed-up to create a pool. The pump was replaced and a new one installed in 2017, (Photo 7). It is an 8-inch line coming from the pump and then 6-inch lines on the wheel lines. Dylan stated that share water is also used to supply the wheel lines, but they only have enough shares to run one line at a time. They have 15 shares and each share is 0.04 cfs per share. This works out to be about 270 GPM, which makes sense why they can only run one wheel line at a time with the share water.

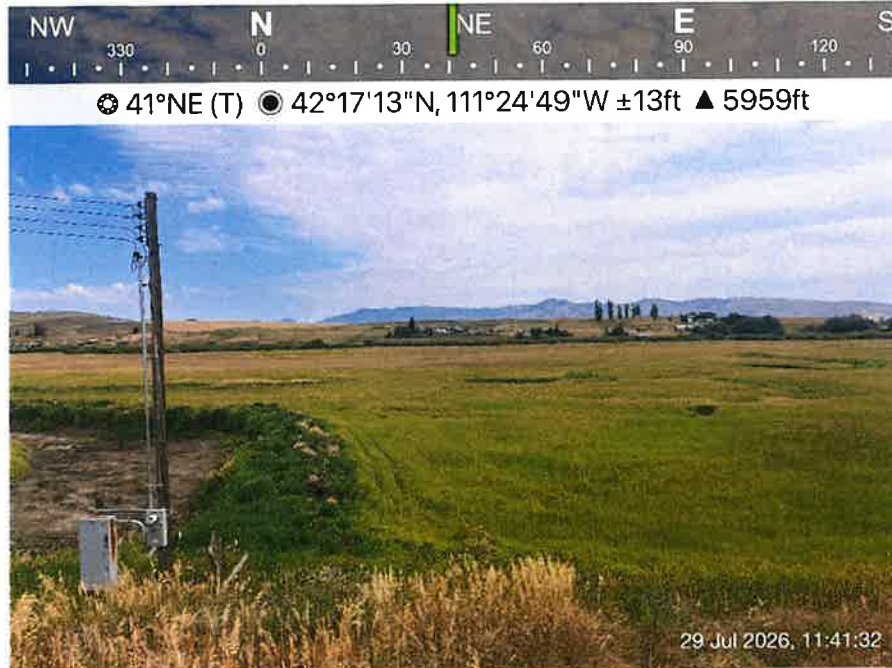
Photo 12

Nothing at either POU was being irrigated at the time due to a low water year and time of year. From the top we could see the entire lower POU, (Photos 12 and 13).
