IDAHO DEPARTMENT OF  
**WATER RESOURCES**

**BRBA FIELD EXAMINATION REPORT**

**Claim Number:** 11-4024B

**Exam Date:** 7/29/2026

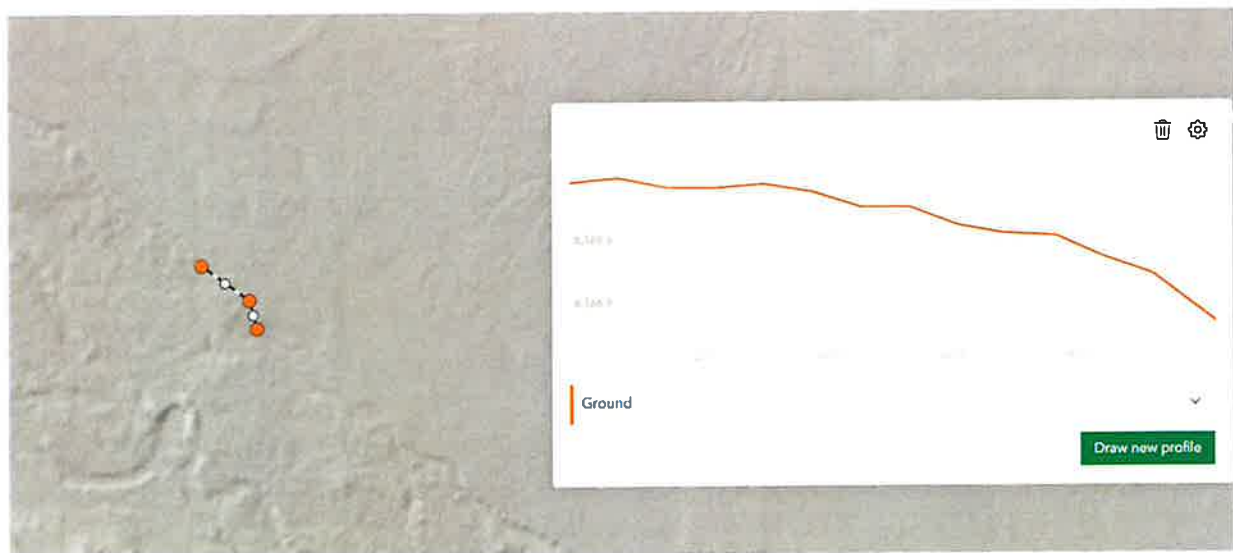
Longer slopes estimated by lidar generally agree with the measurement.

Vertical elevation survey used to verify lidar data

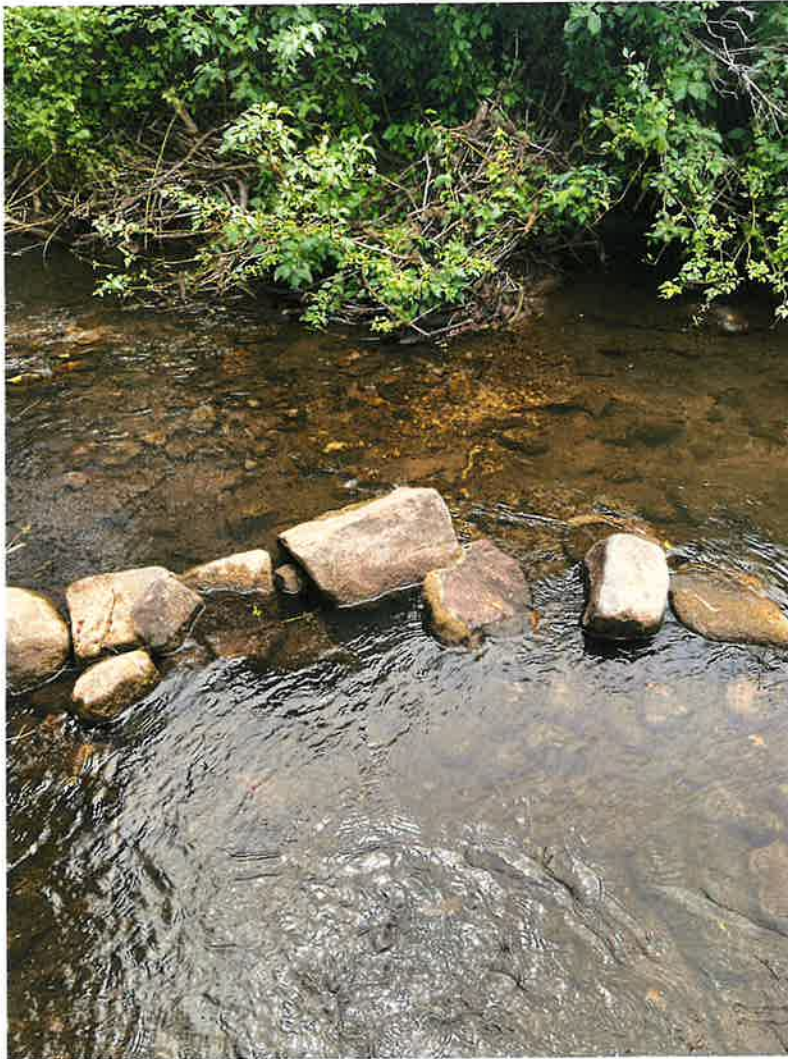
We met Tyler Hymas, Dale Hymas, and Mike Derricott near 551 Old Mill Rd in Ovid. Tyler and Dale took Collin and I down to the POD on Mill Creek. We observed the rock diversion structure in Mill Creek where GPS coordinates and photos were taken.

*Photo 1: Rock diversion on Mill Creek.*

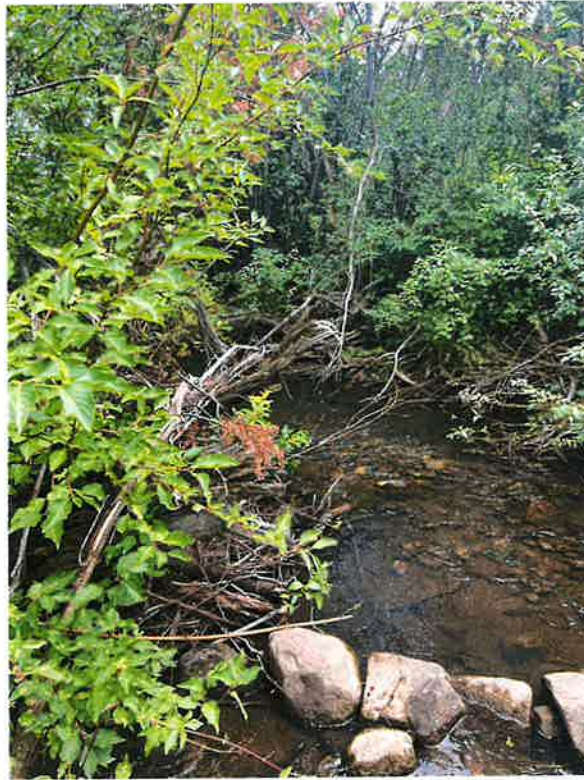
*Photo 2: Mill Creek below POD.*

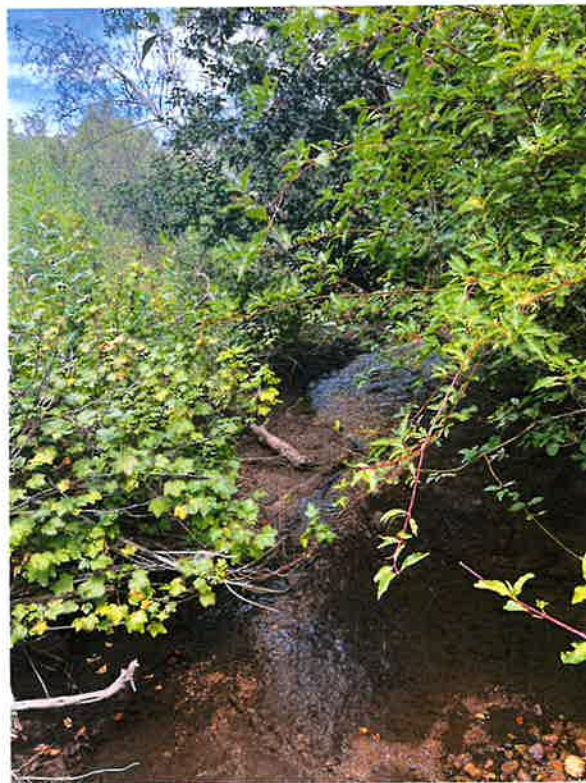
*Photo 3: Liberty Hillside ditch below POD.*

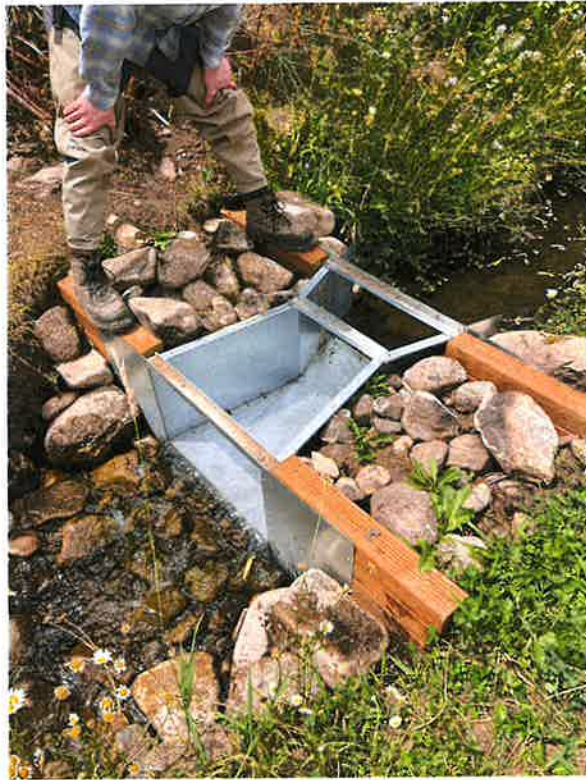
Next, we moved to a location 0.25 miles down the ditch to where a 6 cfs cutthroat flume had recently been installed. An elevation gradient was recorded with an auto level and specifications from the flume were documented.

Flume rated for 6 cfs.

*Photo 4: Cutthroat flume on ditch.*

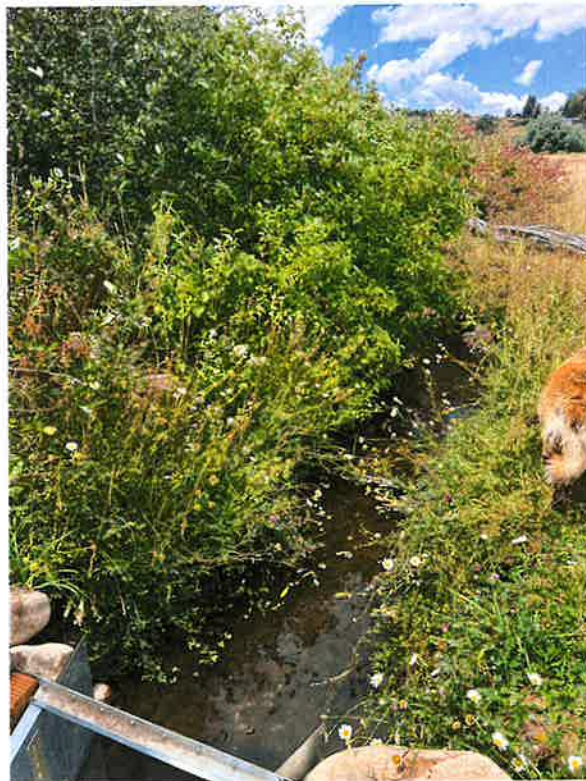
Channel bank erroded where accessible due to stock in the area.

Possibly oversized to due to spring flows as well.

*Photo 5: Ditch upstream of flume.*

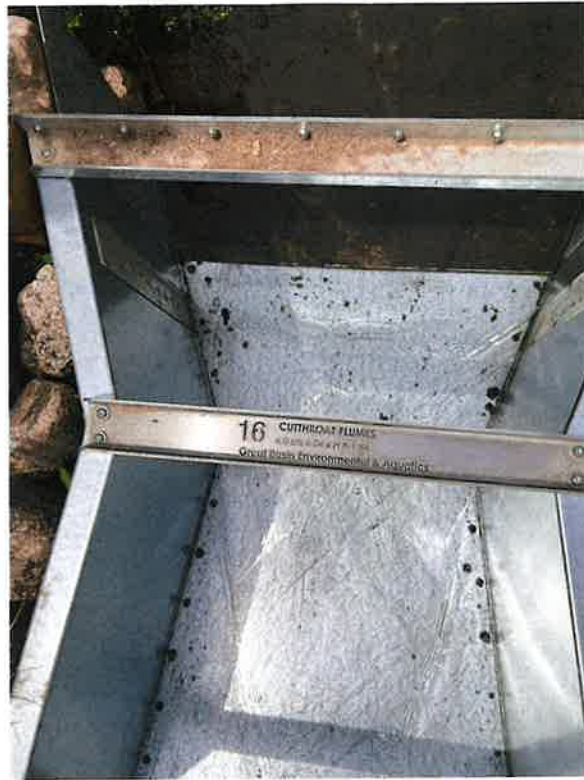
*Photo 6: Flume detail.*

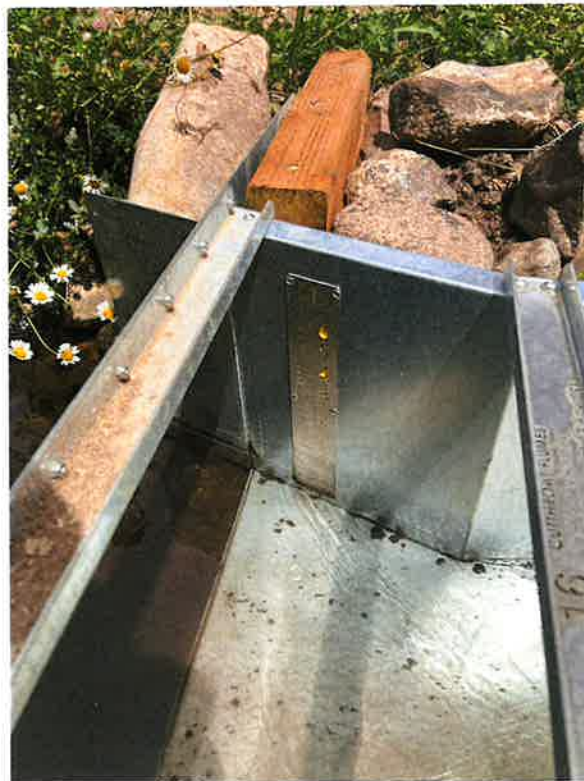
*Photo 7: Flume gauge.*

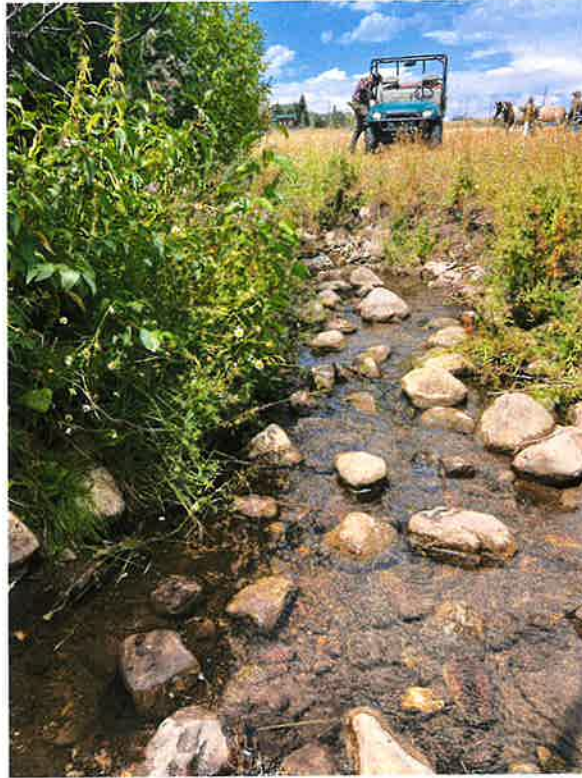
*Photo 8: Ditch downstream of flume, facing upstream.*

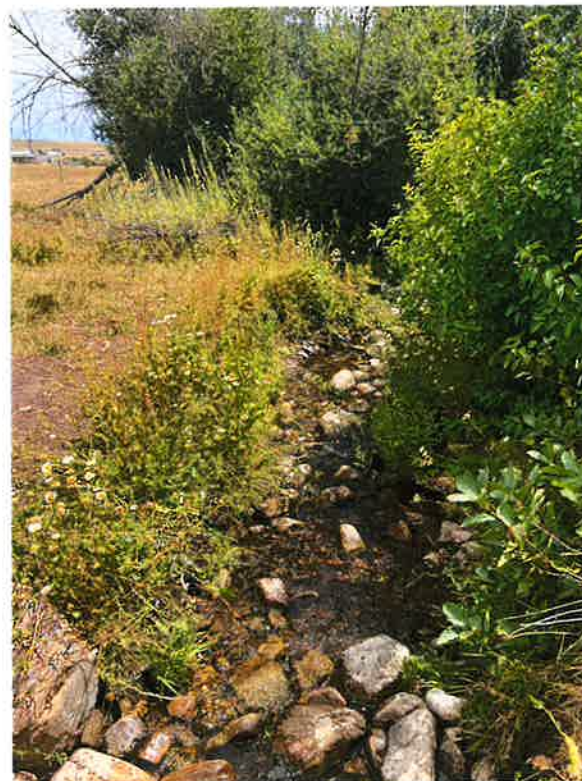
*Photo 9: Ditch downstream of flume, facing downstream.*
