IDAHO DEPARTMENT OF  
**WATER RESOURCES**

**BRBA FIELD EXAMINATION REPORT**

**Claim Number: 11-300**

**Exam Location: Fields Northeast of 1788 Stauffer Canyon Road.**

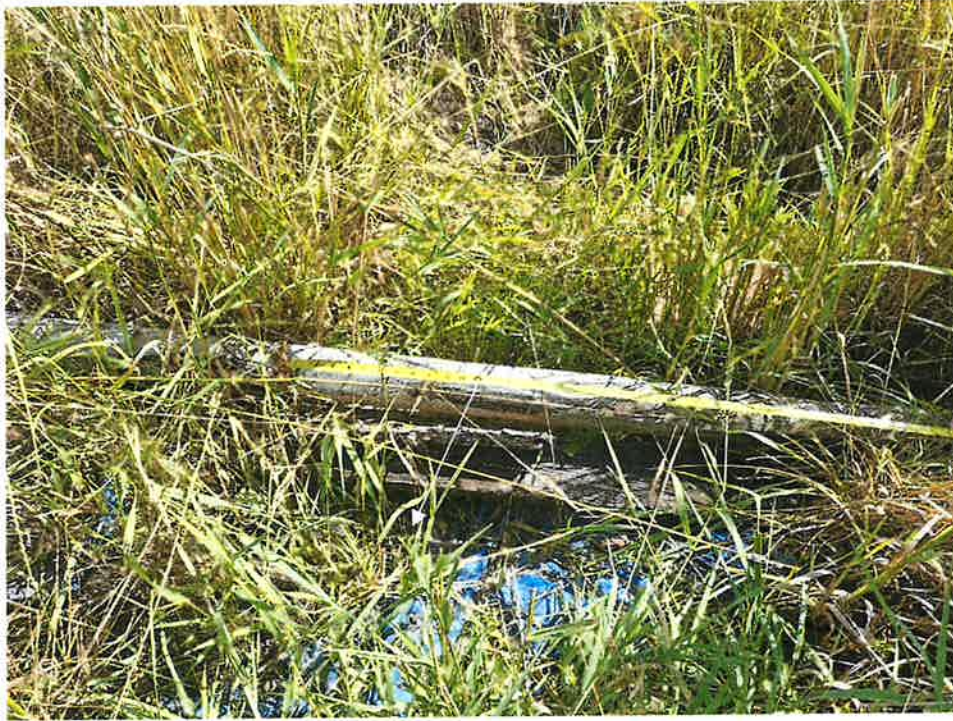
The first two diversion structures encountered are shown in Figures 1–3. One diversion consists of a tarp used to impound water and direct flow into a ditch running east. The second diversion is a culvert accompanied by boards that can be used to dam the culvert and redirect water into a series of ditches extending north and northeast.

*Figure 1: Diversion into the ditch appears to be achieved by placing a tarp in Stauffer Creek to temporarily impound and redirect flow.*

Figures 1–5, 7, and 8 are being recommended as the points of diversion. Because the claimant has not responded to requests for additional information, these recommendations reflect the best determination agents were able to make based on the field observations available.

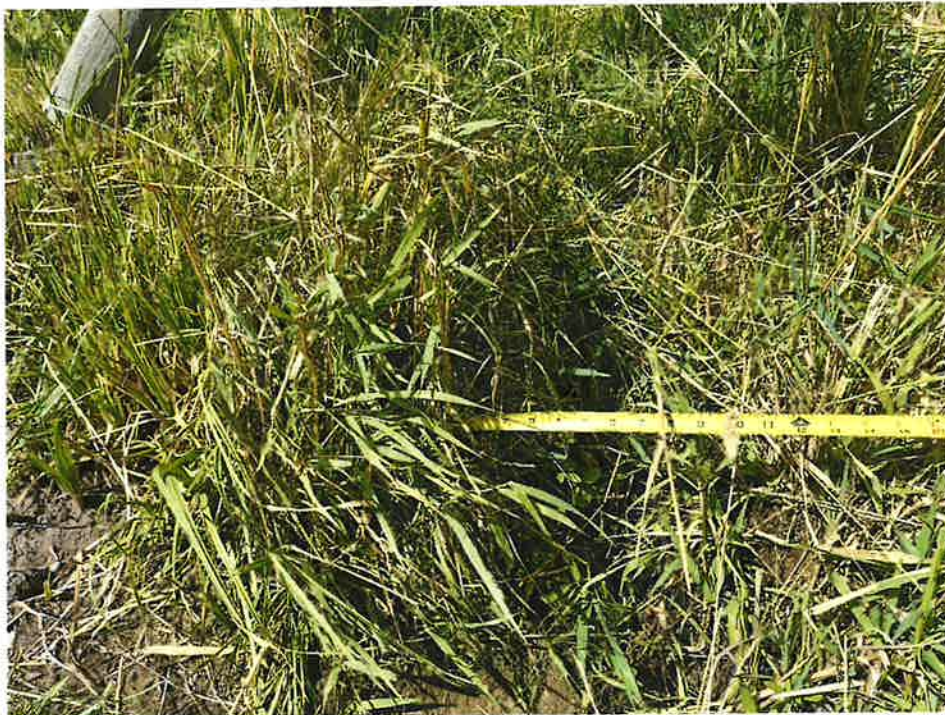
*Figure 2: The ditch that water is diverted to by the diversion in Figure 1.*

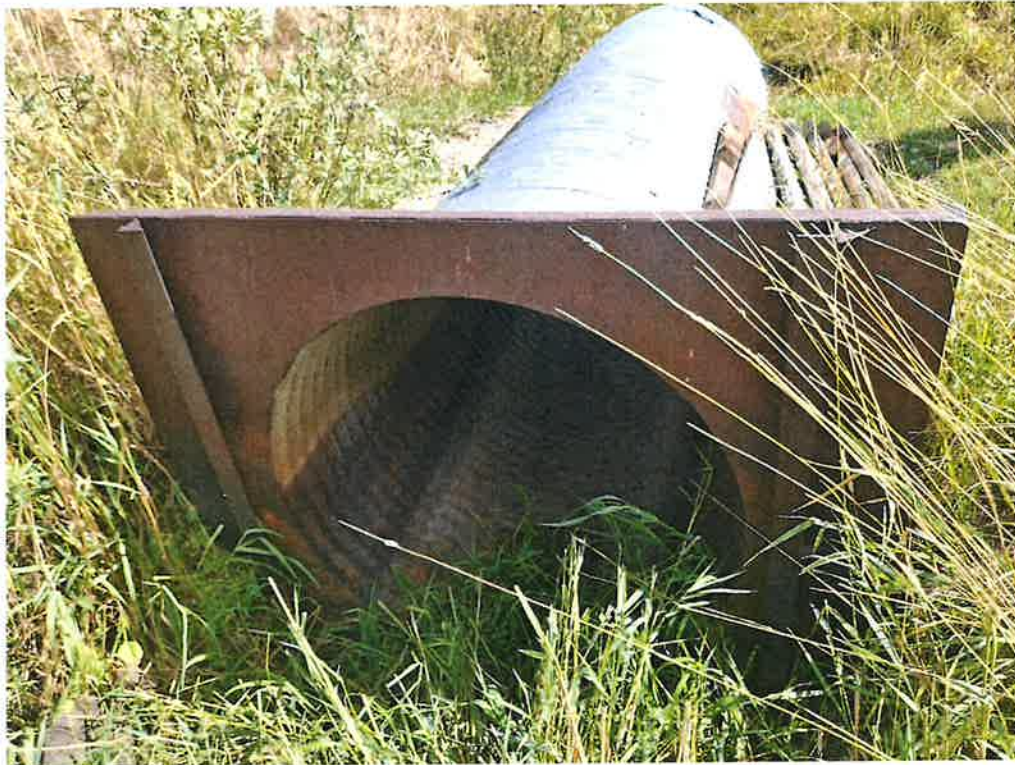
*Figure 3: Culvert diverts water from Stauffer Creek into ditches.*

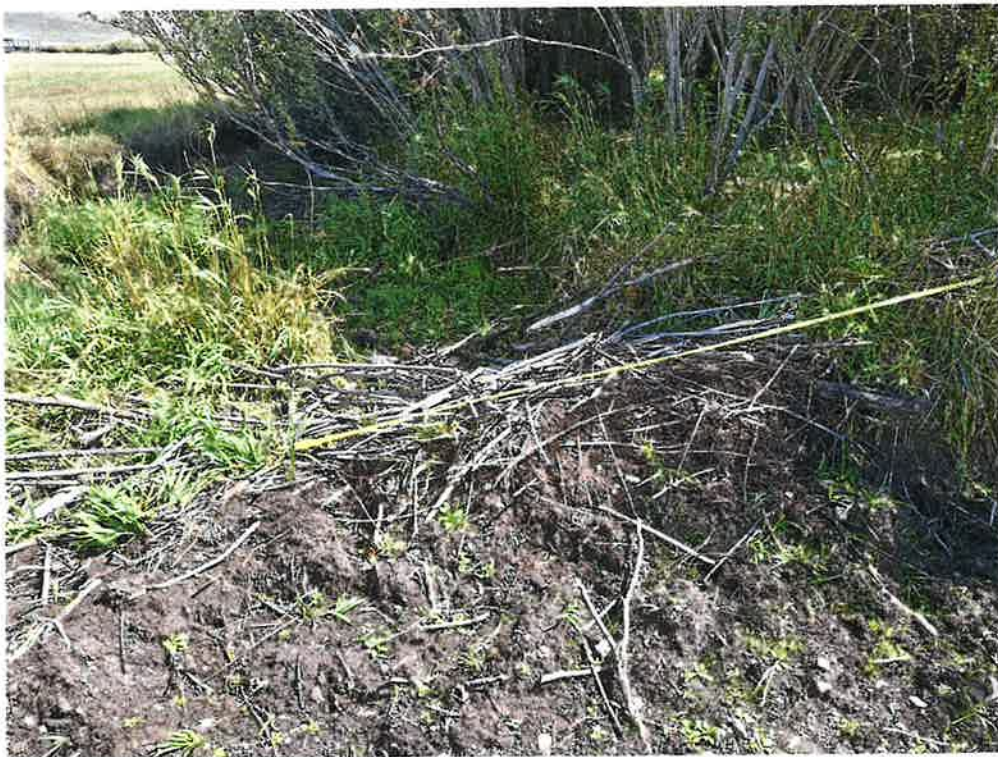
Further downstream, agents located a check dam constructed of willows and mud (Figure 4). Continuing along the creek, agents arrived at a cement structure housing three pipes, each conveying water in a different direction (Figure 5). Metal plates found nearby could be used to block or regulate flow through each pipe, directing water into associated ditch systems. Another check dam, also built from mud and willow sticks, was identified shortly downstream (Figure 6). Its purpose was unclear, as no adjacent ditch was present. It is possible that this feature was intended to back water up the creek to another diversion point. Due to its uncertain function, this location is not being recommended as a point of diversion.

*Figure 4: Check dam that diverts Stauffer Creek.*

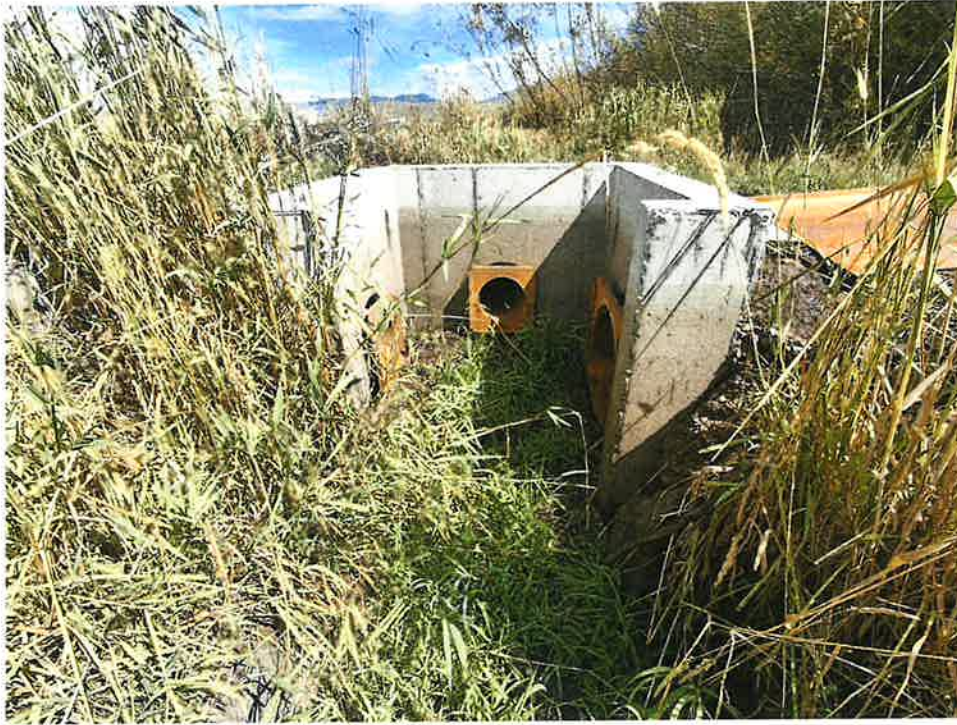
*Figure 5: Cement diversion from Stauffer Creek.*

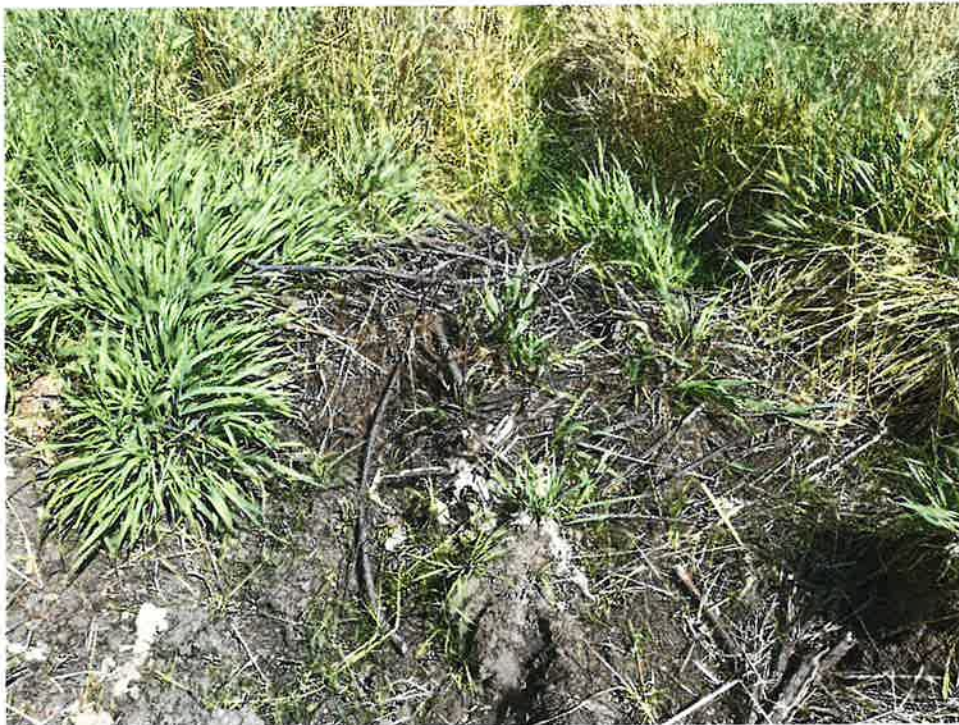
*Figure 6: Check dam that backs the water from Stauffer Creek.*

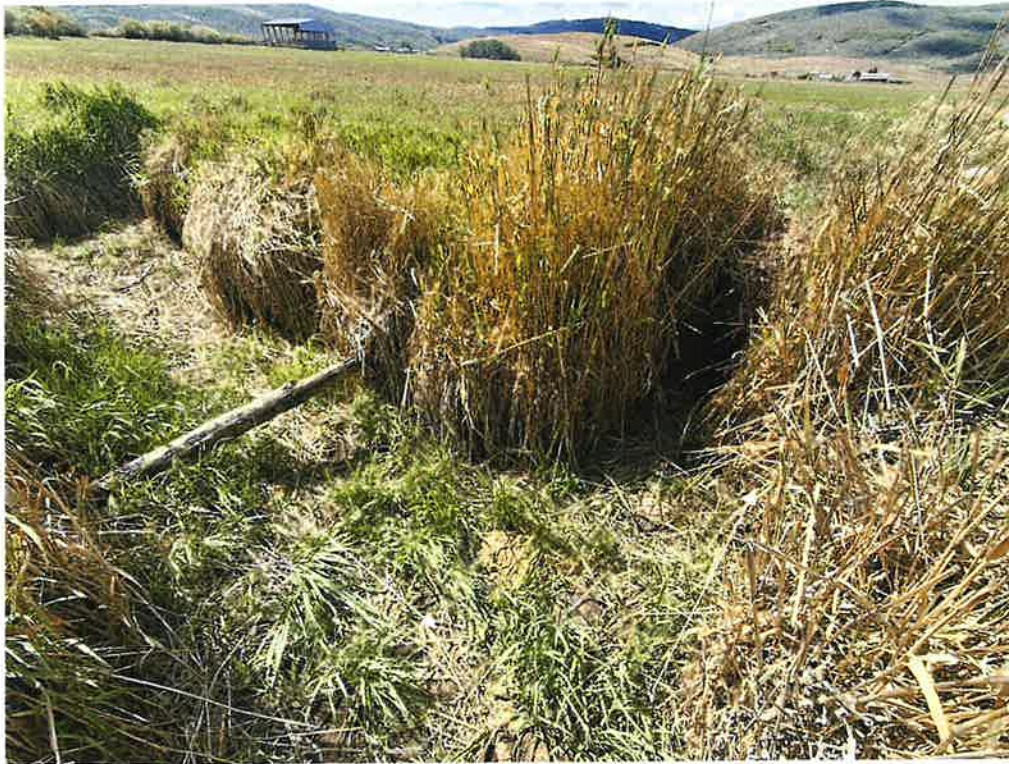
At the furthest downstream diversion site identified, agents observed several indicators of diversion activity but were unable to determine the exact diversion method (Figures 7 and 8). A prominent stick protruding from the creek bed likely served as a marker indicating where the creek should be dammed, and a pipe situated nearby appeared positioned to receive diverted flow.

*Figure 7: A clear point of diversion, but it is not apparent how the claimant pushes the water from Stauffer Creek to a pipe.*

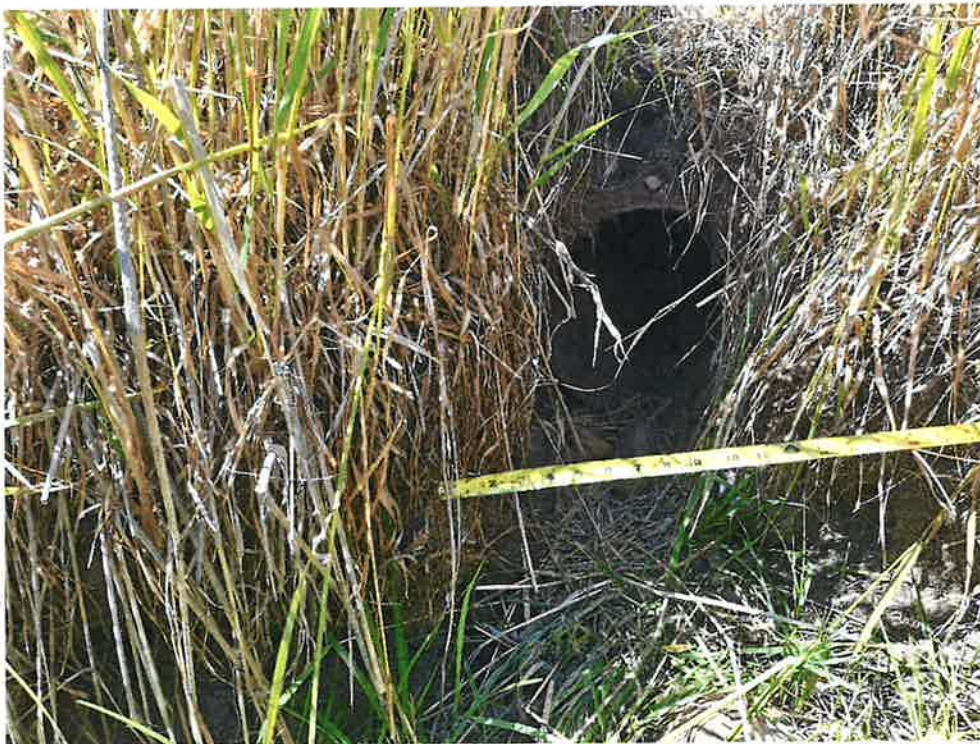
*Figure 8: Pipe that water is pushed into from Figure 7.*

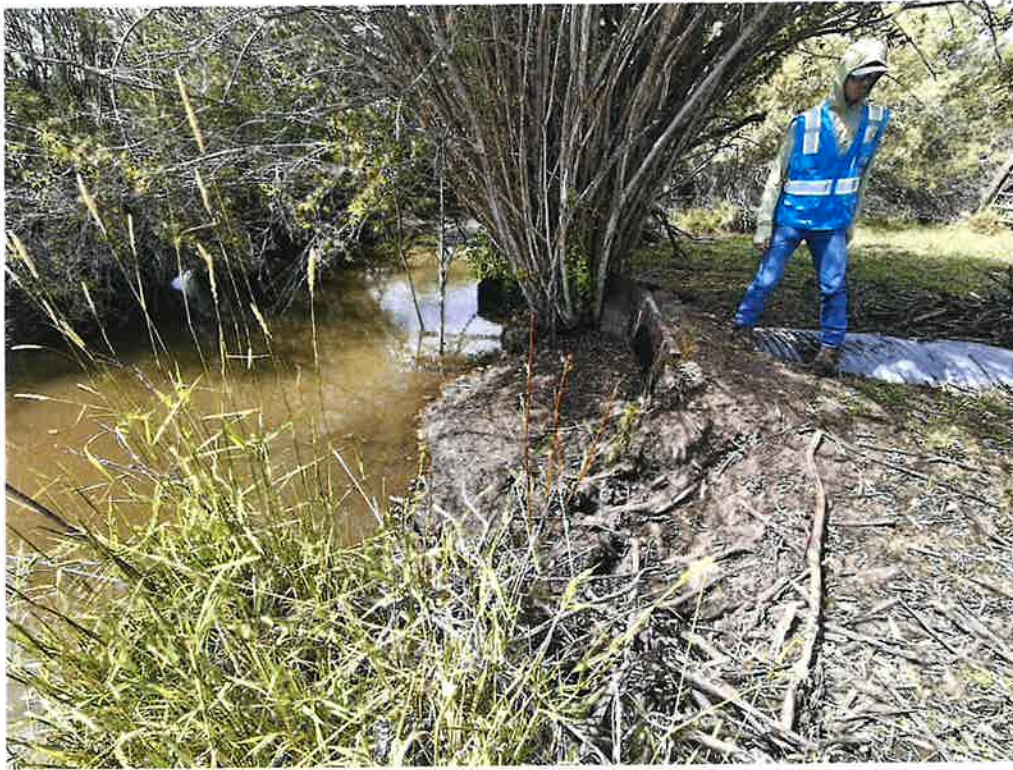
Agents then inspected the final claimed point of diversion referenced by the claimant (Figure 9). No evidence of a ditch leading from this location to the claimant's place of use was observed. As a result, this claimed point of diversion is not being recommended.

*Figure 9: Furthest claimed diversion. No ditch was found running to POU.*
