IDAHO DEPARTMENT OF  
**WATER RESOURCES**

**BRBA FIELD EXAMINATION REPORT**

**Claim Number:** 11-4219

**Purpose of Exam:** Verify PODs, diversion works, and POU. Take diversion measurements if possible.

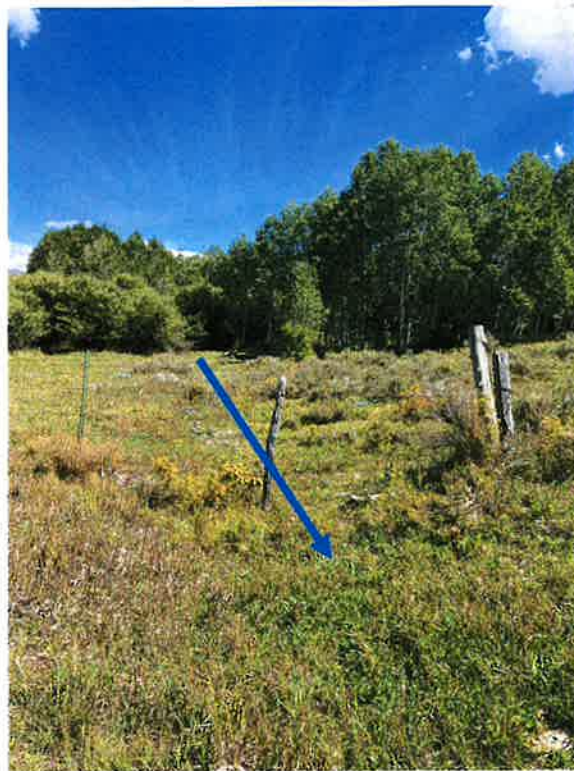
*Photo 1: Old original ditch, not on claim, looking east.*

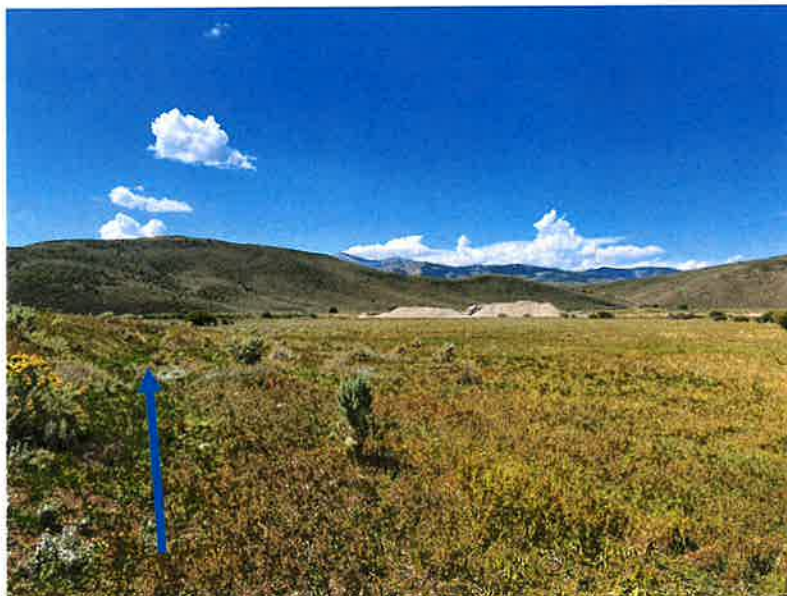
*Photo 2: Old original ditch, not on claim, looking west.*

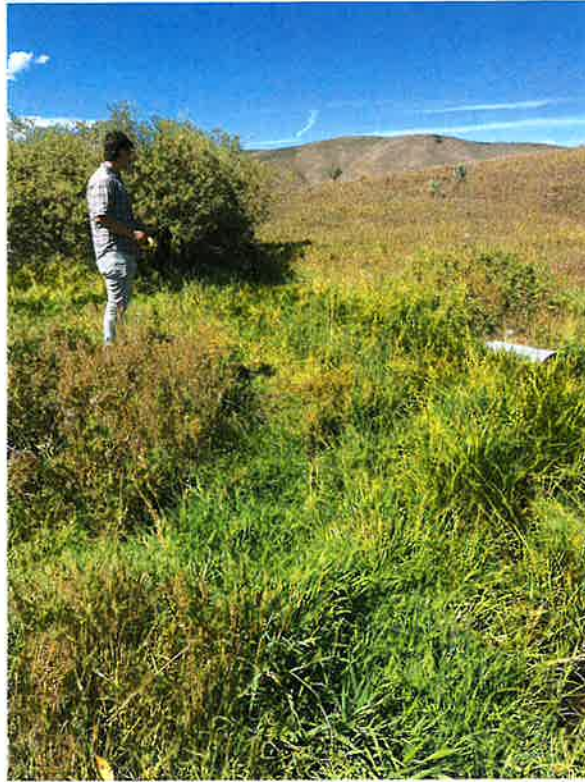
Brent and I entered the property by driving eastward along the south side of the POU. We parked the truck near the eastern fence line on the south side of the unnamed stream. We saw two man-made ditches that would have been used to move water from east to west on the south side of the unnamed stream. Neither of the ditches appeared to be maintained or put to use recently. We were able to identify the lower POD on the natural stream. We stopped and took photos and measurements at this location. This POD did not appear to be maintained, used, or in working order.

*Photo 3: Diversion for south field.*

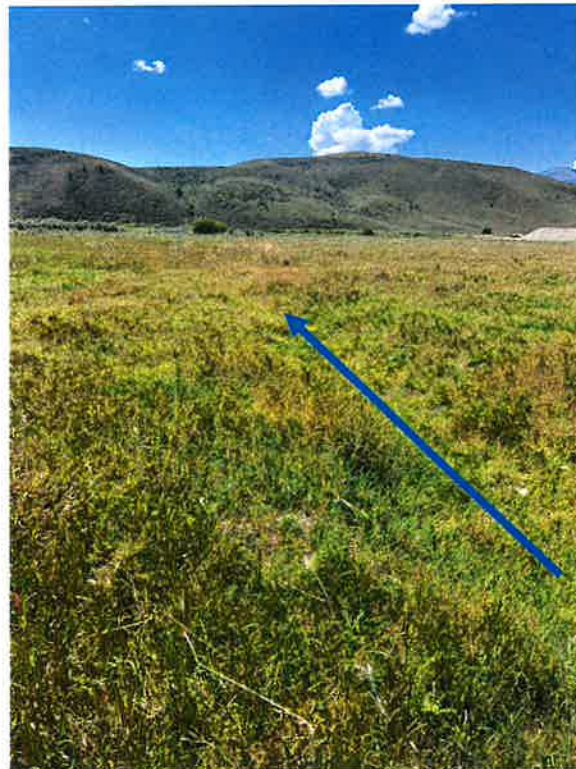
*Photo 4: Main trunk of south ditch.*

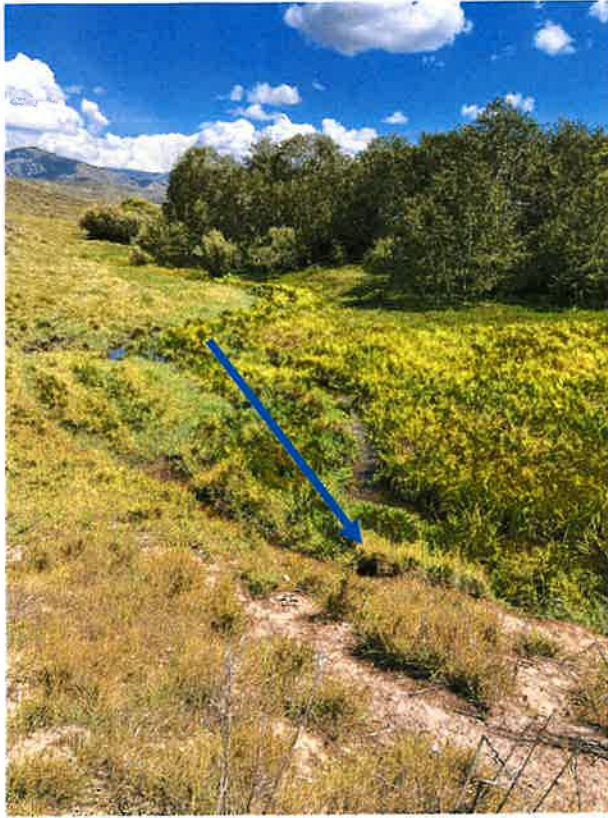
We crossed over the eastern fence line and walked up to the on-stream dam. Water flow through the dam is carried by one culvert about 18 to 24 inches in diameter that was not constricting the flow of water whatsoever. There was nothing in place to impound the water and the dam was completely intact. We walked downstream from the dam to locate the upper POD that was historically used to irrigate the POU north of the unnamed stream. When we arrived at this POD, we took photos and measurements. This POD did not appear to be maintained, used, or in working order.

*Photo 5: Standing on dam looking upstream.*

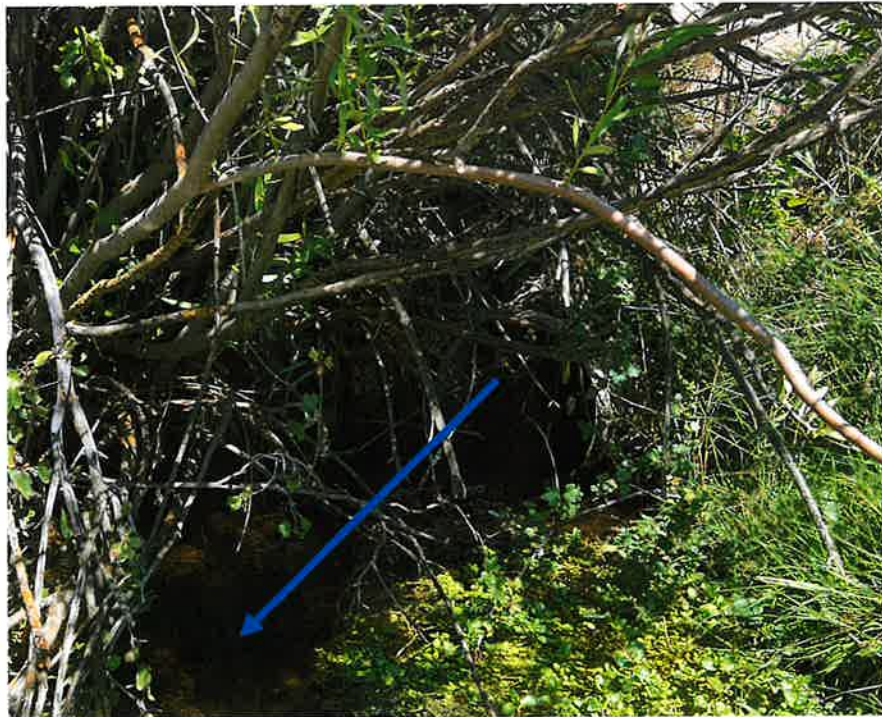
*Photo 6: Culvert through bottom of dam.*

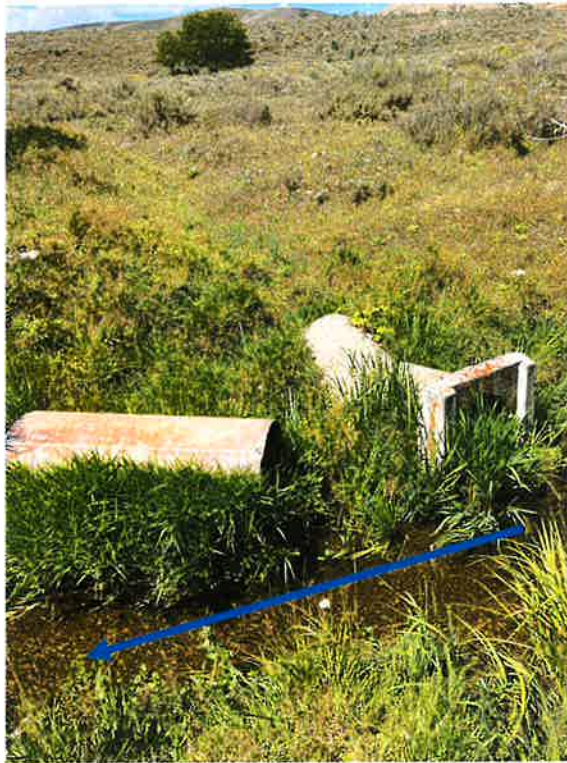
*Photo 7: Diversion for north field.*

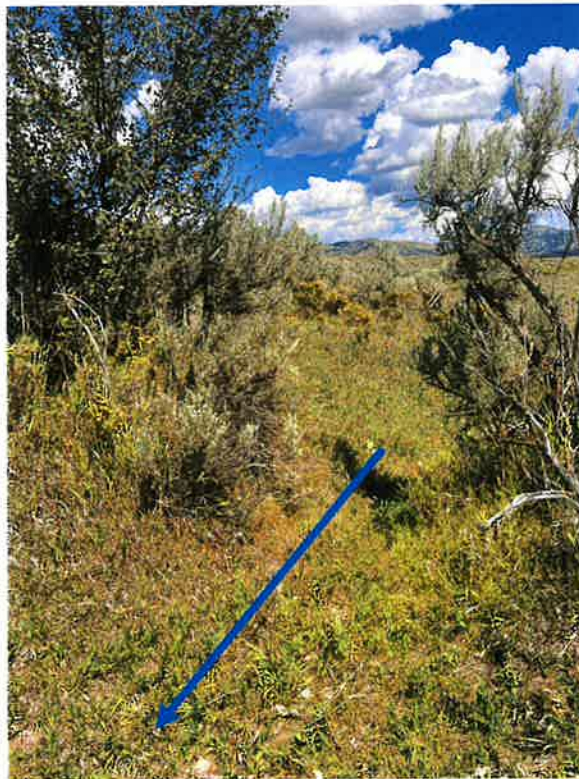
*Photo 8: Ditch for north field looking east.*

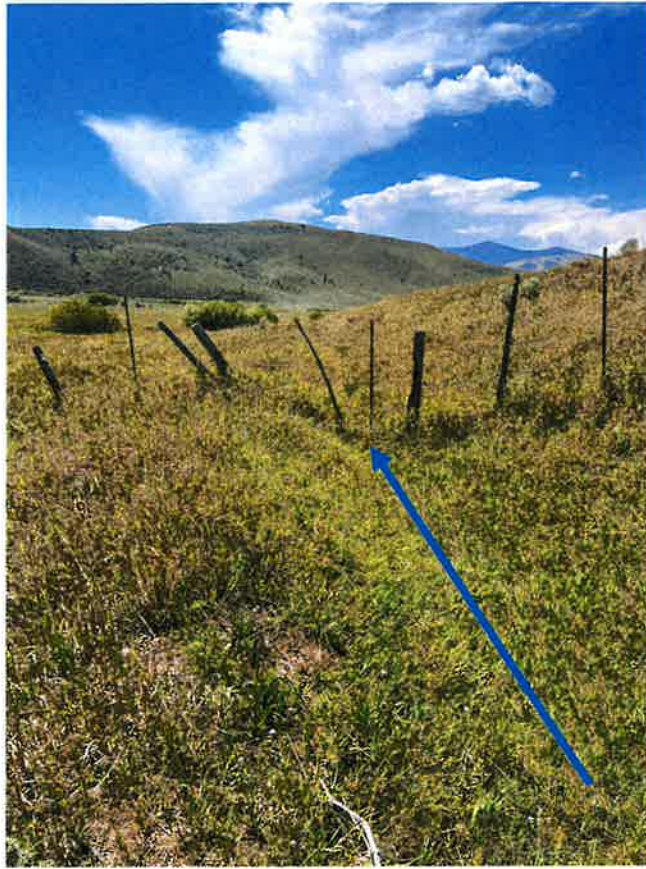
*Photo 9: Ditch for north field looking west.*

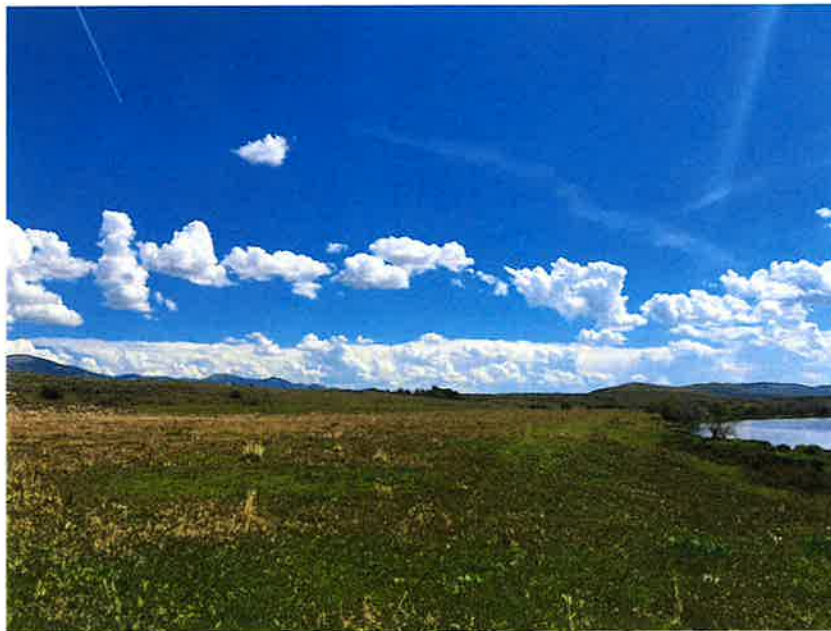
*Photo 10: Looking southeast across north field. Pond on right.*

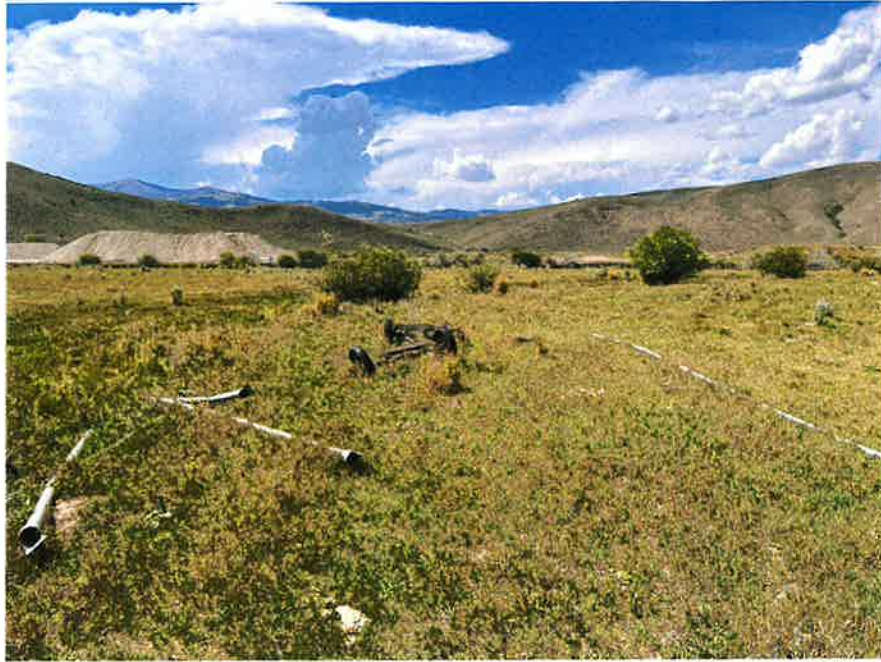
We walked back to the truck, crossed over the stream, and drove west and north across the field to the western edge of the POU. We searched for irrigation infrastructure such as a pump station and hand lines. The claim indicates that neither the on-stream diversion nor the pump on the pond are currently in use for irrigating the POU north of the stream. The only irrigation equipment we were able to see was a few metal hand lines. They did not appear to have been used recently.

Photo 11: Handlines.
