IDAHO DEPARTMENT OF  
**WATER RESOURCES**

**BRBA FIELD EXAMINATION REPORT**

**Claim Number:** 11-4213

**Exam Date:** 10/1/2026

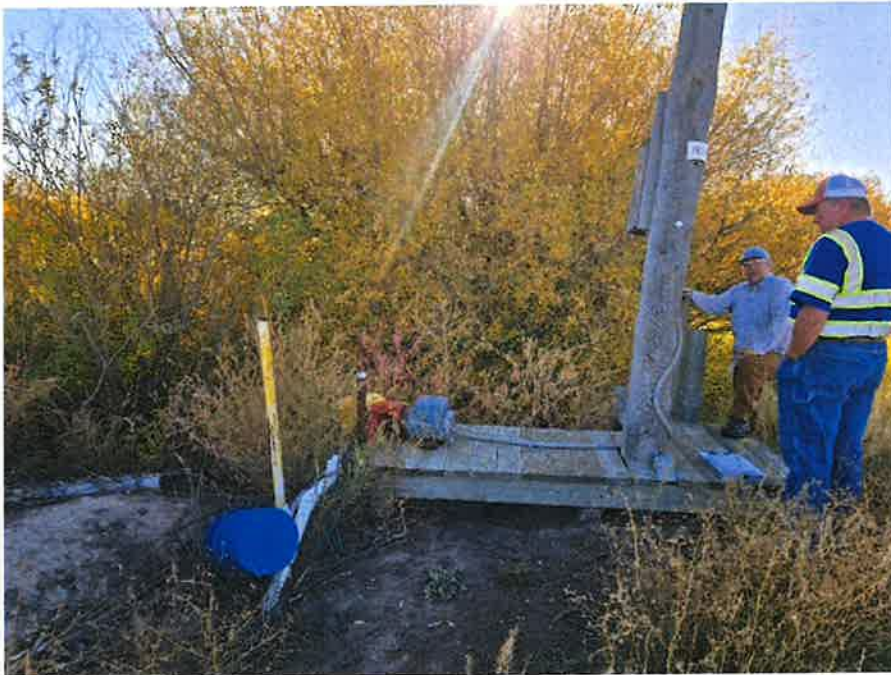
At the POD, the mounted motor that operates the pump was present. It is hardwired into the electrical grid and fastened to a wooden platform on the bank of Ovid Creek. The inlet (wet-end) attachment was not connected, and Michael stated that it was stored in his garage this year due to low creek water levels and an upstream beaver dam near the sawmill. He also noted that this is the same motor that has been in use since he began living in the area. The motor is a Baldor Reliance Industrial Motor, model JPL1409T, with specifications indicating a 5 HP motor operating at 3500

Figure 1: Irrigation pump assembly mounted to a wooden platform.

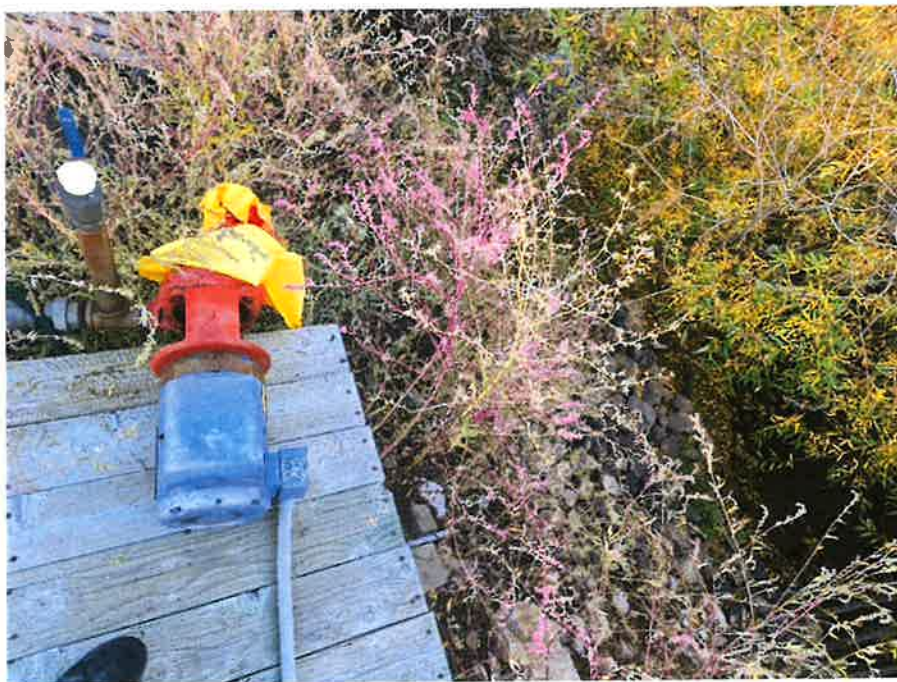
Figure 2: Irrigation pump assembly platform affixed atop creek bench.

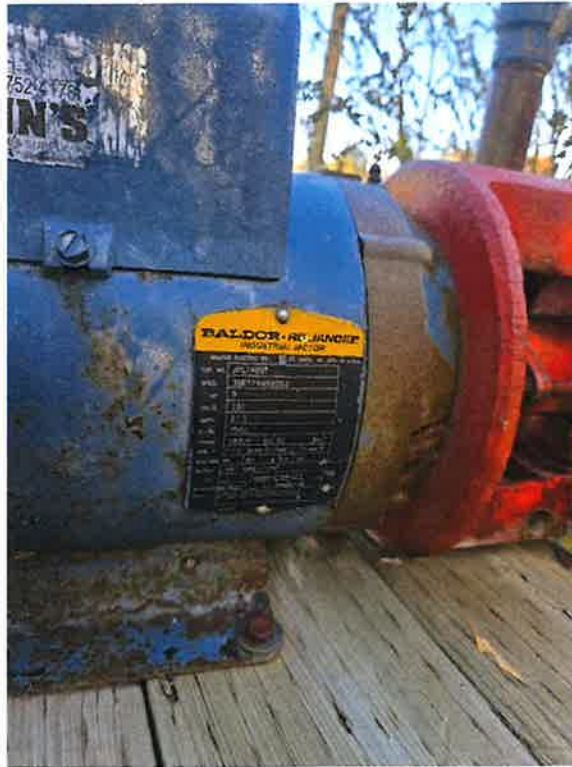
RPM, fully electric, 230V/21.5 amps. From the motor, a 2 ½-inch PVC line enters the ground, running behind the homes and supplying the risers at each property.

Figure 3: Irrigation pump assembly motor specification information.

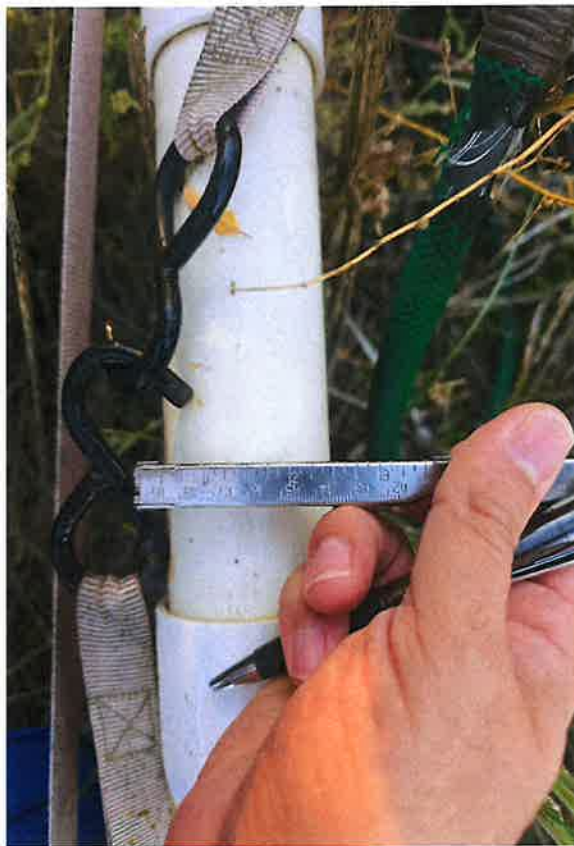
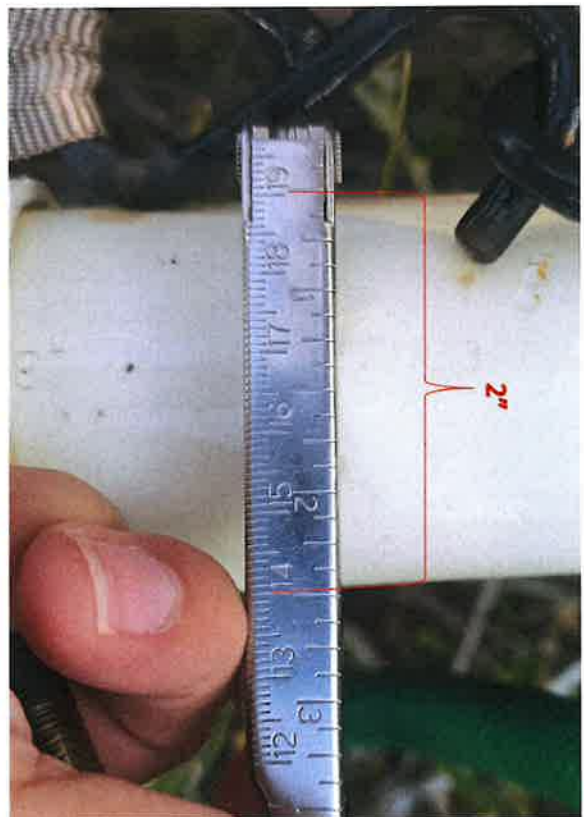
Figure 4 & 4.5: Outlet pipe from pump assembly system with pipe measurement.

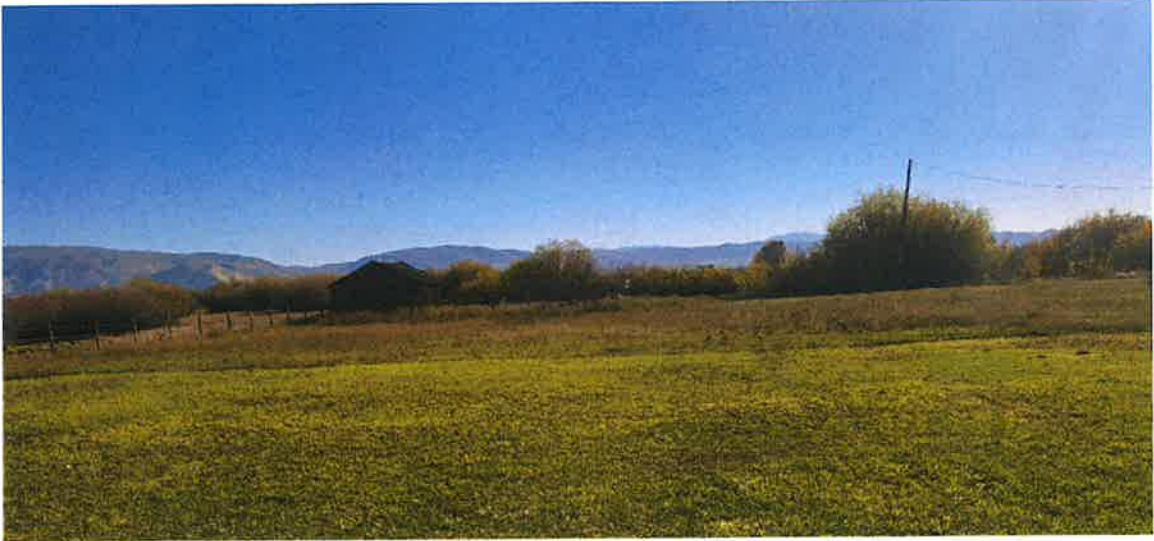
A reduction in irrigated acreage within the place of use was also identified by the claimant. This includes approximately 0.73 acres south of the western residence, located between the privacy screen and the road, which is no longer receiving irrigation. Additionally, about 0.33 acres of pasture adjacent to the point of diversion were noted as not being irrigated.

Figure 5: Unirrigated pasture adjacent to point of diversion.

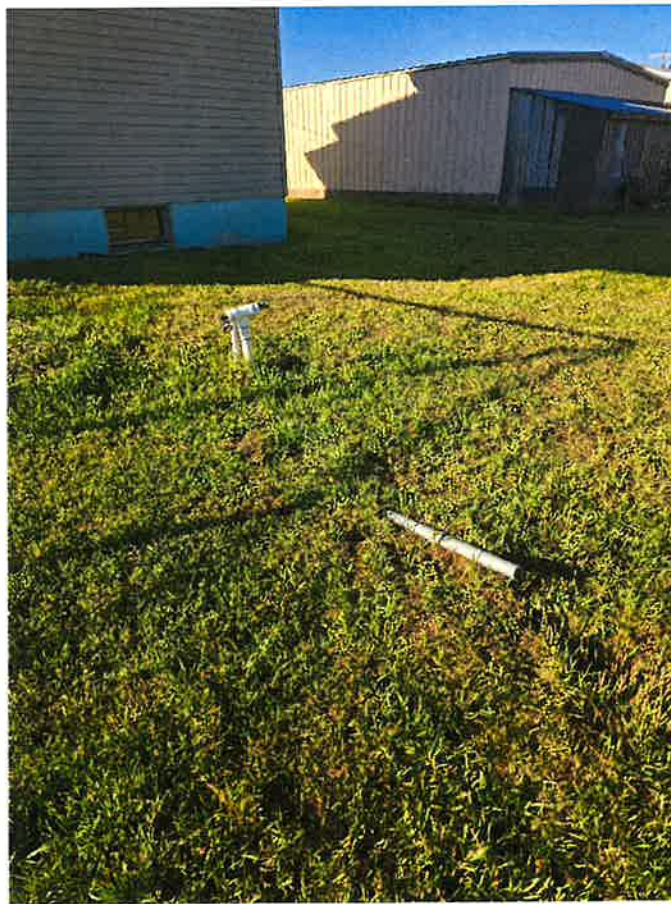
The Kovack residence, located closest to the POD, has one riser directly behind the home. The riser is positioned low to the ground, constructed entirely of PVC, and includes two connection points for garden hoses. Michael explained that this property previously had two additional risers used to irrigate the pasture east of the residence. However, repeated damage from vehicles led to their removal, and the eastern portion of the pasture no longer receives irrigation. Michael was advised that the extended period of non-irrigation may result in a reduction of the approved irrigated area.

Figure 6: Riser located behind Kovack residence.

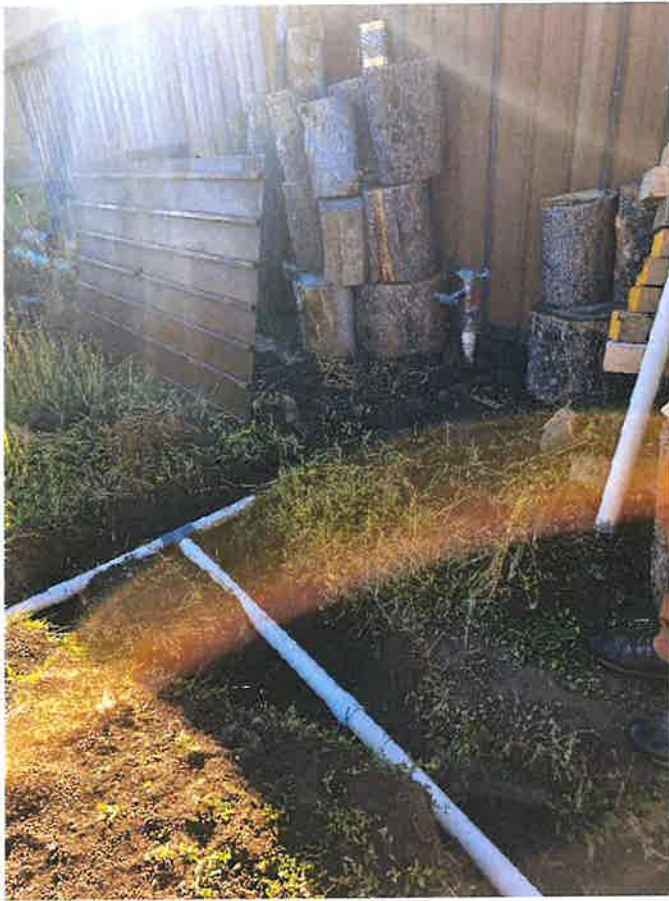
Figure 7: Riser located behind workshop at the Mattson residence showing the initial "T" branch towards the rest of the system..

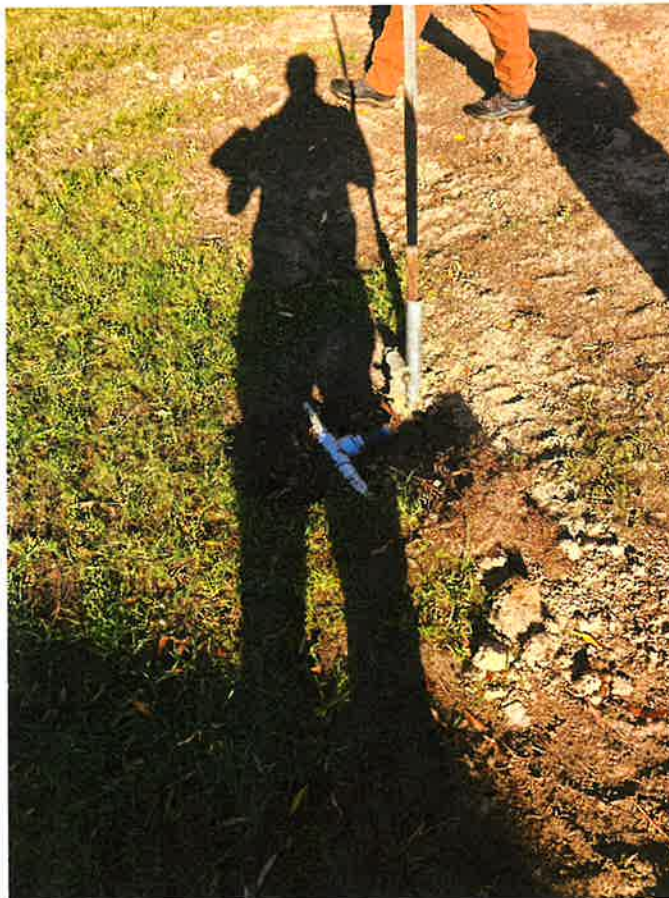
Figure 8: Riser located behind Mattson residence on the western corner.

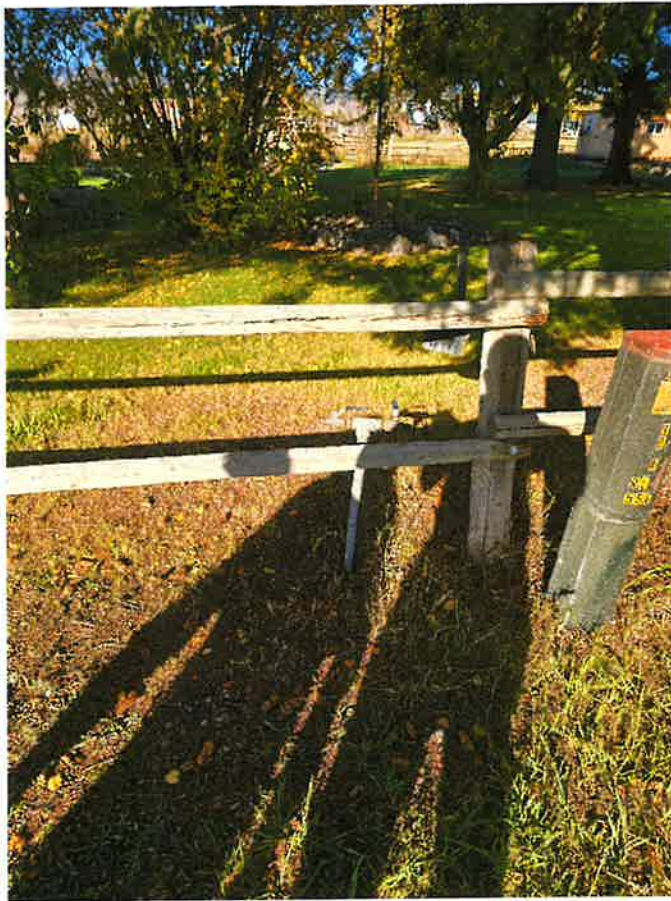
Figure 9: Riser located in front of the Sparks residence. Initial riser that the system connects into from under the street.

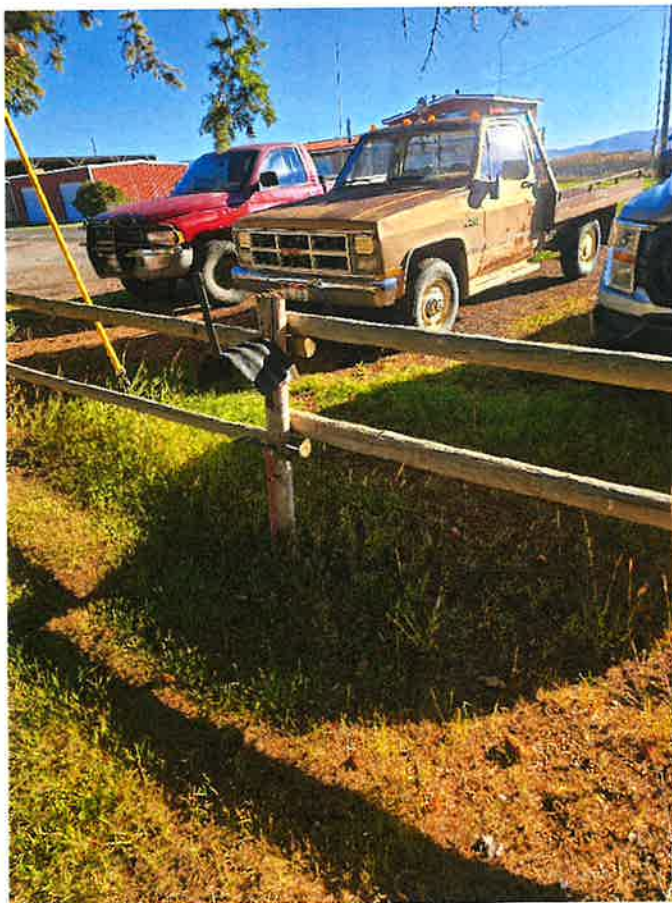
Figure 10: Riser located in front of the Sparks residence along the fence.

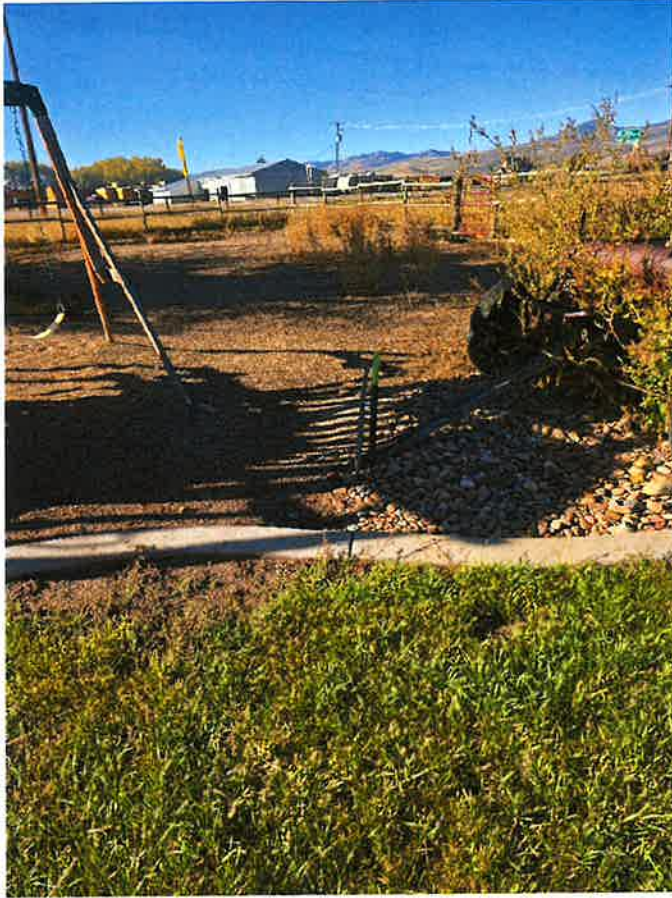
Figure 11: Riser located in in the center of the back yard at the Sparks residence where the system branches.

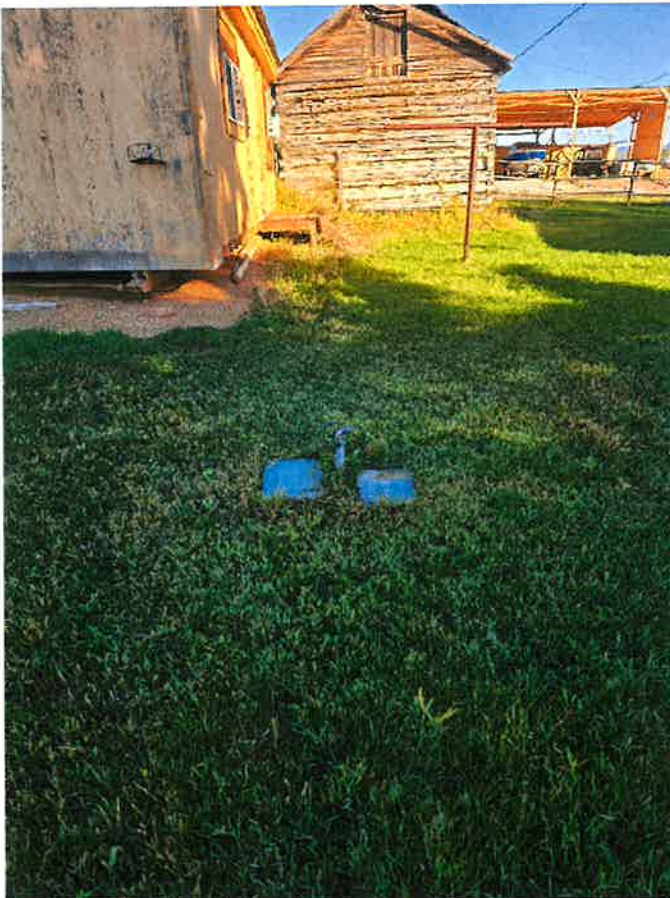
Figure 12: Riser located behind the Sparks residence with the control valve box and blow out box.

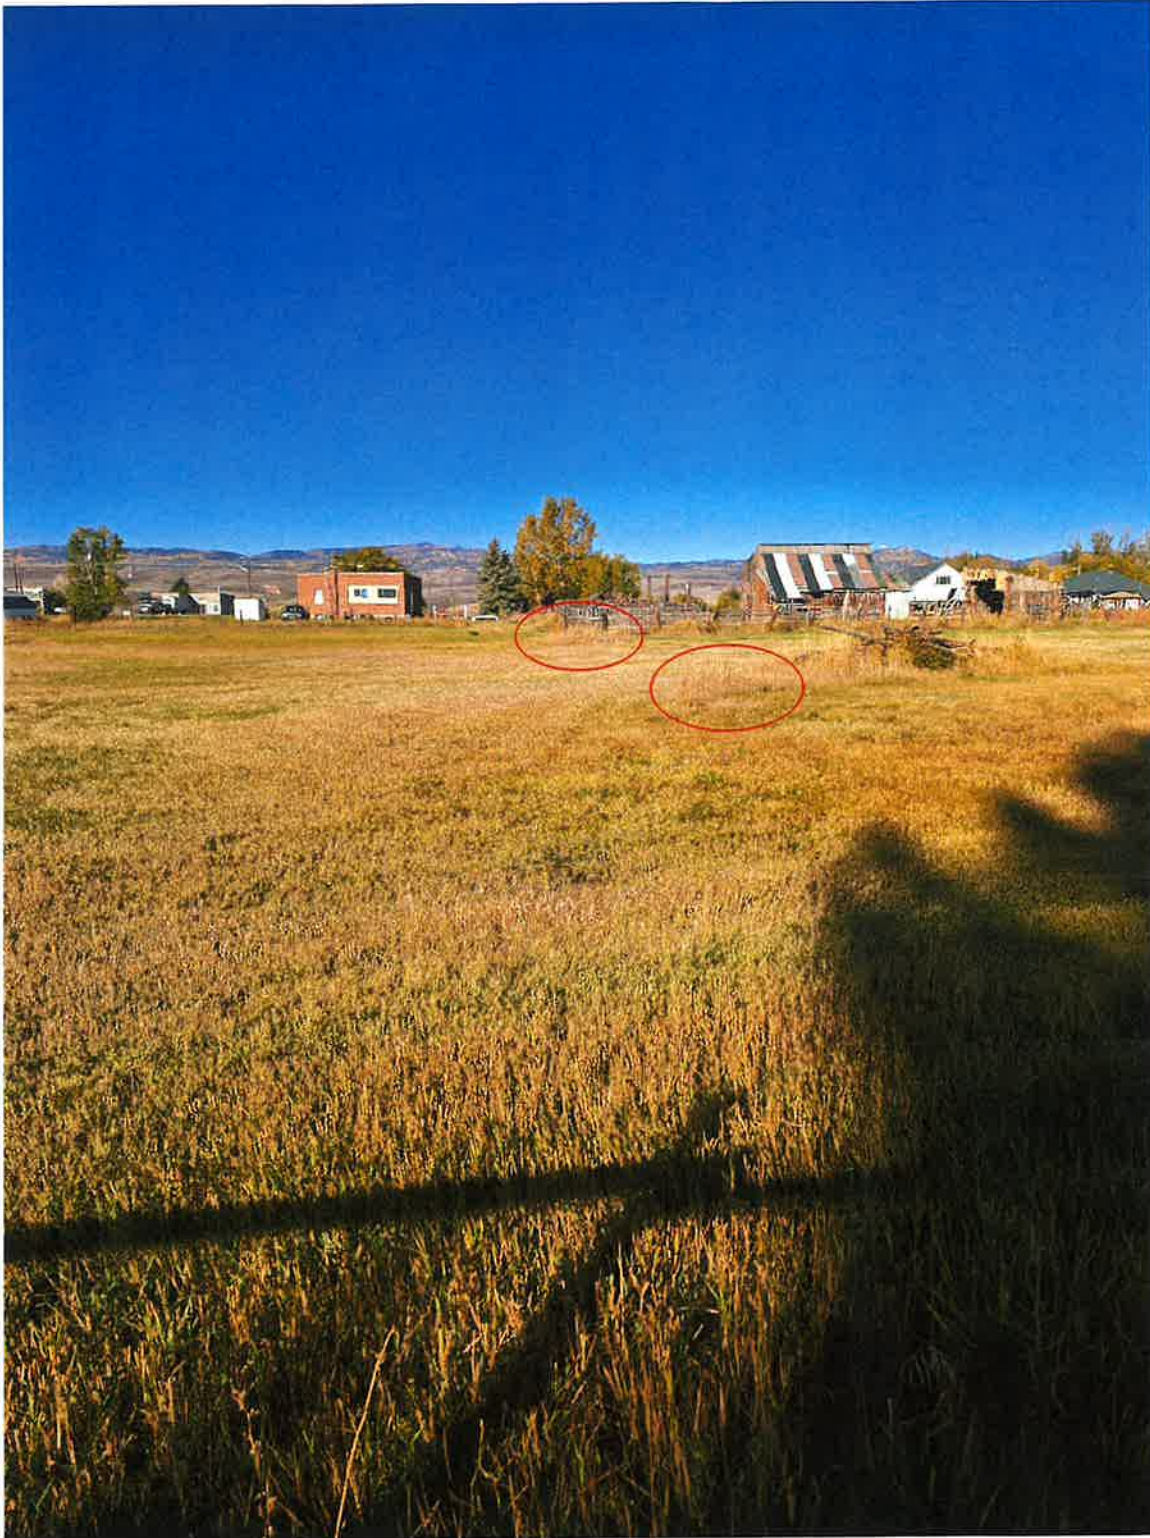
Figure 13: Pasture located behind the Sparks residence that has two risers with locations outlined in red.

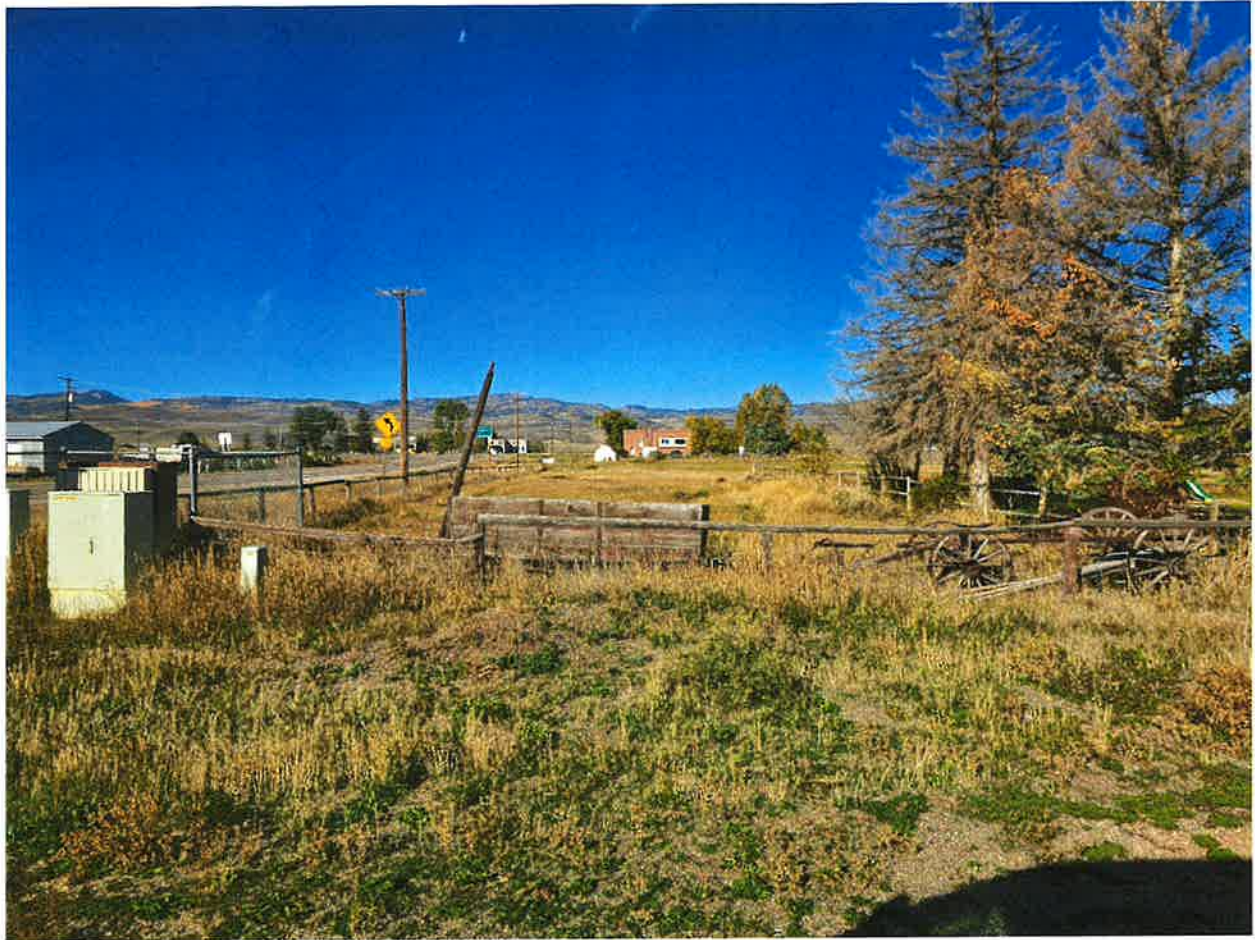
Figure 14: Southern pasture area at the Sparks residence between the privacy screen and the road that is not irrigated.

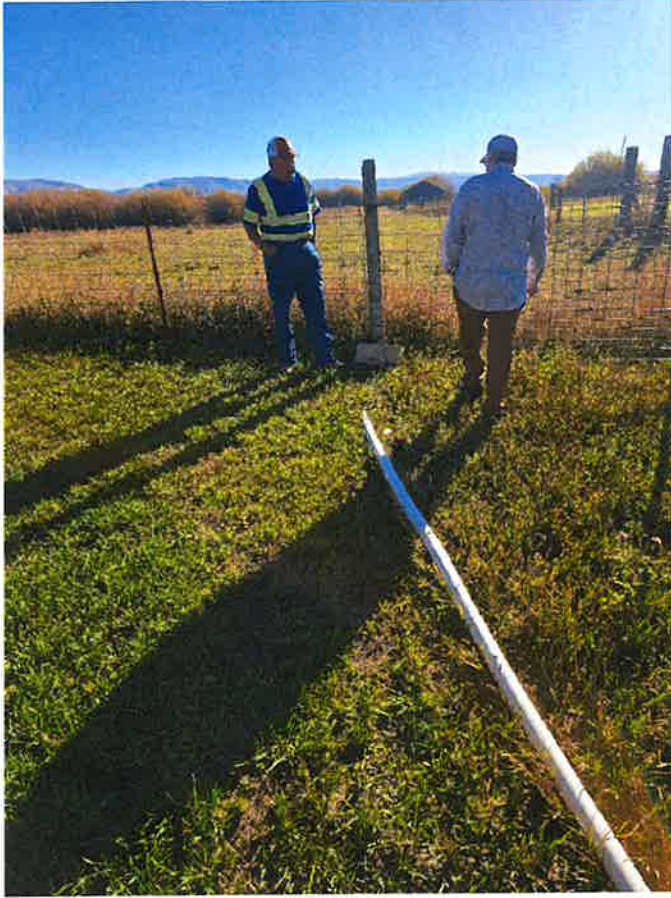
Figure 15: Conveyance line that breaches the surface on the Bergs Residence.

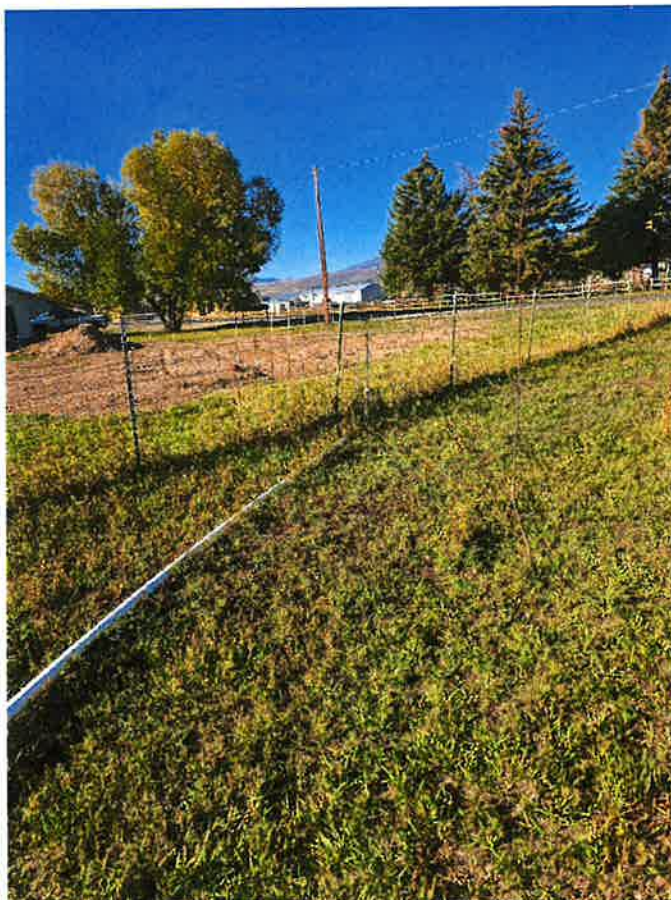
Figure 16: The above ground conveyance line attaches to a riser with an affixed impact sprinkler on the south side of the residence.

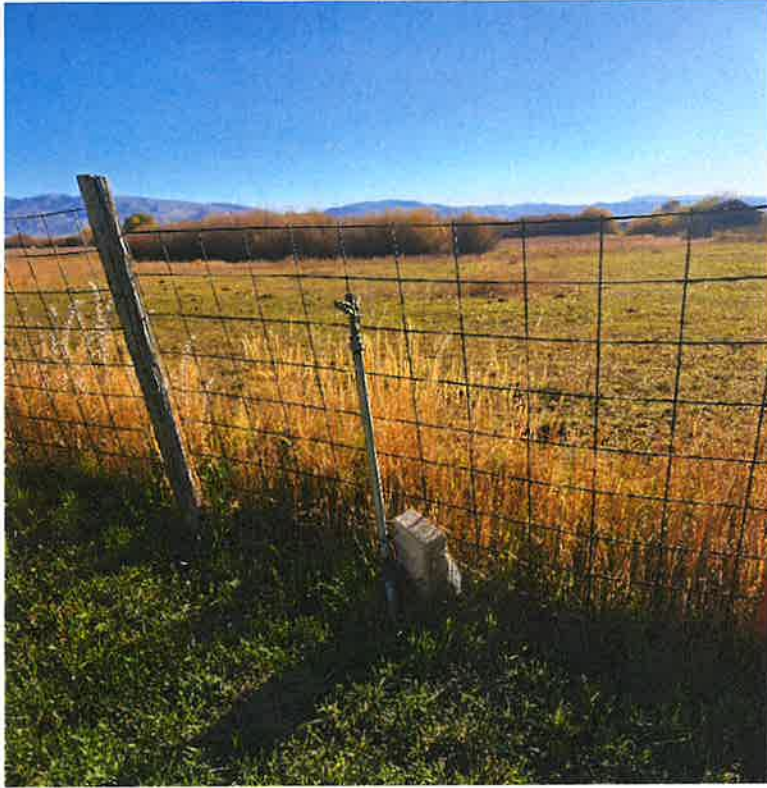
Figure 17: South riser with affixed impact sprinkler behind the home at the Bergs residence.

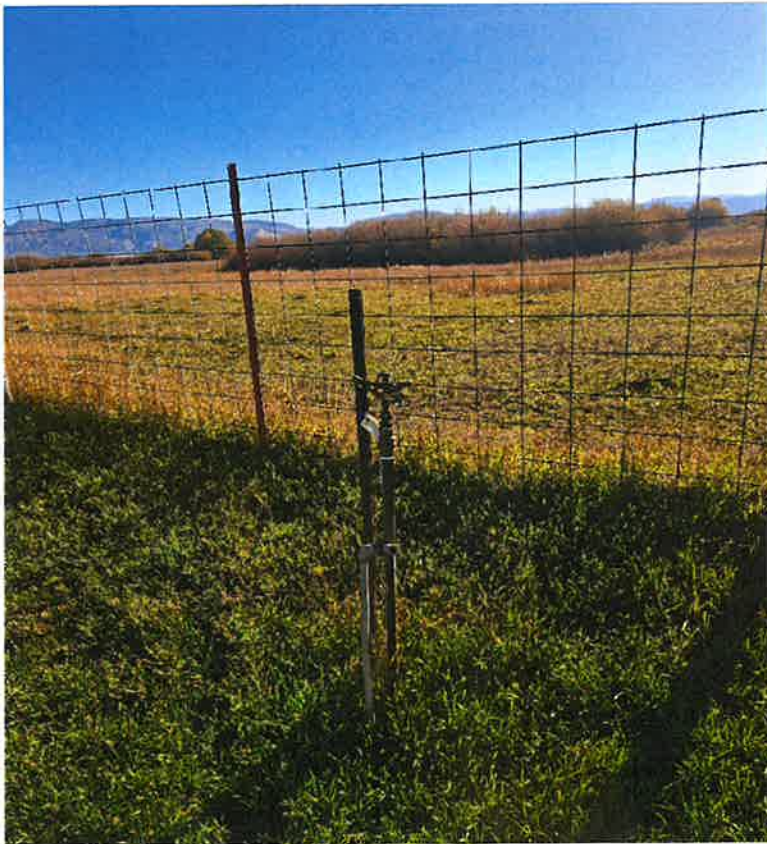
Figure 18: North riser with affixed impact sprinkler behind the home at the Bergs residence.

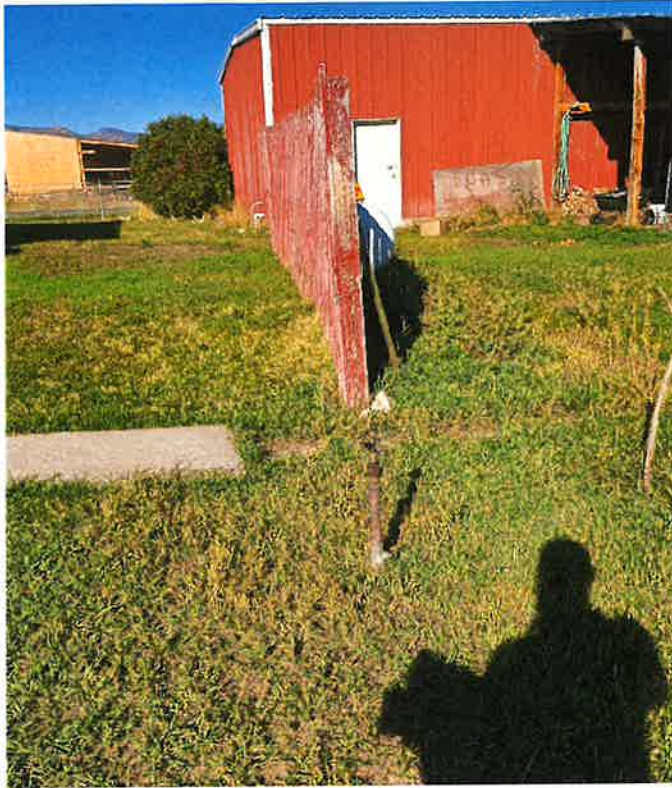
Figure 19: Riser on the north end of the main yard at the Bergs residence and at the foot of the pasture.

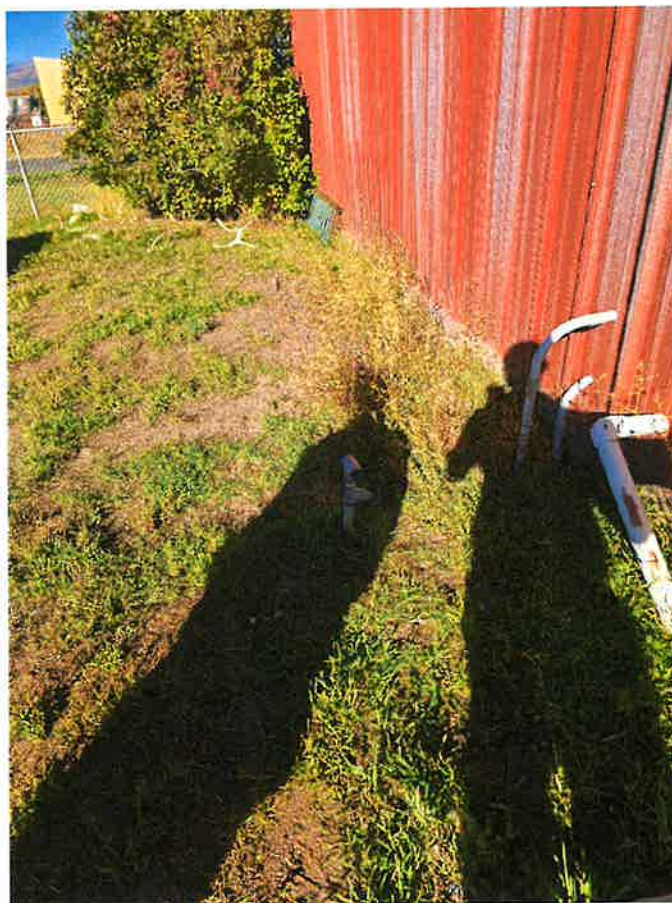
Figure 20: Riser located next to the hay shed in-between the residence and the shed at the Bergs residence.

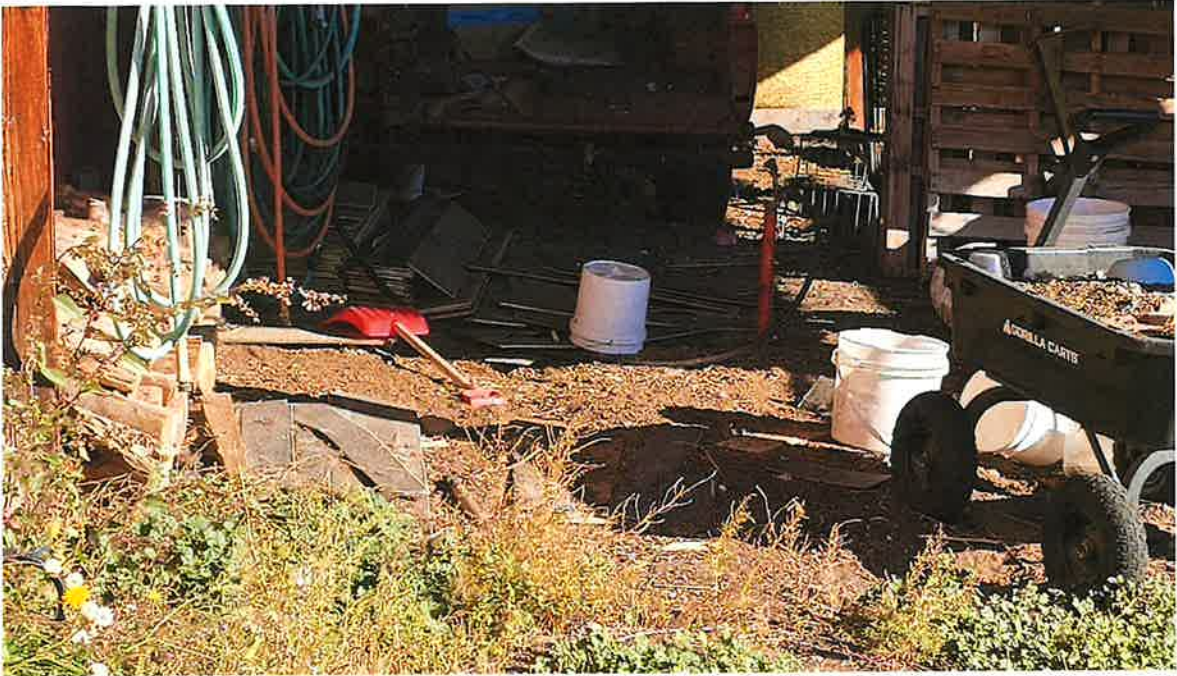
Figure 21: Portable impact sprinkler with additional hoses observed under the storage area of the hay shed.

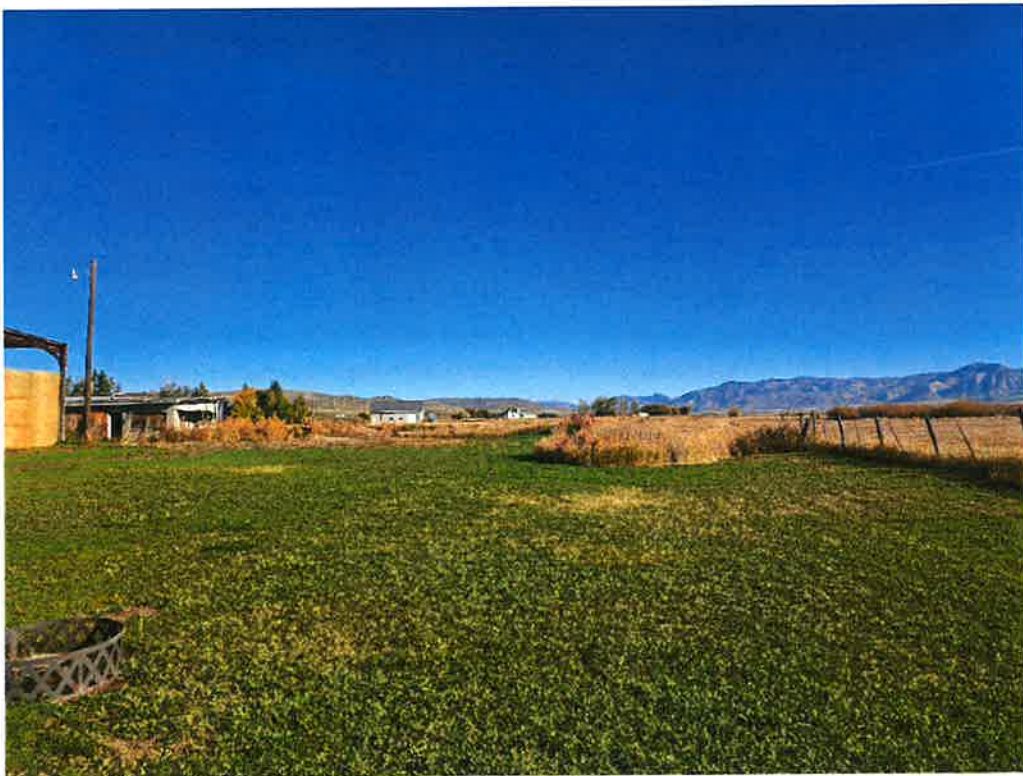
Figure 22: Pasture behind the hay shed and old cinderblock building at the Bergs residence. Tall growth on the right side is a drainage area for the pasture.
