IDAHO DEPARTMENT OF  
**WATER RESOURCES**

**BRBA FIELD EXAMINATION REPORT**

**Claim Number:** 11-4313

**Exam Date:** 6/02/2026

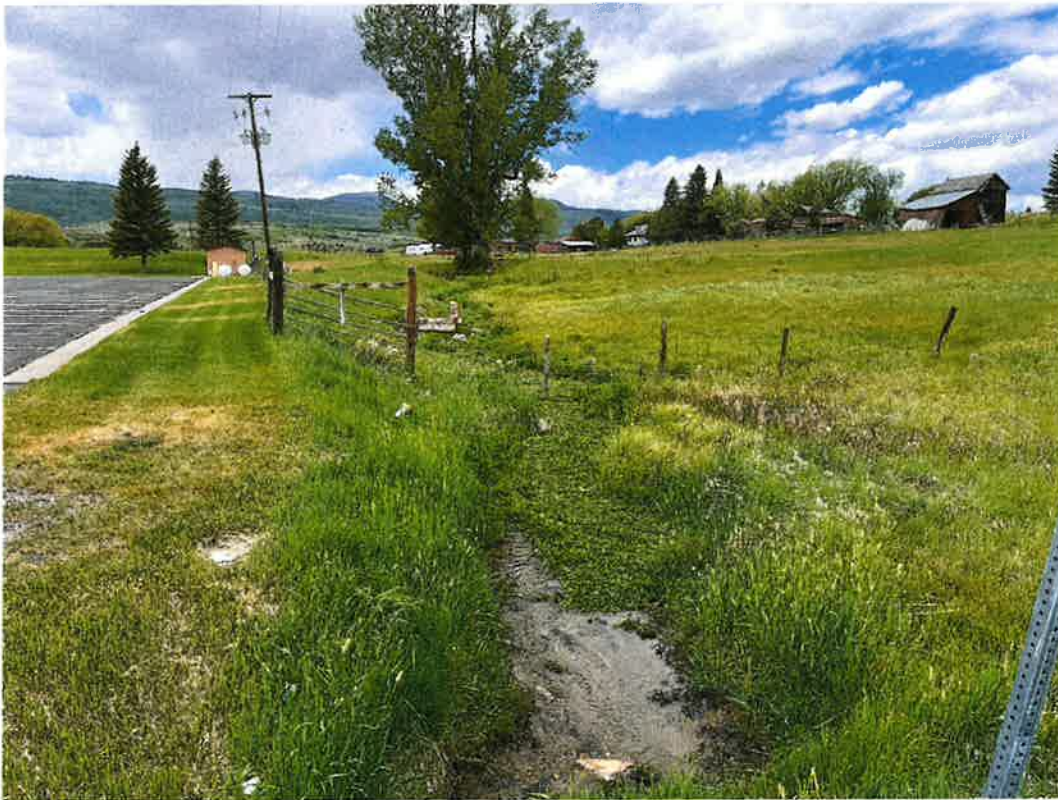
*Spring flowing from the base of the tree, picture downstream looking up.*

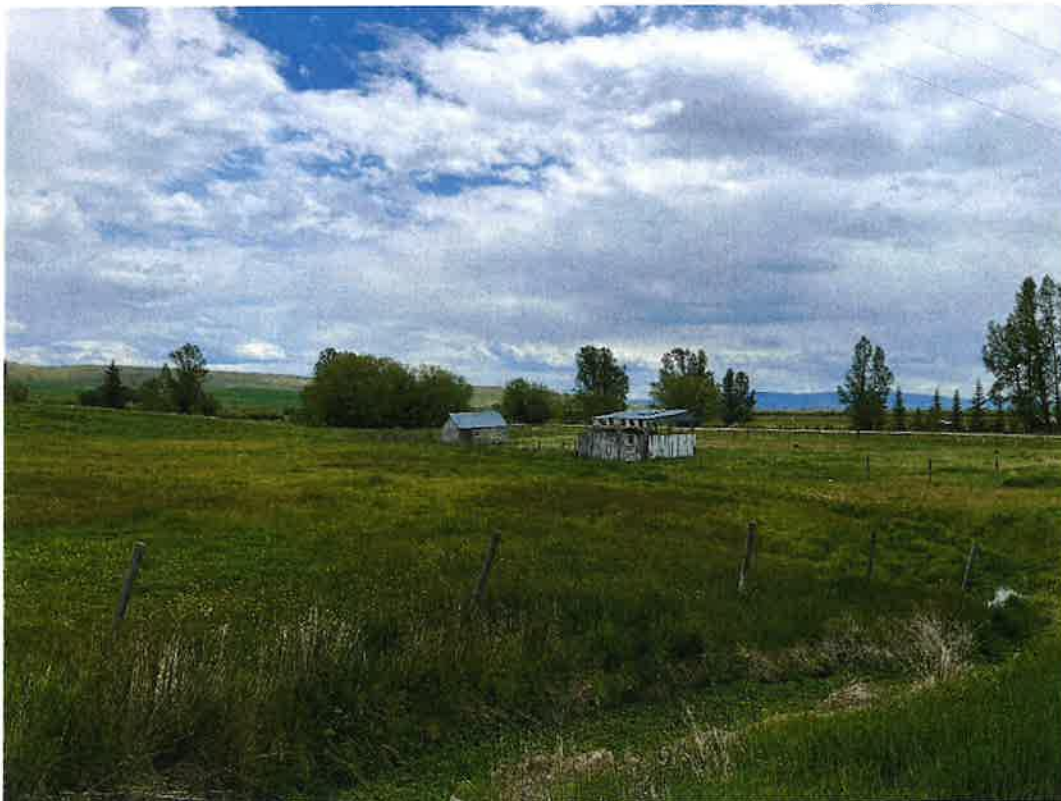
*Same picture location as above, from upstream looking down.*

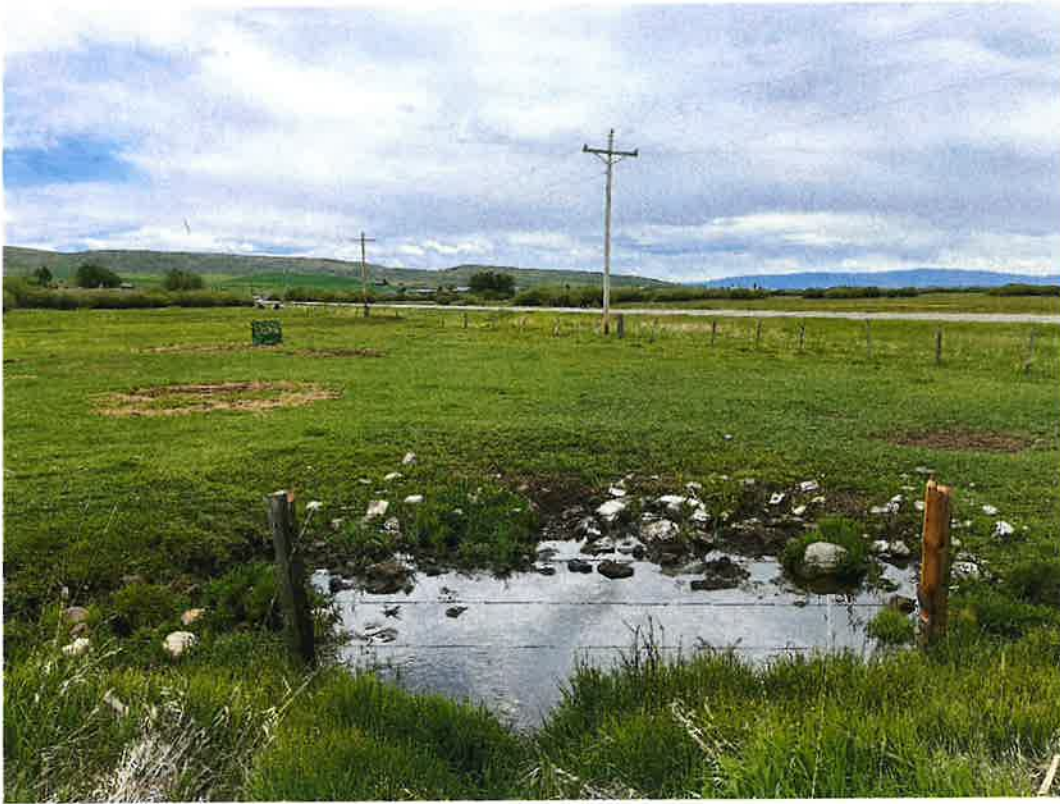
*Stream entering claimed POU where the diversion point would be located.*

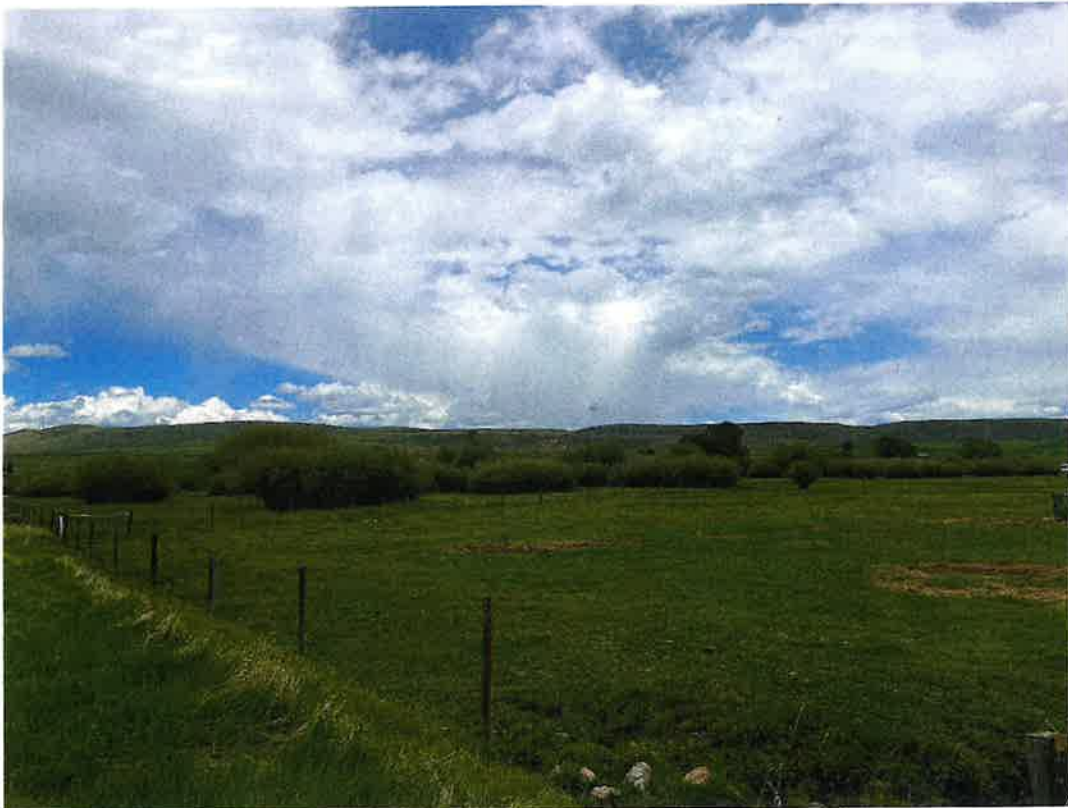
*Looking north from above photo.*

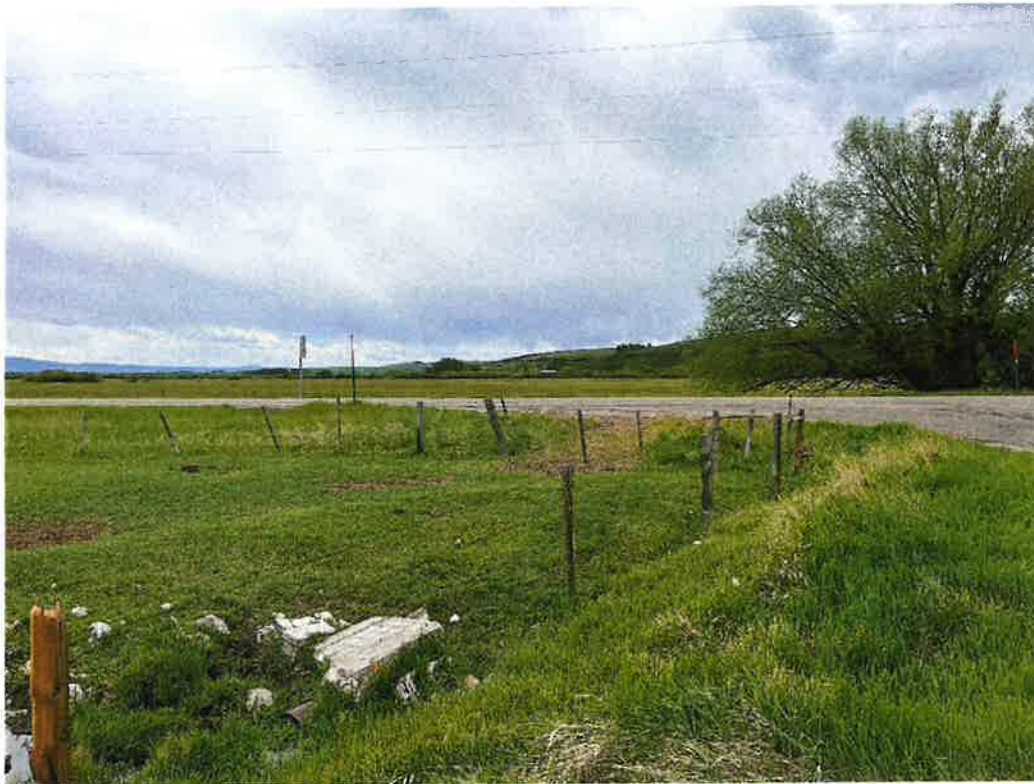
*Looking south from above photo.*

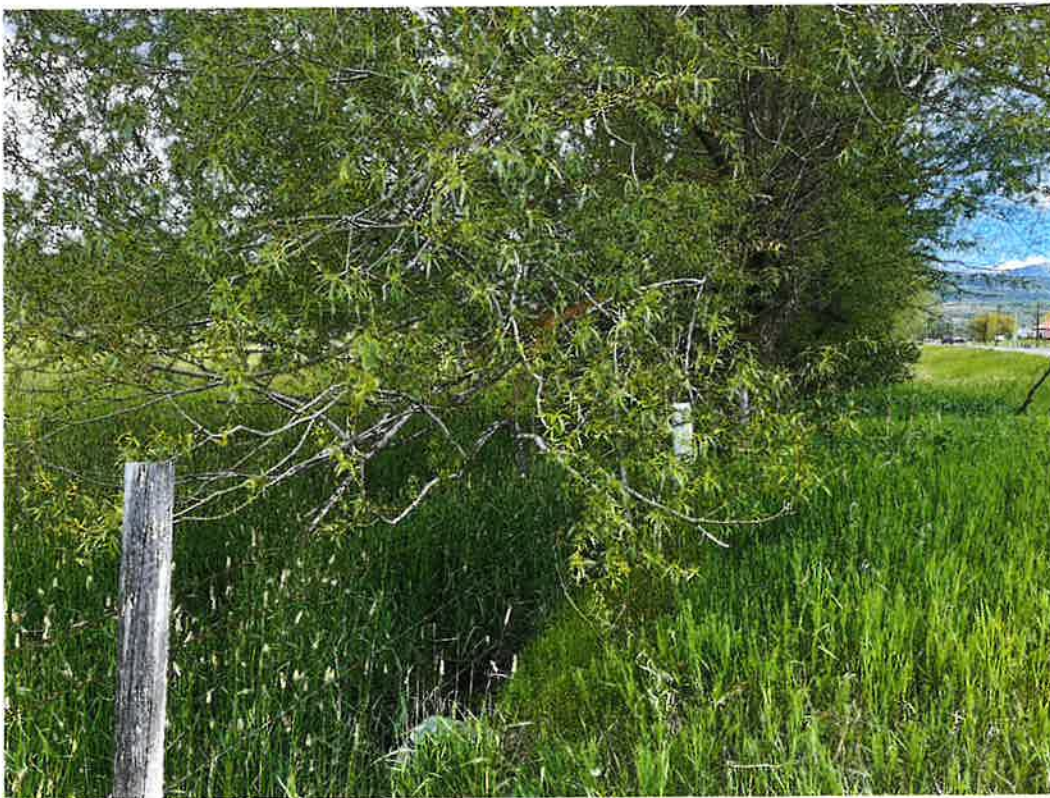
*Western most culvert under the highway reaching the southern POU.*

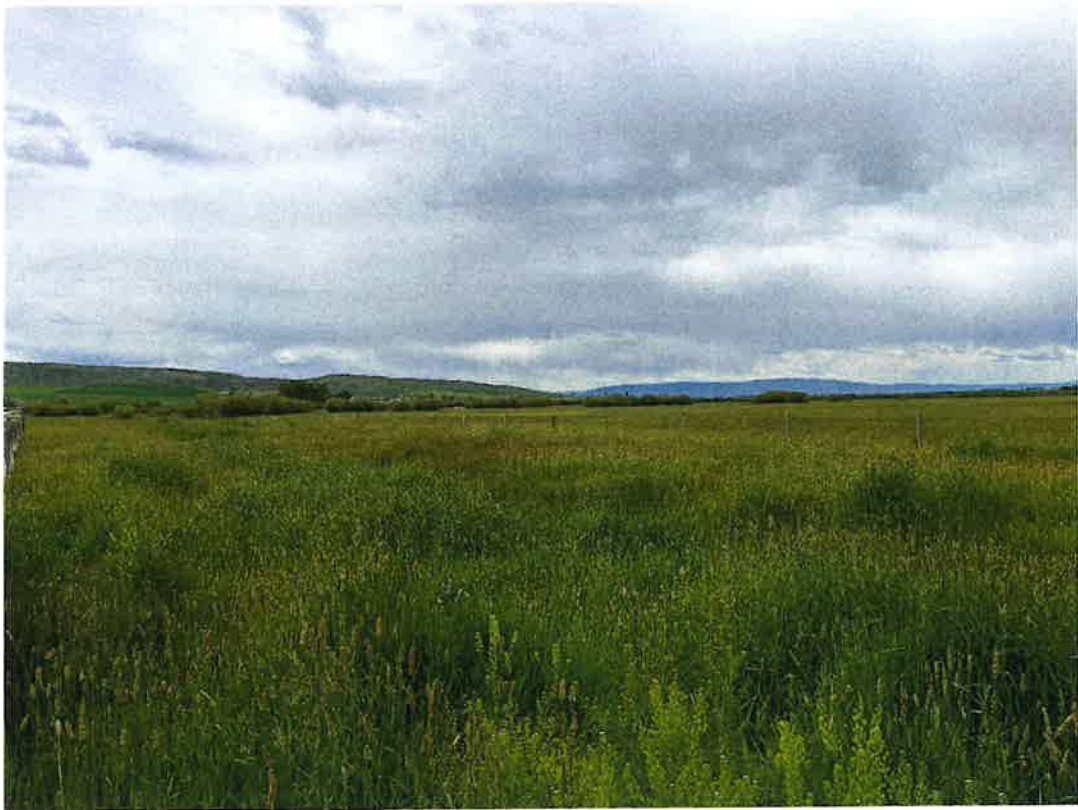
*POU south of the highway looking eastward from the above photo location.*
