**MEMORANDUM**  
**Hess Property Site Inspection**  
(south of Lake Fork)

RE: Complaint--Pond Construction  
E-mail 10/1/02 Attached

On 10/9/02 I made an on-site inspection of the Hess Property just south of Maki Rd on Hiway 55 near Lake Fork. The property is located on the east side of Hiway 55, 17 N-3E-Sec15-NW of NE, see attached map.

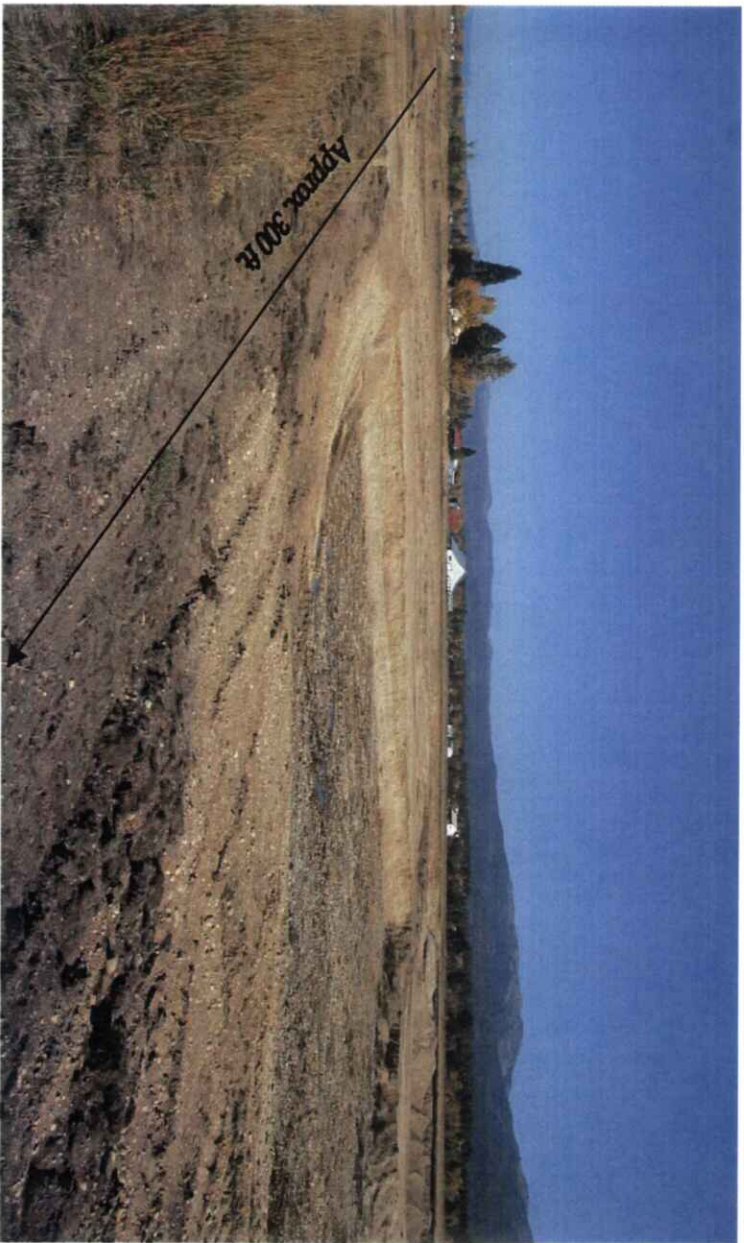
Photo #1: Pit from the southwest corner, The southwest ¼ is approx. 5 ft deep.

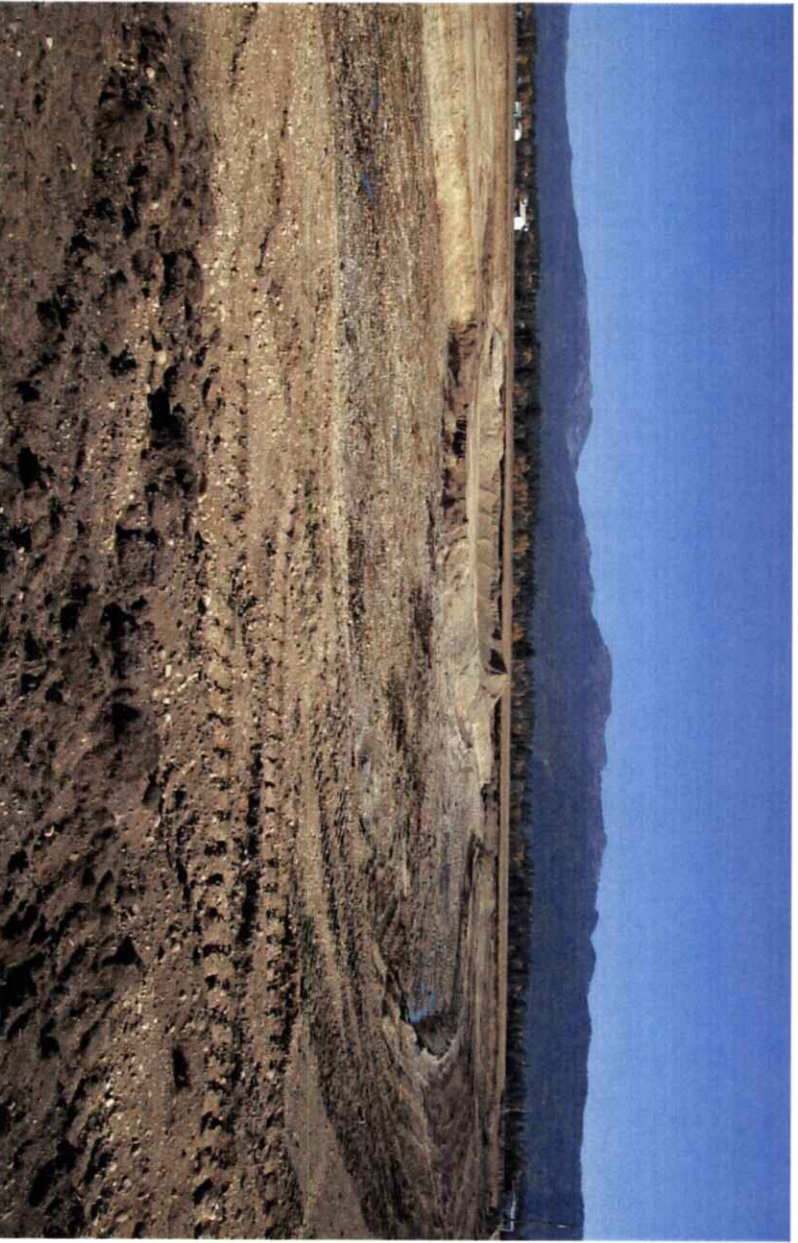
Photo #2: South ½ of the pit, some standing water along the edges, cobble rock along bottom.

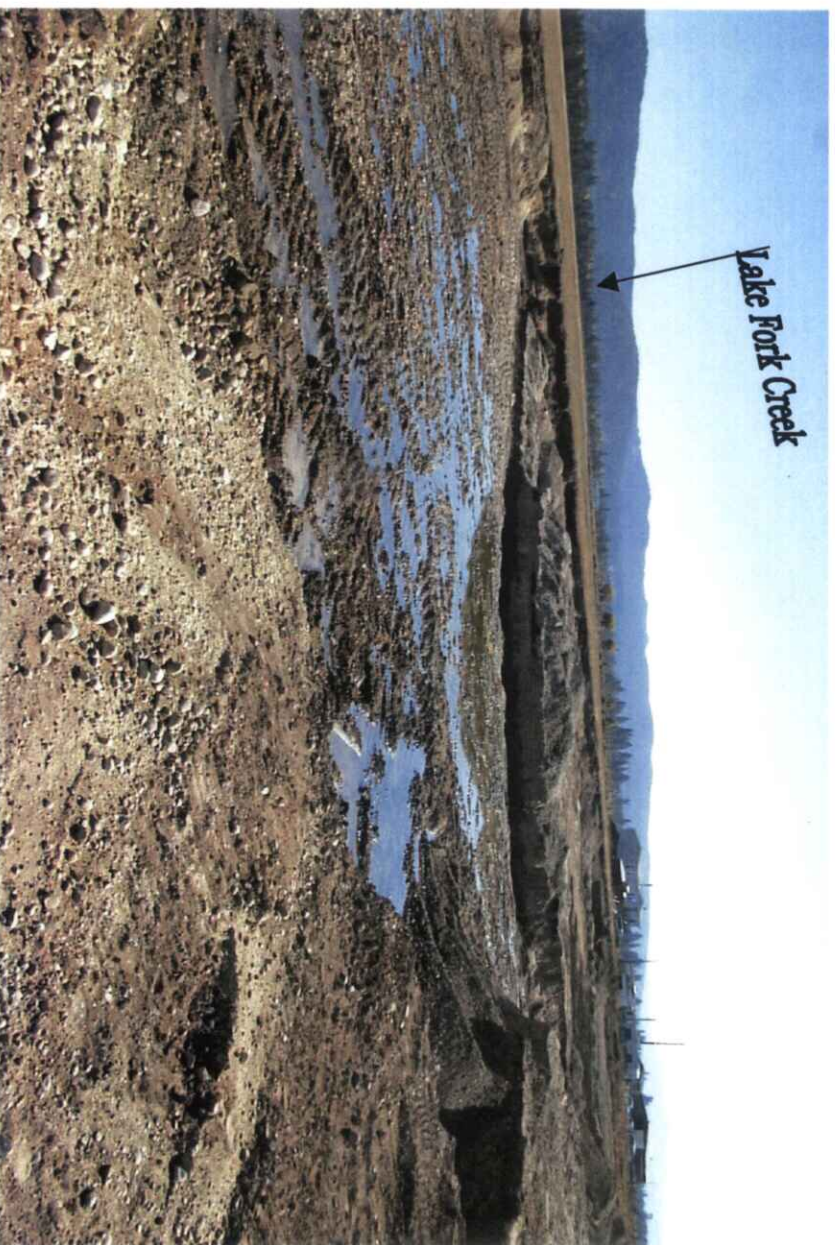
Photo #3: Standing water in the north portion of the pit, considerably deeper.
