STATE OF IDAHO  
Department of Water Resources

## FIELD INSPECTION REPORT

9. Dam name: Hulet Dam #1 Spilling:  No  Yes Q \_\_\_\_\_  
 Outlet open:  No  Yes Q 13.45 Spillway open:  Yes  Fibrd  Gate open  
 Freeboard: Spillway \_\_\_\_\_ Crest \_\_\_\_\_ Res. stage:  Rising  Falling 24 AF/day Rate

10. Area characteristics: \_\_\_\_\_
11. Weather conditions: Hot
12. Describe activity/conditions inspected: Polysomic measure on Nettleton GW  
relief; inspection of upper & lower MMC weirs

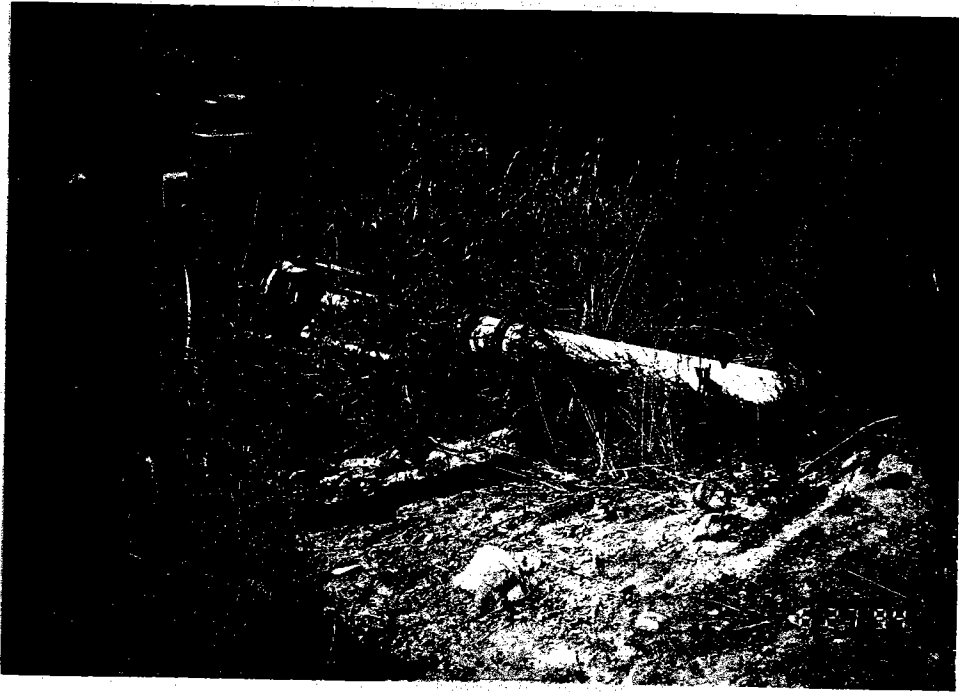
Photo #4 - Site of transducer location - only about 5' from valve but steady R reading obtained

Site of Polysonic  
measure  
Netleton GW relief  
Station.

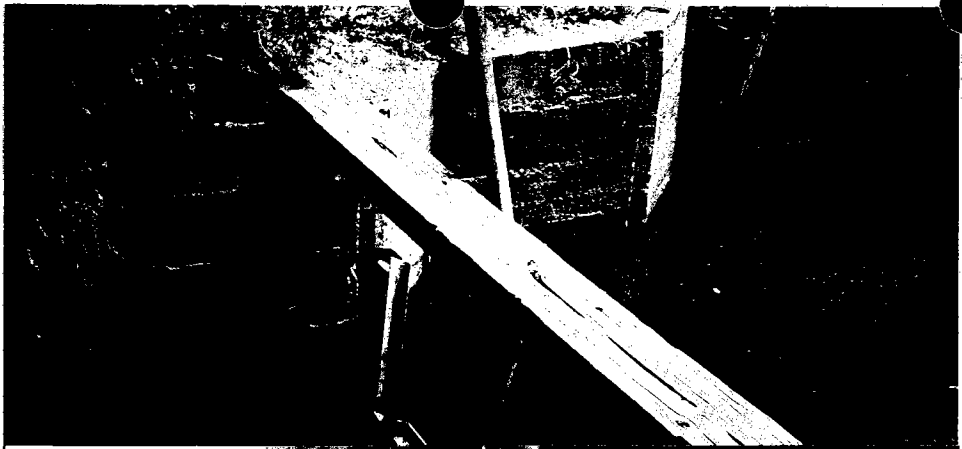
Weir OK - new plastic seal - looks unblemished. at very low flows, approx 1/2 - 1" difference in head.

Head of canal.  
Weir Seal check  
Right edge (downstream)

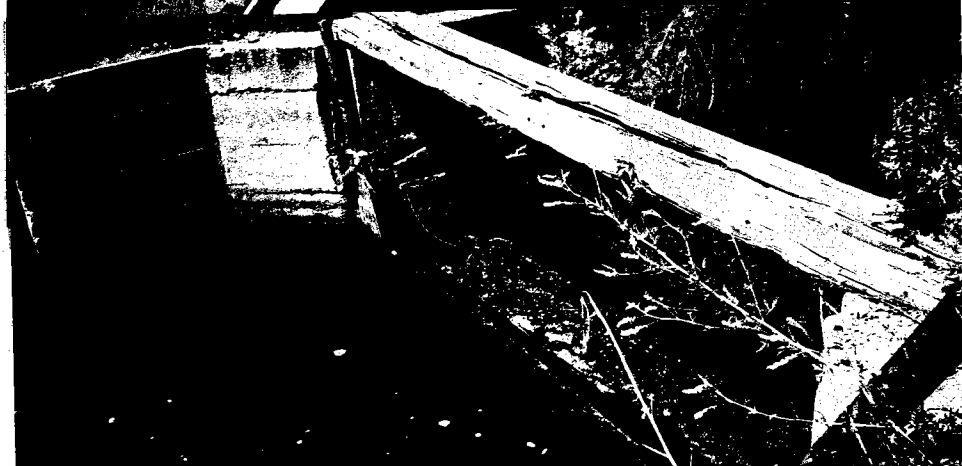
Weir under operation  
13.45 cfs.
