MEMORANDUM

SUBJECT: Filed Visit to West Ditch Diversion on Rock Creek

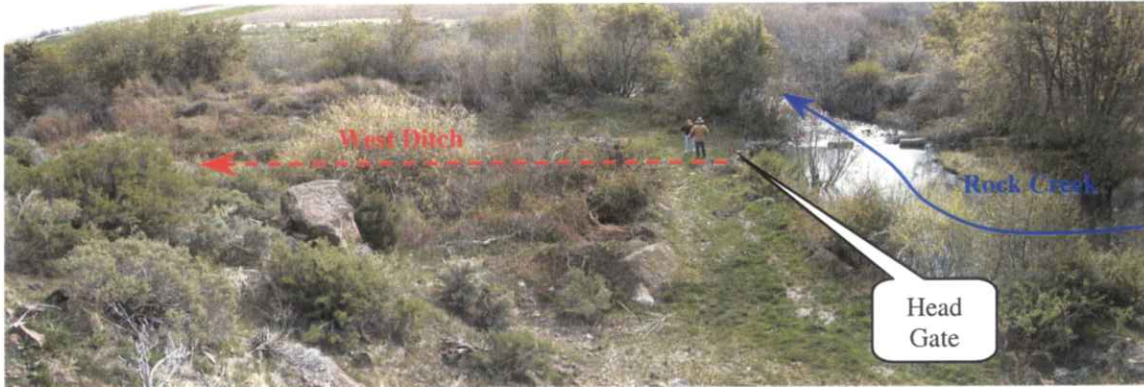
ABOVE: View from side of Cedar Hill looking down on Rock Creek in the area of the West Ditch diversion.

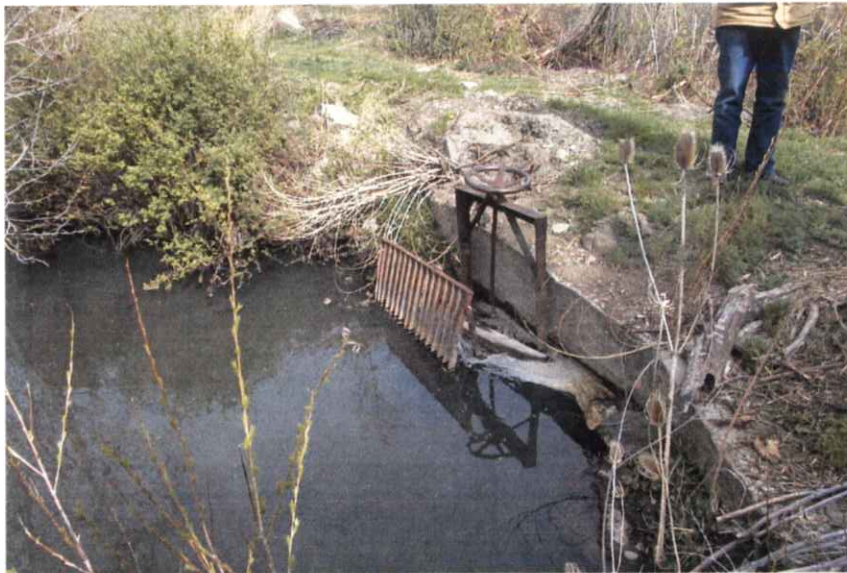
LEFT: View of the West Ditch Diversion from Rock Creek showing gate in the closed position (no gate stem above the operating wheel).

Mr. Smith also indicated that he did not receive the Department's order last summer, and only recently became aware of the order. It seems to reason that there may be some room for compromise for the short term, but eventually the West Ditch head gate at the diversion point at Rock Creek needs to be repaired, or replaced, so that the diversion and use of water will be in compliance with the order issued by the Department last year.

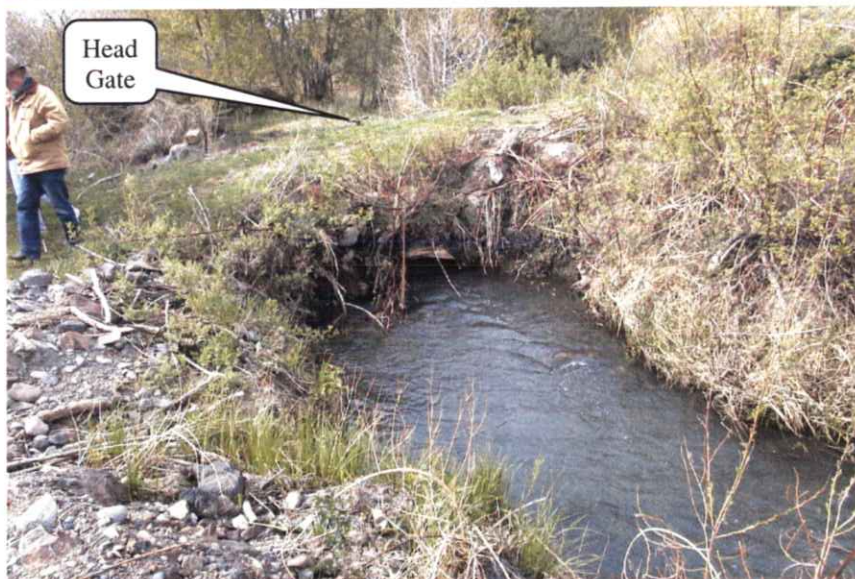
LEFT: View directly below the West Ditch diversion looking back up the West Ditch toward the diversion. Note the large flow entering the West Ditch from Rock Creek despite the diversion gate being in the closed position.

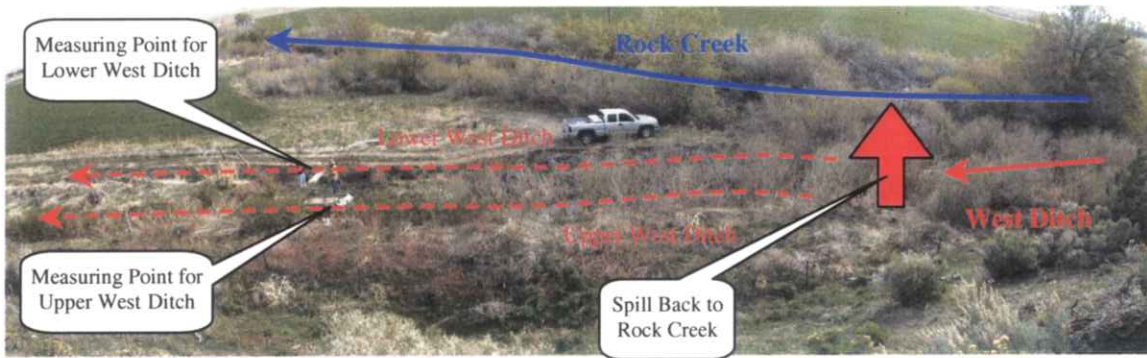
ABOVE: View from side of Cedar Hill looking down on Rock Creek in the area of the West Ditch measuring points.

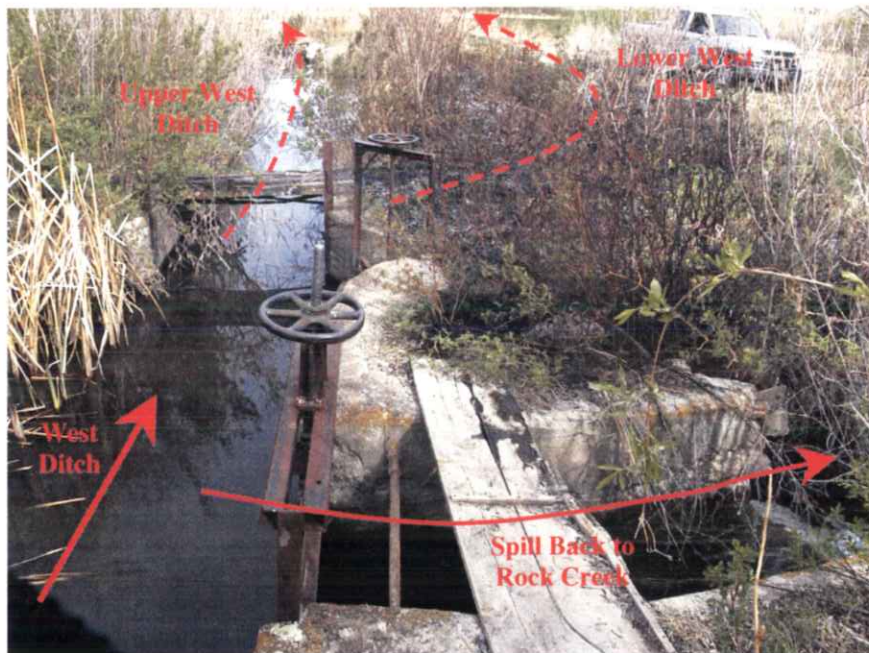
BELOW: View looking down the West Ditch showing the spill head gate back to Rock Creek along with the head gate allowing diversion of water to the Lower West Ditch. At the time of my visit, the spill head gate was adjusted to allow for water to spill back into Rock Creek and Lower West Ditch head gate was closed to prevent water from entering the Lower West Ditch. Essentially the system was adjusted so that the level of water in the West Ditch was such that no water was flowing down the Lower West Ditch and no water was flowing over the Upper West Ditch measuring weir (approximately 100 feet further downstream than this view).

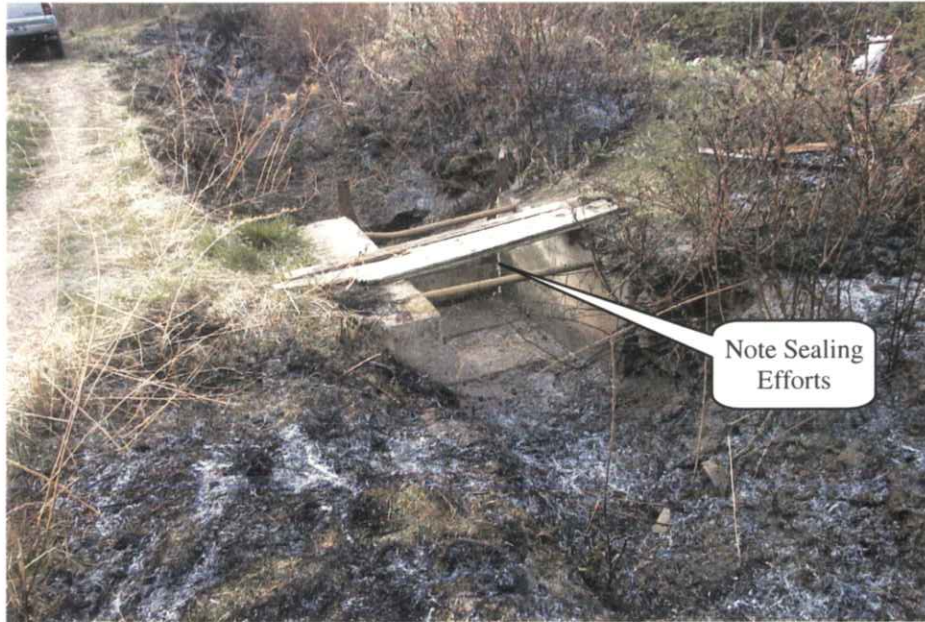
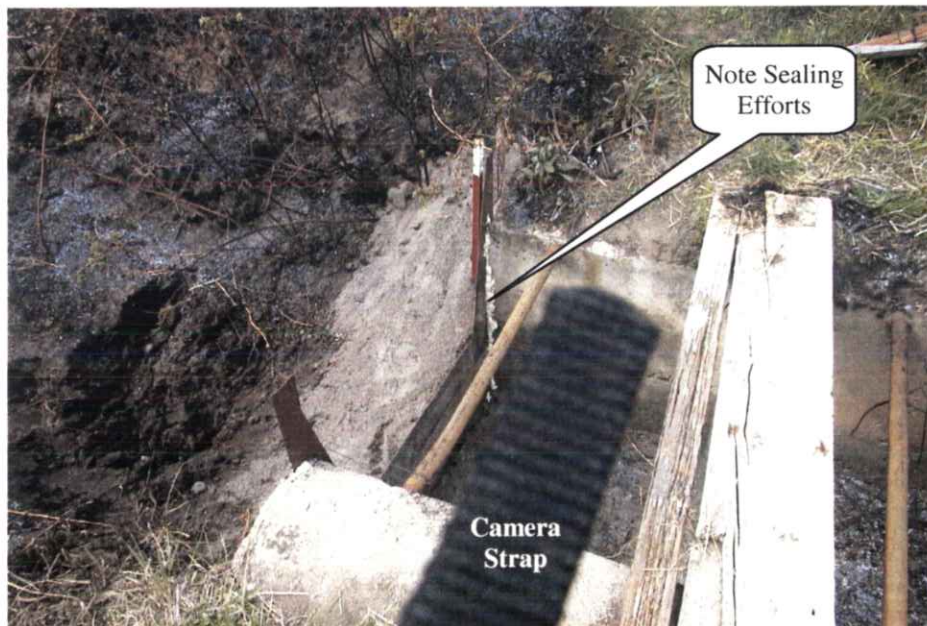
ABOVE & BELOW: Views of measurement point on the Lower West Ditch. Efforts had been made to repair this weir. During the visit, some water was turned down this ditch and it appeared that this weir was functional with very minimal leakage. Note efforts made to seal edges of weir to prevent leakage around the weir.

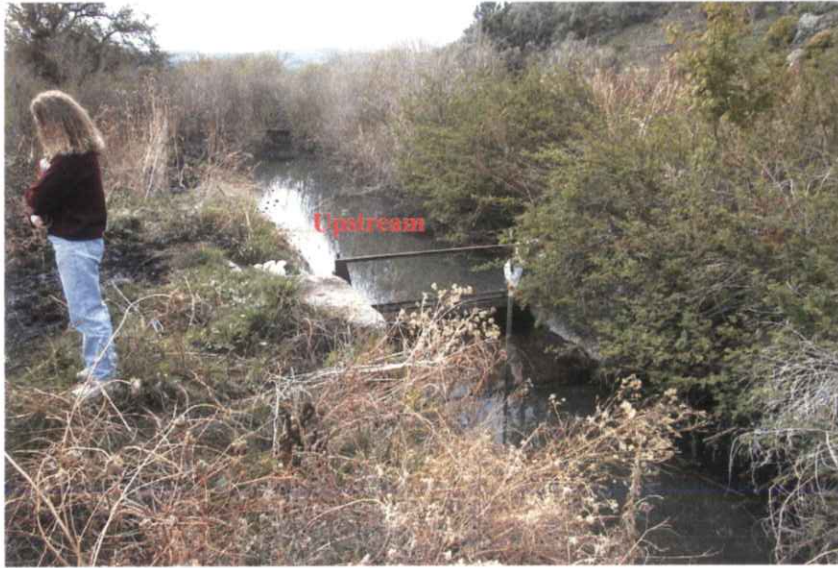
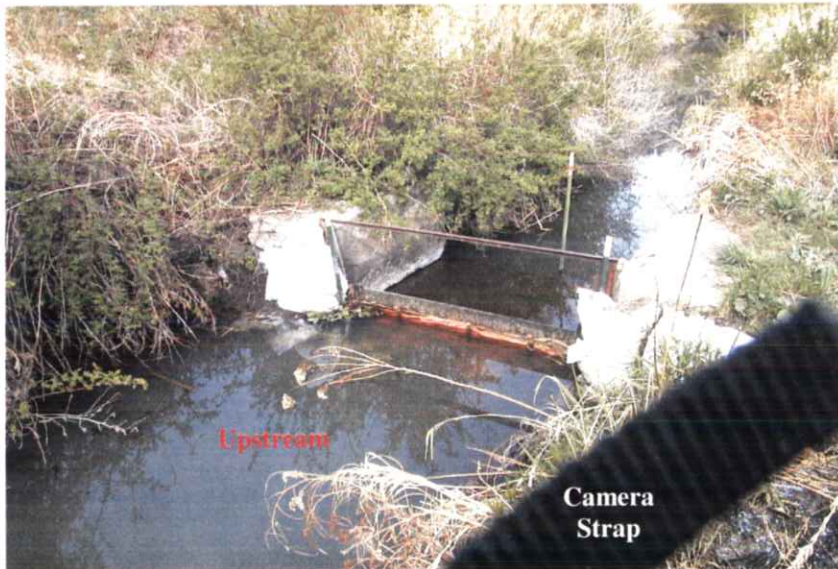
ABOVE & BELOW: Views of measurement point on the Upper West Ditch. Rather recently, efforts had been made to repair this weir. Efforts to repair this weir consisted of attempting to seal the upstream side with a plastic tarp and sand bags (photo below). Note that water adjusted in ditch so that no water is flowing over this weir. Water downstream of view can be contributed to continued leakage &/or water spilled over weir before water was adjusted in ditch or before efforts were made to repair the weir.

Mr. Smith, Ms. Blakely, and I discussed the situation and the current gate setting. It appeared to me that the current settings are in compliance with the Department's order issued last summer. Basically, if functional, lockable, control works and functional measuring devices are not in place, the water master is not to deliver water. Clearly, the control works at the point of diversion for the West Ditch at Rock Creek are not functional. In addition, the efforts to repair the measuring point on the Upper West Ditch could be improved upon.

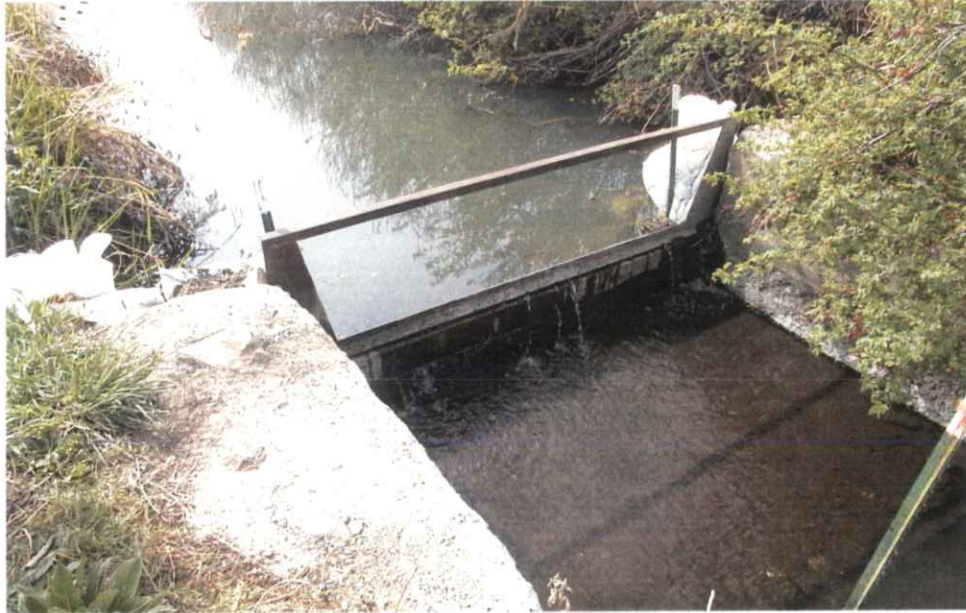
ABOVE: View as adjustment was made at spill location to send additional water down the Upper West Ditch showing leakage through measurement weir.

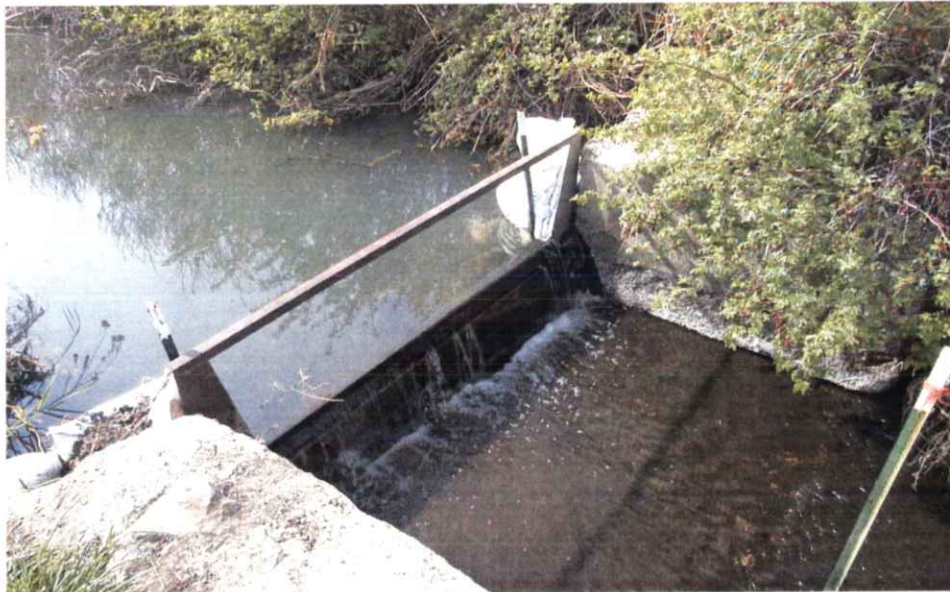
BELOW: Same as above, only view just as water spills over the top of the weir showing leakage.
