RE: Delivery of Pomerelle Diversion

Memo

Subject: Field Visit to Pomerelle Ski Area diversion for 45-04114

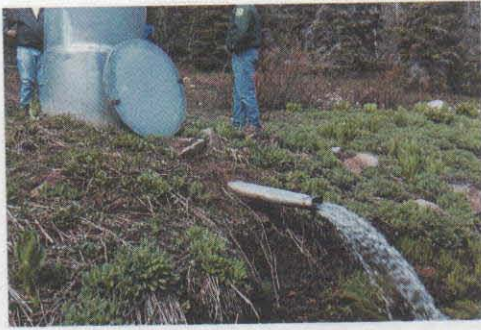
This is the spring box with overflow back into Howell Canyon Creek. Inside the metal box is a submersible pump that conveys water up the canyon to Pomerelle ski facility.

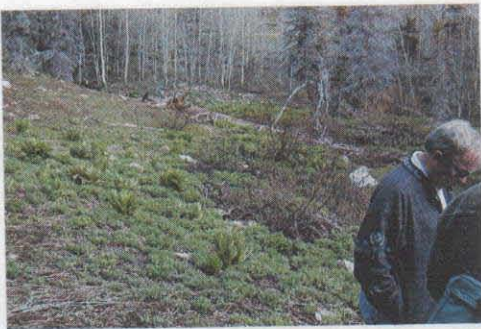
This area west of the spring box is where a tile drain is reported to be located that collects the water that flows into the spring box.

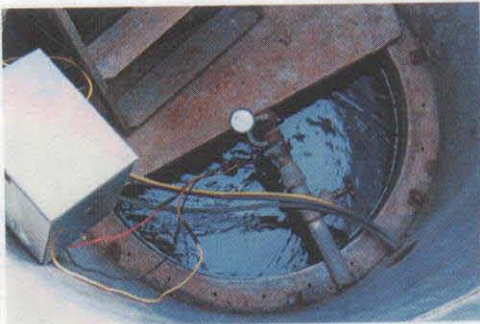
View inside the box. Note the valve was open and the pump was running. The pressure gage was not operating (broken). The top of the spring box is locked with keys possessed by Andrwood Inc.

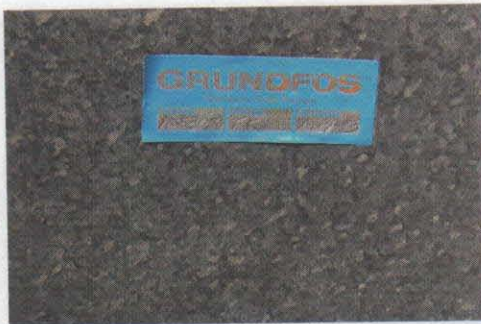
Tag inside spring box.

The pump size was not obtained during the site visit by me; although, it was indicated that documents describing the system were included with the water right files or on record at the Forest Service. Review of the records finds that the pump is a 3.0 HP. This is consistent with the tag shown above. The records indicate originally there was an intermediate 2.0 HP pump and 1000 gallon storage tank at the parking lot but I understand that part of the system is plumbed around and not currently used. Instead the spring pump now pumps against the entire head on the system.

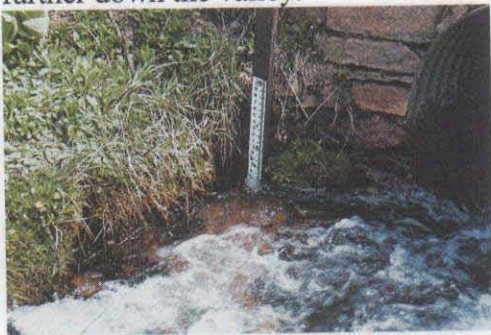
The gage near the spring box read between 0.49 and 0.54 feet. John went up and shut off the pump and we stood around for approximately 15 minutes and nothing appeared to change. We decided due to timing and fluctuation in the gauge that we probably would not note any appreciable change. *Note that Brockway report of measurements is included in the protested application file 45-07745.

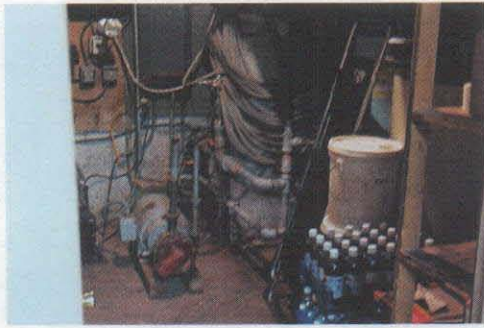
Pump Room. Note that the black plastic line is where the water enters from the spring box pump. The black plastic line was installed after the line froze in February of this year. The line teeing off to the left below the plastic exits to the storage tank above the lodge. The pump to the left not currently connected was the snow making booster pump.

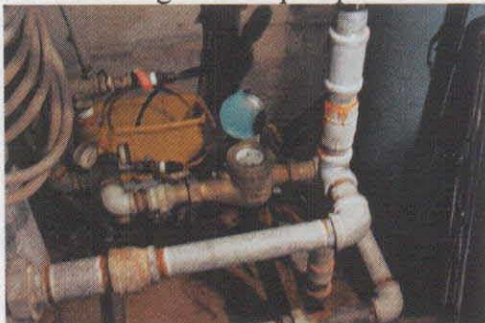
After the tee to the reservoir, water continues down the pipe and over to an iodine injection site then to a pressure tank then back out through the meter and then to the distribution line for uses at the lodge and residences. All water currently used in these facilities is metered. Mr. Anderson has provided copies of the records since 1997. The attached spreadsheet is based on his records. Note that the meter totalizes water use and reads out in hundreds of gallons. We took a reading of 08443. The previously recorded reading was 08442 on 5/5 indicating a use of 100 gallons in 11 days. During this inspection John flushed toilets and turned on water and the meter moved and appeared to be in good operating condition.

-I recommend that the watermaster be instructed to monitor the use using the existing meter and require Andrwood &/or the USFS to make the records available. The meter record

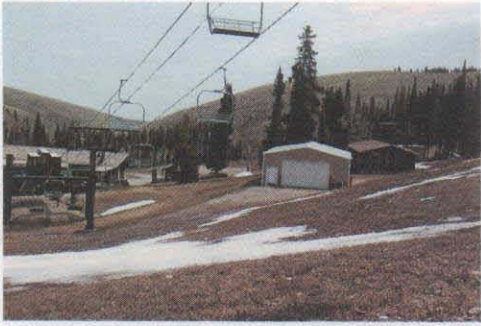
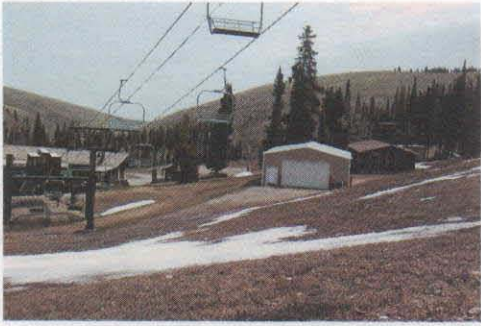
The lodge is to the left. The shop in the center has a small living quarters. The manager's residence is at the right. Some grassed area surrounding buildings is reported to be irrigated on occasion and as noted in the AJ claim there may be up to 2.0 acres irrigated.

-I recommend that irrigation at the facility not be allowed unless the use is mitigated.

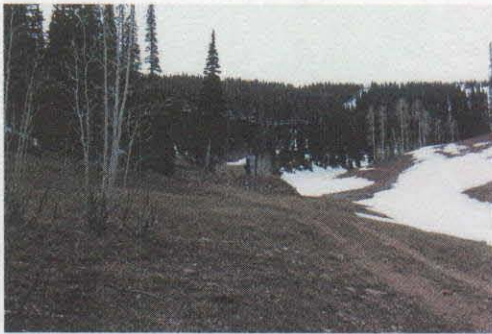
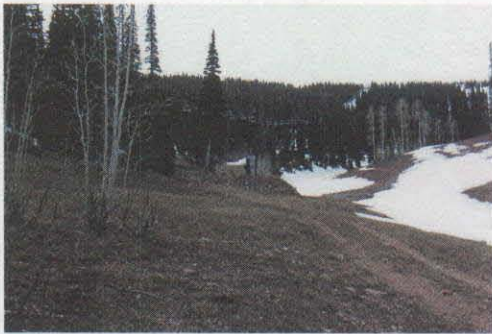
This is the buried storage reservoir above the lodge.

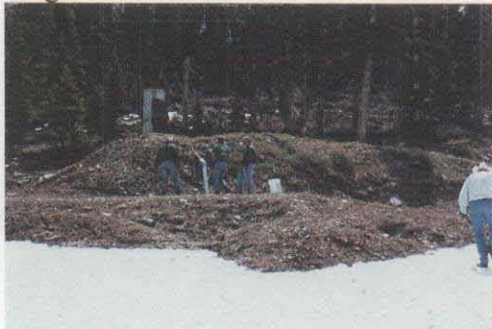
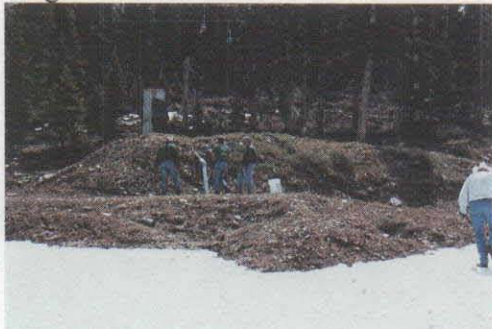
This is a view from the west of the storage tank reported to be 60,000 gallons. The overflow discharges back into the drainage. This was disconnected and the overflow was measured using a bucket and stopwatch while the spring box pump was reported to be running. The measurement found 1.9 gpm being discharged. Assuming all uses were off and the pipeline was not leaking this would be the discharge rate of the spring pump plus water from what is known as Ski Run Spring. This rate seems low when comparing the other records in the water right files and what would be expected to have been pumped. I believe this system may continue to have some hydraulic problems. It is noted that the lower pipeline was replaced last winter due to problems.

-I recommend that the system be analyzed further by the USFS &/or Andrwood for suspected hydraulic problems and any analysis be made available to the department.

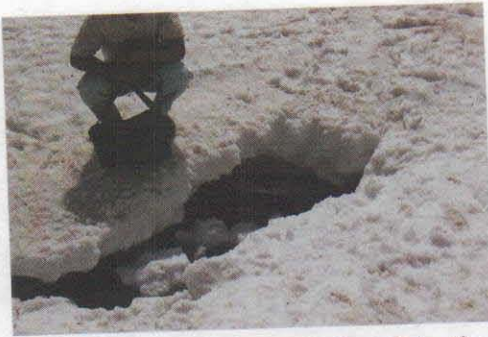
This is the site where the discharge from the tank flows into a stock trough then into the small drainage that flows back to Howell Canyon Creek. It was still covered with snow and could not be totally observed. This stockwater use is covered under decree 45-11985.

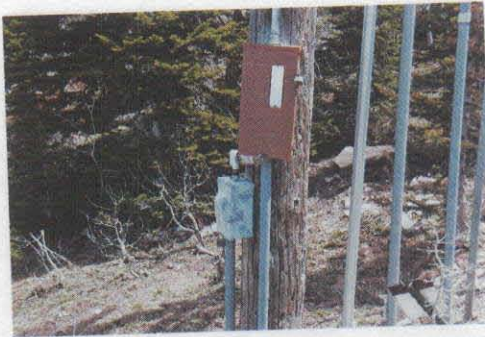
This is the switch box at the lower end of the parking lot at the lodge that controls the spring box pump.

The reason given why the pump runs all the time was to prevent freezing. Past problems with freezing is reported to have caused pipeline failure so it has been determined to keep the pump running instead of having the pipeline freeze.

-I recommend that the pump be shut off during the summer months during the irrigation season and only turned on as required to fill the tank or to protect the line due to a freezing period as needed after consulting with the watermaster. If the watermaster needs to regulate the pump he should seal the power box but not lock it due to potential fire protection needs.

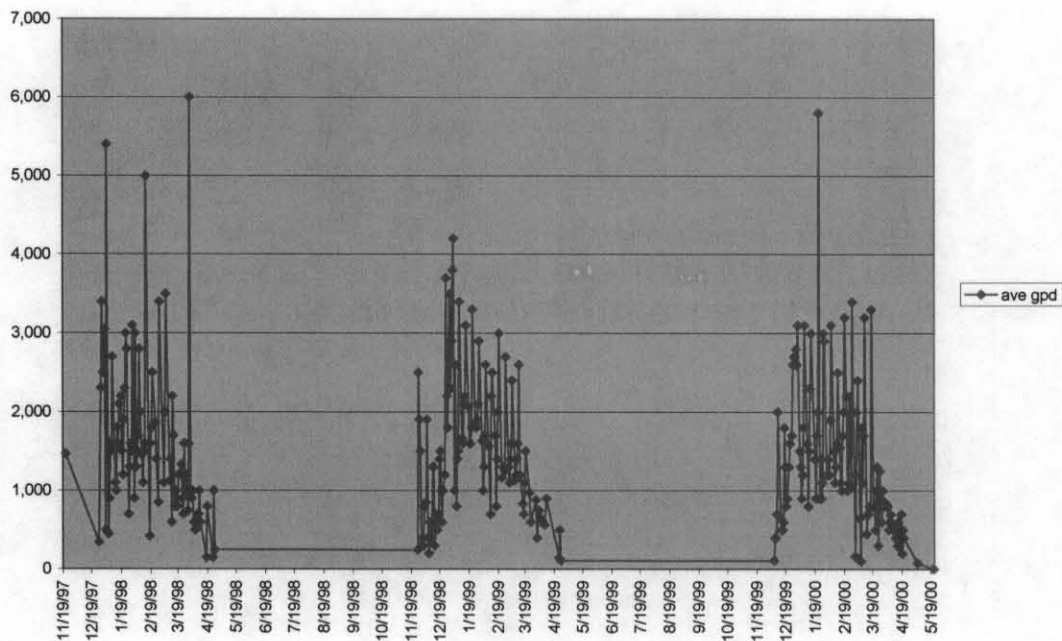
Pommerelle average gpd

This is the metered water use based on the records provided by Mr. Anderson for the lodge and residences. As can be seen the use in the summer is minimal. It is understood that much of the water used is discharged into a septic system within the hydrologic basin of Howell Canyon Creek.
